**CAMBRIAN MOUNTAINS ESA, HISTORIC MONITORING**

**BASELINE 1995**

<b>OS 1:10000 SHEET:</b> <del>SO/SH/SN</del> 80		<b>GRID REF:</b> <del>SO/SH/SN</del> 8519 0091	
<b>PRN:</b> 1729 <b>SITE NAME:</b> Lluest Cethingrych Hafod.			
<b>AIR PHOTO No</b> 649-40		<b>LANDSCAPE TYPE:</b> IIa	
<b>No GROUND PHOTOS:</b> 6			
<b>DATE SURVEYED:</b> 6/12/95		<b>SURVEYED BY:</b> G A Harwood	
<b>ACCESS:</b> Land owned by Mr Pughe, Maesteg Farm, Darowen, Machynlleth. Tel 01650 511840.

CAMBRIAN MOUNTAINS ESA HISTORIC MONITORING RESURVEY 1999

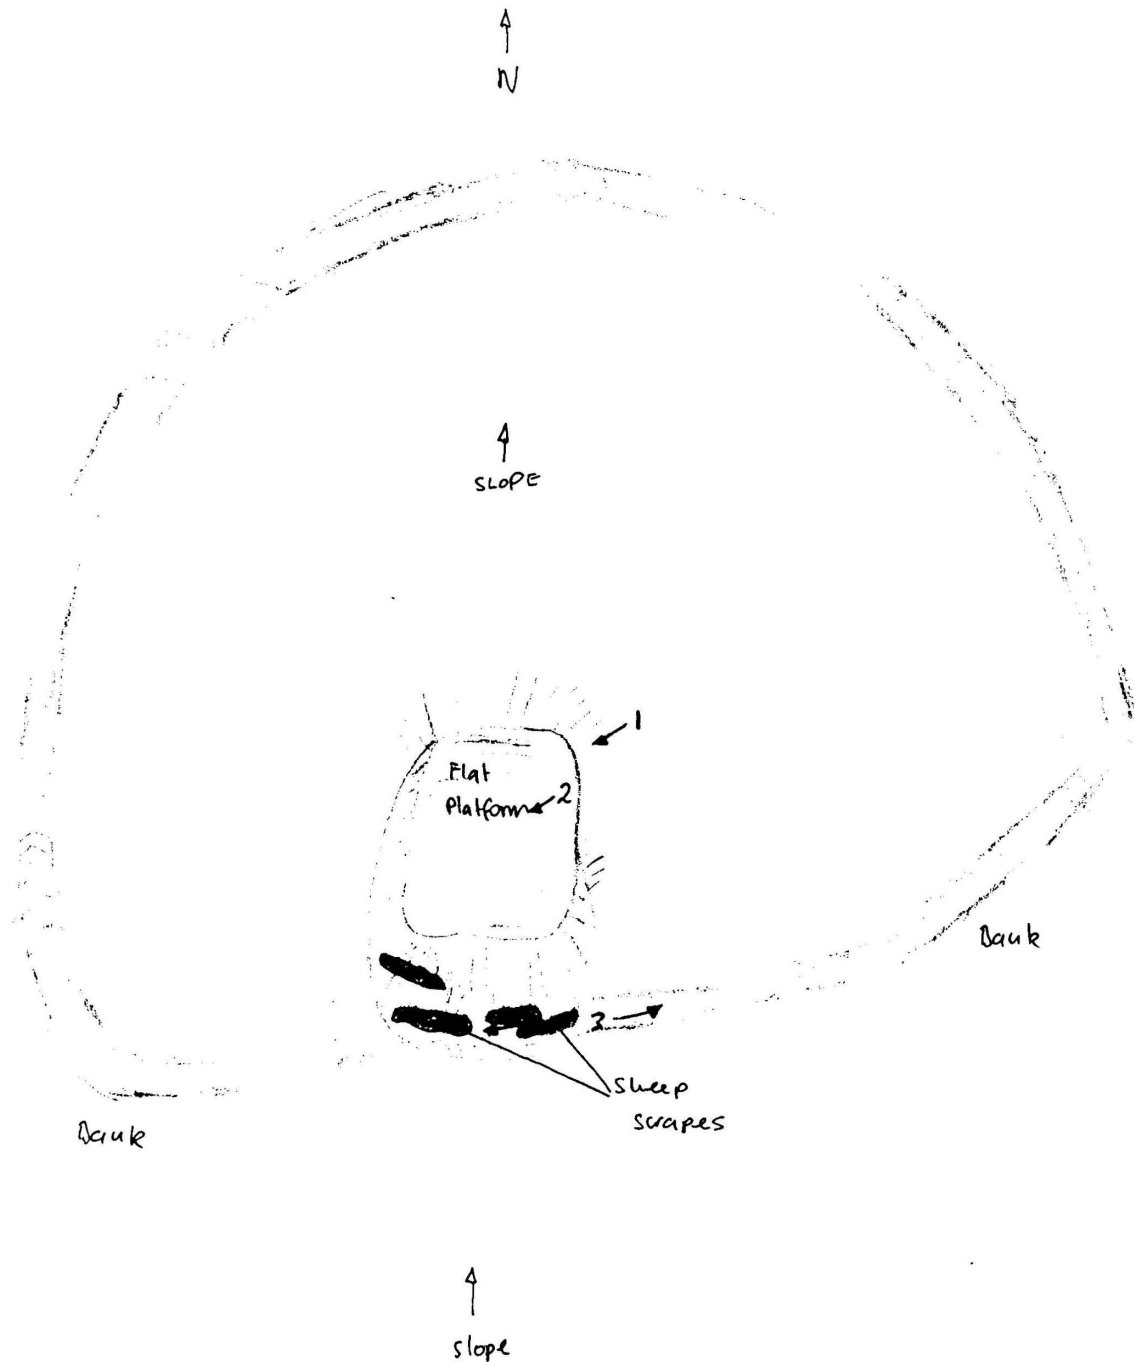
level platform some 8m x 5m cut into hillside.  
Enclosed by a boundary bank approx 2m wide and 20-30cm high. Enclosure roughly D-shaped and 30m wide. Slope behind platform being eroded by sheep - creation of scrapes for shelter. Soil slumping down onto platform area. Banks not very obvious especially directly

Removal of vegetation and soil erosion by sheep via creation of sheep scrapes. Feature is on a fairly steep slope which could cause problems with water erosion if soil is exposed. In fairly good condition at present, banks eroded but still visible.

D/ downslope infant of platform. Feature built on a north facing slope with an excellent view over the valley below.
