CAMBRIAN MOUNTAINS ESA, HISTORIC MONITORING

BASELINE 1995

OS 1:10000 SHEET: SO/SH/SN	GRID REF: SO/SH/SN
PRN: 5069 SITE NAME: TY NEWYDD HOUSE	
AIR PHOTO No	LANDSCAPE TYPE:
No GROUND PHOTOS: 11	
DATE SURVEYED: 19/1/96	SURVEYED BY:
ACCESS: Griffiths, Nant-y-fm.

CAMBRIAN MOUNTAINS ESA HISTORIC MONITORING RESURVEY 1999

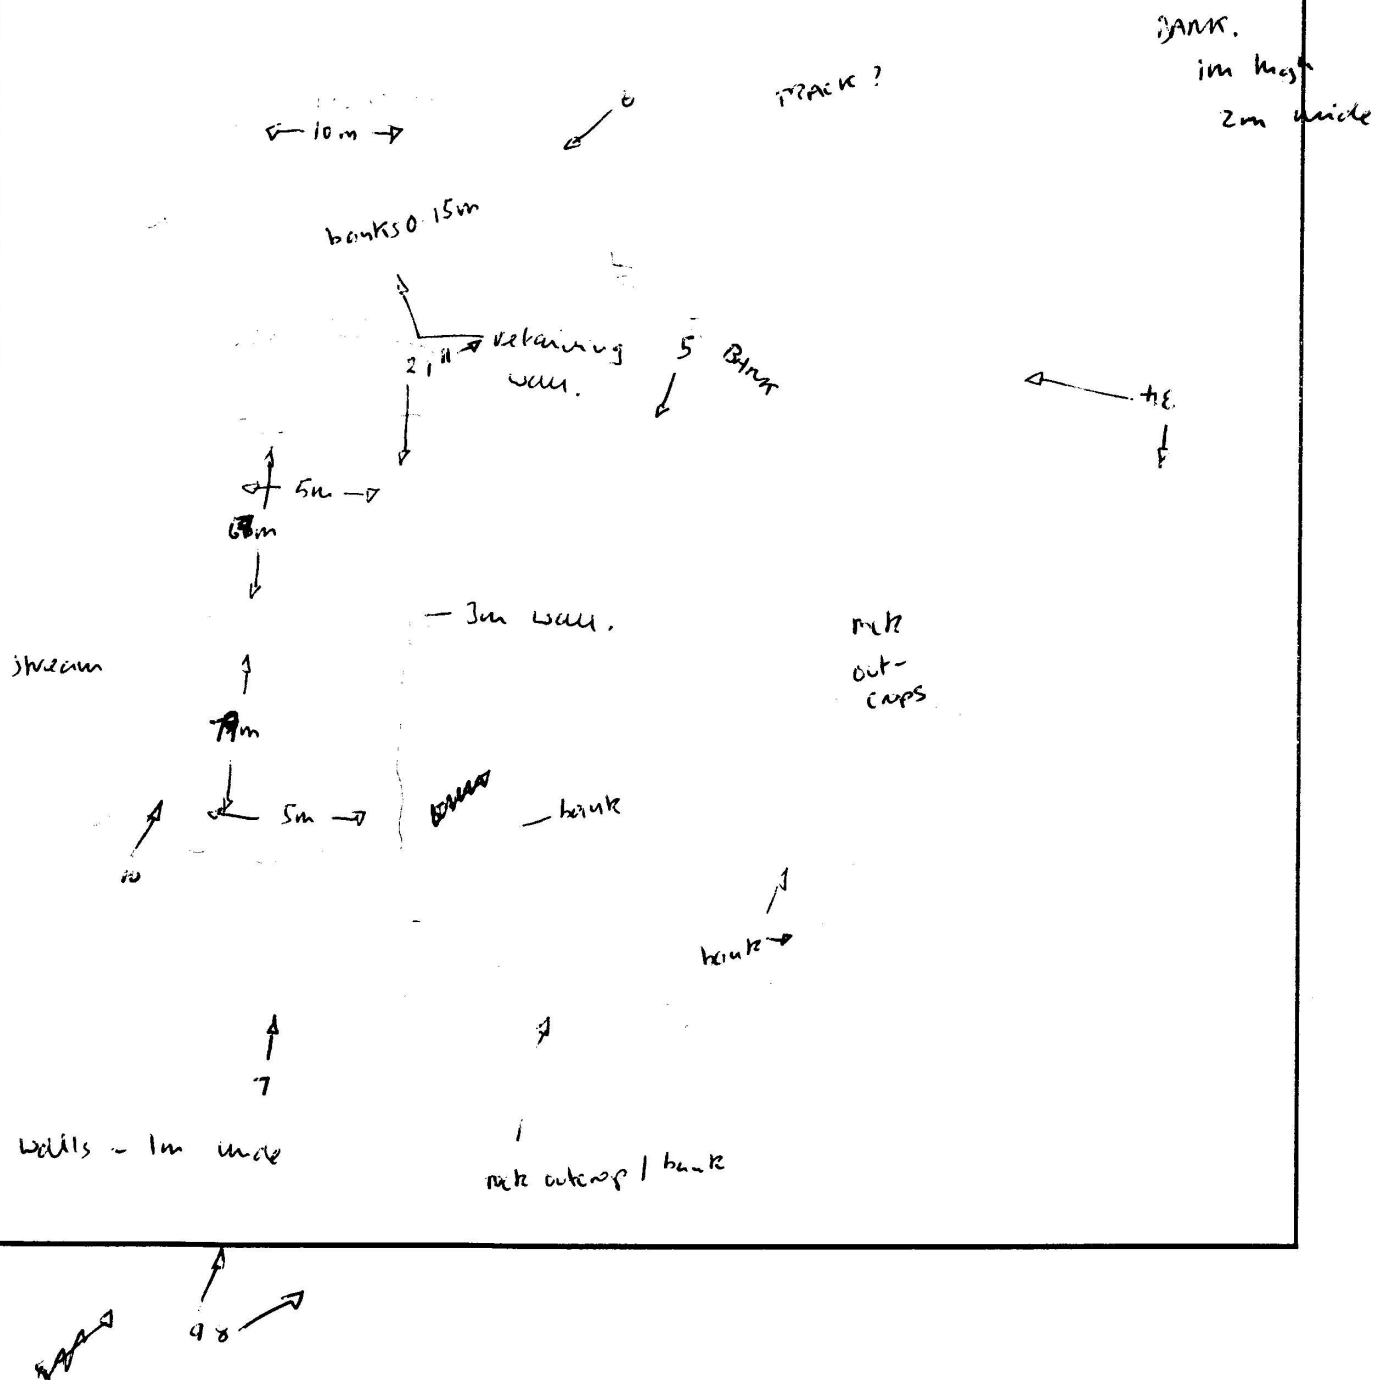
Small circular enclosure below retaining wall to NW.
(Photo 1)

Larger enclosure with internal banks to E. Evidence of
old tracks etc leading to main ruin. Heavily overgrown
by Juncus.
