CAMBRIAN MOUNTAINS ESA, HISTORIC MONITORING

BASELINE 1995

OS 1:10000 SHEET: SO/SH /SN 97	GRID REF: SO/SH/SN
PRN: 5184 SITE NAME: <i>Greenby Mound 1</i>	
AIR PHOTO No <i>649 - 167</i>	LANDSCAPE TYPE:
No GROUND PHOTOS: 6	
DATE SURVEYED:	SURVEYED BY:
ACCESS: <i>land fenced by Allthwaite fm.</i>

CAMBRIAN MOUNTAINS ESA HISTORIC MONITORING RESURVEY 1999

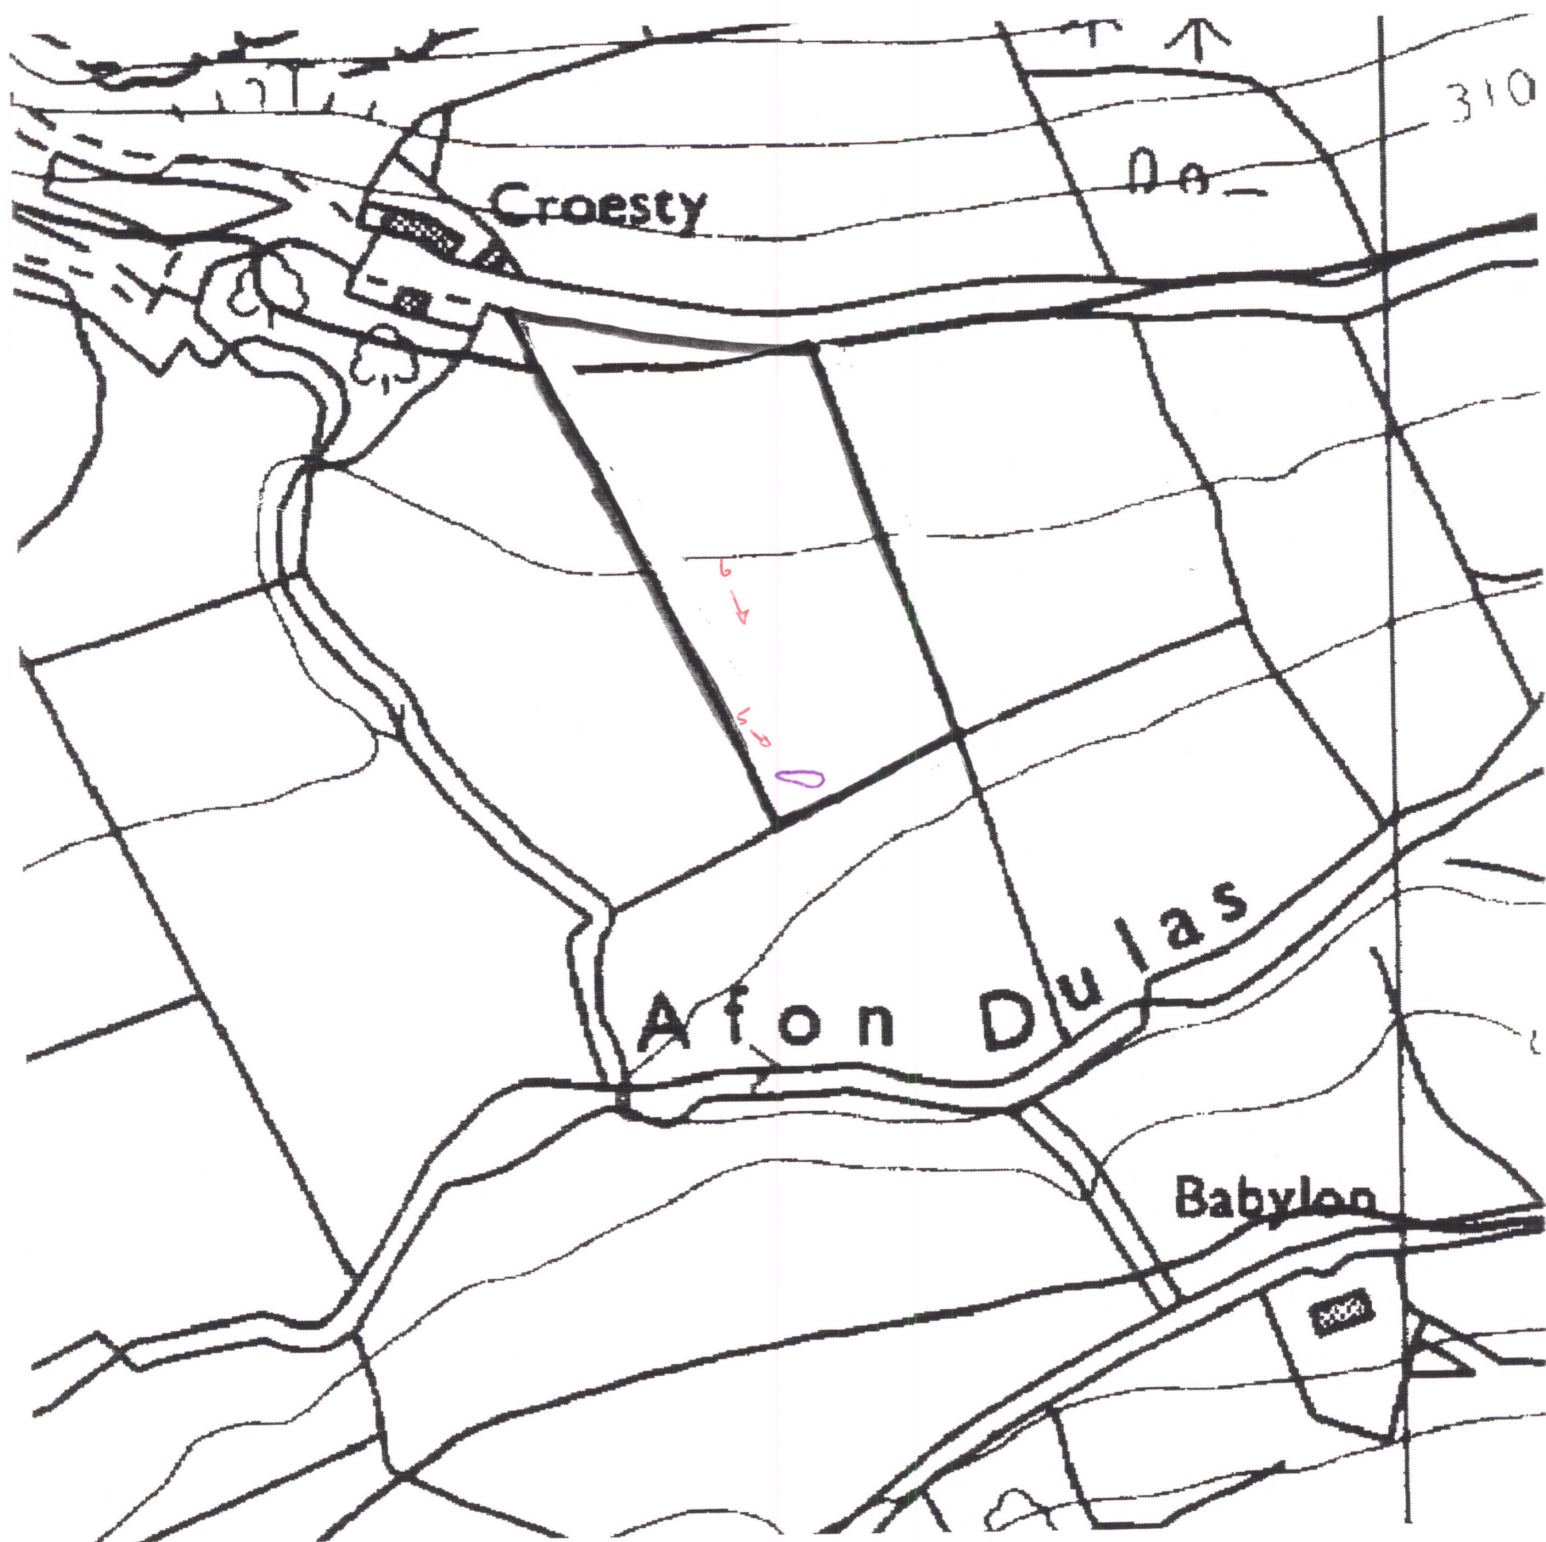
Cambrian Mountains ESA SN 9680 7773

Elongated oval mound on a flat sculpted out bank. Approx 15m long. Ditch upslope 2-3m wide 1/2m deep. Mound 1 - 1.25m high. 3 mature oaks + 3 hawthorn + 1 blackthorn growing on mound. 6m wide at fat end, tapering to a point. Does not appear damaged apart from tree roots.

Badger damage to sword near to mound, no burrowing. Very big oak trees - 20-25m, mature with some old horn bushes. Root damage. Mound still grassy and very little evidence of erosion / subsidence etc.
