LLEYN PENINSULA ESA, HISTORIC MONITORING

BASELINE 1994

OS 1:10000 SHEET: SH 44 SW	GRID REF: SH 4217 4070
PRN: 1310 SITE NAME: Standing Stone, Gwynedd, Llangybi	
AIR PHOTO No 88/04/19	LANDSCAPE TYPE: B. Plateau Mosaic
No GROUND PHOTOS: 3	
DATE SURVEYED: 25/8/94	SURVEYED BY: Lynn Davies
ACCESS: Land owned by Mr Hughes, Capel Mely, Llangybi. Park car in council houses estate car park, & walk down track by side of electricity sub-station to field.

LLEYN PENINSULA ESA HISTORIC MONITORING RESURVEY 1998

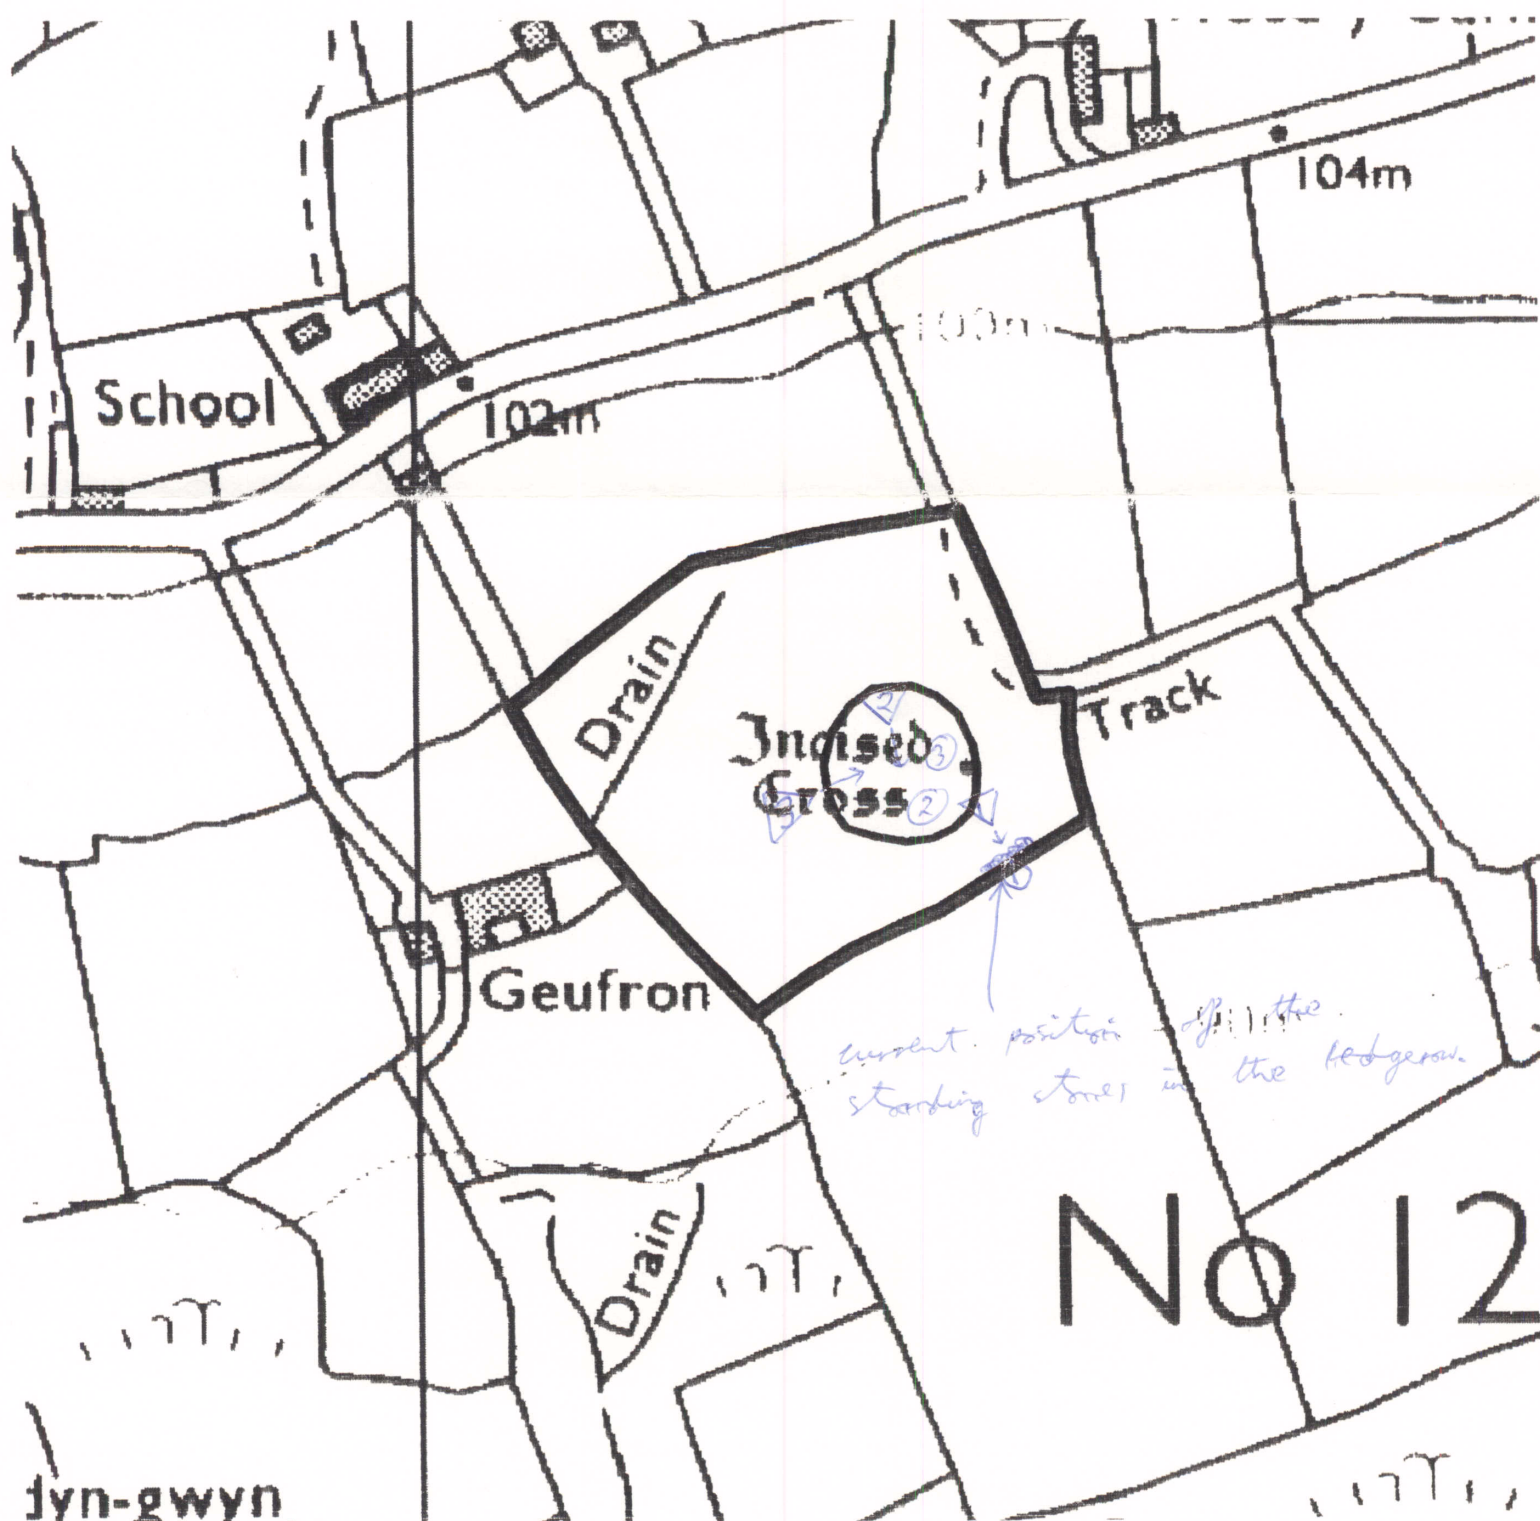
Talked to Farmer's father who told me that the stones (apparently there was more than one) were lifted & placed in the adjacent hedgerow several years ago as they were an obstruction (see map & photographs) to farming operations.

The removal of the monument from its standing position to its current sideways position in the hedgerow. The damage has already taken place.
A significant amount of cattle poaching, unlikely to lead to erosion.
