LLEYN PENINSULA ESA, HISTORIC MONITORING

BASELINE 1994

OS 1:10000 SHEET: SH 33 NE	GRID REF: SH 3820 3666
PRN: 432 SITE NAME: Hut Circle, Yoke House	
AIR PHOTO No 88/04/25	LANDSCAPE TYPE: A. Sheltered Parkland
No GROUND PHOTOS: 4	
DATE SURVEYED: 24.8.94	SURVEYED BY: Wyn Davies
ACCESS: One owner, Yoke House, Pullbrelli Park on farm lane leading to Yoke House, site adjacent to farm lane.

LLEYN PENINSULA ESA HISTORIC MONITORING RESURVEY 1998

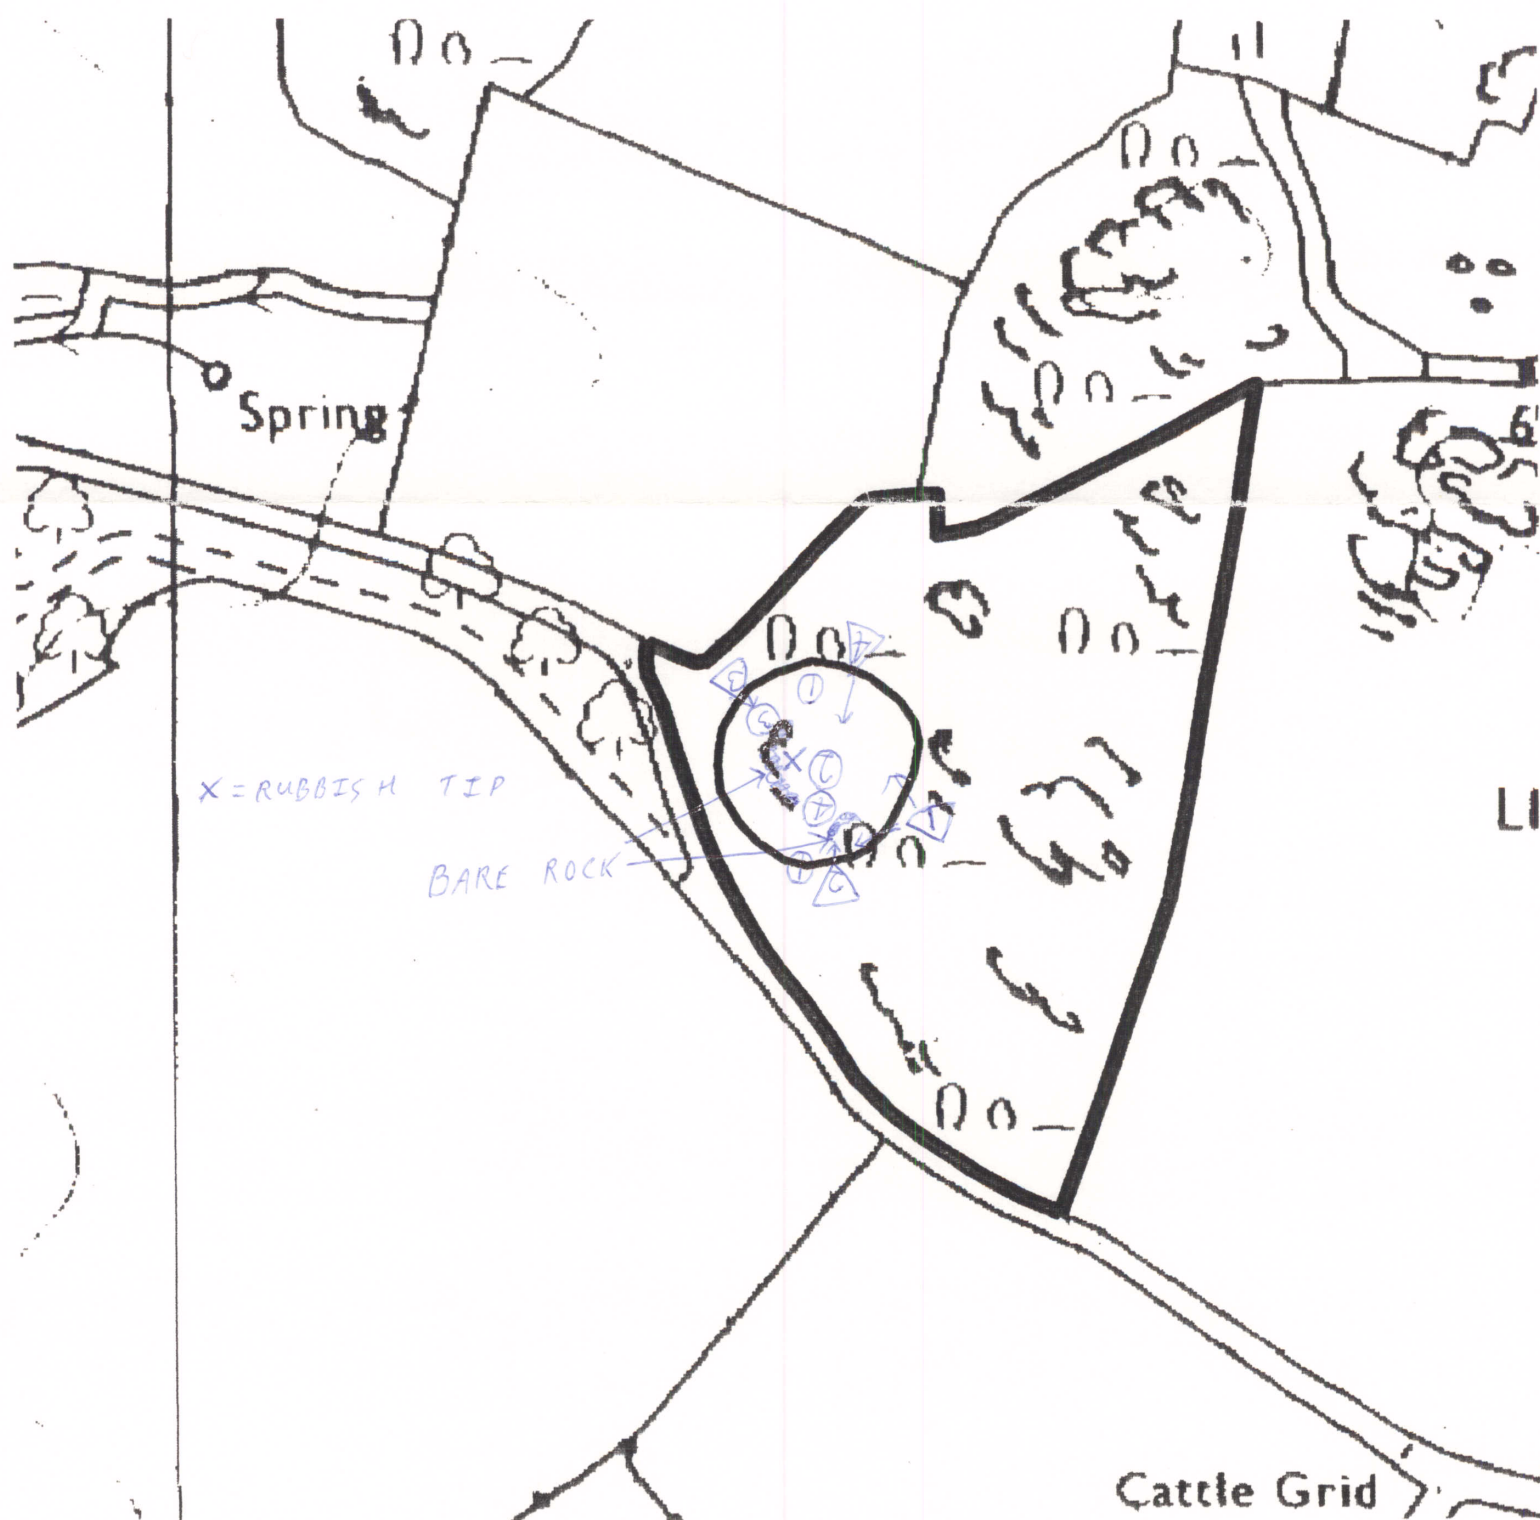
SH3820 3666

Timber frame & old roof ^{BRASS} ^{SLATE} ^{TILES} have been tipped in monument, around which ^{WIND} perennial weeds have grown to a height of up to 1m. Monument clearly defined raised feature. Intense tipping - use of monument as a tip is a threat to integrity of monument as it stands.
