PRESELI ESA, HISTORIC MONITORING

BASELINE 1994

OS 1:10000 SHEET: SM/SN 02NW	GRID REF: SM/SN 0281 2963
PRN:1289 SITE NAME: MYNYDD CASLEDMHE	
AIR PHOTO No 57/92/146	LANDSCAPE TYPE: A.
No GROUND PHOTOS: 4	
DATE SURVEYED: 15/11/94	SURVEYED BY: G.A. Harwood
<p>ACCESS: Common land.</p> <p>Path near cattle grid at grid ref: 020295.</p> <p>Follow fence line up slope and then follow indistinct path through heather to summit.</p>

PRESELI ESA HISTORIC MONITORING RESURVEY 1997/98

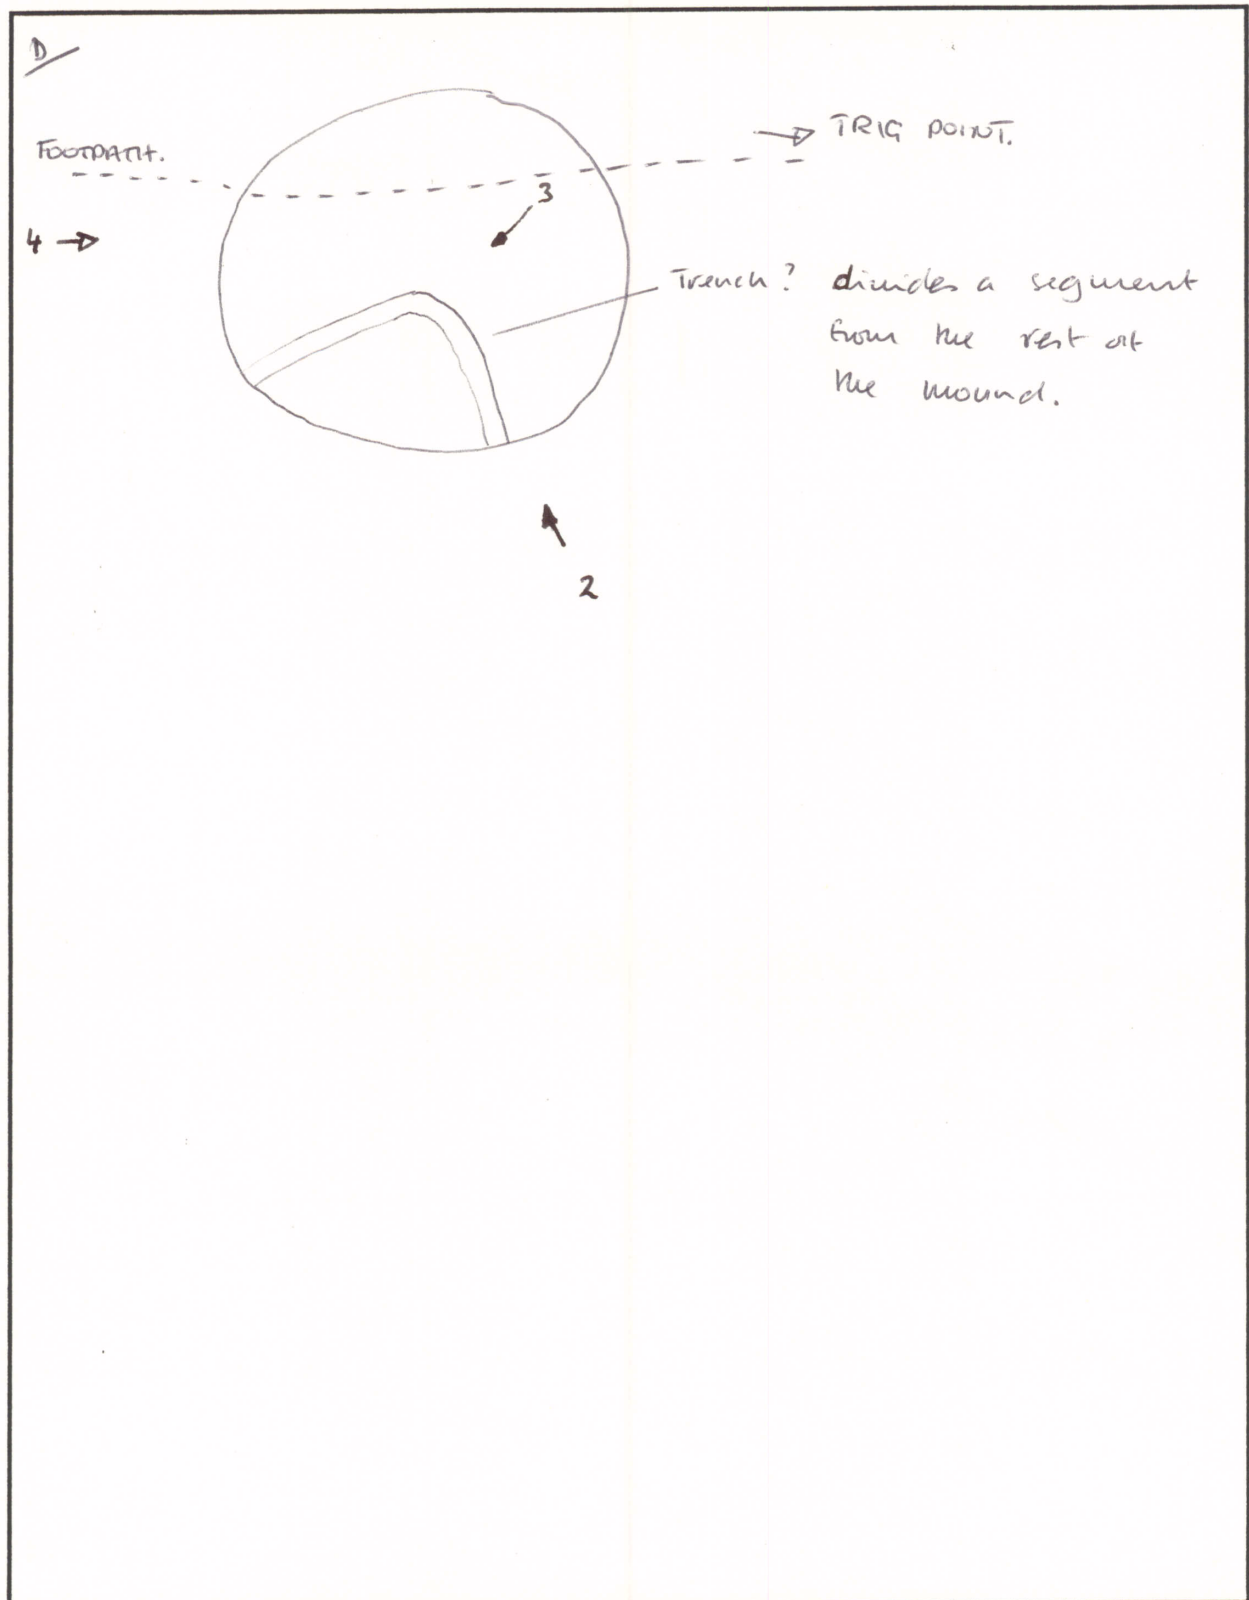
SUPPLEMENTARY NOTES TO FIELD SURVEYS PAGE OF PRN: 1289

circular raised mound 1.5 - 2 m above surrounding land. Continuous grassy / calluna SWS cover. No obvious signs of erosion etc. V shaped notch which resembles a 'slice of pie' is incised into one edge. See map overleaf + photo 2/3.

Diameter approx 18m.
