PRESELI ESA, HISTORIC MONITORING

BASELINE 1994

OS 1:10000 SHEET: SM/SN 02 ME	GRID REF: SM/SN 0641 2729
PRN: 1317 SITE NAME: HONMUS CROMLECH	
AIR PHOTO No 56/92/261 No GROUND PHOTOS: 8	LANDSCAPE TYPE: 9
DATE SURVEYED: 5/1/95	SURVEYED BY: SA HOPWOOD
ACCESS: land owned by Mr Phillips, Blacknuck farm. Tel: Maenchochog 532471. Grid ref: 070275.

PRESELI ESA HISTORIC MONITORING RESURVEY 1997/98

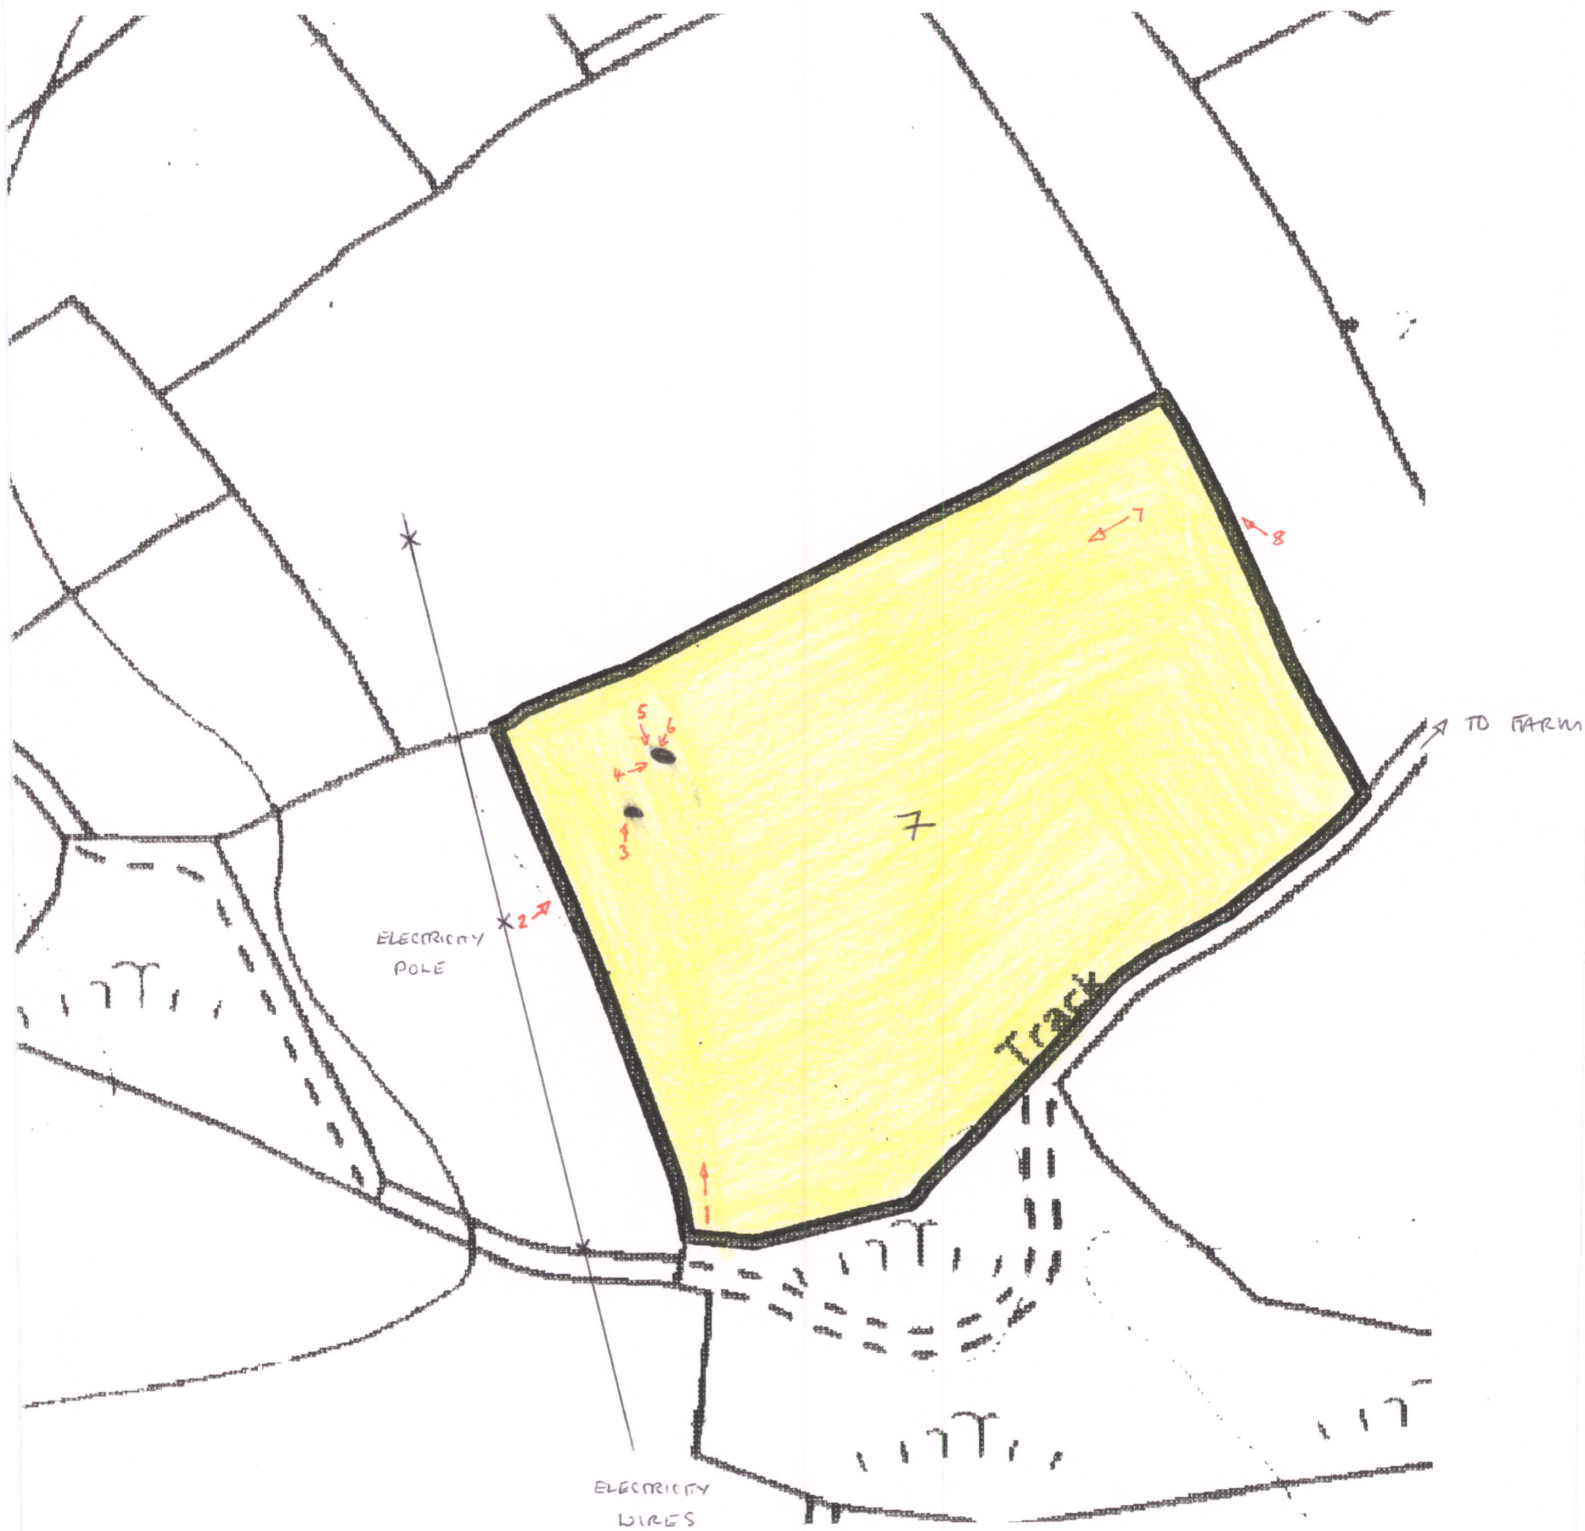
Two separate piles of stones. The smaller of the two lies to the S and is virtually flush with the ground surface. The mound of stones to the N consists of two buried stones protruding 0.75-1.0 m above the ground with a third boulder wedged between. There are smaller rocks heaped around these three stones. This mound appears

Currently at risk from damage caused by livestock rubbing on stones and poaching surrounding ground.

D/
to be a focal point for livestock. The stones have been rubbed smooth and there is a muddy circle around them where livestock have trampled the sward. The farmer has cleared other stones in this group and mentioned that some were buried 15-20 feet deep. He seemed to think that they were a natural feature.

The present arrangement is semi-natural. Some of the stones could obviously not be moved - while others have been placed on or around them to clear the surrounding area.

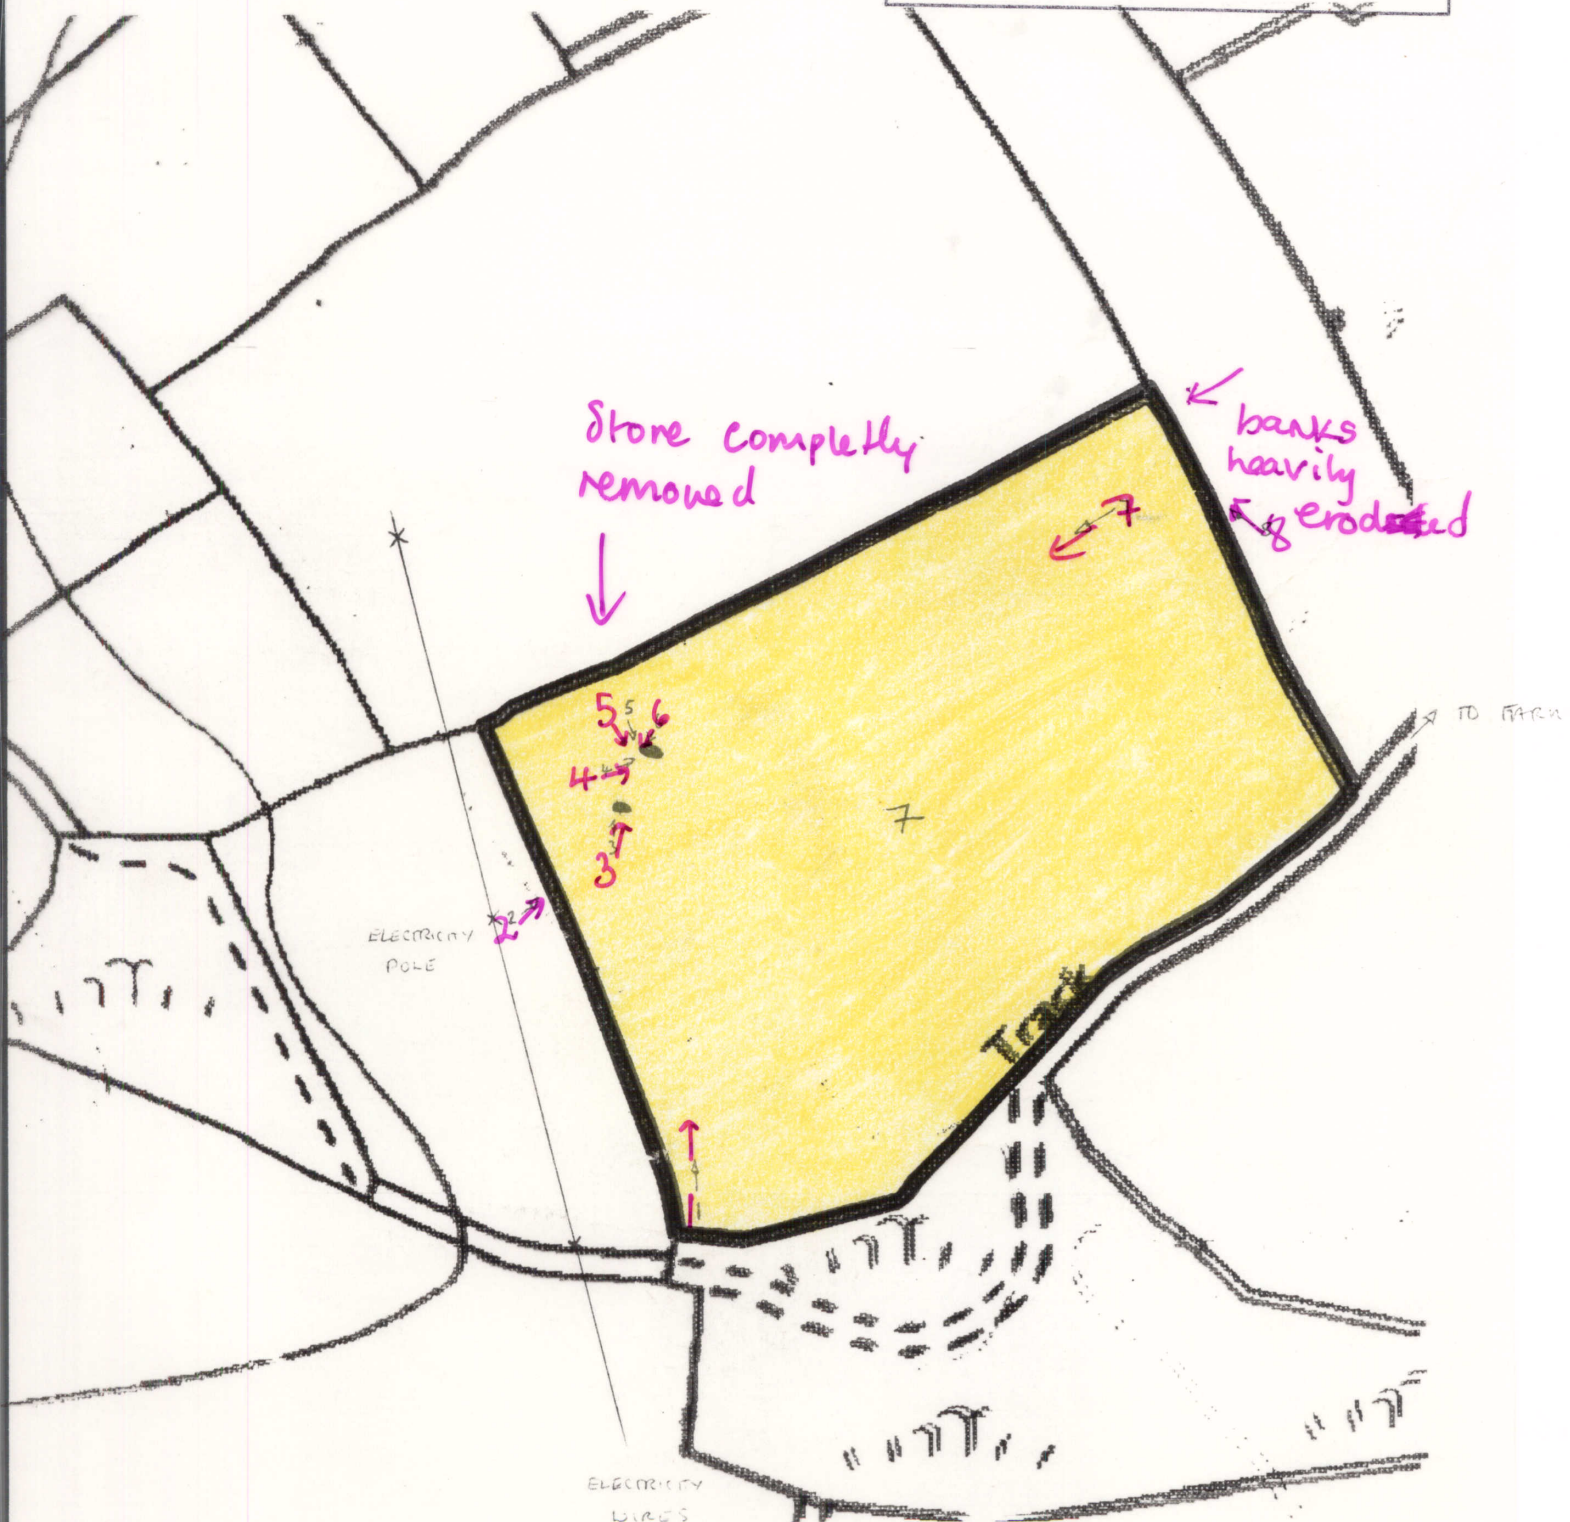
Stones COMPLETELY REMOVED. SEE photos ③ ④ ⑤ ⑥
Farmer recently removed them, believed them
to be just natural features - as he had to
dig down a considerable way to remove them.

Completely removed.
