YNYS MÔN ESA, HISTORIC MONITORING

BASELINE 1993

OS 1:10000 SHEET: SH 47 NW	GRID REF: SH 4164 7503
PRN: 2136 SITE NAME: STANDING STONE, GRAIG LAS	
AIR PHOTO No 63, 64	LANDSCAPE TYPE: 2
No GROUND PHOTOS: 4	
DATE SURVEYED:	SURVEYED BY: Mark Recorder.
ACCESS: Mr BONES CAE E THIN	
CONSENT FOR RELEASE? YES <input type="checkbox"/> NO <input type="checkbox"/>

RESURVEY 1996

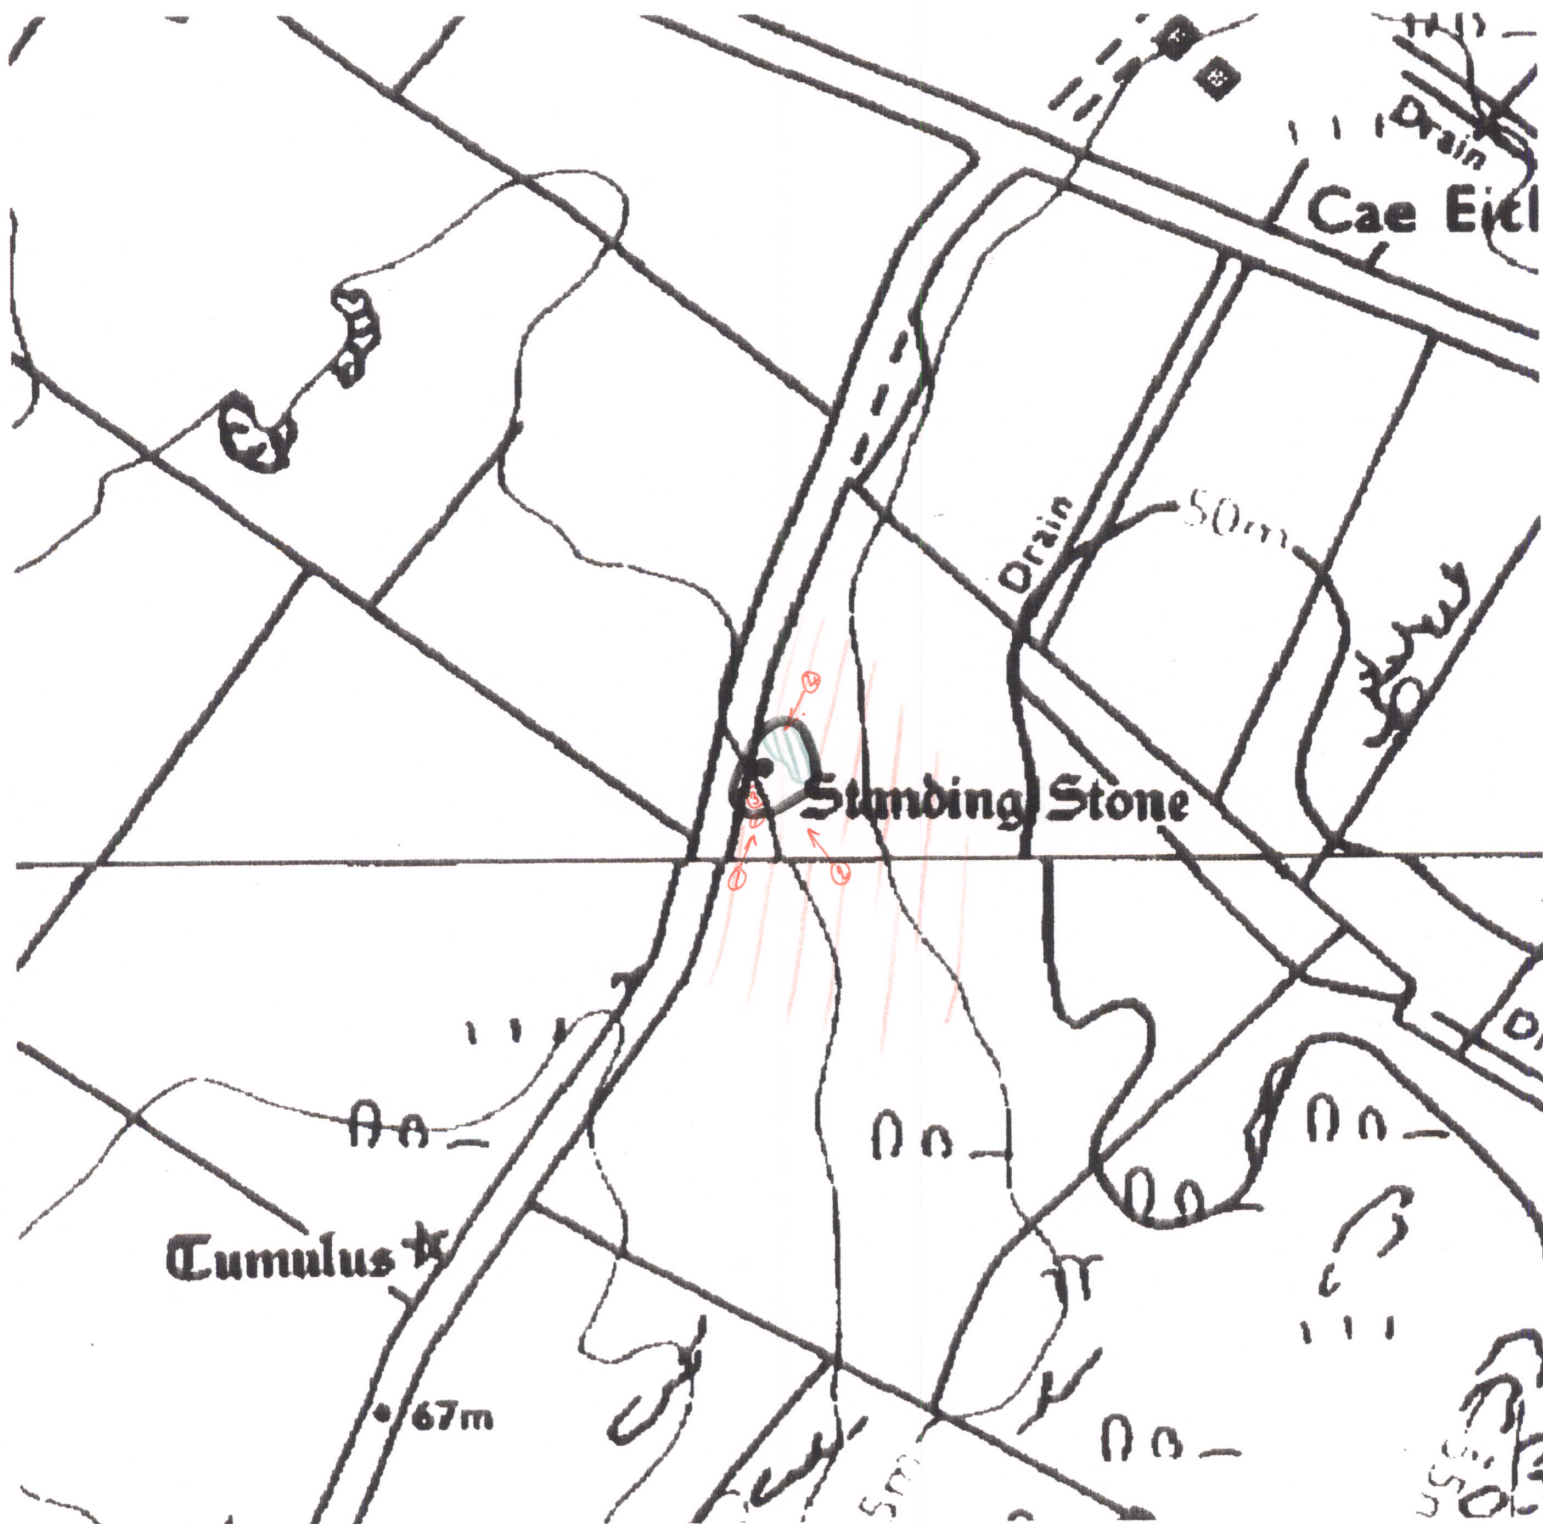
GORSE

IMPROVED PASTURE

<p>LAND COVER:</p> <p>SITE: A raised area, because (of the promontory) of a rock outcrop - the stone is vegetated by grass and moss. The outcrop is only visible in about 15% of the area.</p> <p>HALO:</p> <p>Mostly improved pasture - but with patches of vegetation similar to above.</p>
--

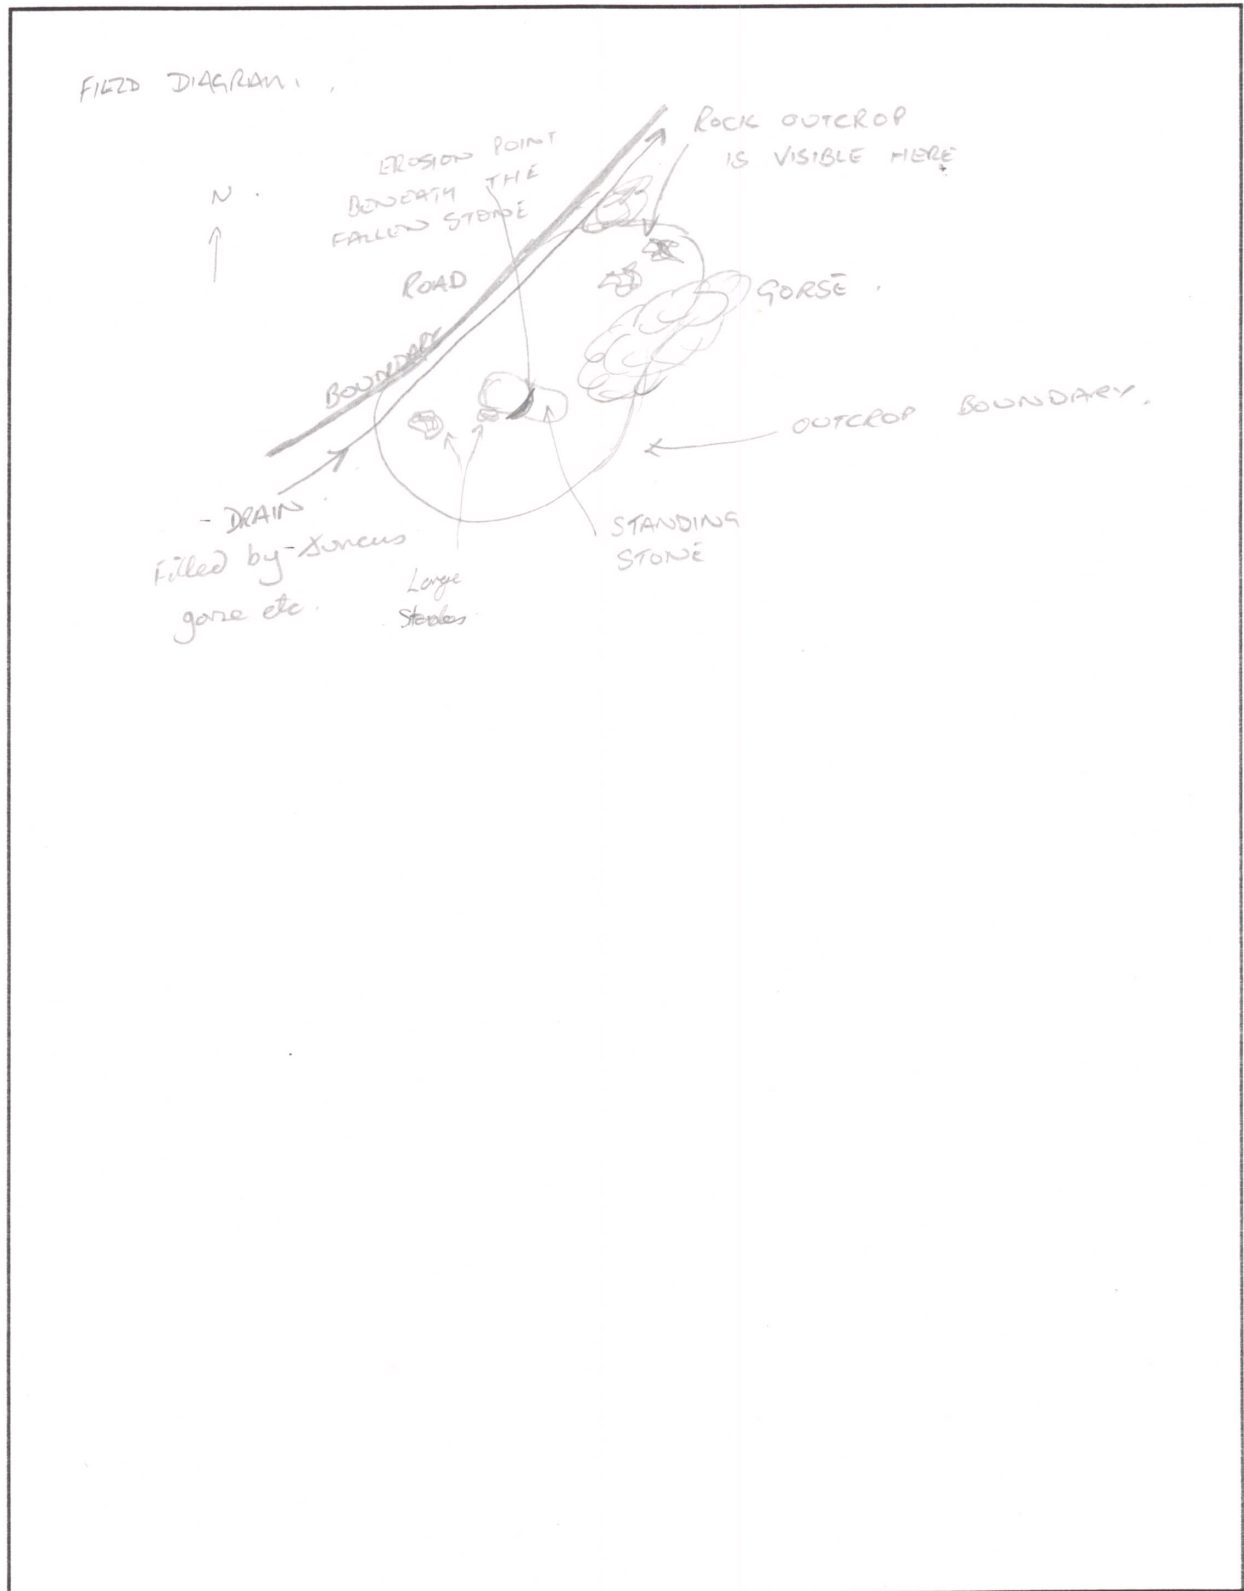
SUPPLEMENTARY NOTES TO FIELD SURVEYS PAGE OF PRN: 2136

Set on a raised outcrop the standing stone was set amongst several smaller stones which were buried around it. The stone has now fallen off over and from the marks at the base of the stone was only buried to a depth of just over 6 inches.

Now the stone has fallen there is the possibility that it may be removed. The reason for it falling was probably because of the depth that it was buried and from erosion at the stones base on the east side, the direction it fell.

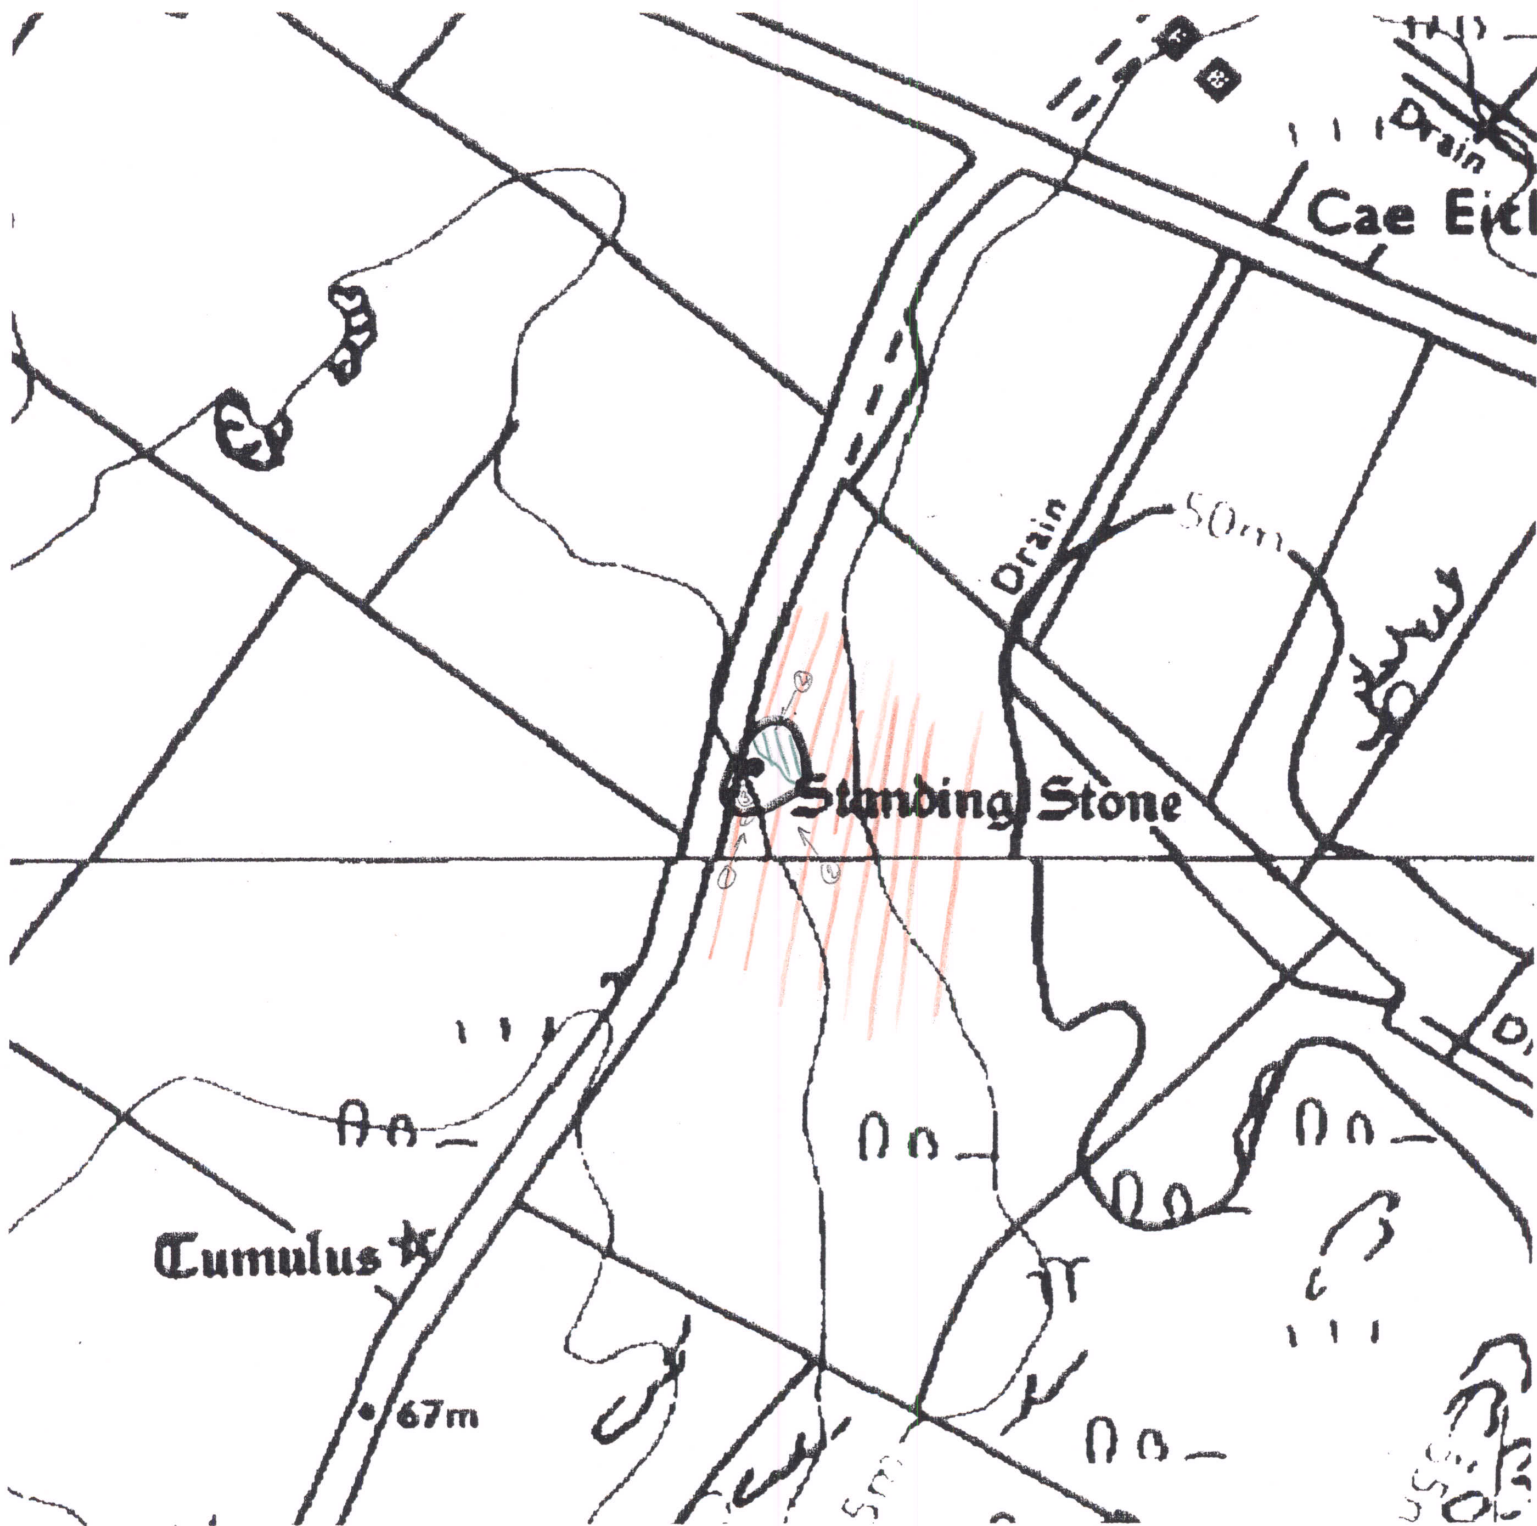
GORSE

IMPROVED PASTURE
