YNYS MÔN ESA, HISTORIC MONITORING

BASELINE 1993

OS 1:10000 SHEET: SH 28 SE	GRID REF: SH 2596 8004
PRN: 2504 SITE NAME: Treardur burial chamber:	
AIR PHOTO No 203	LANDSCAPE TYPE: 10
No GROUND PHOTOS: 6	Holy Island.
DATE SURVEYED: 8/12/93	SURVEYED BY: Mark Alexander.
ACCESS: GR: 261 804 for the owner. from on the left coming from Holyhead - large farm.	
CONSENT FOR RELEASE? YES <input type="checkbox"/> NO <input type="checkbox"/>

RESURVEY 1996

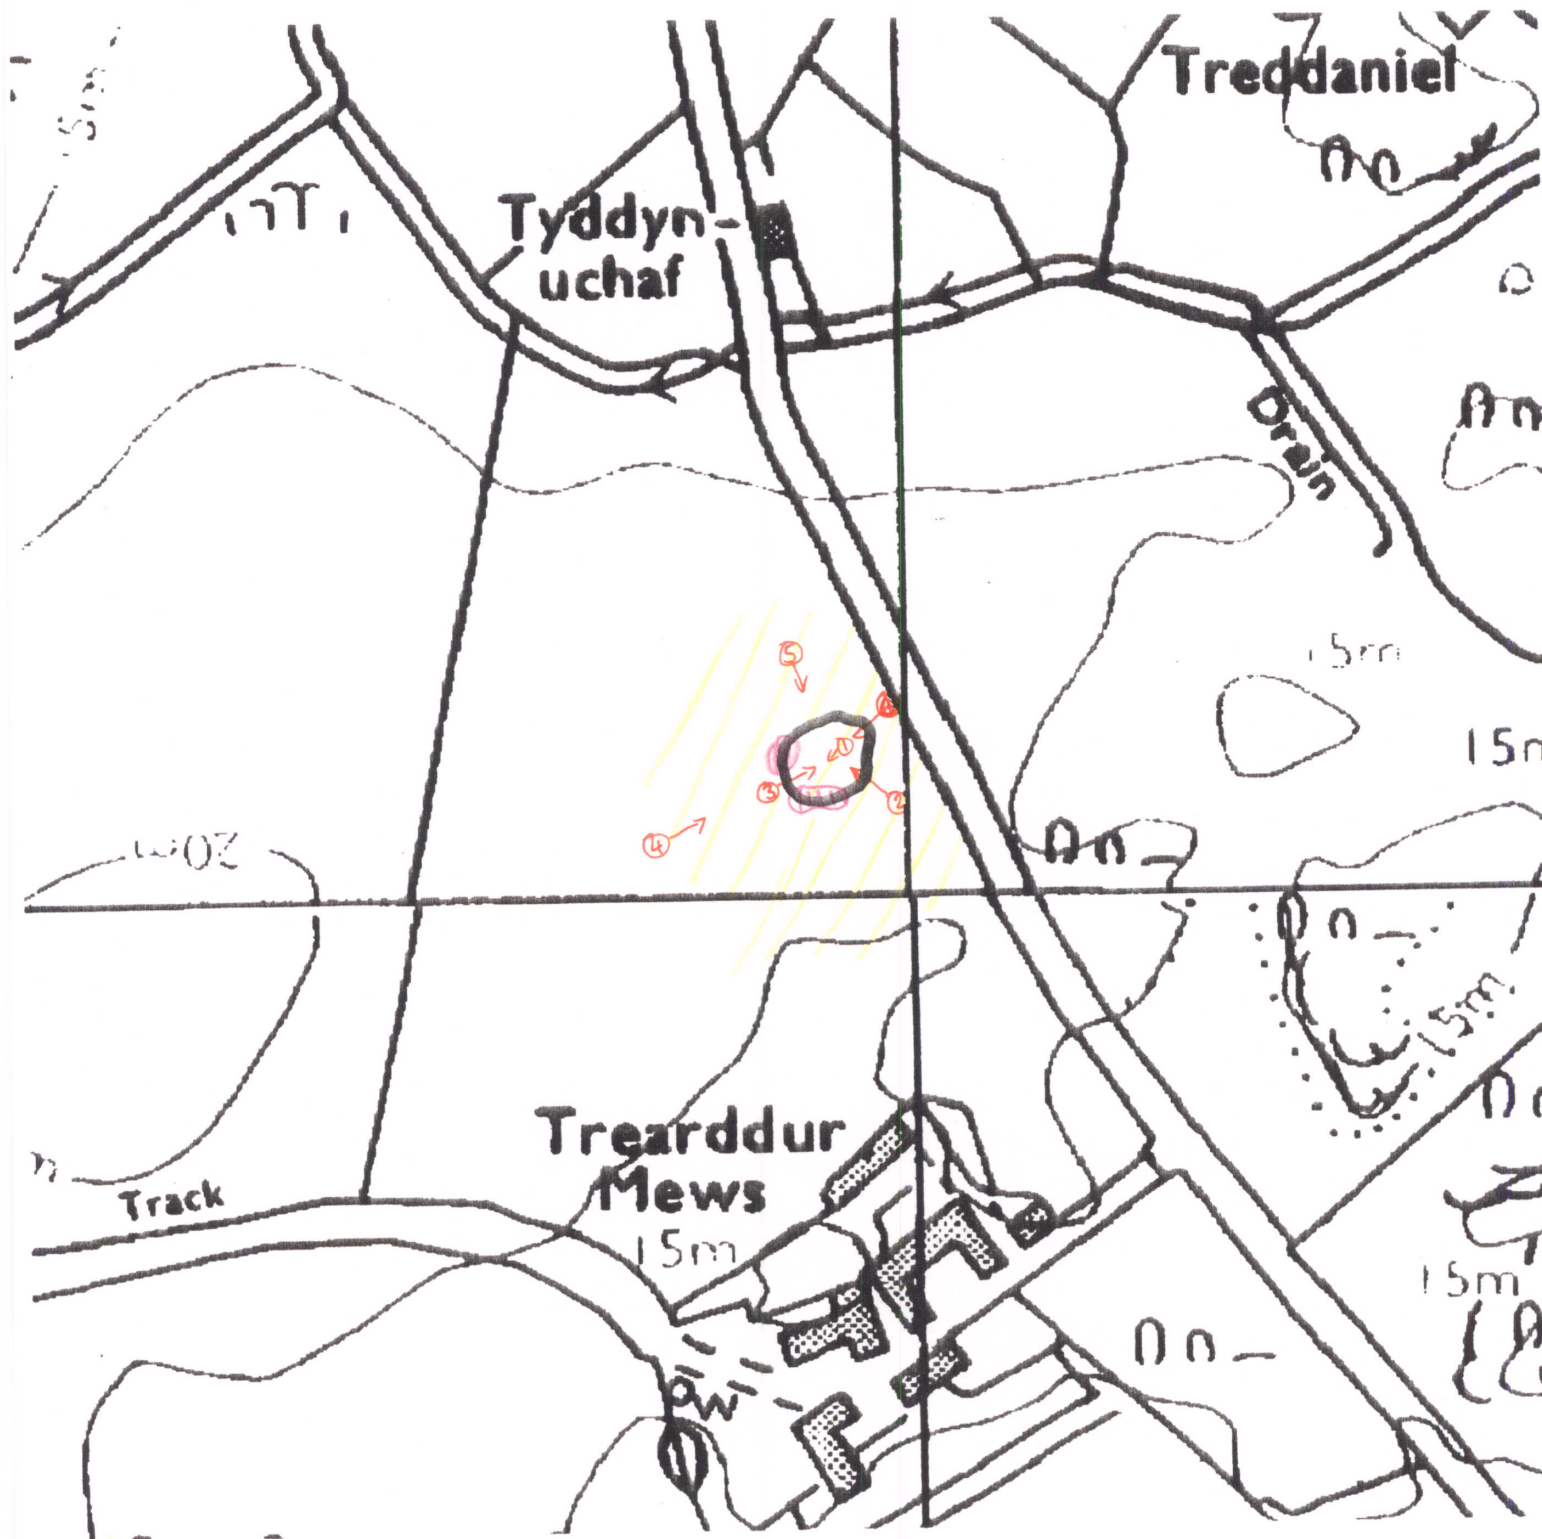
Improved Pasture.

Clare.

A standing stone is situated in the centre of a large platform area. Surrounding the standing stone, which has deteriorated considerably are several large boulders which are now buried in the ground.
