YNYS MÔN ESA. HISTORIC MONITORING

BASELINE 1993

OS 1:10000 SHEET: SH 49 SE	GRID REF: SH 4656 9329.
PRN: 3567 SITE NAME: Ffynnon Eilean, holy well, Hanelian	
AIR PHOTO No 173	LANDSCAPE TYPE: Coastal Shelf.
No GROUND PHOTOS: 4	
DATE SURVEYED: 24/12/93	SURVEYED BY: MARK ALEXANDER.
ACCESS: M. Emrys Owen Peelton Farm Amledwr. Use coastal path.	
CONSENT FOR RELEASE? YES <input type="checkbox"/> NO <input type="checkbox"/>

RESURVEY 1996

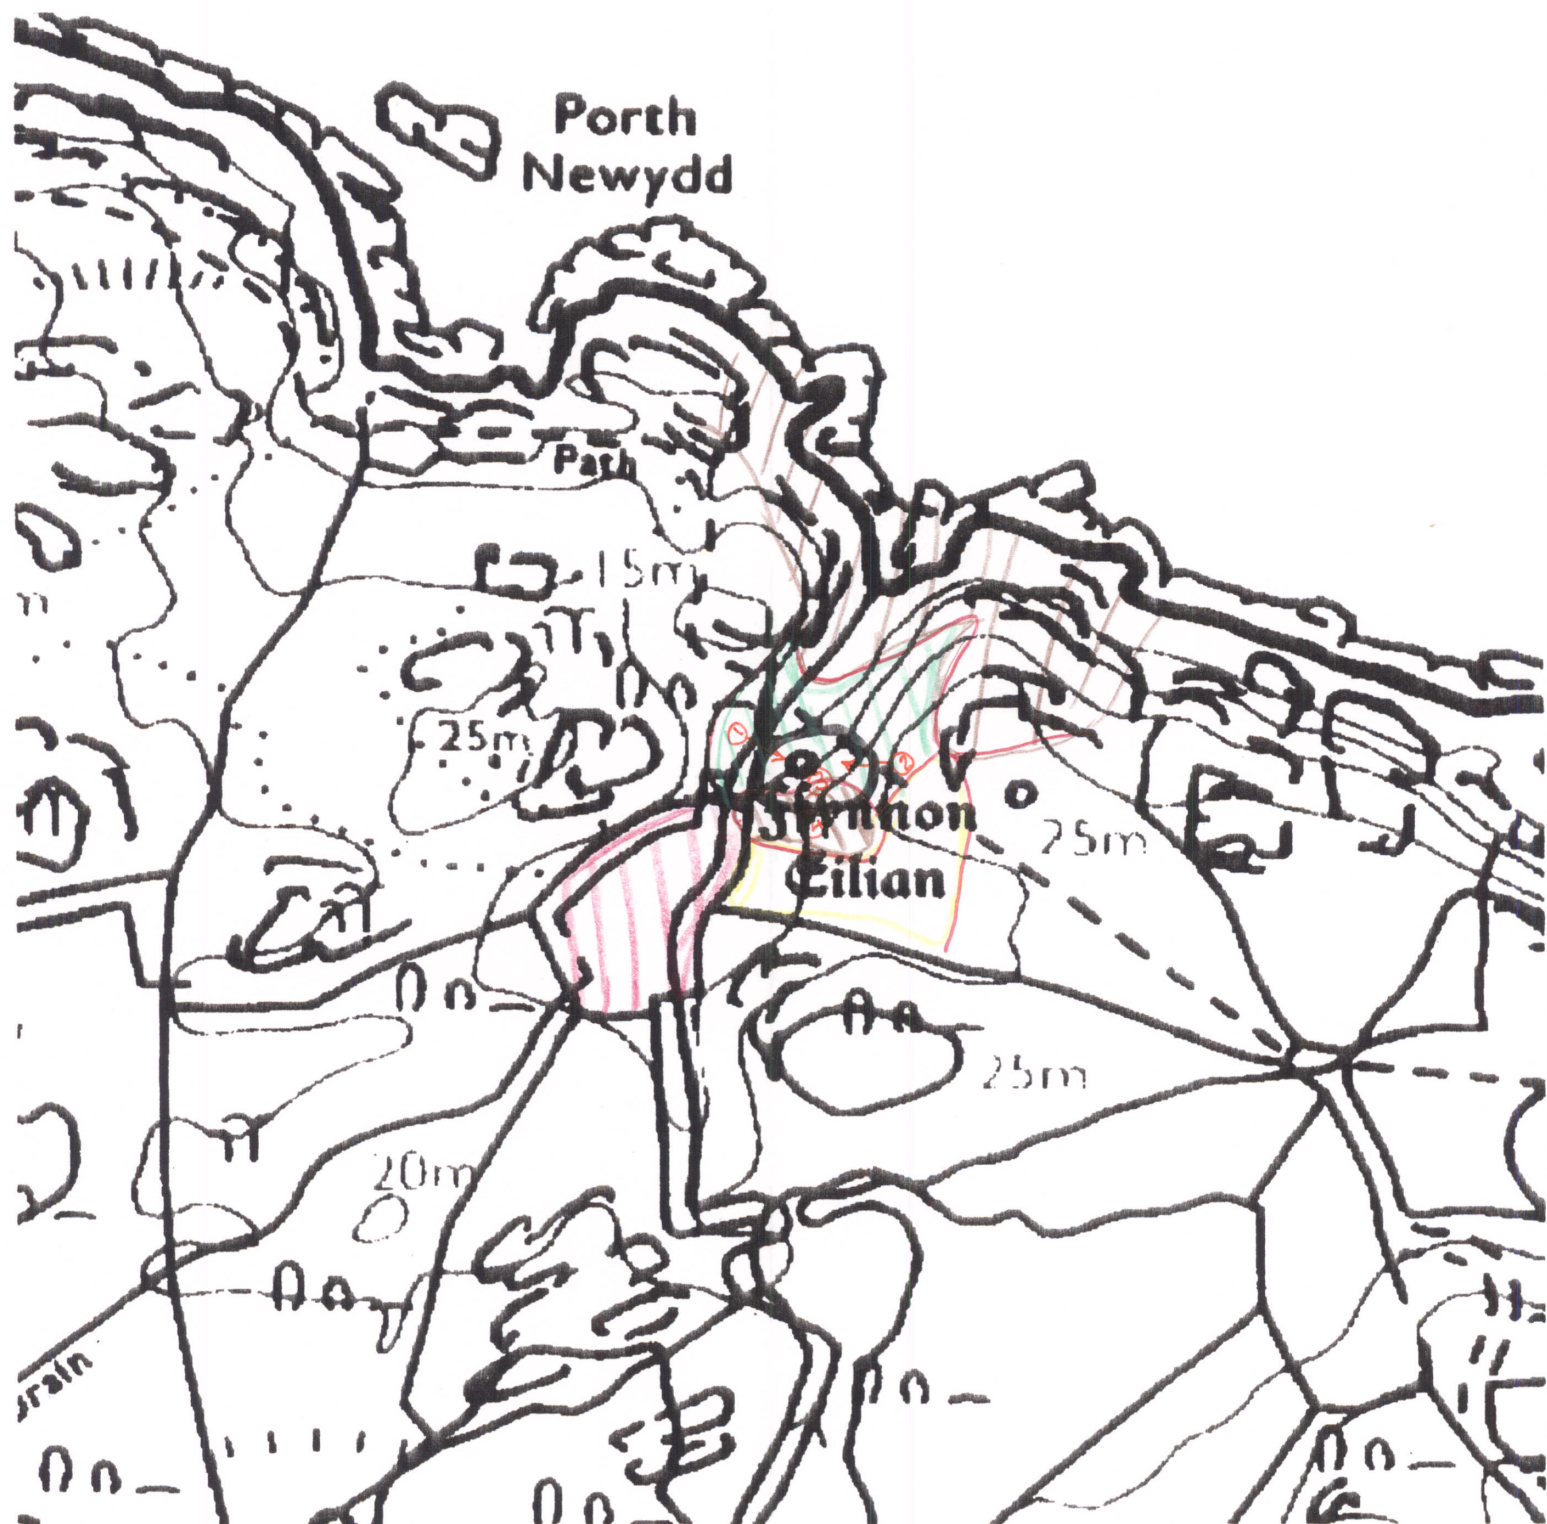
- COASTAL HEATH
WETLAND.
ROCK OUTCROP.
AGROSTIS/FESCUE/NARDUS.

LAND COVER:
SITE: Coastal heath and dune - rock outcrop.
HALO: Coastal heath - Erica, Calluna, Agrostis Juncus, grass, Dandelion

The site is a spring from a rock face - surrounded by a rectangular wall - designed to hold the water. The wall divided into two halves, has collapsed on the one side filling the inside with rocks - while the other side is in reasonable condition. The spring has now moved down hill to an opening some 6 feet above the sea, although the site is still well

The exposed face of the fallen down wall is being eroded away quickly from the sea wind and animal and plant activity.

Scrub - is growing on the side of the good wall dislodging some of the stones.

Drain lines run close to the site - with the coastal path not far away.
