**WESLEYAN CHAPEL  
LONGBRIDGE STREET  
LLANIDLOES**

**Level 2 Building Record**

Planning ref: 23/1741/FUL

CAP REPORT 737

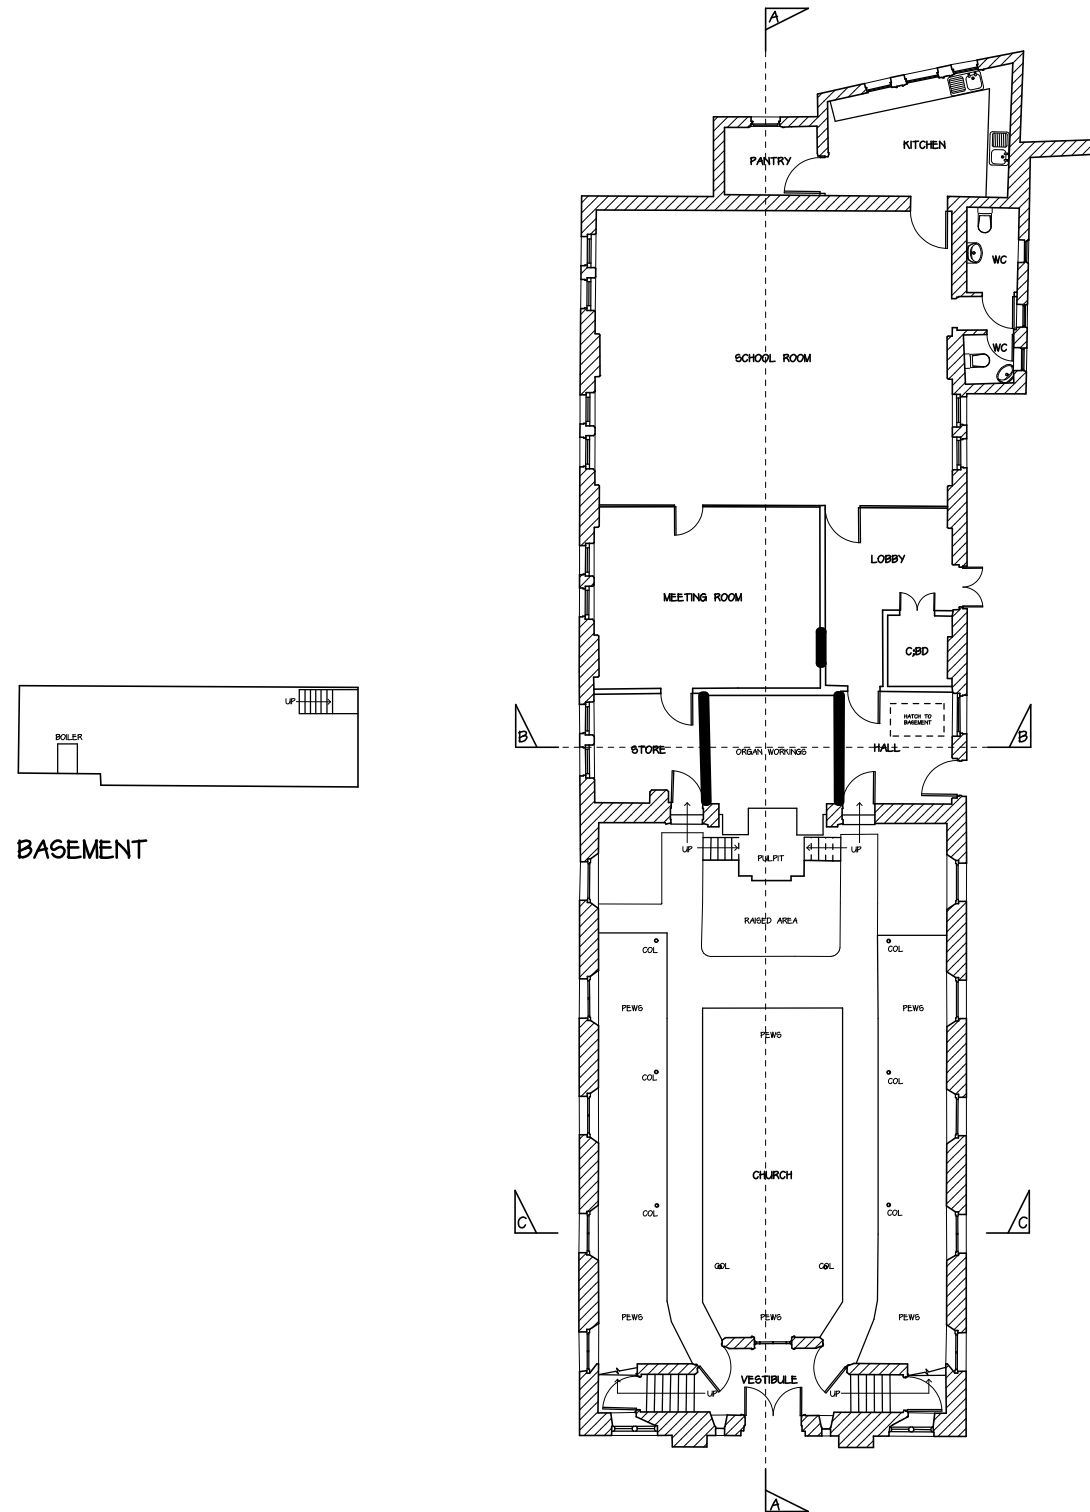
Figure 2: PLANS

- 4.2.2 Ground floor. The ground floor plan of the chapel measures 9.19m x 15.62m. The floor is of timber planks. At the east end of the chapel is a pulpit accessed by steps from the north and south (PLATE 42) and with a railed area to the west (PLATES 20 and 44). There are three rows of pews, with aisle between (PLATE 21, 34-35). At the east end of the pews in the north and south aisles are three rows of pews facing into the chapel (PLATE 27 and 40) the remainder face east with a slight cant towards the pulpit (PLATES 28 and 40). All of the pews are of the box type in Pitch Pine, with doors (PLATE 43). At the west end is an entrance vestibule with tiled floor. Double doors give access to the vestibule from outside (PLATE 31) and there are two door giving access to the chapel (PLATE 30) with a decorative window between (PLATE 29). To the north and south are stairs to the first floor (PLATE 30). The first floor is supported by cast iron columns with foliate capitals and decorated brackets (PLATE 26).

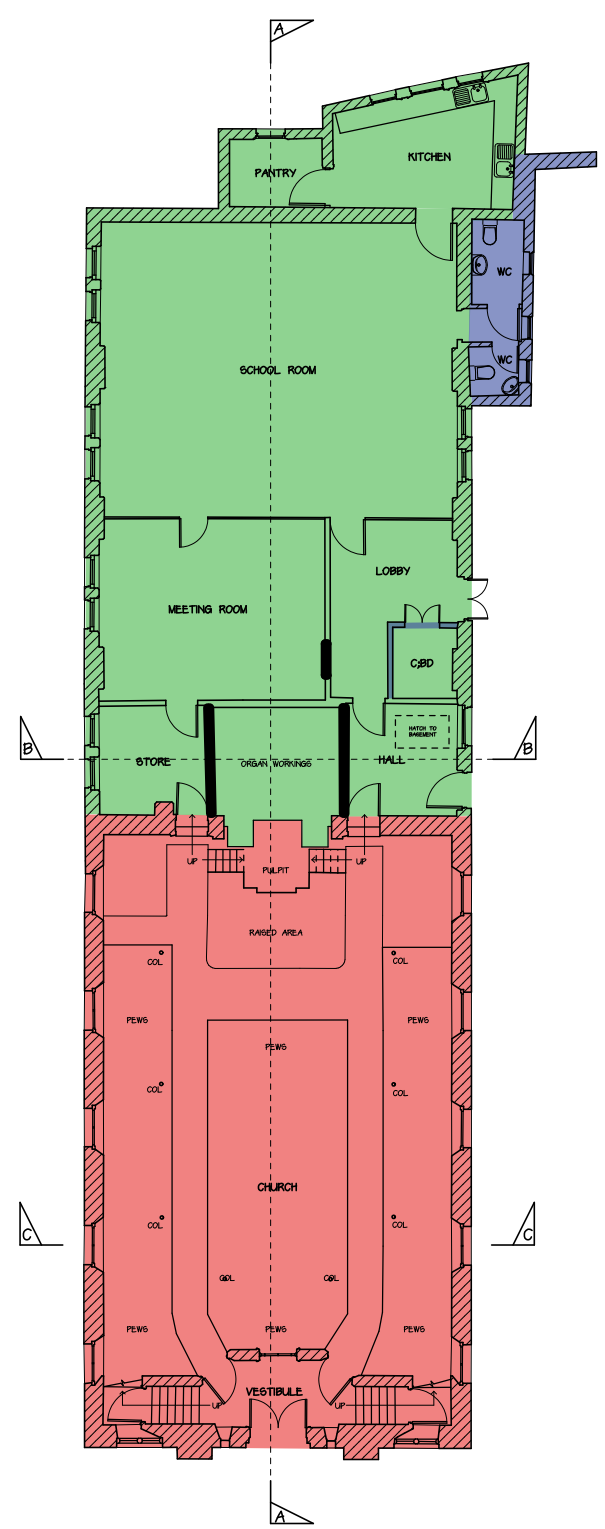
Job Title: Longbridge Chapel Llanidloes
Drawing Title: Phased Plan
Date: October 2024
Drawn By: Dr Kevin Blockley
Scale: 1:200 at A3
Figure 6: PHASED PLAN

- 4.1.1 The work was undertaken inside in good conditions with adequate lighting, although strong external lighting did affect some of the internal views of windows. External work was undertaken in good weather.
- 4.1.3 The phasing identified in the chapel is as indicated on the inscribed stones, as follows (FIG 6):

*PHASE I: Rebuilt Wesleyan Methodist Chapel built in 1874 (western end of complex)*

*PHASE II: Eastward extension comprising meeting room, school room and kitchen built in 1900 with organ added in 1925 (eastern end of complex)*

*PHASE III: Expansion of toilet facilities in 1995 and insertion of a cupboard in the lobby (on south side)*

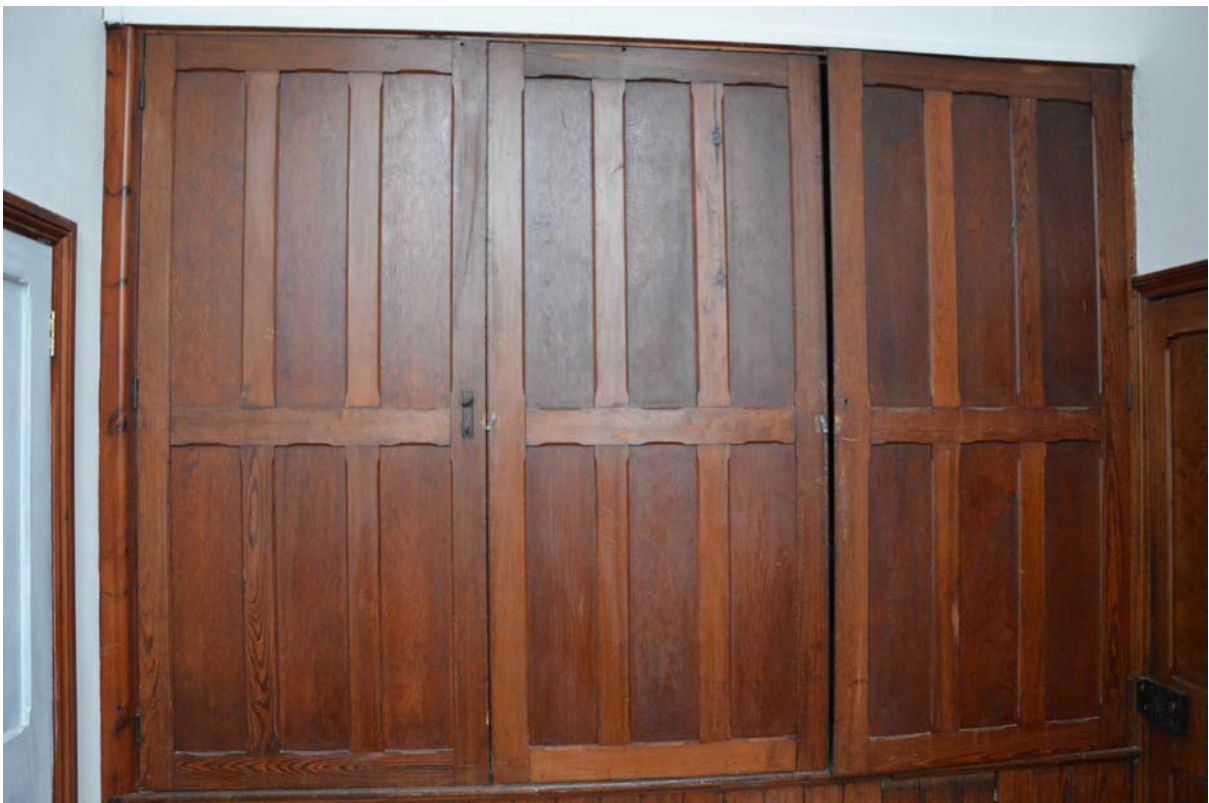
PLATE 19      Wooden panelling on south side of store room (screening organ works).  
Looking south

4.2.7 Ground floor. The ground floor of the extension comprises a number of rooms all with planked floors: A hall and lobby on the south side, store room and meeting room on the north side, with room housing the organ workings between, to the east of the organ. The lobby and meeting room lead onto the school room which runs the full width of the extension. Off the east side of the school room is a kitchen with pantry to the north and toilet to the south-west. FIG 5 shows the original arrangement of the toilet off the kitchen. PLATE 1 records the doorway between the kitchen and pantry; FIG 2, the windows in the east wall of the kitchen and PLATES 3 and 4 show the south wall of the kitchen and doorway into the school room. The screen between the school room and the meeting room and lobby is panelled and has glass at ground floor level (PLATE 6). The school room is panelled below window level (PLATES 5, 7, 8 and detail 13). In the ceiling are two ornate plaster roses (PLATES 10-12). Doors have inset brass handles (PLATE 14). The lobby has had a cupboard inserted as this is not an original part of the 1900 layout (PLATE 15). The lobby continues the theme of panelling (PLATE 16) and with a floor-to-ceiling panelled wall with doors providing access to the organ workings (PLATE 17). The floor-to-ceiling panelling with doors is matched in the meeting room to provide further access to the organ workings (PLATE 19).

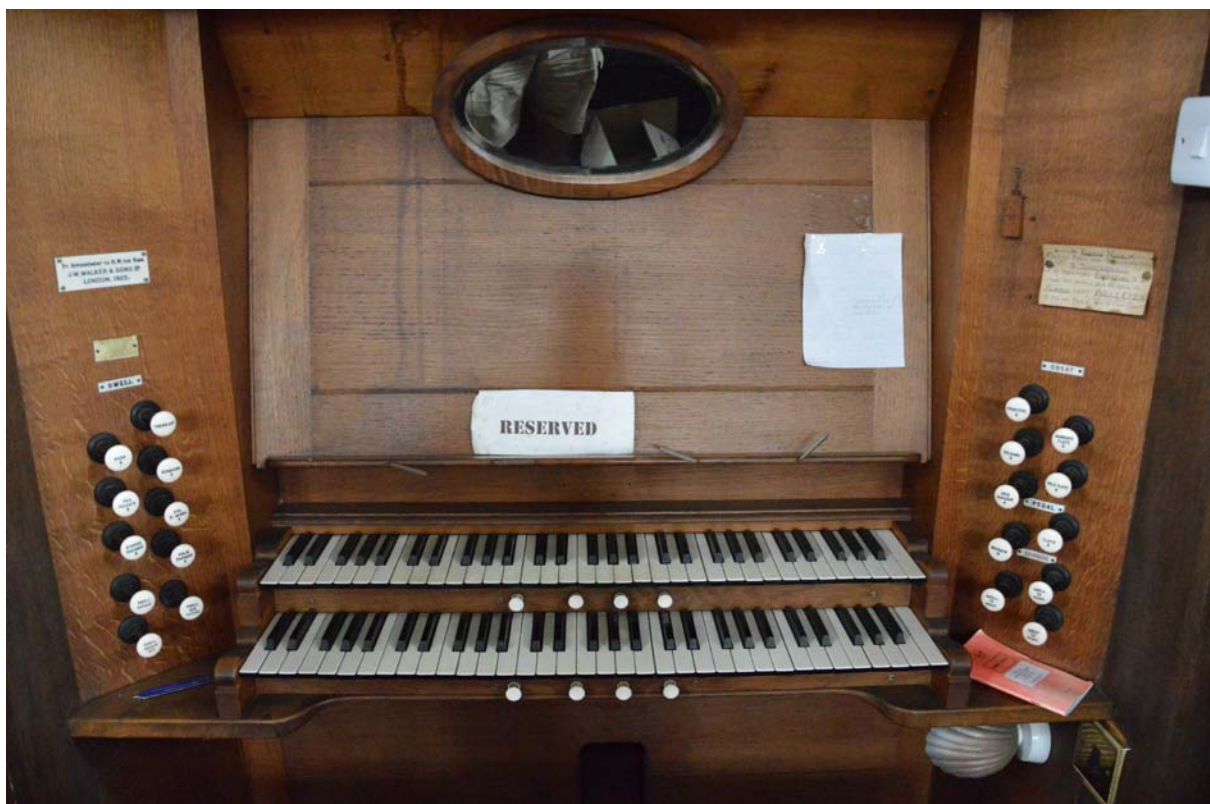
PLATE 23 Detail of organ keyboard. Looking east

4.2.8 Organ. At the east end of the Phase I chapel is an organ (PLATES 23, 28 and 33) with nearby commemorative brass plaque inscribed *"TO THE GLORY OF GOD. THIS ORGAN WAS PRESENTED TO LLANIDLOES WESLEYAN CHURCH, 1925. BY ARTHUR E. WHITBY. STOKE BISHOP, BRISTOL. IN LOVING MEMORY OF HIS WIFE, PEGGY"* (PLATE 24).

4.2.9 The pulpit and balcony are made from Pitch pine. The pews are Pitch pine with Chestnut seats. The glass frame around the 1925 organ keyboard is in oak.

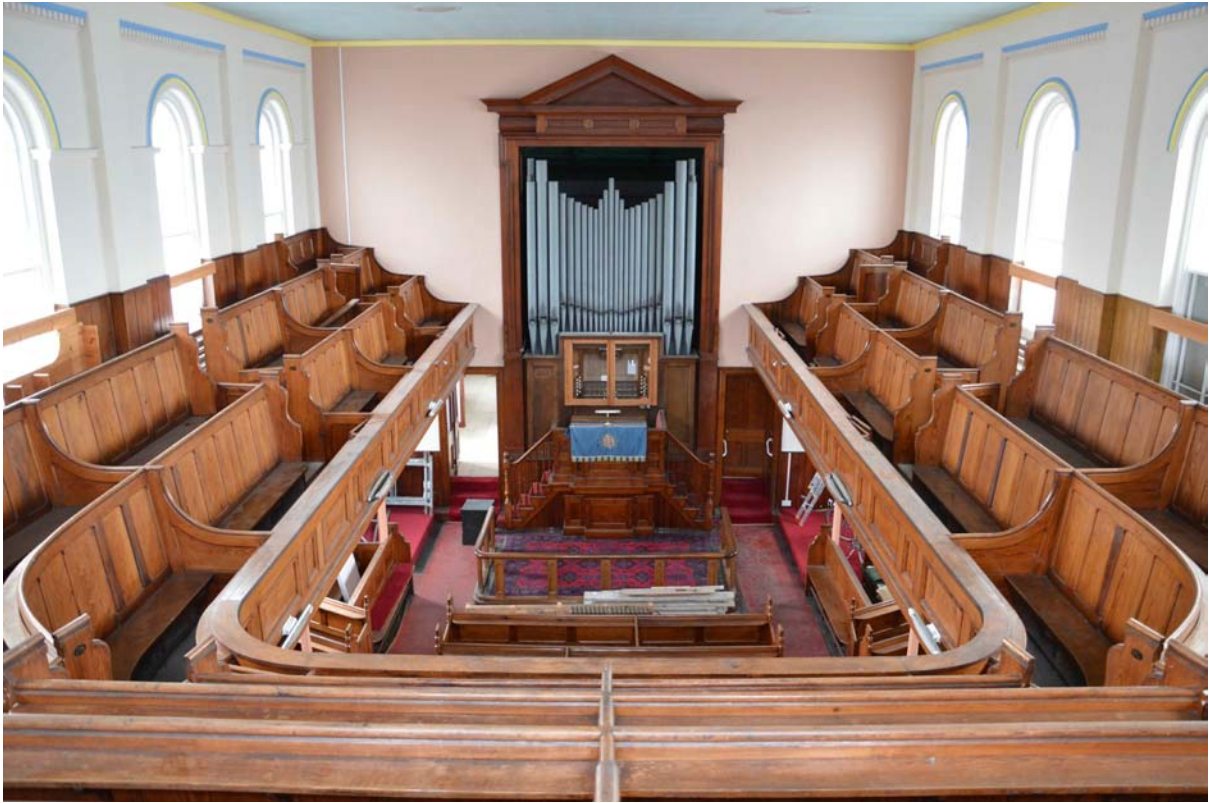
PLATE 32 Main body of chapel from 1<sup>st</sup> floor. Looking east

- 4.2.3 First floor. On the first floor of the chapel is a balcony housing three banks of pews along the north and south sides, facing into the chapel (PLATES 32, 36, 38 and 41). At the west end the pews are arranged in 5 tiers (PLATES 37 and 39). Around the 1<sup>st</sup> floor is a decorated balcony (PLATES 28 and 41).

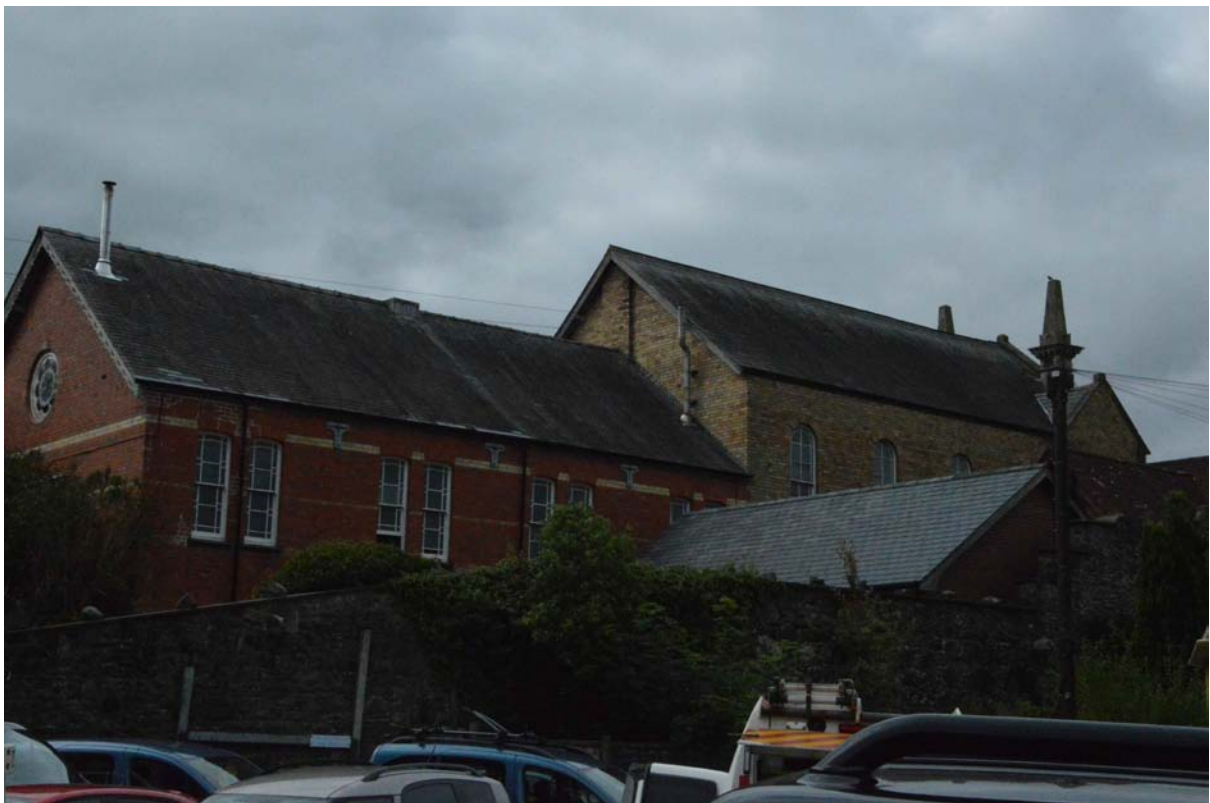
PLATE 62 North and east elevations of Chapel and extensions. Looking s-w

- 4.2.5 External elevations. The extension is built of red brick with bands of yellow brick (PLATES 51, 62-63). On the south wall are two doorways, one to the lobby and the other to the hall. There is a single sash window lighting the hall and a pair of windows lighting the lobby. This wall houses a number of commemorative stones (PLATES 47-50) all dated 1900. The north elevation is similar to the south but has no doors, and four paired sets of windows (PLATE 62). The east wall holds an oculus window at height (PLATES 62) with coloured glass (PLATE 9). Attached to the east side of the extension (offset to the south) and of the same build as the remainder of the extension, is a kitchen lit by three tall windows and with a small pantry off the north side (PLATE 64). The toilet block on the south

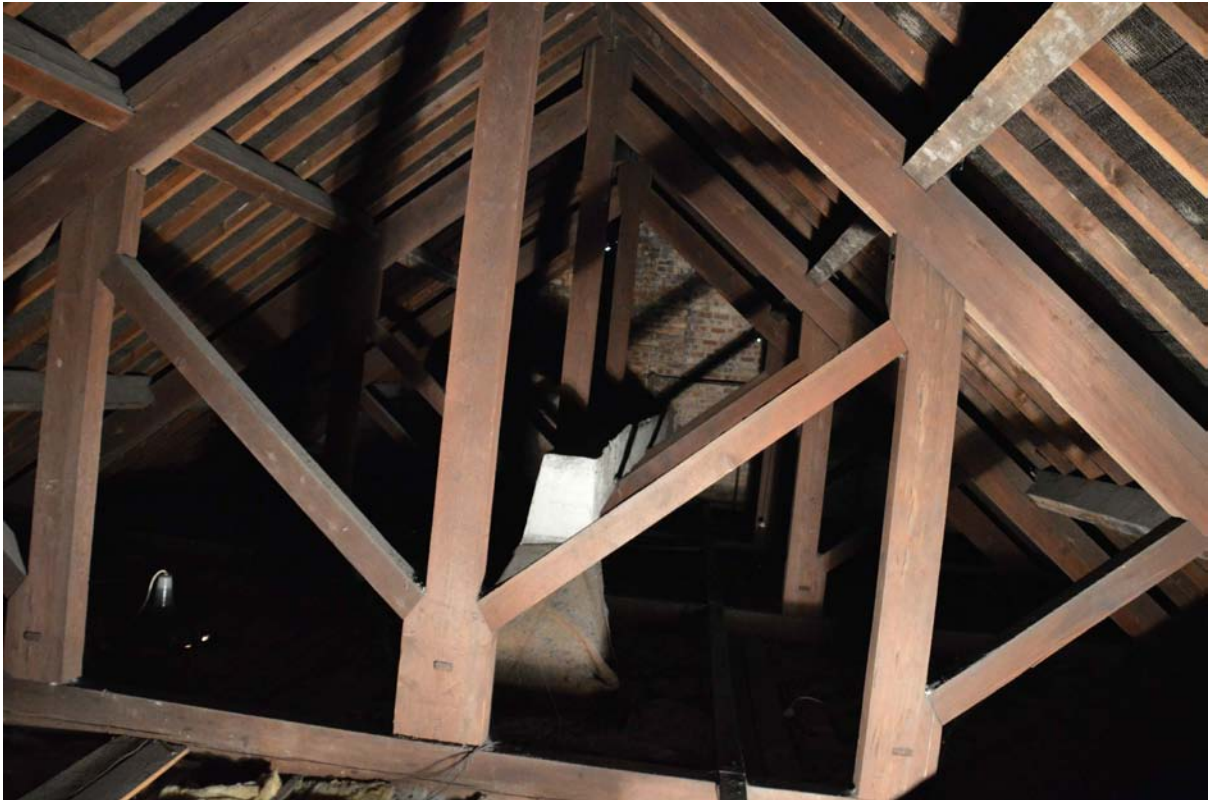
PLATE 65      Timber roof trusses above main body of chapel. Looking east

- 4.2.4 Roof. The timber frame in the roof contains the original, 1874 King Post trusses (PLATE 65).
