52 HANOVER QUAY, HAVERFORDWEST, PEMBROKESHIRE: ARCHAEOLOGICAL WATCHING BRIEF

RHIF YR ADRODDIAD / REPORT NO. 2010/56
RHIF Y PROSIECT / PROJECT RECORD NO. 100047

**52 HANOVER QUAY, HAVERFORDWEST,
PEMBROKESHIRE:
ARCHAEOLOGICAL WATCHING BRIEF**

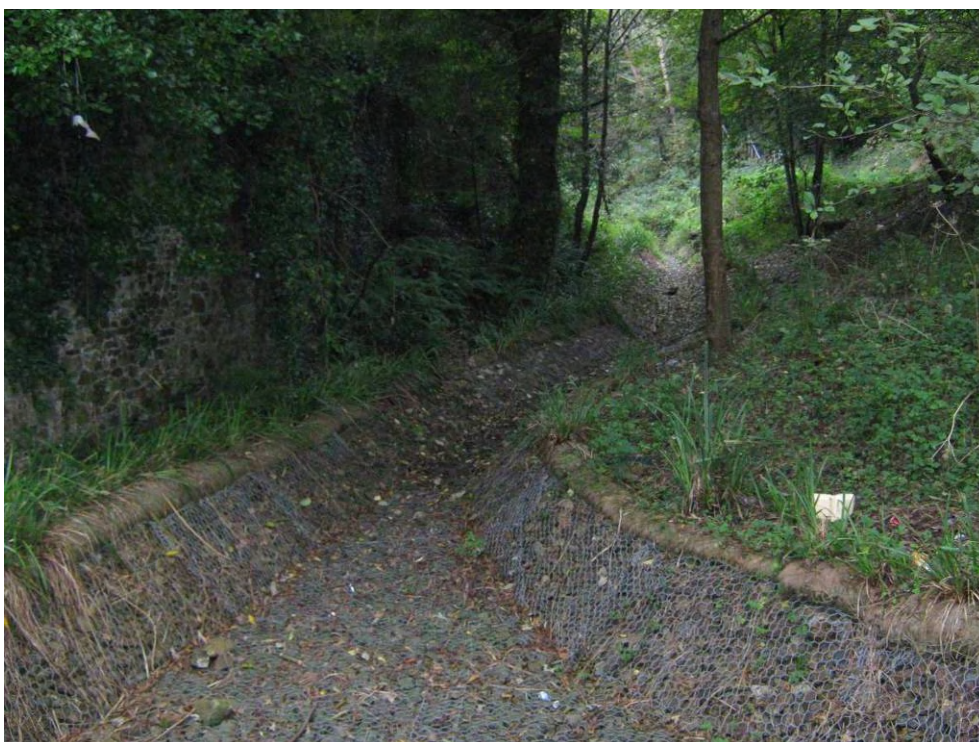
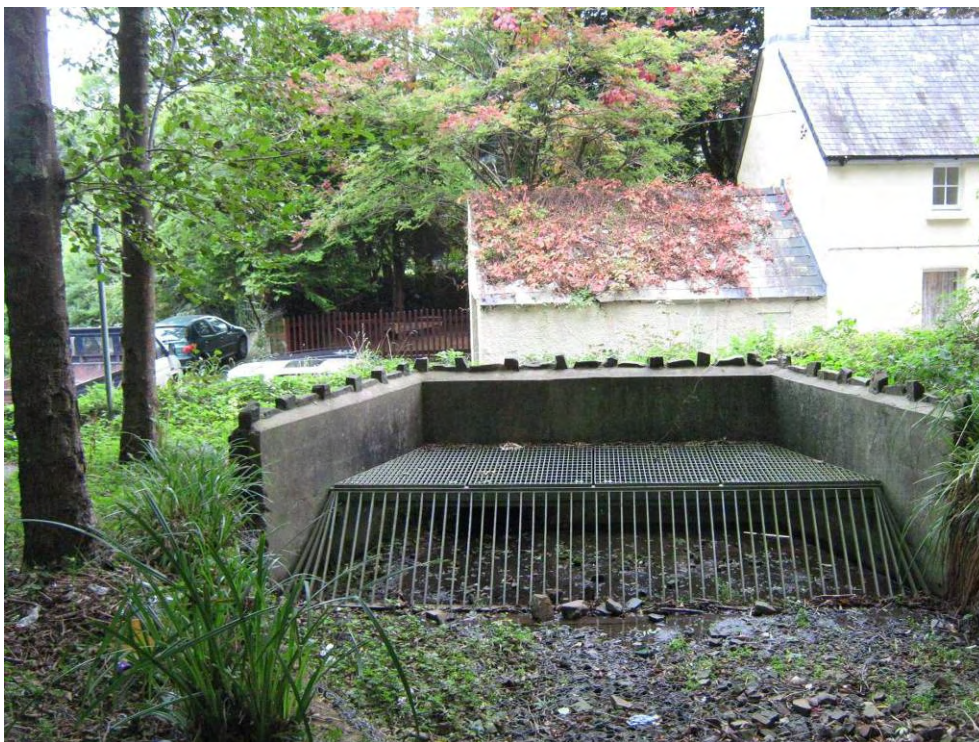
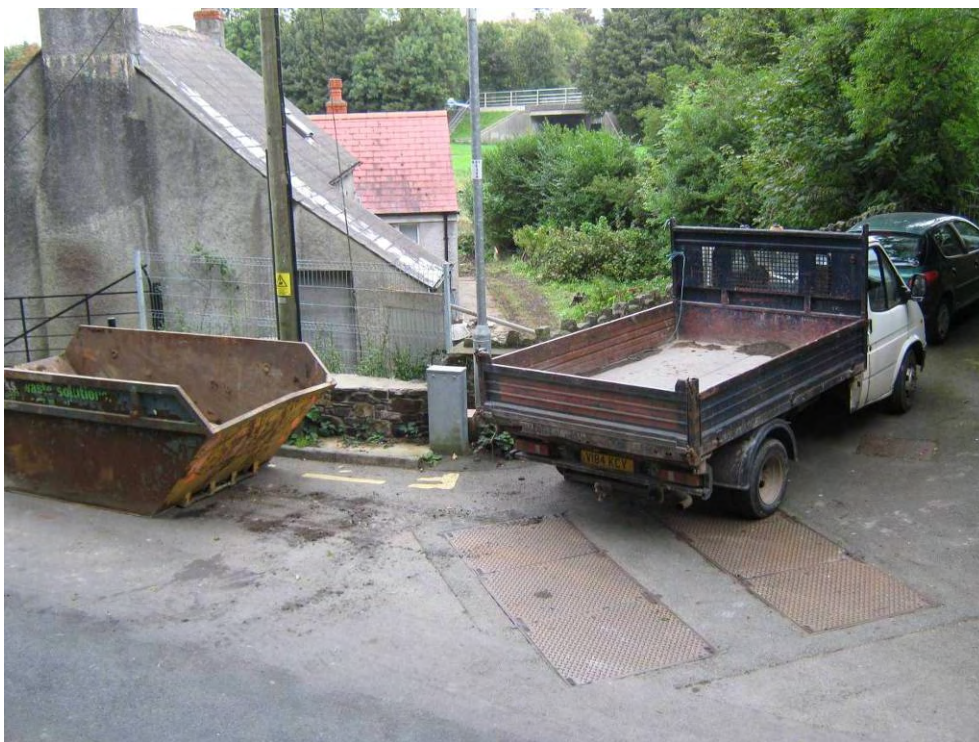
To the south of the house runs a sewer serving this and the adjacent property. A large culverted stream runs on the south-western side of the road, in a easterly direction, down the adjacent hill into the Western Cleddau. This culvert would appear to run directly through the southern part of the garden to the property (Photos 2, 3 & 4).

Photo 2: Line of stream course culvert to south-west of 52 Hanover Quay (viewing south-west)

Photo 3: Culvert cover taking stream under Quay Street (viewing east)

Photo 4: Culvert covers within road looking across Quay Street from culvert cover, leading directly through the south-eastern part of the garden

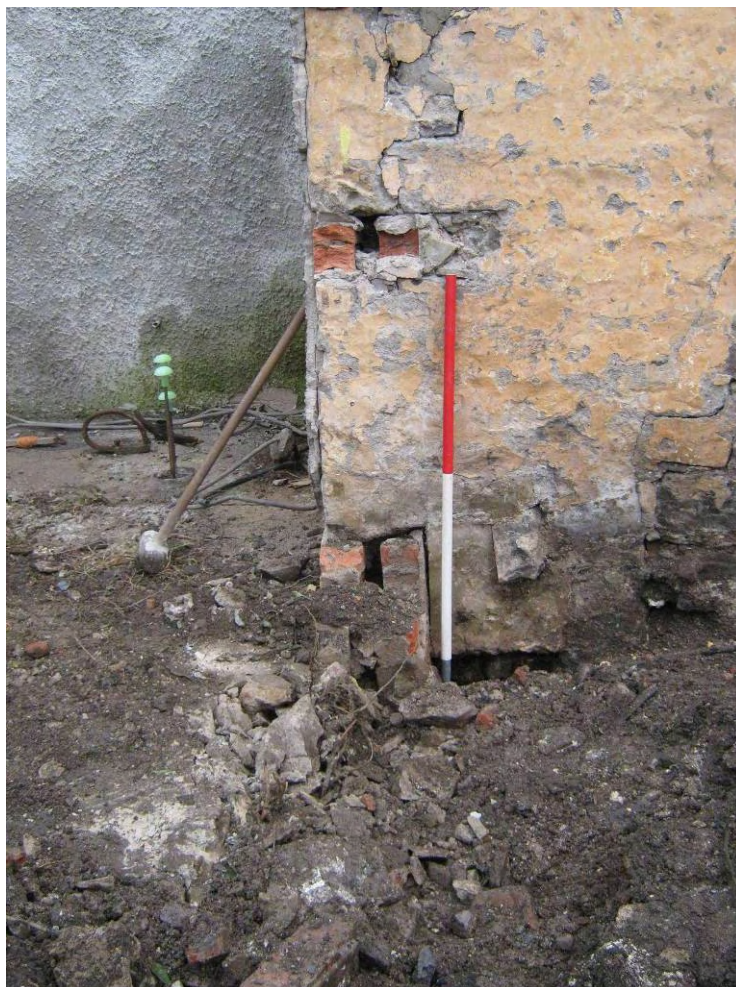
Brick and stone footings for the wall of the previous extension on the site were visible at its southern end. Evidence that this wall had been keyed into the stone wall of the property was also apparent (Photo 5). This extension had been previously demolished and replaced with garden sheds, which themselves had been demolished before the works commenced.

Photo 5: North-east facing end wall of 52 Hanover Quay, showing bricks inserted into stone wall to key in former extension

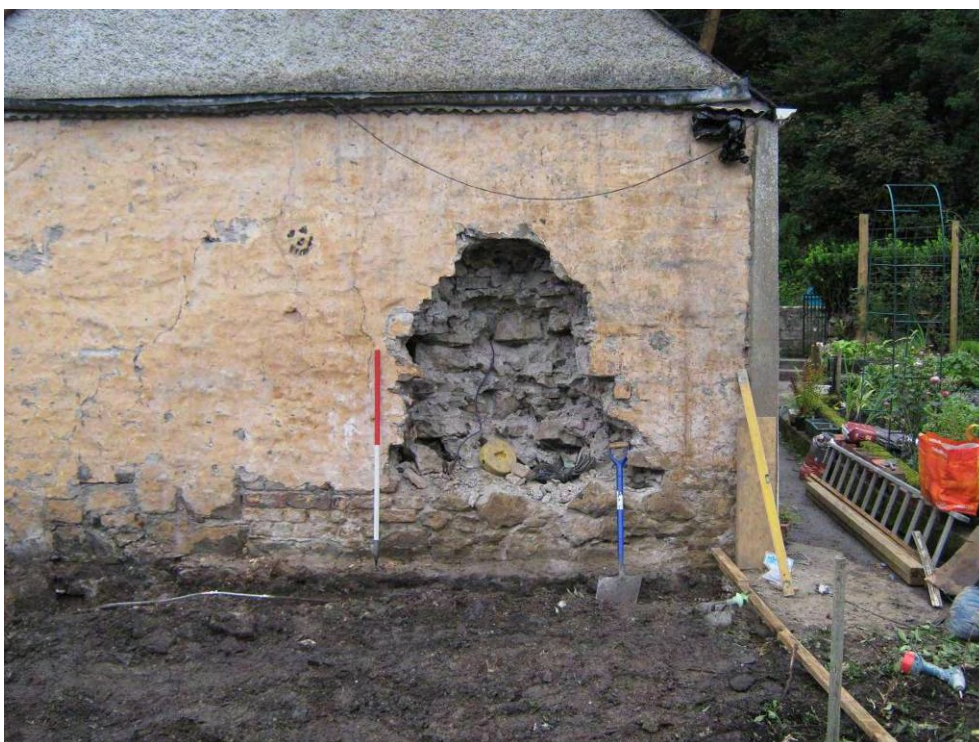
The north-western façade of the property was built of stone rubble construction, on larger stone block footings and some brick patching was also visible (Photo 6). The wall had been partially breached, adjacent to a chimney, in readiness to create a new access into the proposed extension.

Photo 6: North-west facing wall showing partial breach in wall, which wall form access into new extension. Note the stone rubble construction of the wall, with some earlier brick inserts to the lower left

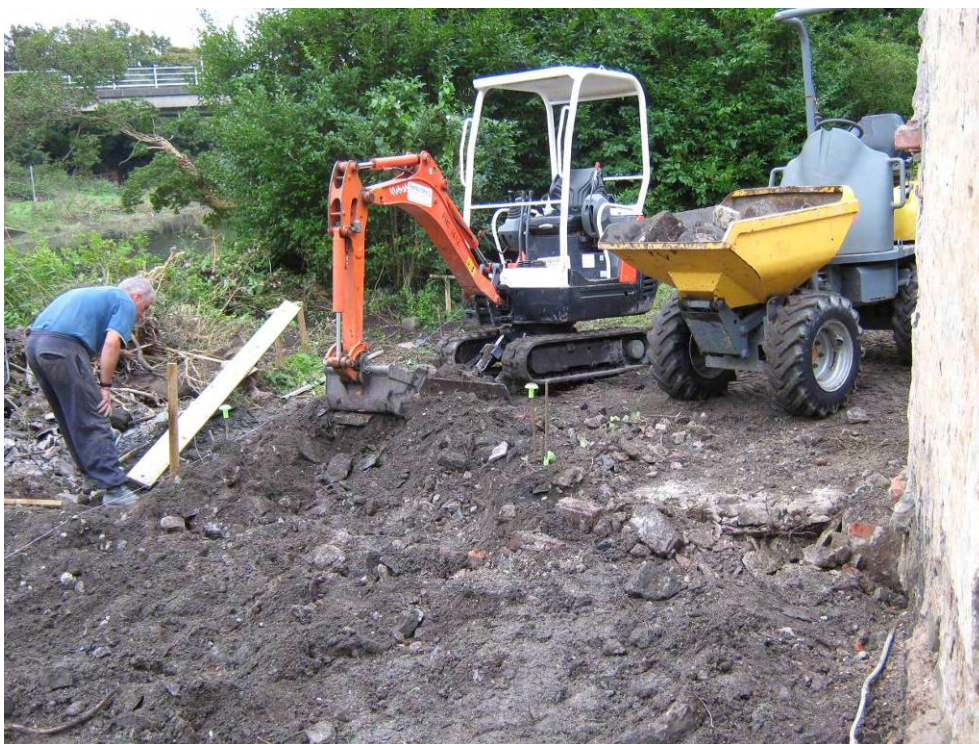
Following removal of the former sheds and concrete floors a mixed topsoil was exposed, through which the piles had been inserted (Photo 7). This soil comprised a very dark brown silty soil with a fair quantity of building rubble and modern debris (breeze block, pottery and glass, which was not retained).

Photo 7: Site area, viewing south-east, following demolition of former sheds and removal of upper overburden (flooring and concrete) and insertion of piles

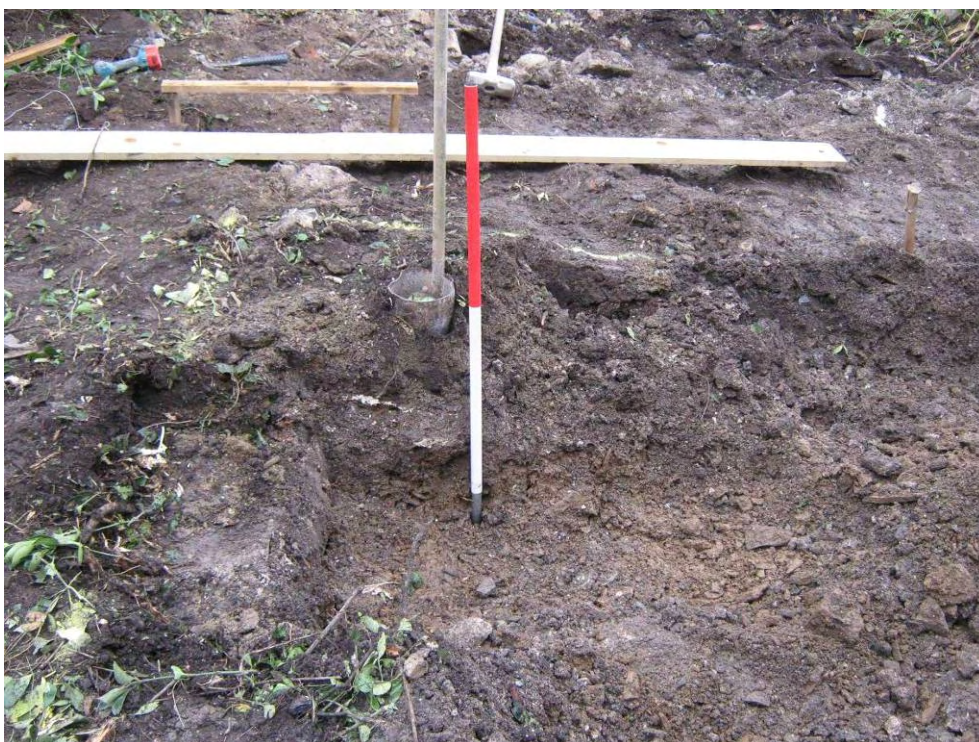
The footprint of the proposed extension was excavated down to the required formation depth using a machine fitted with a toothless bucket. The deeper excavations at the northern end of the site revealed heavily disturbed soils to a depth of around 0.40m (Photo 8). Below this was a compact layer of reddish brown stoney soil (similar to rab; Photo 8). Although no finds were recovered from this lower layer, they had clearly been redeposited and laid down. At the southern end of the site the upper layers of disturbed dark brown soil were still visible at the base of the formation level for the concrete floor slab that was to be laid (Photo 9).

Photo 8: North-western corner of excavation area following excavation to required depth for new extension. Section shows heavily disturbed upper layers, with redeposited clays and stone (lighter fill) towards base

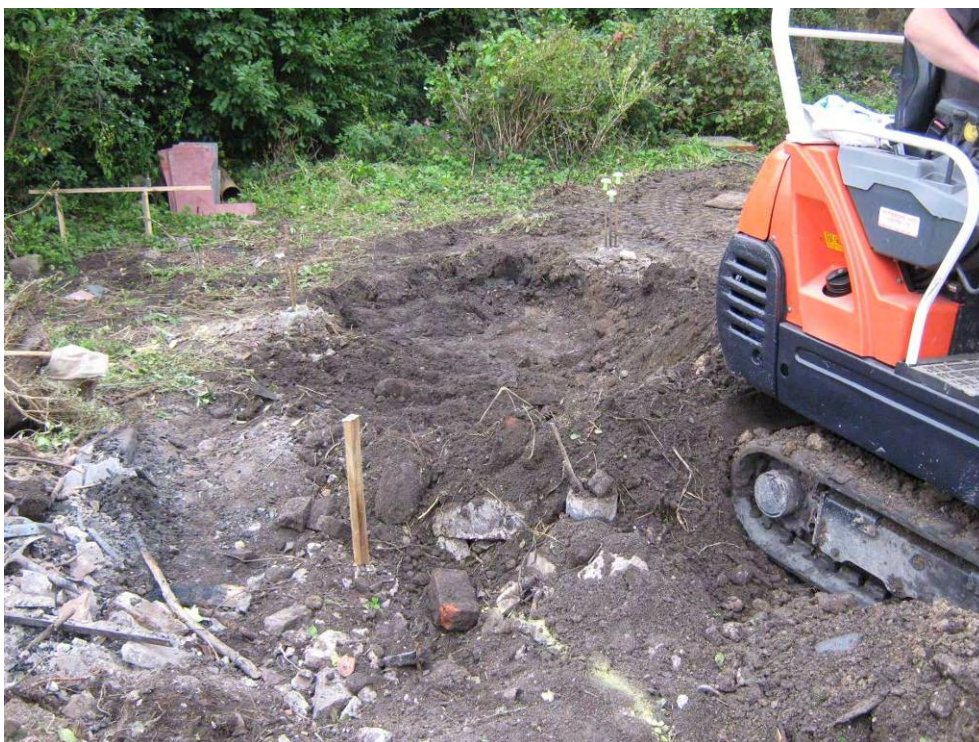
Photo 9: South-eastern corner of excavation area following excavation to required depth for new extension. Section shows heavily disturbed layers only

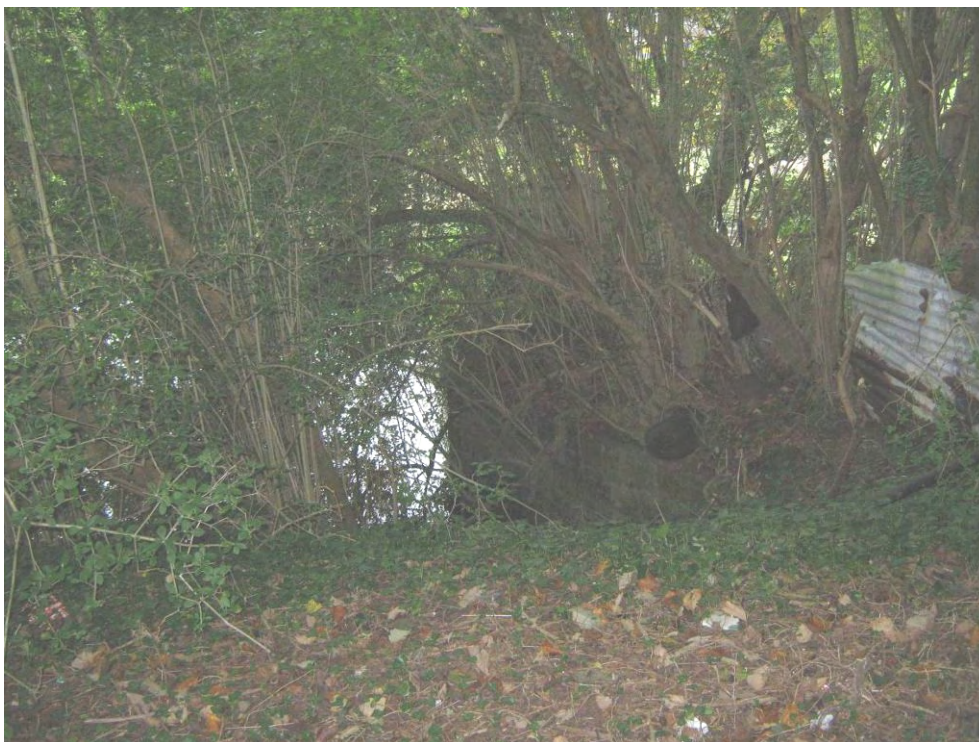
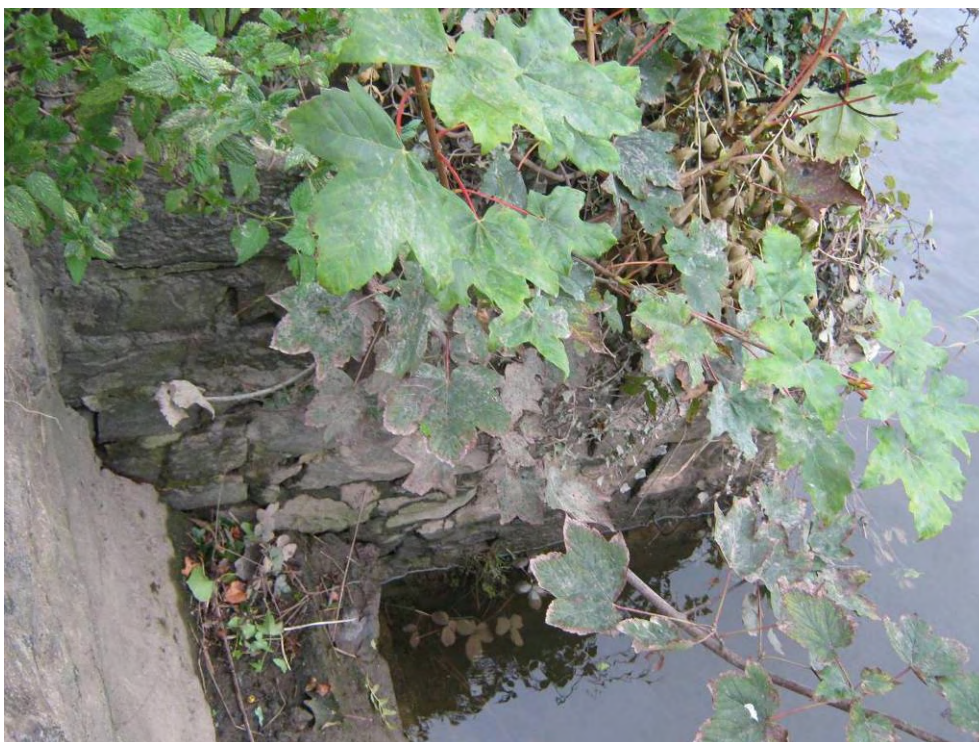
Below this disturbed soil was a redeposited layer, seemingly made up of rab like material (the natural geology of much of the surrounding area, formed by decayed bedrock). The compaction of this layer and its location directly on the waters edge is considered to be associated with the construction of the quay itself which projects into the Western Cleddau, on which the building stands. The date of construction of the quay is uncertain, and no finds that might have indicated a date for its construction were recovered in the layer. It is assumed to be of later post-medieval date, possibly associated with the import and export of goods, when Haverfordwest was an important port within the region. The name of Hanover Quay itself is likely to originate from this time, the name reflecting trade links with Germany. The north and south corners of the quay projecting into the Cleddau, as shown on the 1:500 OS map from the 1880s are still visible today (Photos 10 & 11).

Photo 10: North-western edge and corner of quay projecting into the Western Cleddau, on which 52 Hanover Quay is located.

Photo 11: South-eastern edge and corner of quay projecting into the Western Cleddau, on which 52 Hanover Quay is located
