# CARDIGAN CASTLE, CARDIGAN, CEREDIGION: ARCHAEOLOGICAL EVALUATION

Prepared by Dyfed Archaeological Trust  
For: The Cadwgan Trust

RHIF YR ADRODDIAD / REPORT NO. 2010/57  
RHIF Y PROSIECT / PROJECT RECORD NO. 100048

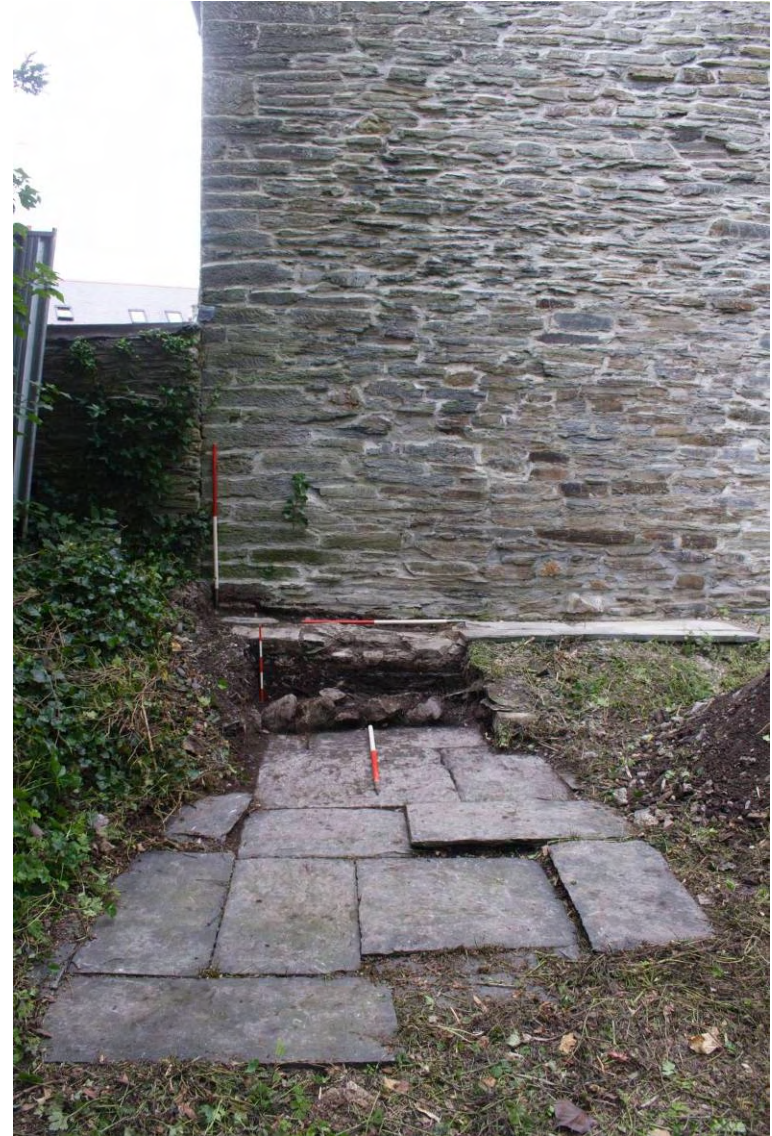
Between the two walls of the Fernery was a rough slate slab surface (context 5; Photo 2). It is considered that this floor is later than The Fernery although any relationship between the floor and the eastern wall had been truncated. The slate slabs may have formed an external yard / patio area as defined by the former stone walls. The slabs were laid on backfilled soils and rubble (contexts 4 & 7), the same as those through which the Fernery walls had been built (Photo 4). A few sherds of medieval pottery were recovered from these layers, although more recent material was also noted and by comparisons elsewhere in the castle, it is almost certain that these layers date to the early 19th century when extensive landscaping was taking place.

**Photo 2:** Slate slab flooring within Fernery, viewing west

The substantial nature of The Fernery walls was such that it was not possible to gain any information on the foundations of the property of Ty Castell. Any further development proposals in this part of the site is likely to need the full removal of The Fernery walls. The slate slab floor seen within The Fernery was set within topsoils and is thus considered to be a later addition to the structure, possibly associated with the reuse of the area as a yard or patio area following demolition of the structure. The slabs seem to have been limited to within the area between the walls, indicating that the walls would have been visible to some degree when the flooring was laid.

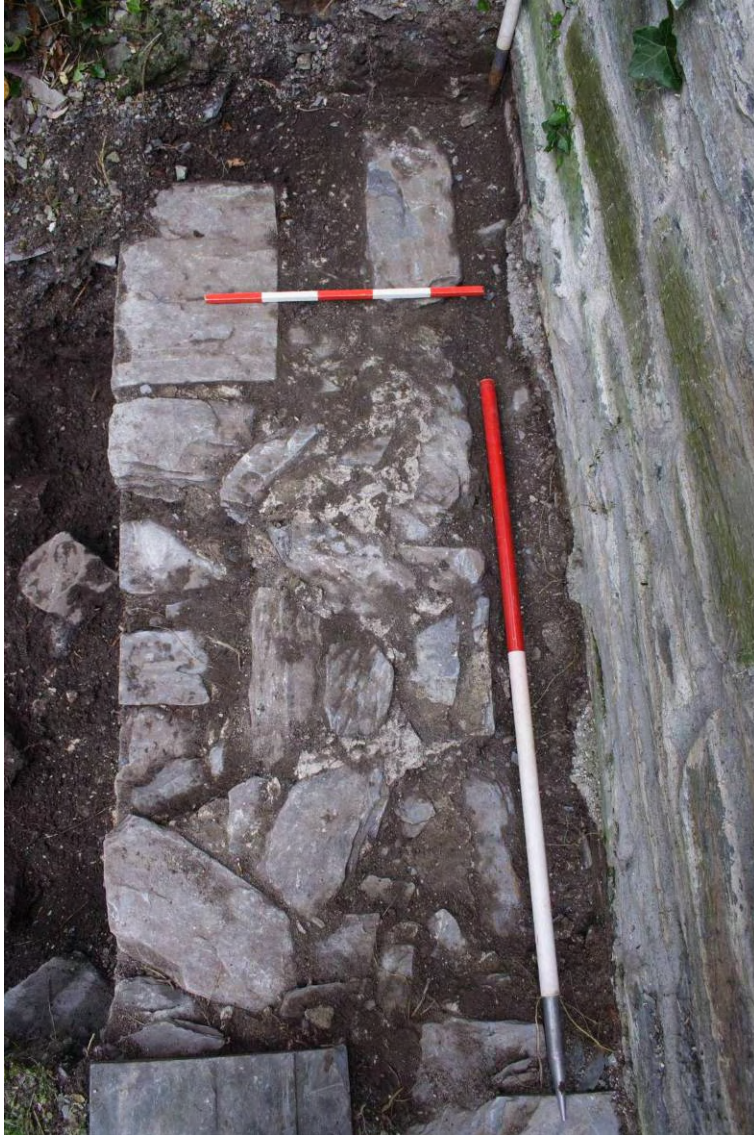
The trench was located directly adjacent to the east wall of Ty Castell (Photo 1). Following limited removal of topsoil the top of the surviving western wall of The Fernery was revealed (context 1; Photo 2, 3 and 4). Further excavation revealed the eastern wall of The Fernery (context 2), which survived at a lower level than that to the west, possibly as result of later landscaping of the garden area (Photo 2 and 4). The western wall had been built directly adjacent to the wall of Ty Castell (Photo 2, 3 and 4). The Fernery was far more substantially built than expected, comprising large mortared stone walls. It was therefore not possible to ascertain any information regarding the foundations of Ty Castell, as they were covered by the wall of The Fernery. The walls of the Fernery sat on rubble and layers of soil, silty clay, slate/shale and rubble.

**Photo 3:** Western wall of Fernery, abutting wall of Ty Castell, viewing north

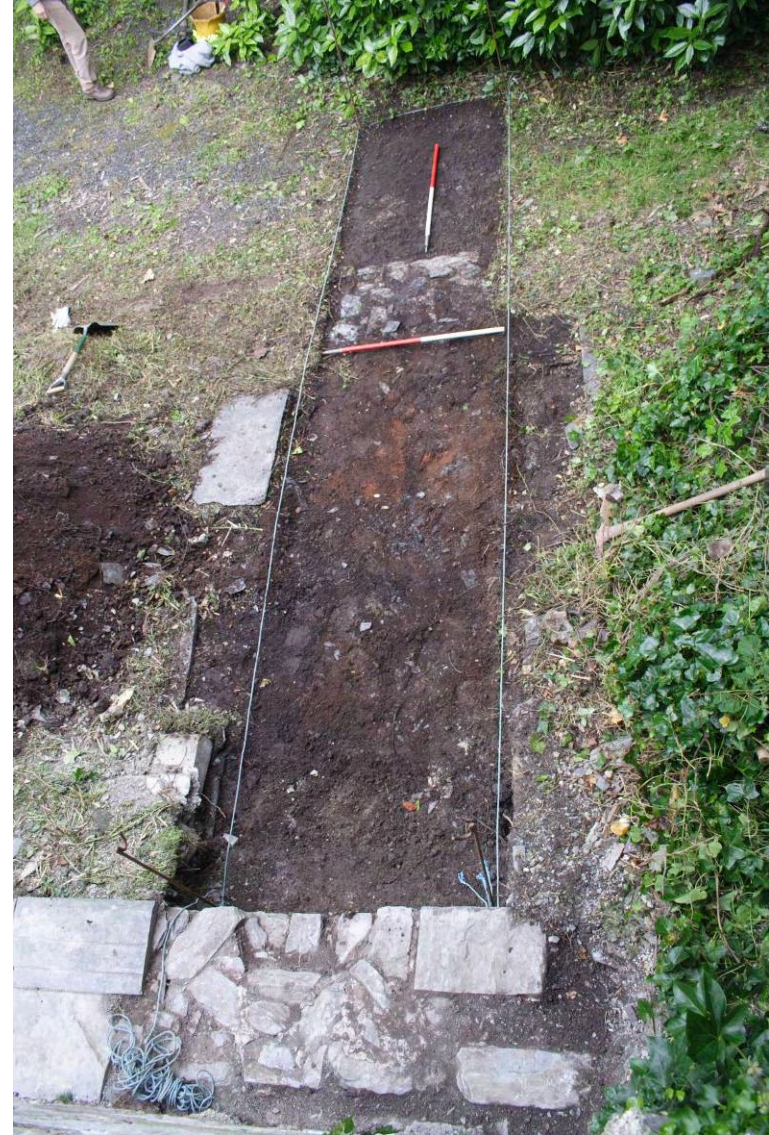
**Photo 4:** Overview of Trench 1 showing exposed walls of Fernery following removal of slate slab floor, viewing east

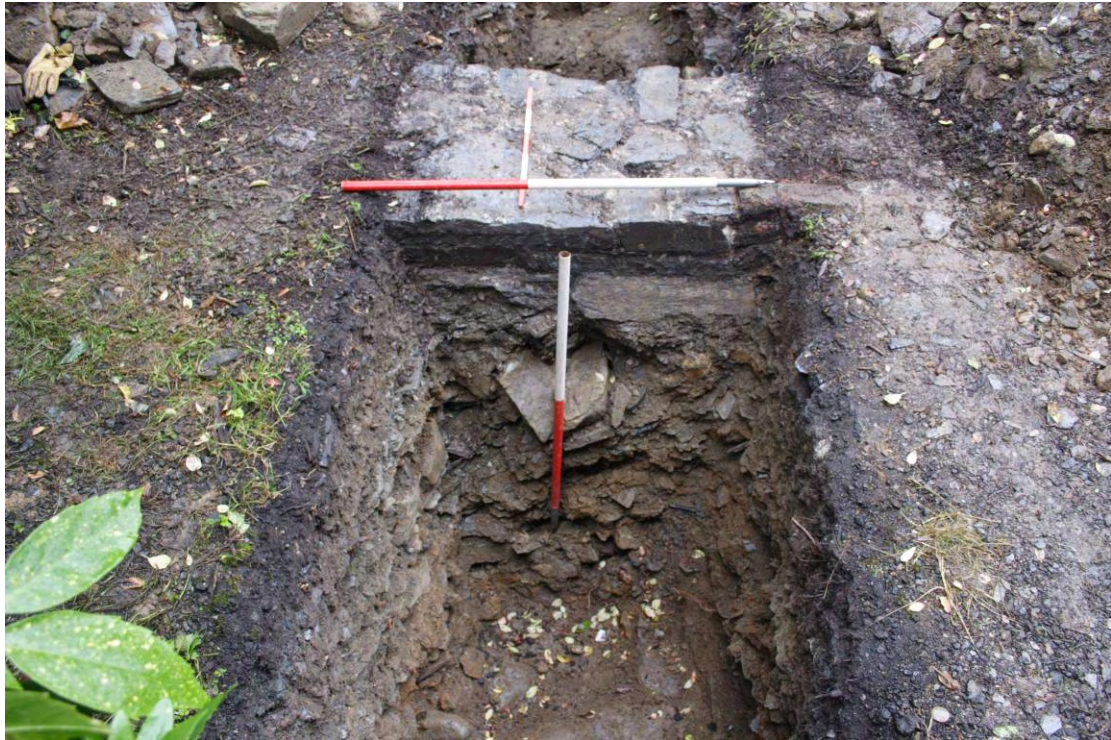
At c.1.45m below the current ground level in the east end of the trench (Photo 5 & 7), c.6m east of Ty Castell, these 19th century levels gave way to an orange-brown silty clay containing mortar flecks, pieces of shale and charcoal and occasional sherds of medieval pottery (context 15). The change in character of the deposits and the presence of a number of sherds of medieval pottery, without the modern debris seen in the layers above, would suggest that this may be an in situ medieval deposit. It should also be noted that the layer was of a mixed character indicating that it has been disturbed. This may suggest that it is either an archaeological feature such as a pit, or that it is possible it has been redeposited and dates to the 19th century as with the layers above. Owing to the depth of the trench it was not possible to investigate this layer any further.

**Photo 5:** Eastern wall of Fernery, viewing west

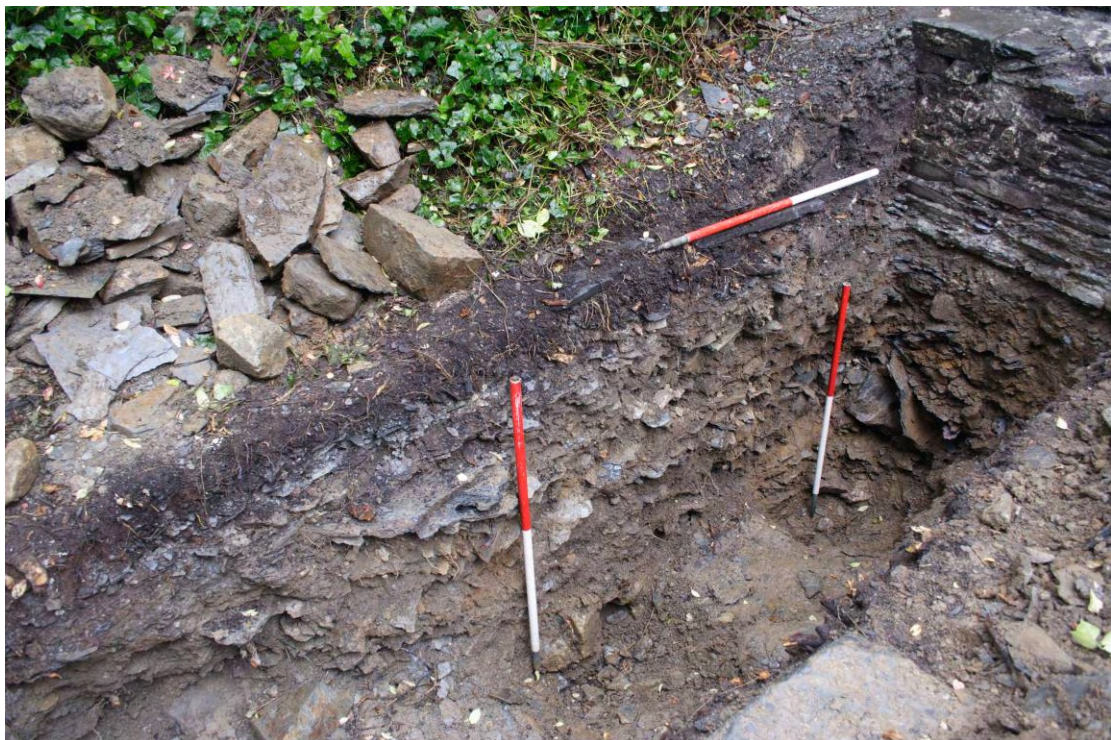
Closer to Ty Castell it was not possible to consistently excavate down to 1.5m for health and safety reasons (Photo 6 & 7). However, some small test pits at the base of the trench within this area indicates that the 19th century rubble deposits get thicker towards the house (contexts 9 and 16). This is also apparent in the slight eastern slope visible from Ty Castell.

**Photo 6:** Trench 1 excavated to maximum depth to the east of Ty Castell, viewing south-west

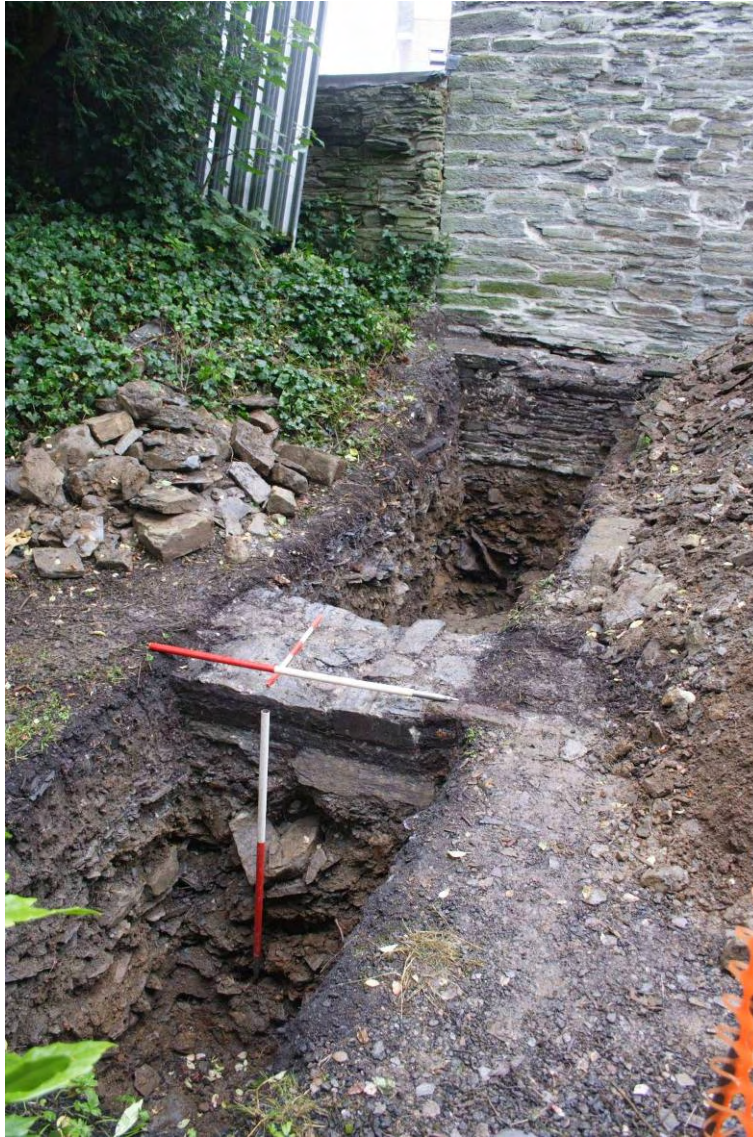
**Photo 7:** View south-west across Trench 1 showing fully excavated Trench 1, with Fernery walls visible and Ty Castell to rear

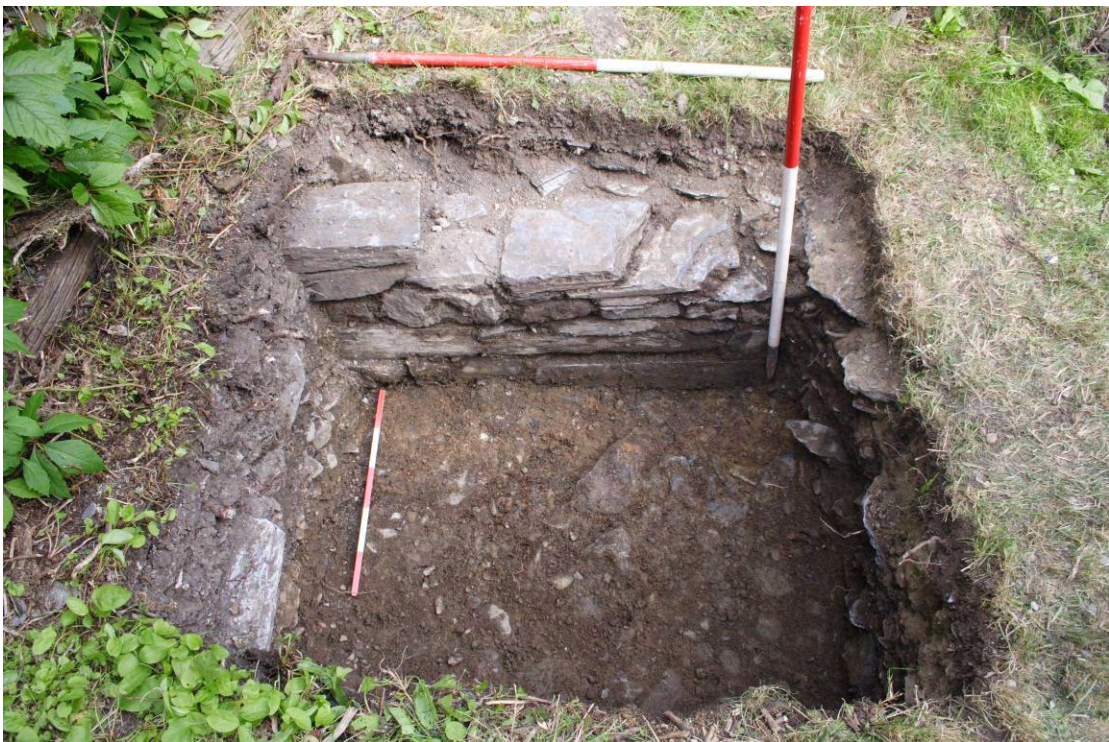
Excavation of the trench revealed a thicker topsoil than seen in Trench 1 (context 1). Beneath the topsoil along the south-eastern end of the trench, a substantial stone wall was revealed (context 8). The wall appeared to be the outer wall of a former structure that was located adjacent to the Ty Castell extension.

**Photo 9:** Stone wall revealed in the eastern side of Trench 2

The stone built wall revealed along the south-eastern edge of the trench would appear to correspond with a wall associated with the former No. 1 Bridge Street or smaller auxiliary building as seen on the 1906 OS 2nd Edition 1:2500 map (Figure 3). The possible cobbled surface recorded within the trench may represent a yard area or path surface outside of the structure. The building post-dates the disuse of the main castle external ditch, which would have passed through this area.

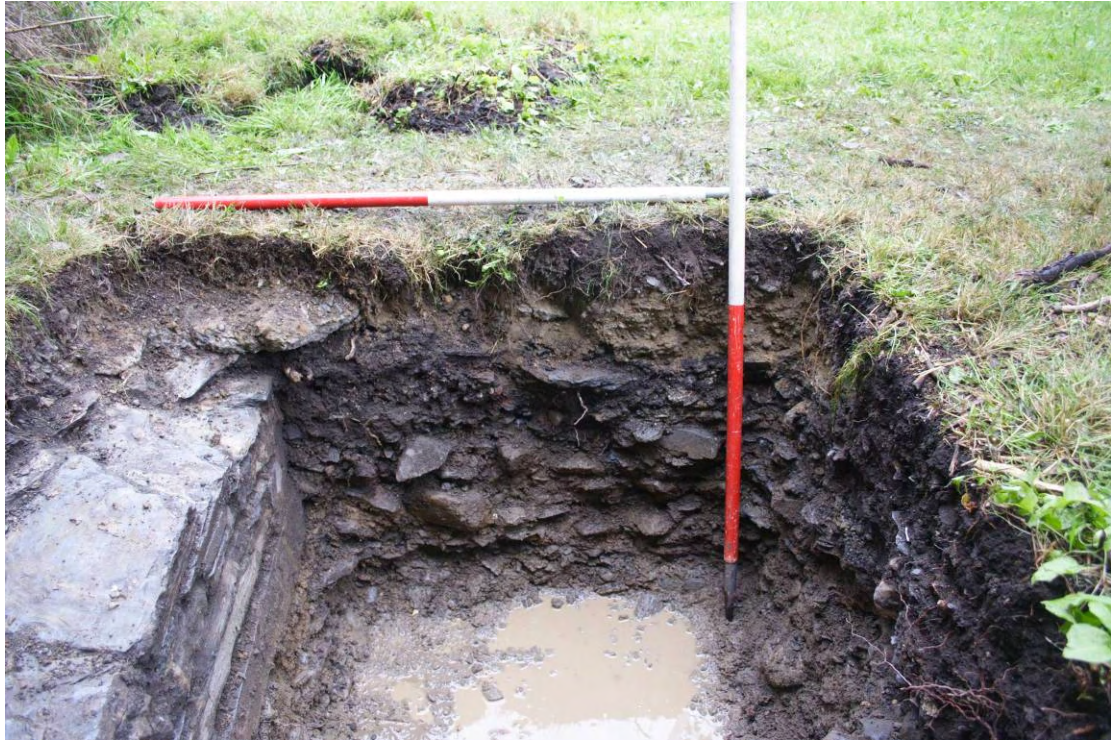
The trench was excavated to a depth of c.0.9m at which point water ingress covered the base of the trench and excavation had to be abandoned. The material removed from the trench to this depth consisted of rubble layers and shattered shale bedrock.

**Photo 10:** Trench 2 after completed excavation, with wall to the east and water ingress, viewing south

Trench 2 was restricted by existing services and a concrete slab. The trench was also constrained by water ingress through the side of the trench at a depth of c.0.9m.
