**NO 49 ANGLE,
PEMBROKESHIRE
SM 8614 0301**

ARCHAEOLOGICAL WATCHING BRIEF

RHIF YR ADRODDIAD / REPORT NO. 2010/63
RHIF Y PROSIECT / PROJECT RECORD NO. 100380

**NO 49 ANGLE, PEMBROKESHIRE,
SM 8614 0301**
ARCHAEOLOGICAL WATCHING BRIEF

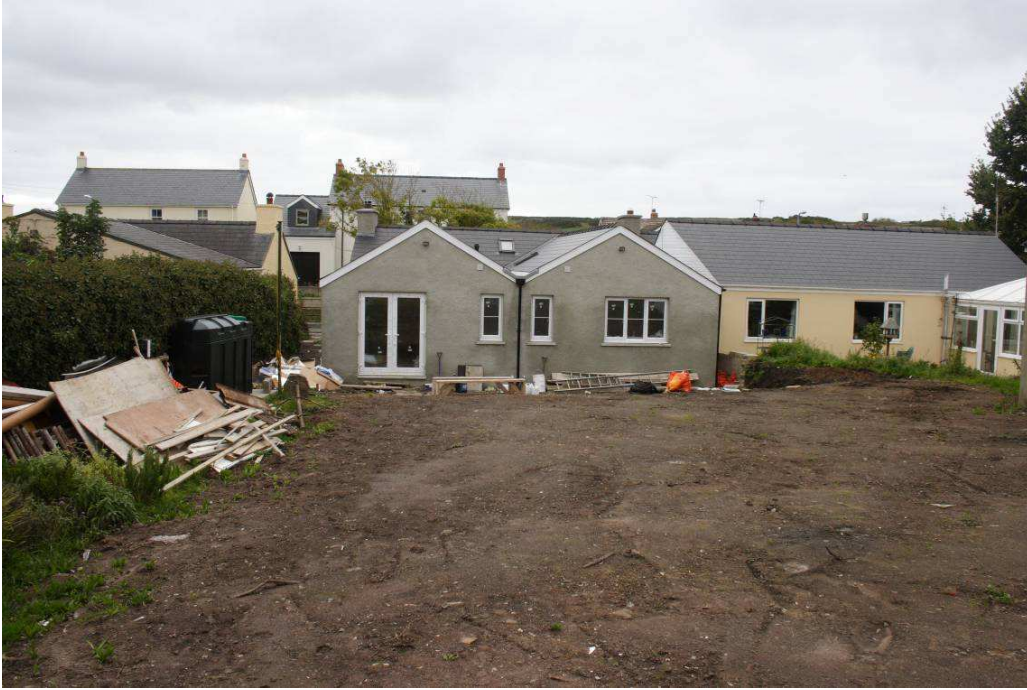
The rear yard area of the property was located on a south facing slope which had been partially terraced into with the excavation for the patio area (Photo 1). The majority of the garden comprised exposed soils, some of which presumably derives from the recent groundworks associated with the digging out for the area of the new extension. The exposed surface for the patio area was relatively level (Photos 2 & 3).

The patio area had been excavated into the south-facing slope of the garden. As far as could be ascertained, this was deepest in the north-west corner of the area, lessening to the south and south-east (Photos 1 to 3).

Photo 1: Rear of No 49 Angle from north, showing new extension and raised area of garden

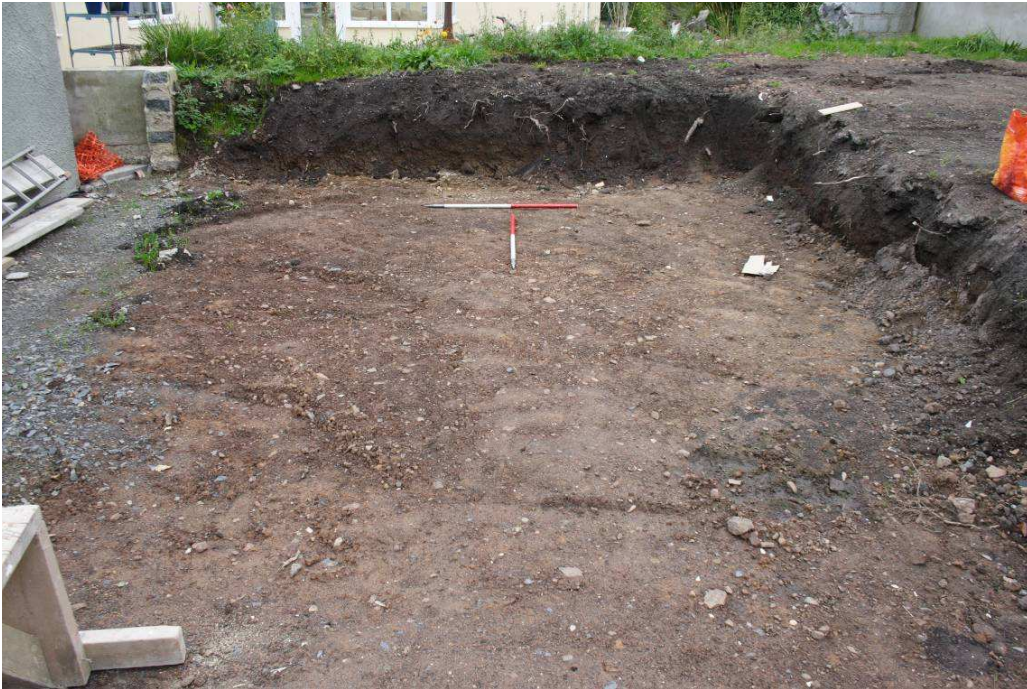
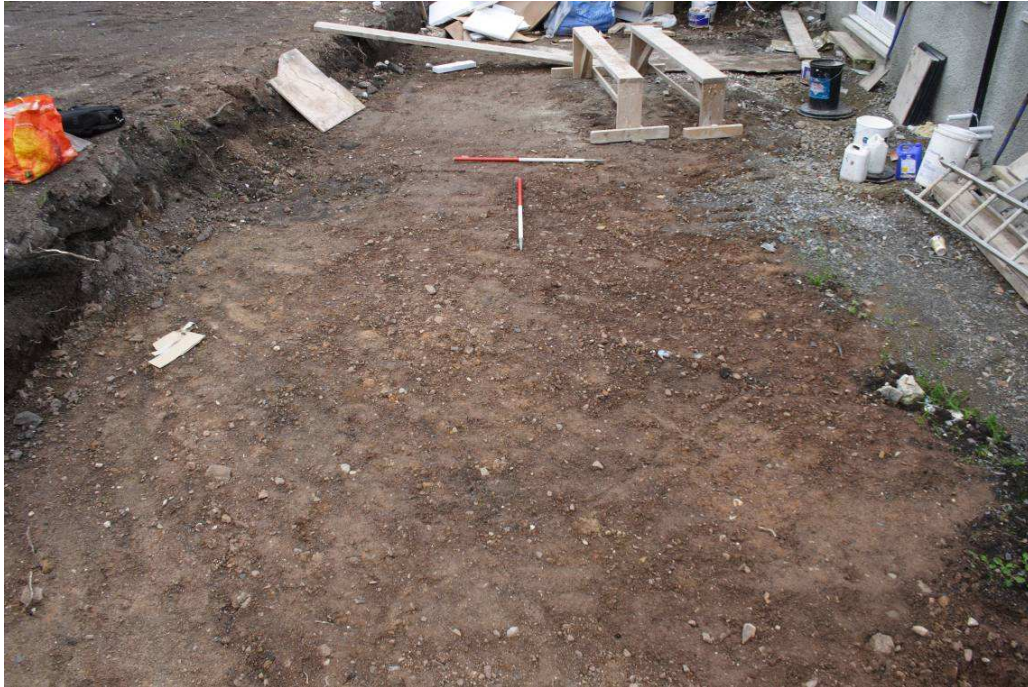
The material removed from the site comprised a very dark brown topsoil containing frequent fragments of 20th century debris and ceramic material. The material was very loose. The topsoil was an average of 0.44m in depth.

Beneath the topsoil was a layer of subsoil, of around 0.18m depth, comprising a dark brown clayey silt sand soil which was more compact than the layer above. The exposed surface at the base of the subsoil comprised a very mixed soil, with areas of dark topsoil areas of compacted red-brown silty sandy clay soils with small stones within. Root holes of former vegetation were also noted.

A number of sample areas were cleaned on the exposed surface to determine if natural undisturbed ground had been reached. Only a few areas of exposed natural clays were revealed in the eastern half of the area. Mostly only remnants of a mixed soil containing mixed clays and topsoil as described above.

Photo 2: Exposed ground surface within patio area from east, seen at commencement of watching brief

Photo 3: Exposed ground surface within patio area from west, seen at commencement of watching brief

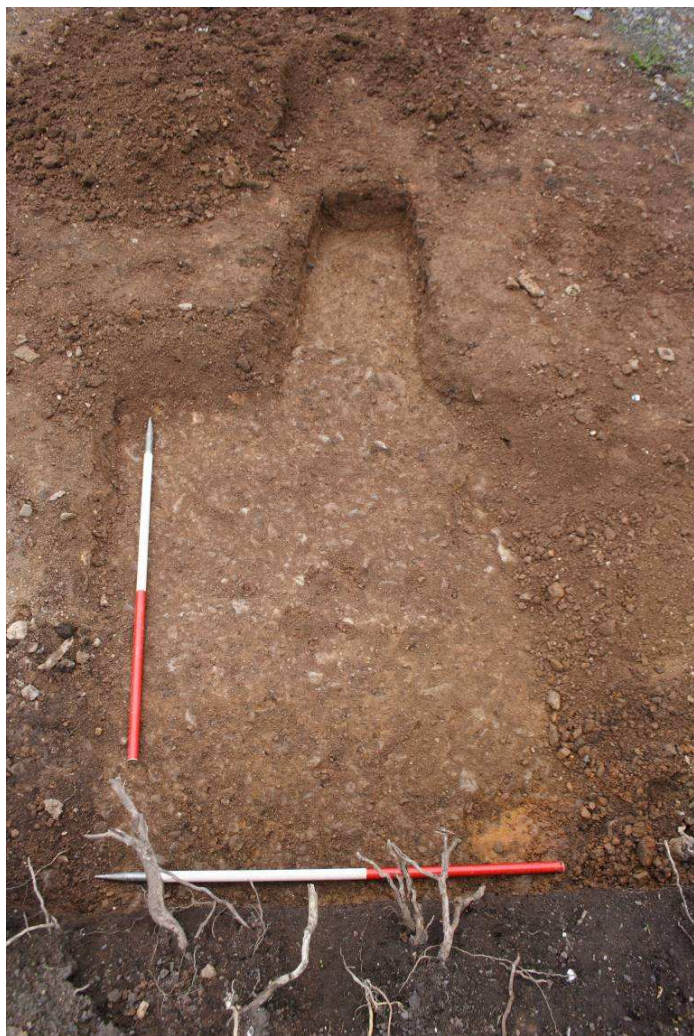
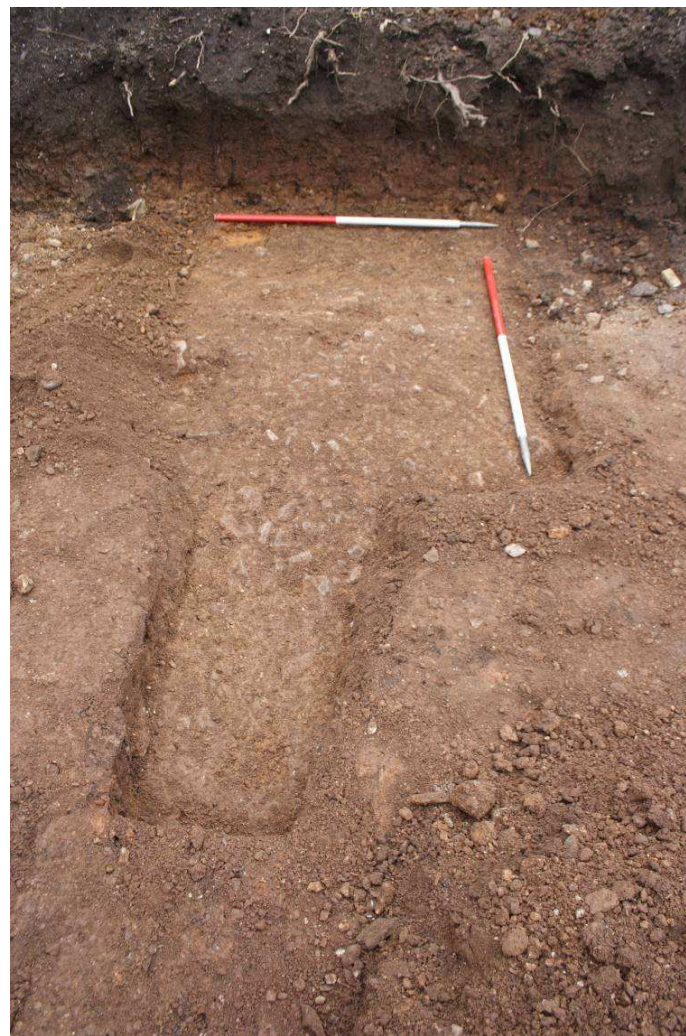
The second area (Photos 4 and 5) was located on the western edge of the proposed patio, where it was noted that a small patch of harder gravelled area was situated. Further cleaning in this area demonstrated that the gravelled area formed a metallised surface which was present directly below the mixed soil layer and covered an area of at least 2.5m x 1.2m, continuing beyond the cleaned area on all sides. The level of the metallised surface dropped to the east, sealed beneath a greater depth of the mixed soil to a maximum exposed depth of 0.14m below the top of the exposed surface. The full extent of the metallised surface was not exposed, as it lay below the construction layer of the patio and would thus not be disturbed by the development. A number of 18th or 19th century sherds of pottery were recovered from the top of the surface.

The metalled surface found on the western side of the site area would correspond with the trackway illustrated on the 1880s OS map. The original date of construction for the trackway is unknown, but it is at least as early as the building of No 49 itself, possibly created to provide easy access for the earlier residents of the house to get to the agricultural land to the north.

Photo 4: Exposed sample area of metallised surface seen on western edge of patio area

Photo 5: Exposed sample area of metallised surface seen on western edge of patio area

The watching brief has demonstrated that the only significant archaeological feature is a metalled surface for a former trackway that survives within the patio area of the development. The trackway will be preserved beneath the patio. The watching brief has also indicated that much of the rear garden of No 49 Angle had a layer of topsoil deposited over it at some point during the 20th century. Potentially if such a layer was also present over the area of the extension it may have afforded some protection to any archaeological remains that may have been present from the development. No medieval finds or features were revealed during the watching brief works.

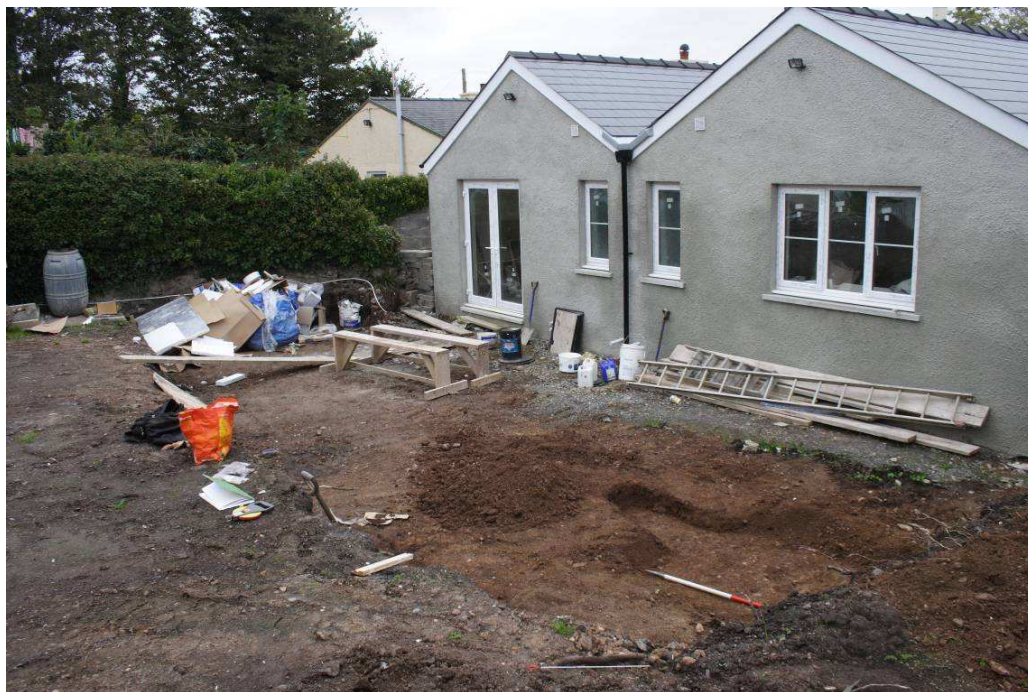
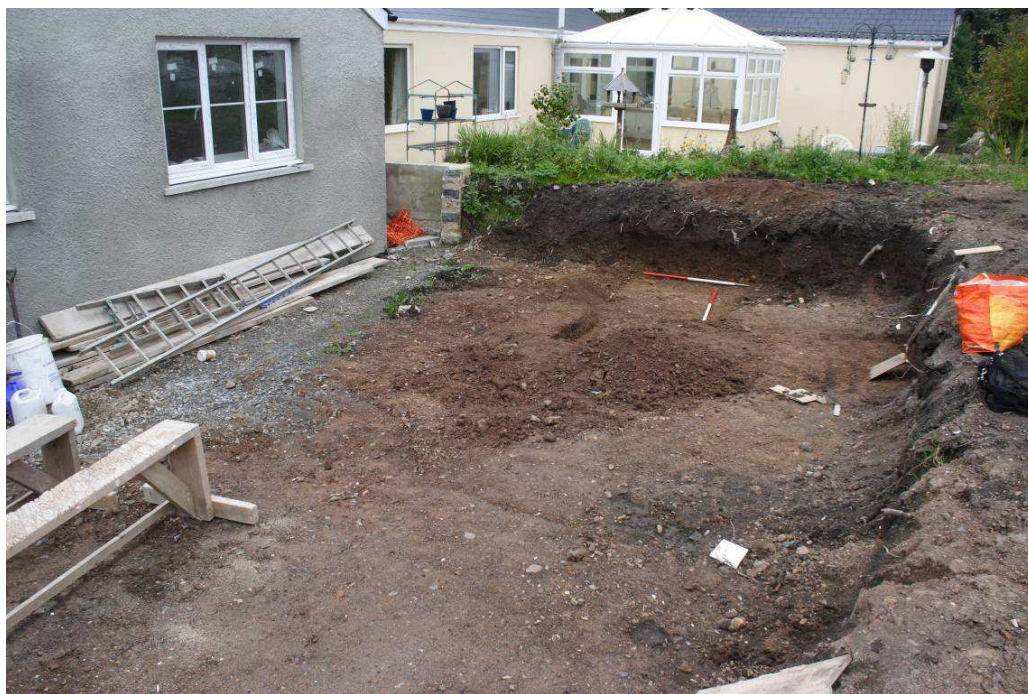
It would appear that the garden area of No 49 Angle had been previously built up using topsoil with a mix of rubbish and other debris dating from the 19th and 20th centuries (Photos 6 and 7). It is unclear where the material would have originated from, but could have been associated with development during the 20th century. As far as it is known, this material only partially originated from groundworks associated with the present development (soil clearance associated with levelling the extension area), the remainder appearing to be soil laid down previously. This loose topsoil layer overlay a more compact soil which may represent the original ground surface (topsoil/garden soil), and below this the subsoil cultivated up to the end of the 19th century. Root activity and evidence for the ground having been turned over (natural clay patches mixed in with the topsoil) holes were present within this buried subsoil layer.

Photo 6: Rear of No 49 Angle showing patio area from northwest

Photo 7: Rear of No 49 Angle showing patio area from northeast
