# CAREW CASTLE PEMBROKESHIRE

## Lift Base Archaeological Evaluation

Report No 2011/3

### Carew Castle, Pembrokeshire Lift Base Archaeological Evaluation

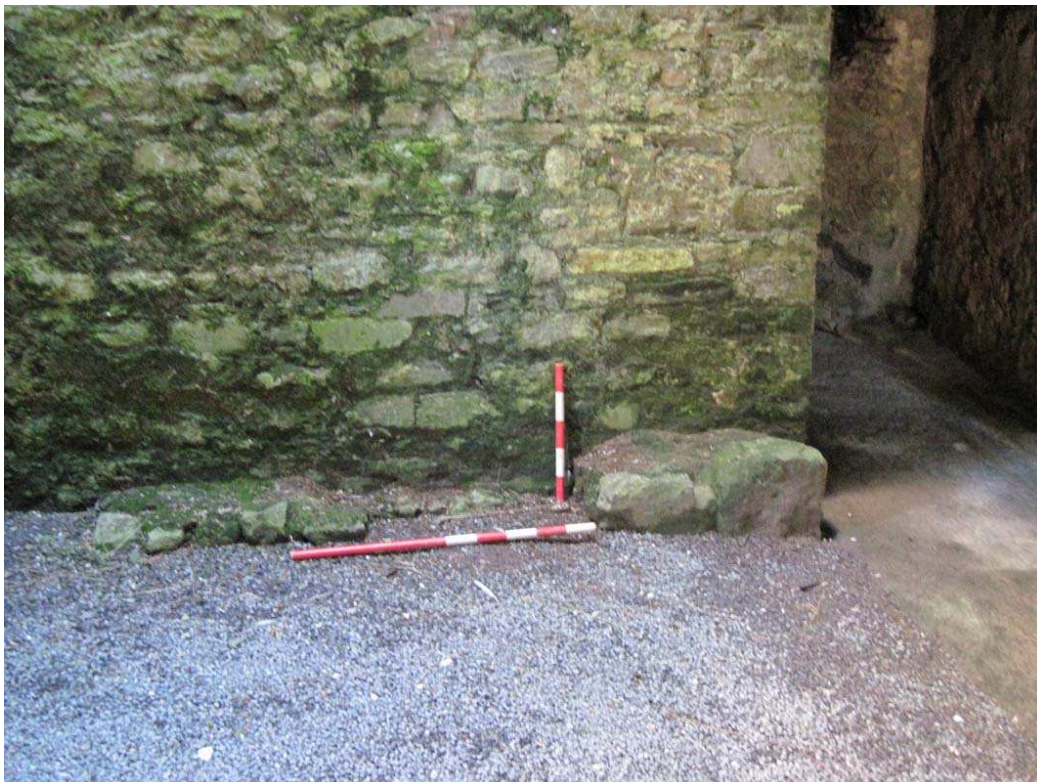
Having obtained Scheduled Monument Consent from Cadw, a small test strip, c.1.7m x 0.6m, was cleared by hand of modern gravel (Photo 1) in the area of the proposed lift base. This revealed a mortar and stone floor, c. 70mm to 100mm below the top of a concrete path which runs between the doorways on the east side of the room. It is likely that this floor extends over the whole area. A "plinth" against the north wall appeared to be built on the stone floor (Photo 2). The modern concrete path, to the east, also lies on the floor, but is separated from it by a membrane (Terram?). The floor surface was photographed but not drawn or excavated. The area was refilled again with the gravel.

Photo 1: Area before excavation. View N. Scales 0.5m and 1m

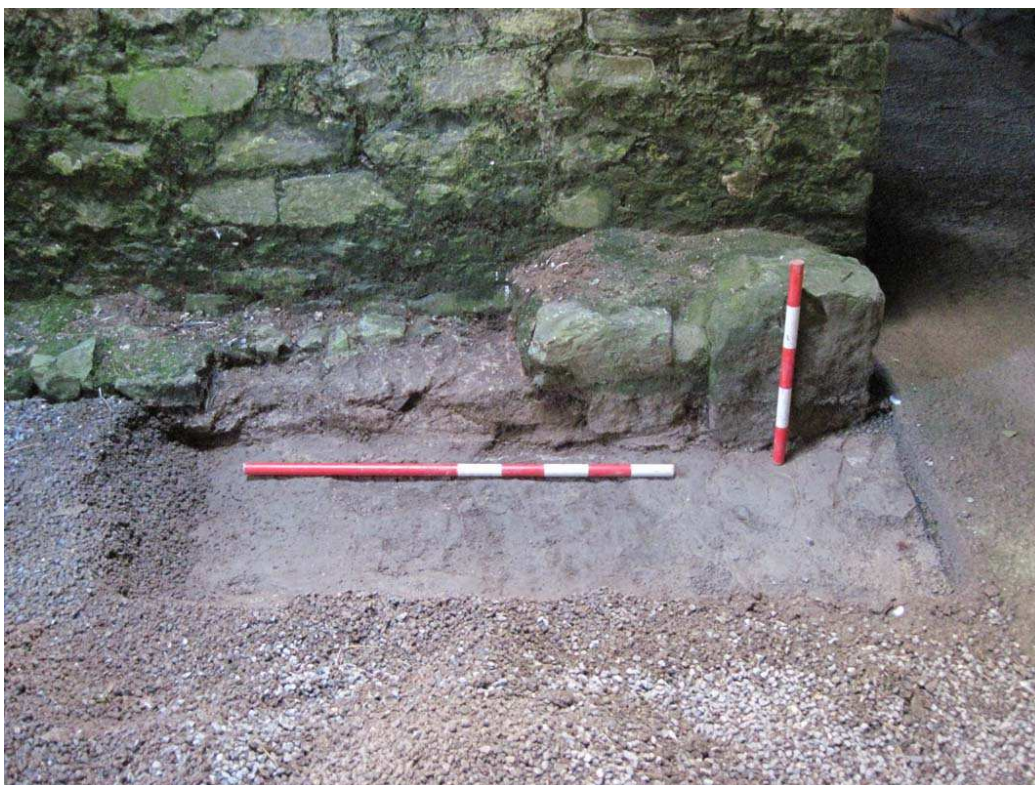
Photo 2: Area as excavated. View N. Scales 0.5m and 1m

The stone and mortared floor is considered to be an historic floor surface that will need to be retained as a significant part of the historic fabric of the castle. It is considered that both the mortared stone floor and plinth should not be disturbed. Cadw do not normally allow such significant aspects of scheduled monuments to be disturbed.

It is unknown at present whether it is possible to build the lift base above this floor level. If it is possible to do so, the floor will need to be adequately protected. Any concrete base should, like the path, be separated from the archaeology with at least a membrane, and may require further protection. If this lift installation proceeds, it is recommended that all of the floor area below the gravel should be cleared and recorded prior to any new build. This would probably only take a day or two for two archaeologists – depending on the standard of floor recording required.

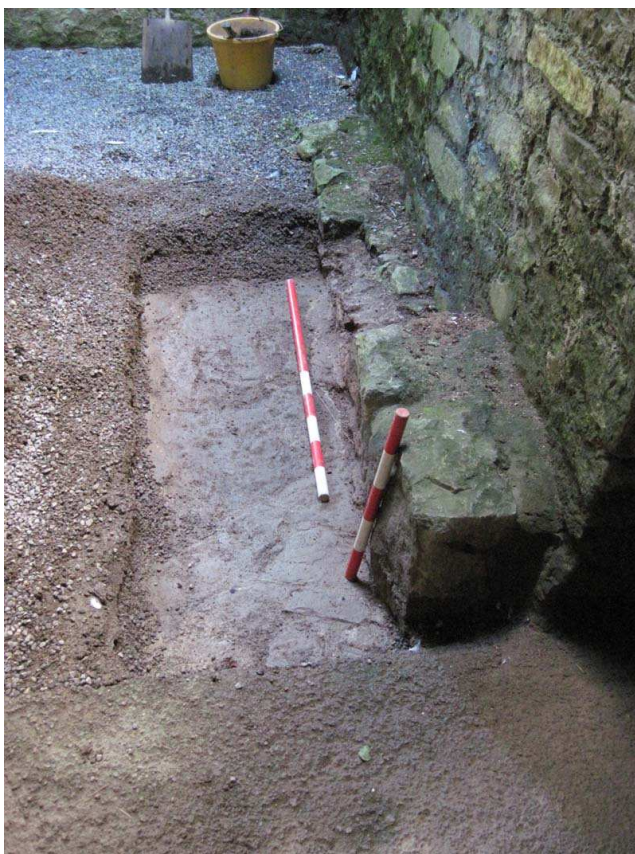
Photo 3: Area as excavated. View W. Scales 0.5m and 1m
