UPPER EASTERN ARM CAUSEWAY, STACKPOLE, PEMBROKESHIRE: (SR 9784 9622)

ARCHAEOLOGICAL SURVEY AND INVESTIGATION

Prepared by Dyfed Archaeological Trust
for Bob Haycock, Countryside Council for
Wales

RHIF YR ADRODDIAD / REPORT NO. 2011/12

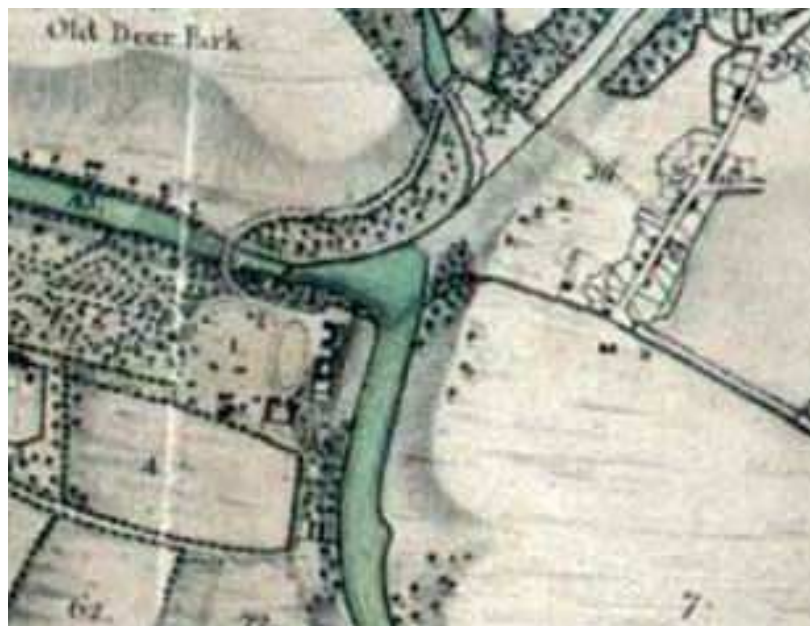
Figure 3: Extract of 1782 Estate map showing possible blurred alignment of walkway feature

- 2.2 A study of the available map evidence for Stackpole provides an indication that a causeway was present crossing the lake from at least 1782. The estate map of this date shows a blurred feature crossing the lake from east to west with a slight kink towards its western end (Figure 3). The feature is not clearly defined and is certainly not as clear as the roadway shown crossing the lake to the NW. Although the alignment starts and ends at the same points as that surveyed, the route between the two is slightly different. The accuracy of the map is questionable as a number of wall lines and features do not accurately correspond with features still extant today.

- 2.7 The area of Stackpole Court Park and Gardens is considered to be a historically significant area and has been subject to a Historic Landscape Characterisation study (Appendix 1). The study provides information on the date and development of Stackpole Court, indicating its medieval origins, with a number of rebuilds and redesign of the manor house until the 18th century. At this point major landscaping works are undertaken to create the parkland visible today, including the damming of rivers and streams to create the layout of lakes as evident today. The Eastern Arm of the lake system had been created by 1782, as shown on the above estate map (Figure 3).

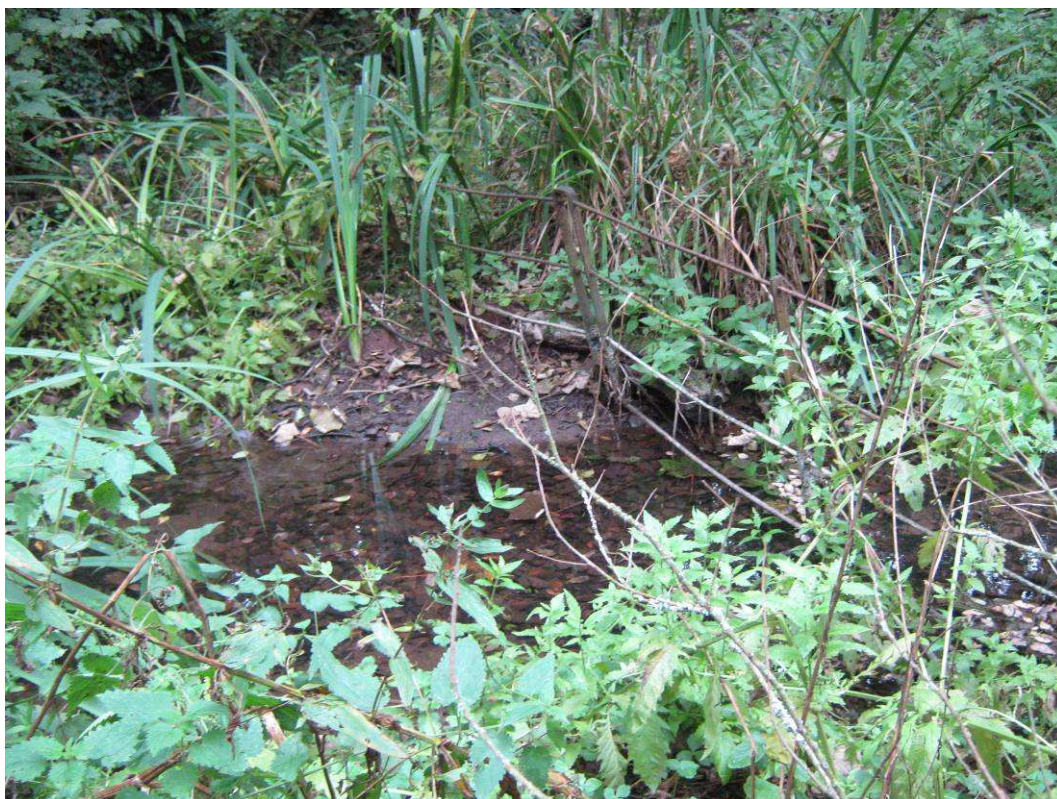
Photo 1: Iron railings of causeway visible through undergrowth

- 4.1.1 The initial site visit was undertaken in September 2010 which identified the start of the railings for the causeway on the western side of the lake (Photo 1). It was not possible to determine where they joined the pathway on the western bank. It is likely that any such join had been removed or covered when the mansion house was demolished.

- 4.1.2 The iron railings survived to a maximum height of just around 0.90m from the top of water level (as seen in Photo 1) to the top of the four rail fence. The fence was constructed of spun iron railings supported through holes in two single flat piece iron upright posts, with larger fixing posts at the ends. These larger posts were constructed of a single flat strip of metal curved into an arch allowing the spun metal railings on either side to be passed through holes in the upright and bolted at the ends. This is shown in more detail on Figure 6.

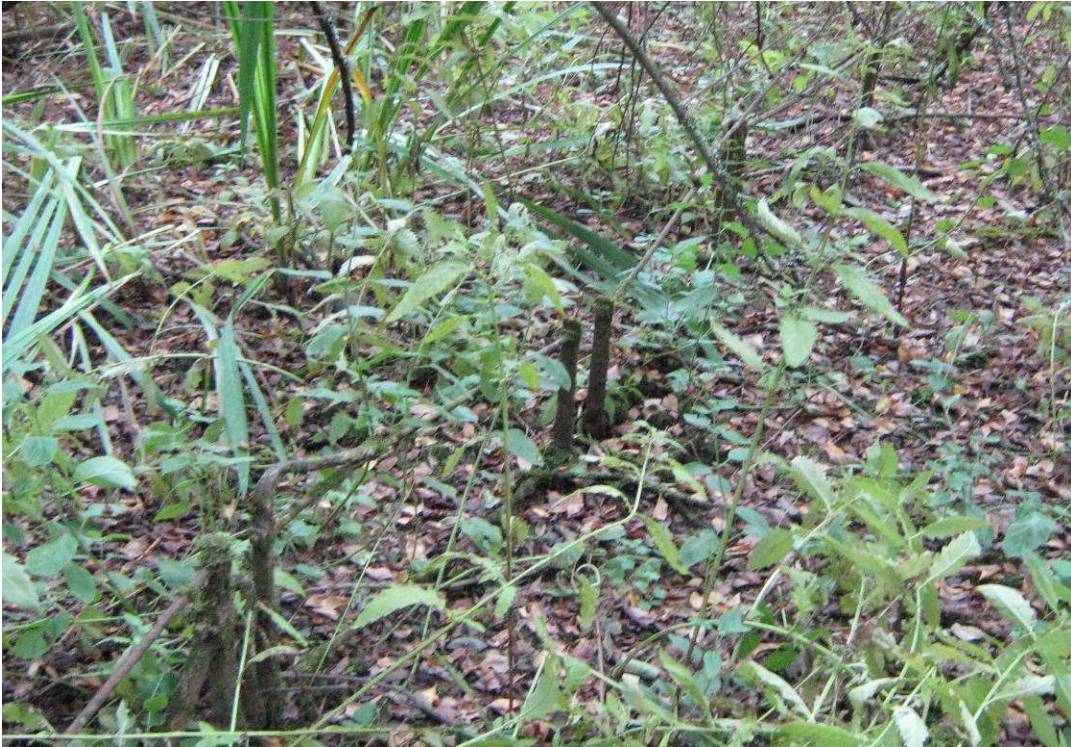
- 4.1.3 A gate was present in the railings close to the western bank (Photo 2). This was mostly covered by silt, but the upper parts were still visible. The gate was of simple construction and similar in design to the rest of the fence being of spun iron railings bolted on both sides of flat metal strips at either end. The metal strips on the outer parts of the gate were longer than those in the centre, and had been curved over to form a simple decorative scroll (Photo 3). The dimensions of the gates were roughly 1.2m in width, forming an total entrance of c.2.4m.

Photo 2: Part of gate exposed in western end of railings

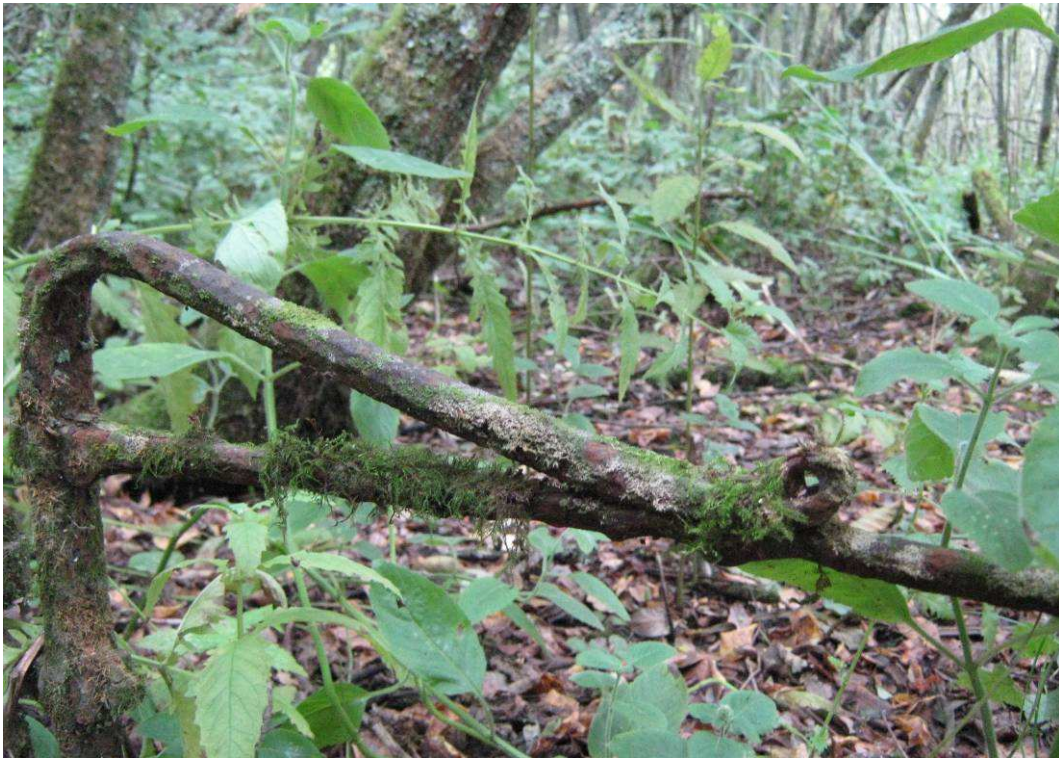
Photo 3: Detail of decorated scroll on end of gate

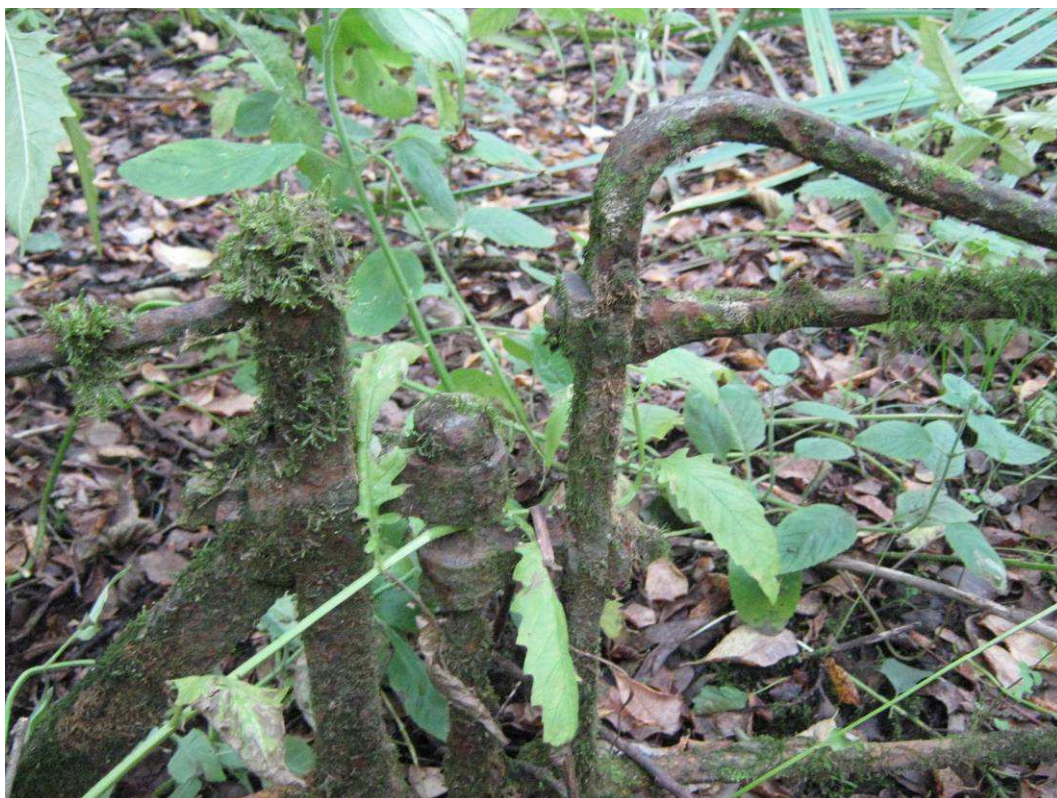
- 4.1.4 The gates were supported to a round upright iron post at either end, through the use of a bolted on strip of metal that had been looped and passed over the metal upright, forming a simple pin and eye hinge (Photo

4). The metal upright was attached by a similar strip of metal curved to form a loop over the metal upright, and bolted to the adjacent single fence upright.

Photo 4: Gate hinge in railings supported on separate metal post

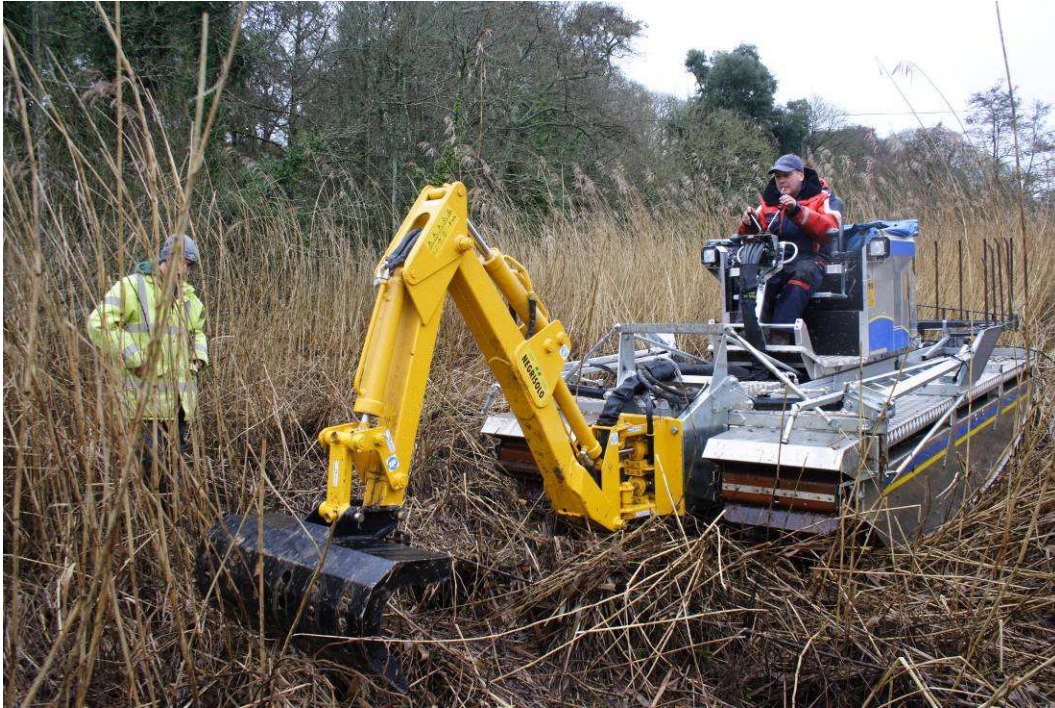
- 4.3.1 In February 2011 a single trench was excavated across the line of the causeway feature (Photo 5). The trench was located on the eastern half of the causeway route and excavated using the "Truxor" machine described briefly in section 3.2.

Photo 5: Excavating the trench

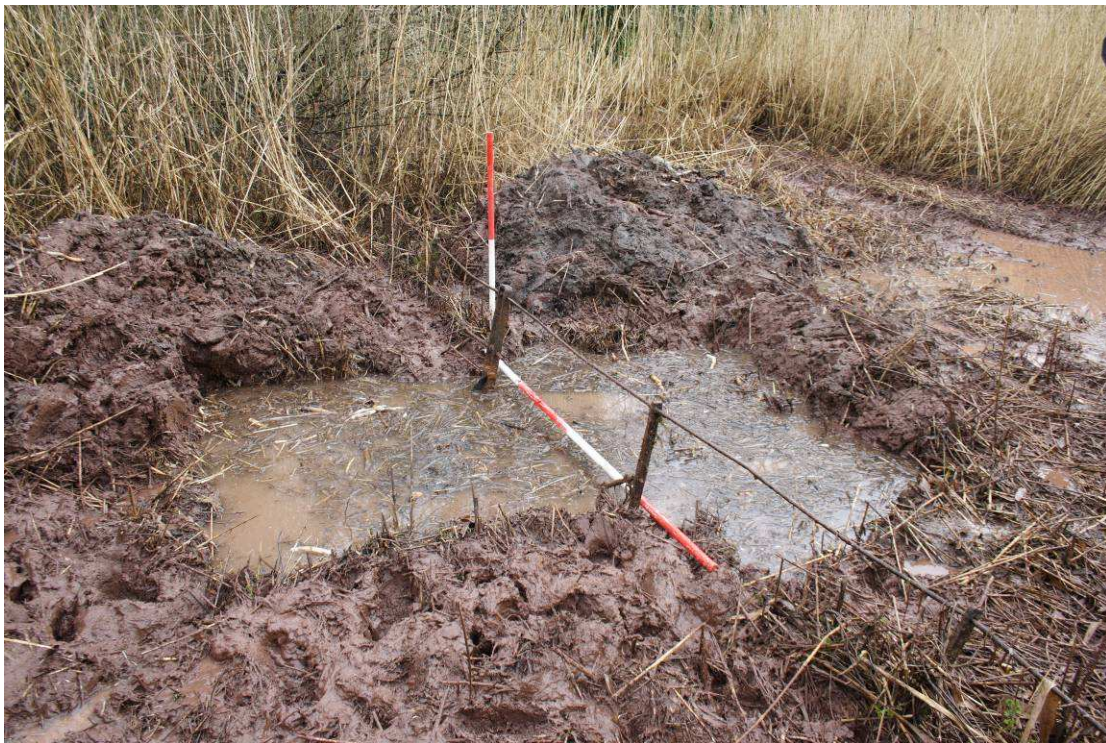
Photo 6: The excavated trench showing the fence line from the NW

- 4.3.3 The trench measured roughly 1.3m x 2.4m in size, with the railings approximately central to the excavated area (Figure 6) (Photo 6).
- 4.3.4 It was apparent that the railings ran along the northern edge of the causeway. They were of the same construction as those seen on the western side of the causeway, with no gateway apparent in the exposed area.

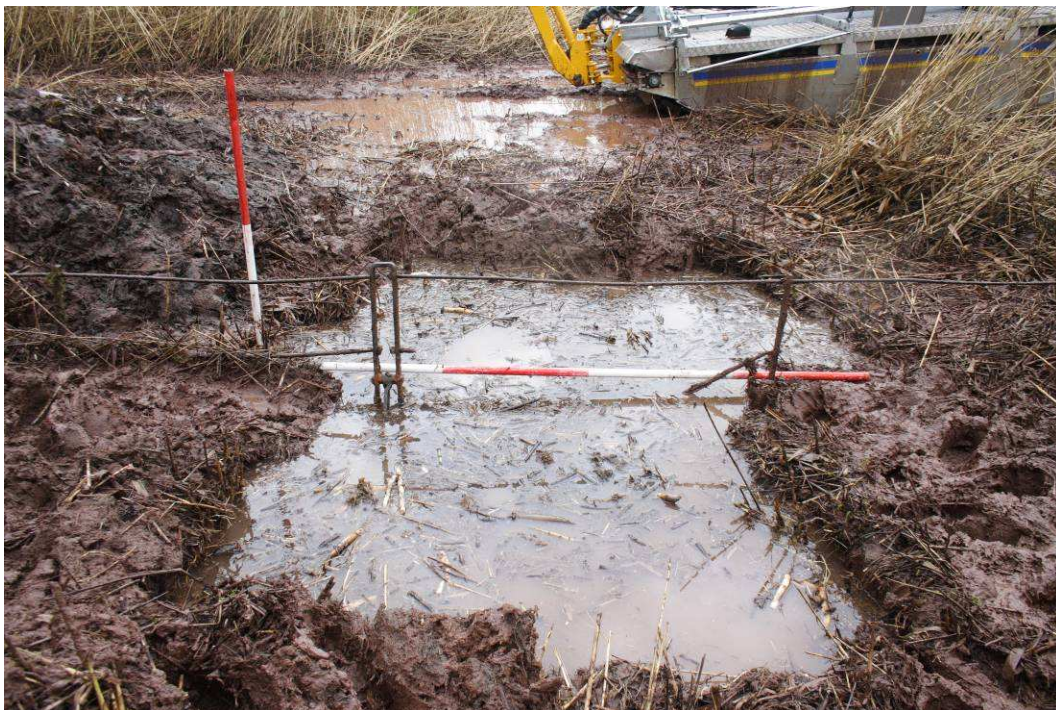
- 4.3.7 The section of the fence exposed within the trench was drawn (Figure 8) showing details of the arched metal fixing post, with the bolted railings (Photos 7 & 8). The flat strip of iron used for the brace was fixed by a looped eye to a pin bolted across the width of the fixing post (Photo 8). The iron railings were badly corroded in this area, one of which had broken through.

Photo 7: View of trench from NE showing railings

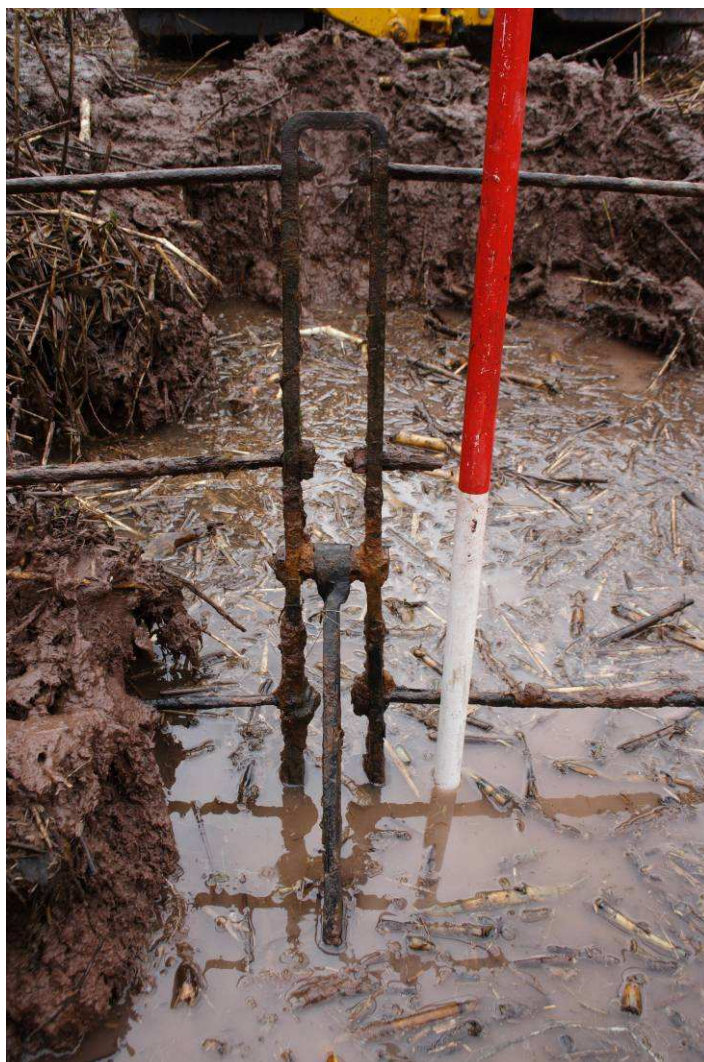
Photo 8: Detail of fixing metal post and brace
