MAES Y FFAIR, MATHRY, PEMBROKESHIRE:

ARCHAEOLOGICAL WATCHING BRIEF

RHIF YR ADRODDIAD / REPORT NO. 2011/14
RHIF Y PROSIECT / PROJECT RECORD NO. 100558

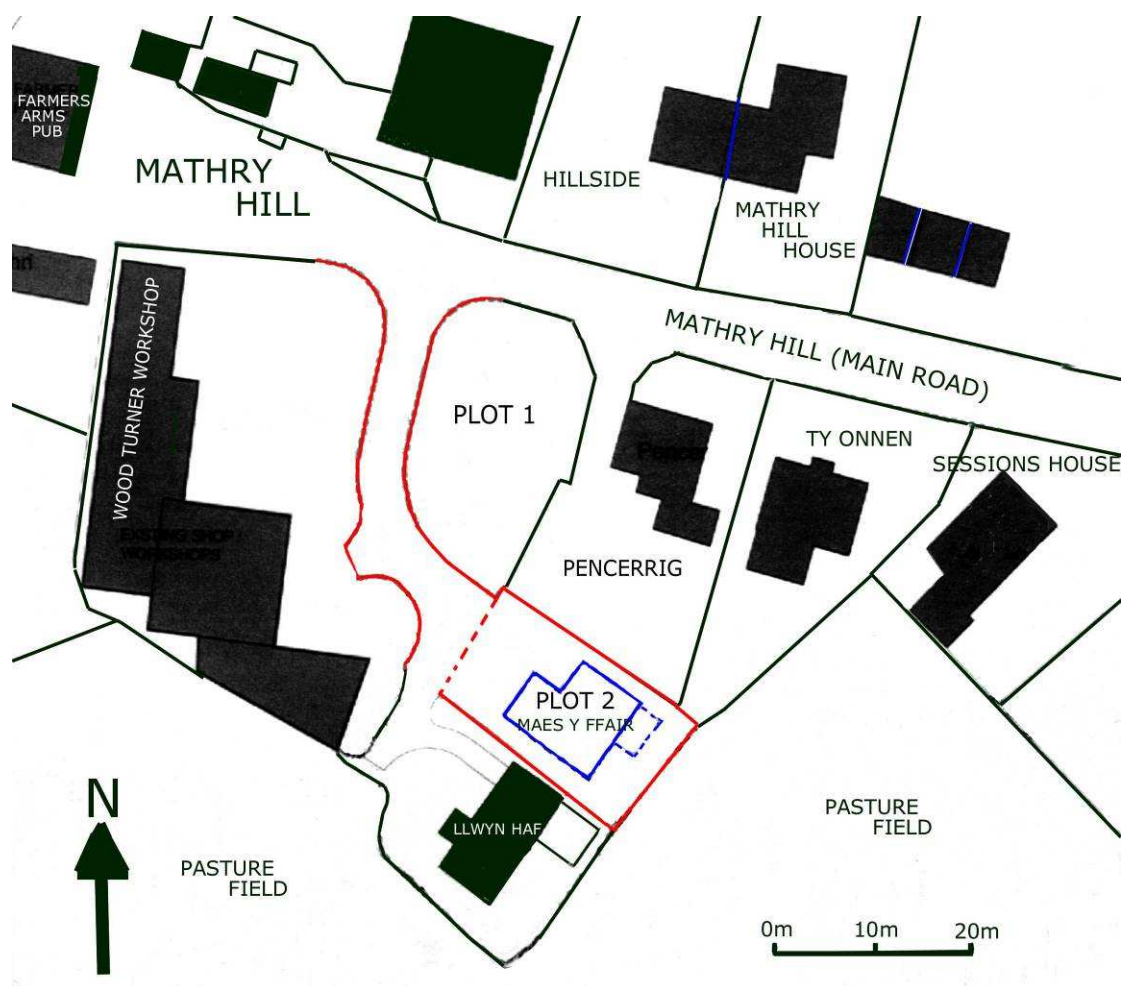
Figure 2: Plan showing location of Plot 2, Maes Y Ffair, area of the watching brief. Based on the client's site plan.

The development area (centred on NGR SM 88021 31895, at c.125m OD) comprises a rectangular plot of land (Figure 2) bounded on its northeast side by gardens to the rear of properties that front on to the main road of Mathry Hill. A relatively new property, Llwyn Haf, bounds the development area to the southwest with an enclosed pasture field forming the southeast boundary. Access to the development area is from its northwest end via a yet to be finished private access road. The site area is on a moderate southeast facing hillslope.

The watching brief was carried out during the final machine clearance of the topsoil and footings excavation at the northwest, upslope, edge of the building footprint (see blue outline of building 'Plot 2' in Figure 2). Part of that area was covered by a concrete slab³ that lay above a sub-base of medium to small angular rubble to a depth of 0.5m; removal of these layers revealed a buried reddish brown silty clay topsoil to a depth of 0.2m (Photo 4).

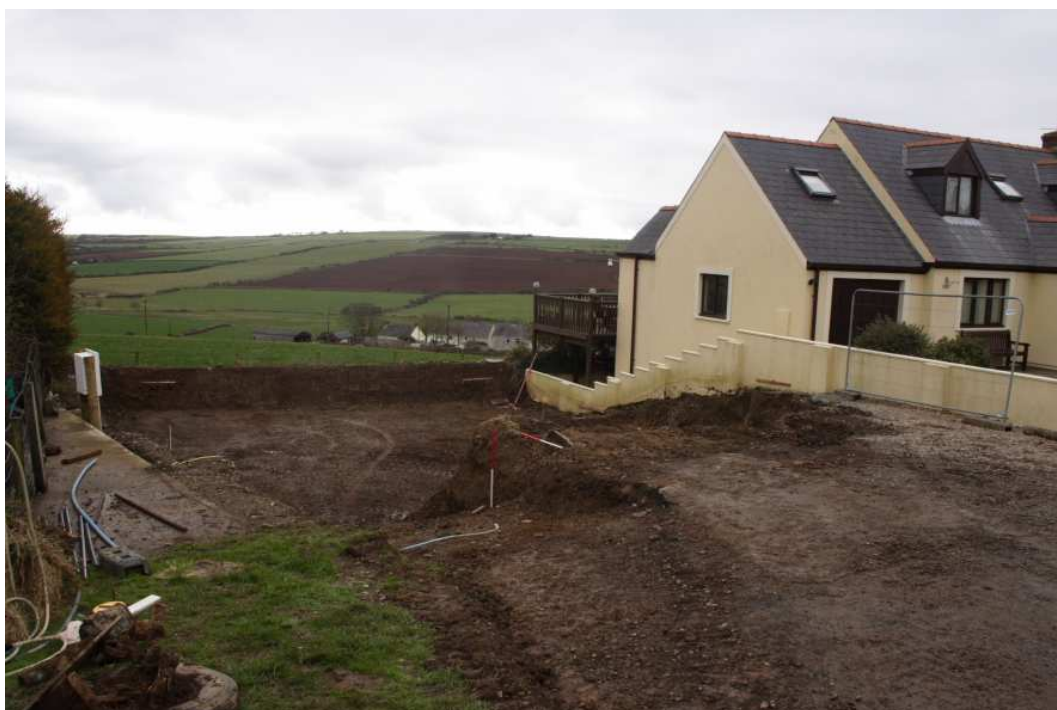
Photo 2: General view across the site, looking southeast

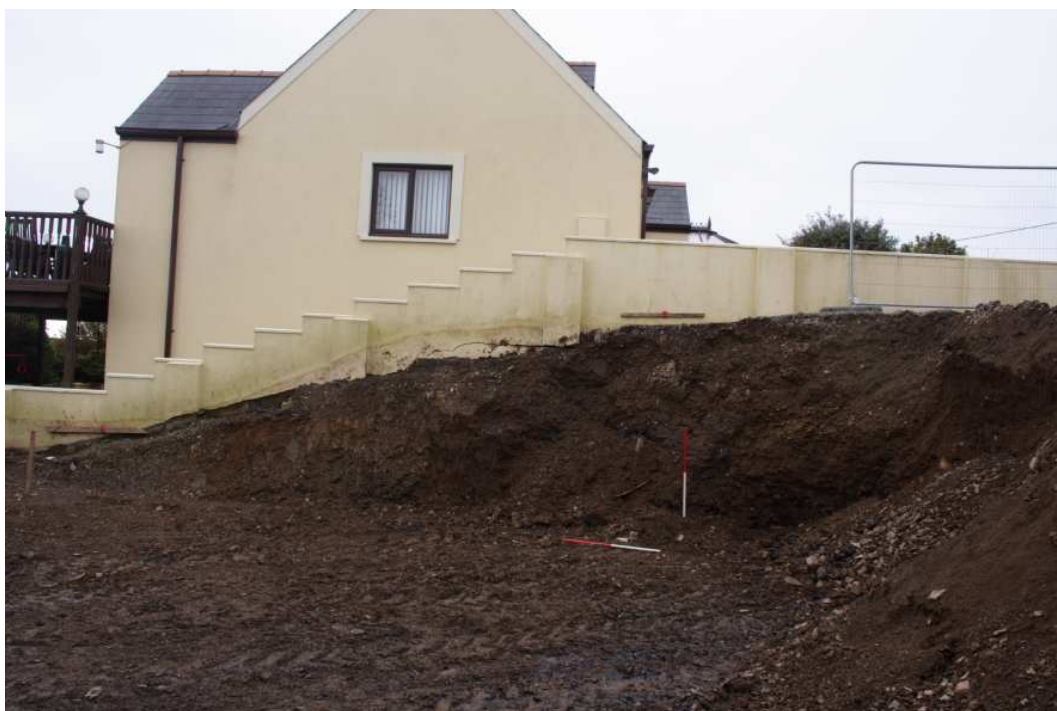
Photo 3: View southwest showing revealed section, the 2 x 1m scales are positioned in front of the profile of a deep modern rubbish pit.

The exposed vertical sections on the northeast and southwest sides of the excavations are the only record that we have of the general stratigraphy across the sloping site (Photos 3, 6 and 7) prior to the site clearance. The topsoil, where present in either section, had an average depth of 0.45m and overlay a compact yellowish brown natural subsoil to an average depth of 0.35m. The subsoil overlay natural loosely bedded shale bedrock. Both sections showed that building rubble had been dumped over the topsoil in discrete areas, probably during the relatively recent construction of both Pencerrig to the north and Llwyn Haf to the south of the development area. Also apparent in the sections were a number of fairly large pits, all of which contained building debris and other modern rubbish. At the east end of the southwest facing section the dark brown soil profile of the former field boundary could be seen (Photo 7).

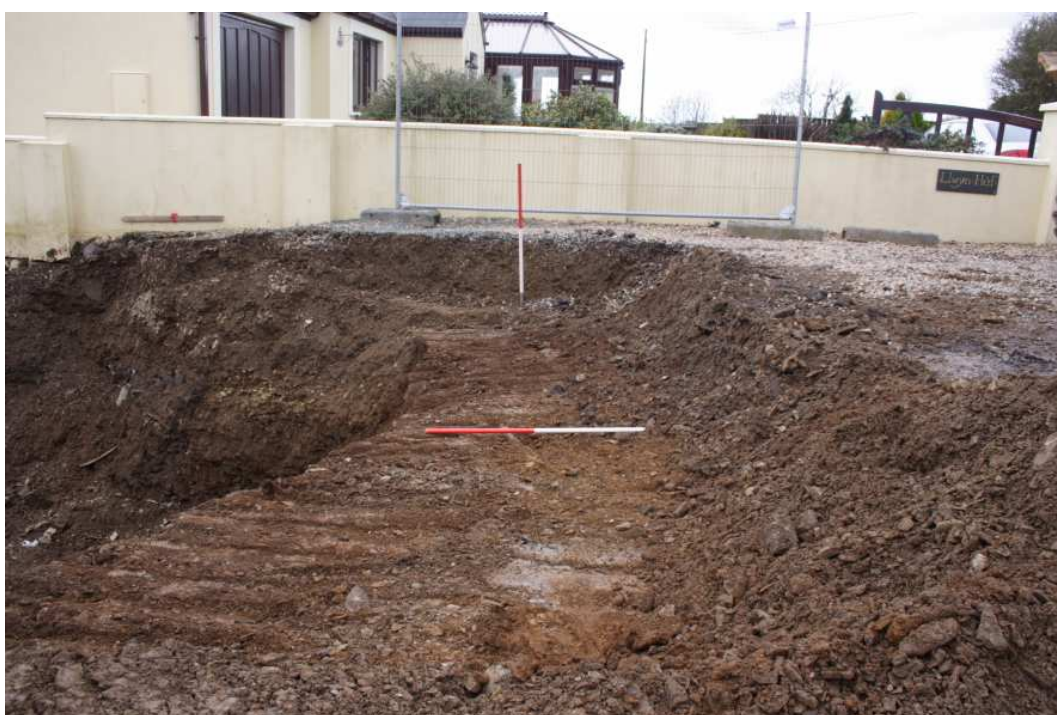
Photo 4: The top of the buried soil horizon revealed at the northwest edge of the plot after the removal of layers of concrete, ornamental gravel and hardcore rubble/shale sub-bases. View southwest, 2 x 1m scales.

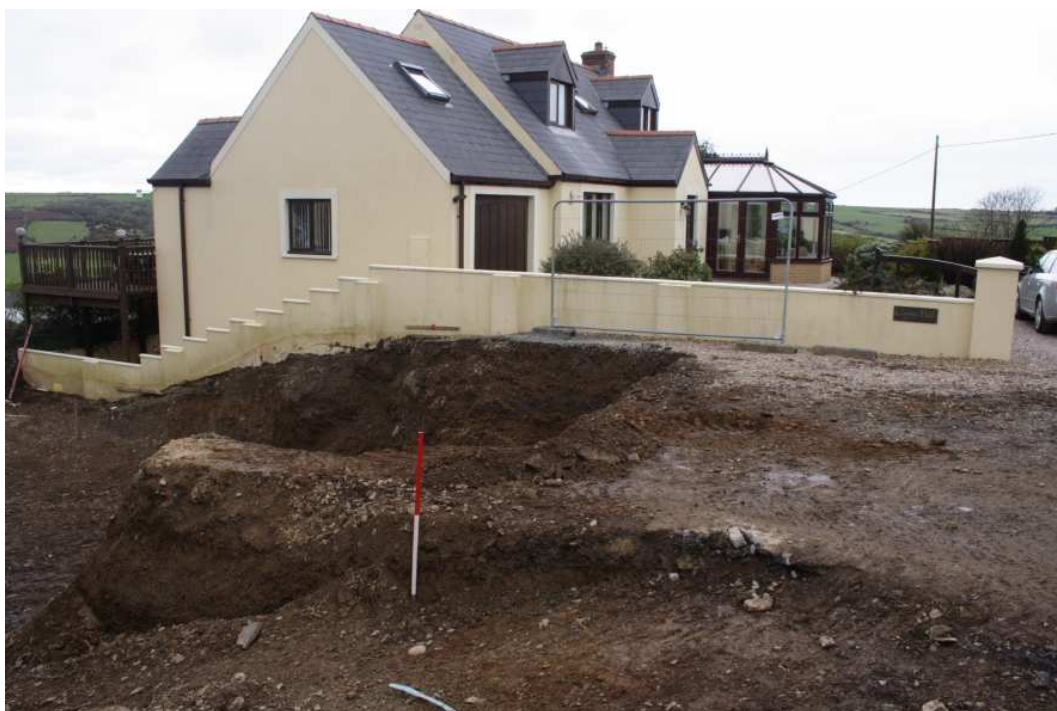
Photo 5: View of the northwest edge of the plot after the removal of the buried topsoil layer. Looking south, 1x1m scale.

Further southwest towards the adjacent property, Llwyn Haf, the concrete slab gave way to a 0.1m deep layer of ornamental gravel which overlay a 0.5m deep sub-base of medium size shattered shale fragments; removal of these layers again revealed a c.0.2m deep buried topsoil. Gentle machine removal of the topsoil layer revealed only undisturbed compact orange-brown natural subsoil with no archaeological features or deposits present within the layer or cut into the subsoil (Photo 5).

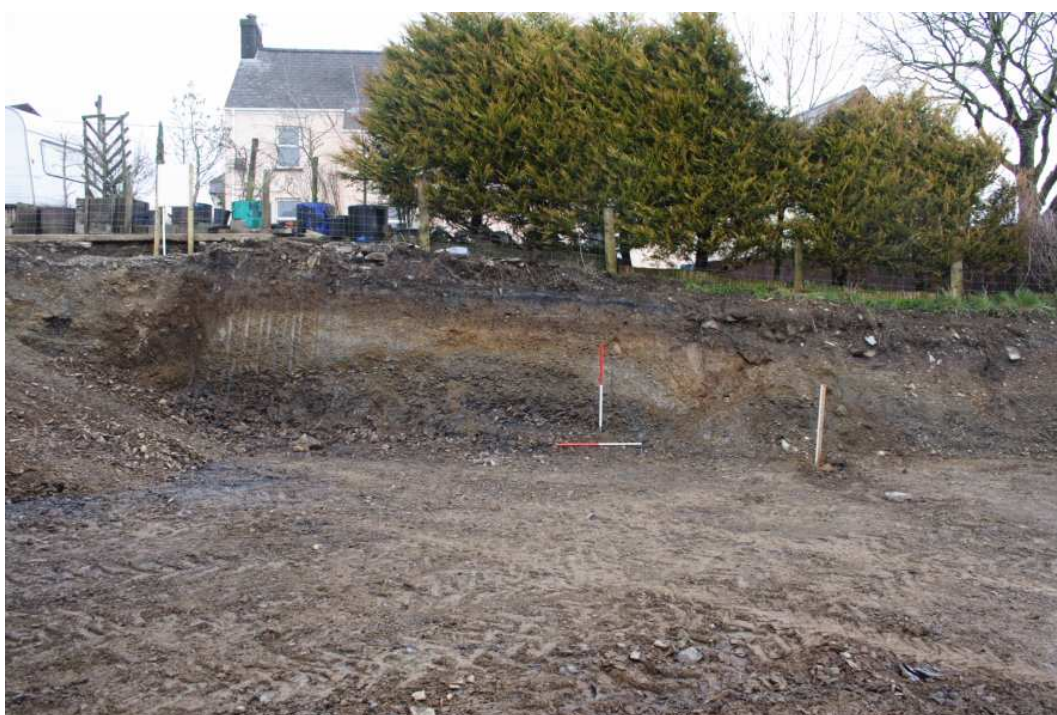
Photo 6: Section showing deposits exposed along the west end of northeast edge of the development area. 2 x 1m scales

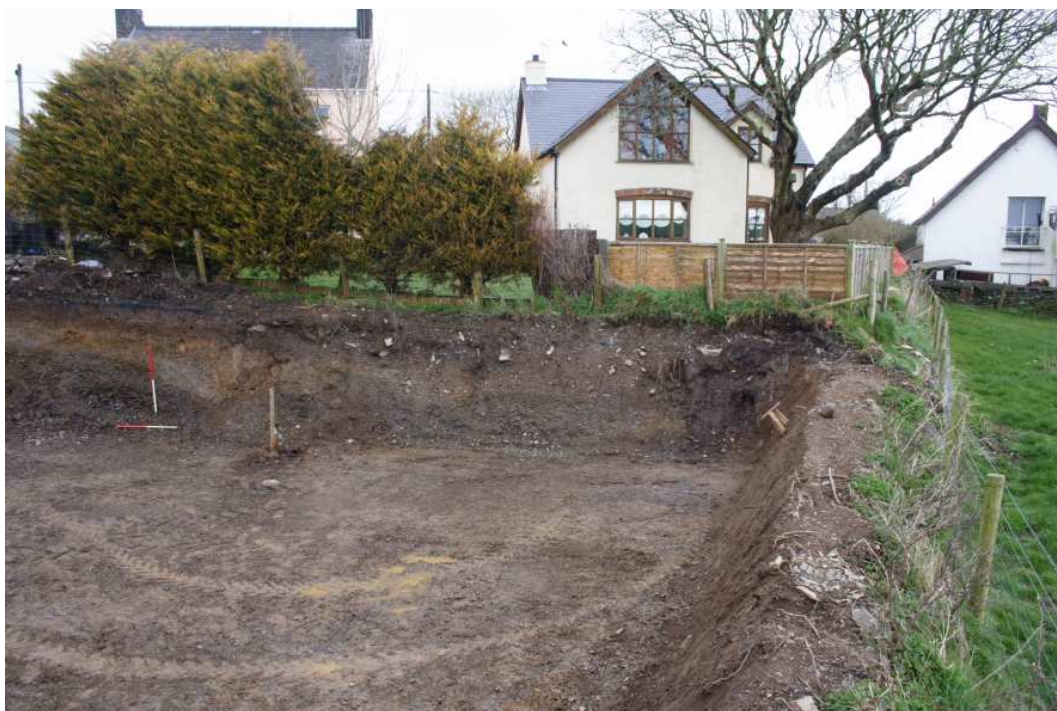
Photo 7: Section showing deposits exposed along the east end of the northeast edge of the development area. Note the dark soil profile of the former field boundary at the east end of the section, with the newly remodelled field boundary in front of it (right side of photograph). 2 x 1m scales

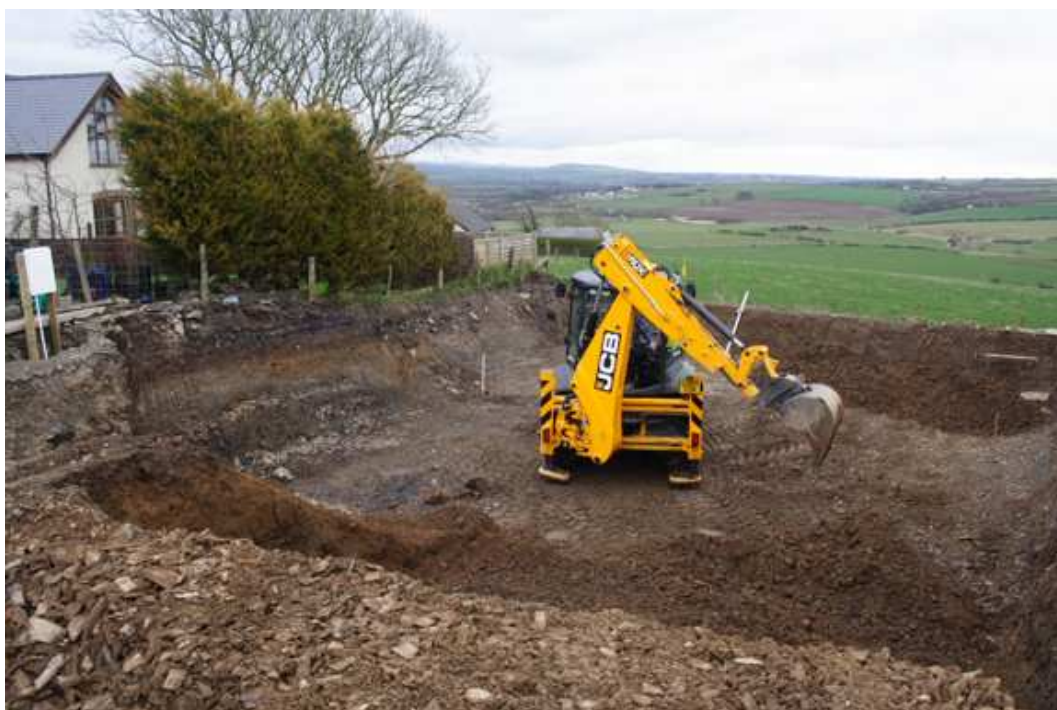
Photo 8: View east across the development area during the finishing touches to the groundworks.
