MAESLLAN, PENYBONT, CARMARTHENSHIRE: ARCHAEOLOGICAL WATCHING BRIEF

Prepared by Dyfed Archaeological Trust
For: Mr Colin Bowen

RHIF YR ADRODDIAD / REPORT NO. 2011/15
RHIF Y PROSIECT / PROJECT RECORD NO. 100559

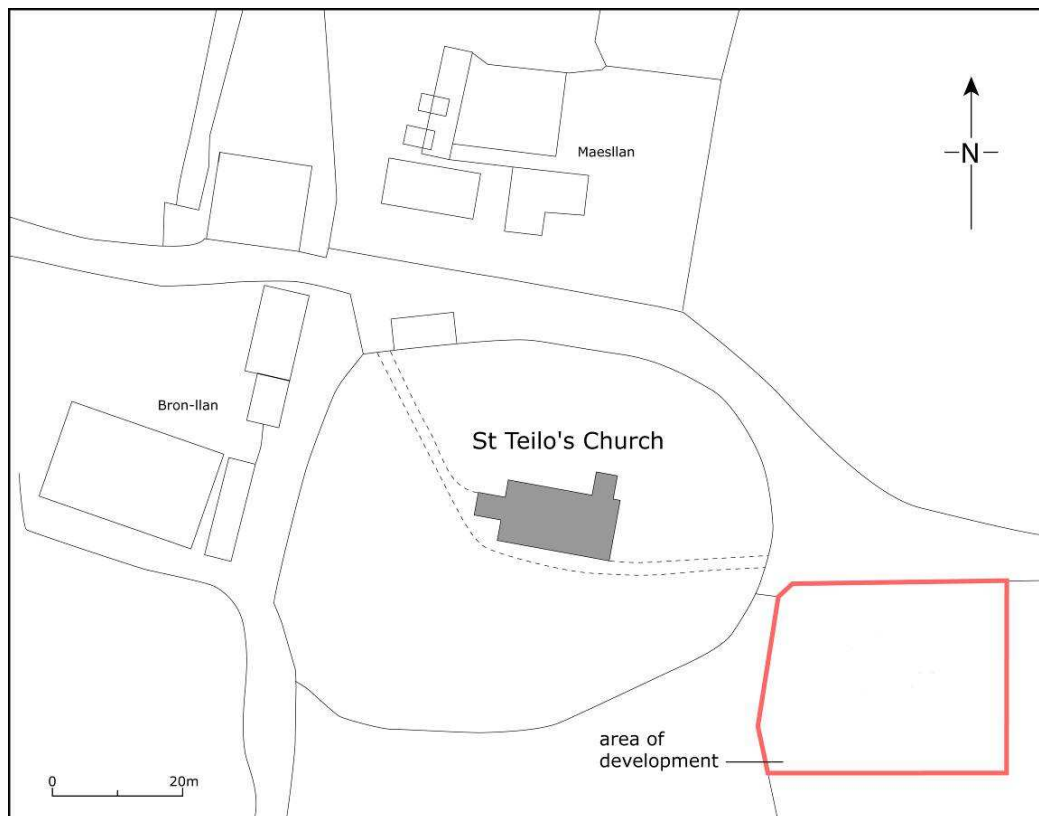
- 2.1.1 The development area is located in an undeveloped field at NGR SN 3096 2666 and lies to the south east of St Teilo's Church, Trelech a'r Bettws. An unclassified road runs along the north boundary of the development area whilst a small watercourse forms the western boundary. The land slopes steeply to the southwest of the development area which is at a height of c.80m above Ordnance Datum.
- 2.1.2 The underlying solid geology of the area is represented by undivided Ordovician shales of the Ashgill Series (British Geological Survey, 1994).

Figure 2: Detailed Location Plan showing development area.

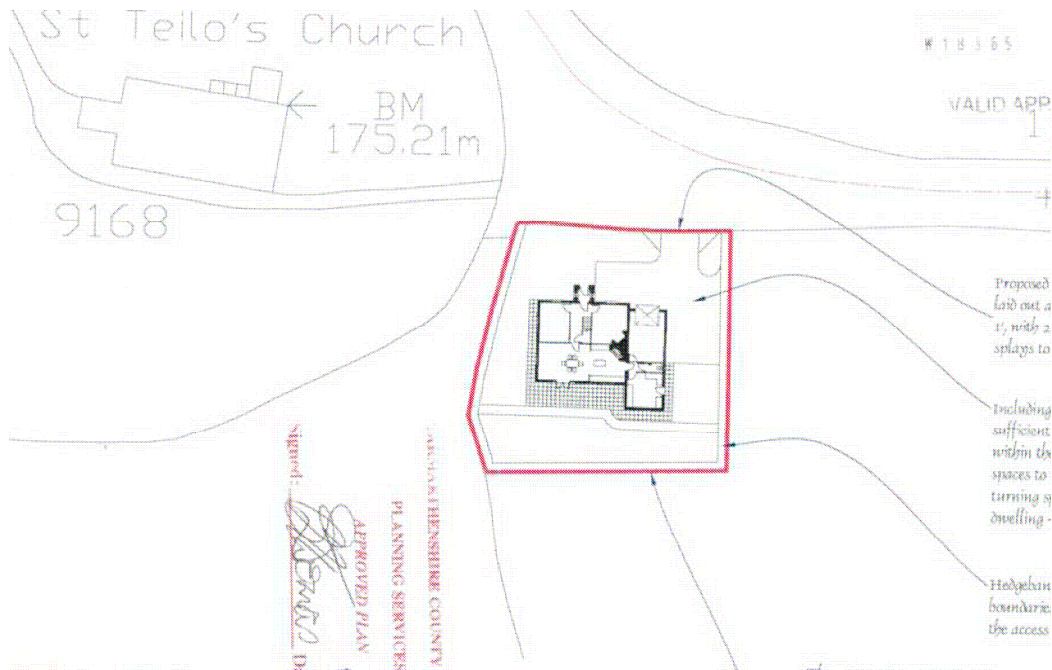
Figure 3: Detailed Location Plan (as supplied for planning application)

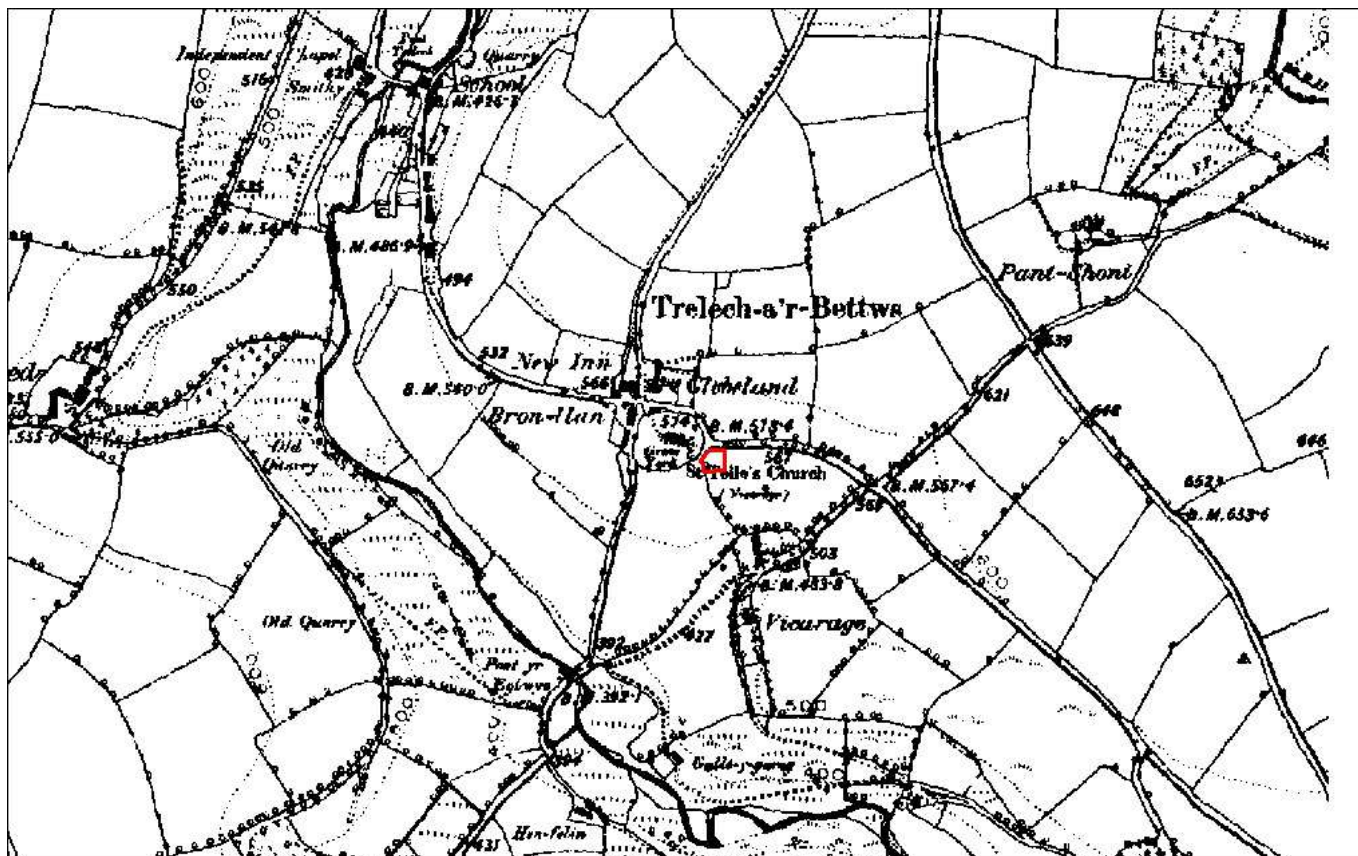
- 2.3.5 No change is visible within the development boundary or the immediate area surrounding the site.

Figure 5: Extract of 1891 1:10560 scale Ordnance Survey Map.

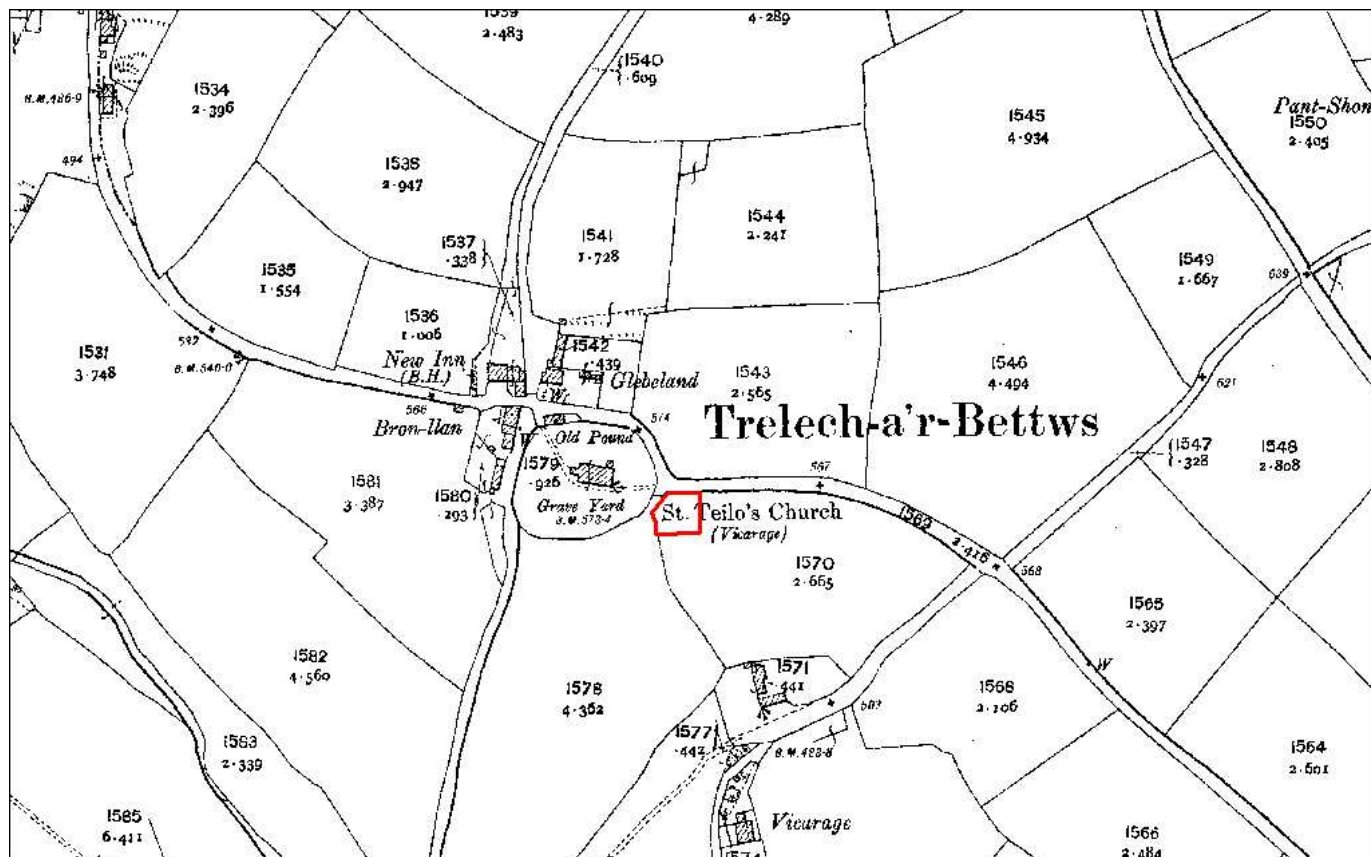
- 2.3.6 No change is visible within the development boundary, the area remaining undeveloped. The animal pound marked on earlier map editions appears to have been disused by this time and is marked as 'Old Pound'. The New Inn continues to be marked but is unnamed, recorded only as B.H (beer house). A Well is marked at the roadside fronting the property known as Glebelands. The Vicarage and Bronllan are still marked on this map.

Figure 6: Extract of 1906 1:2500 scale Ordnance Survey Map.

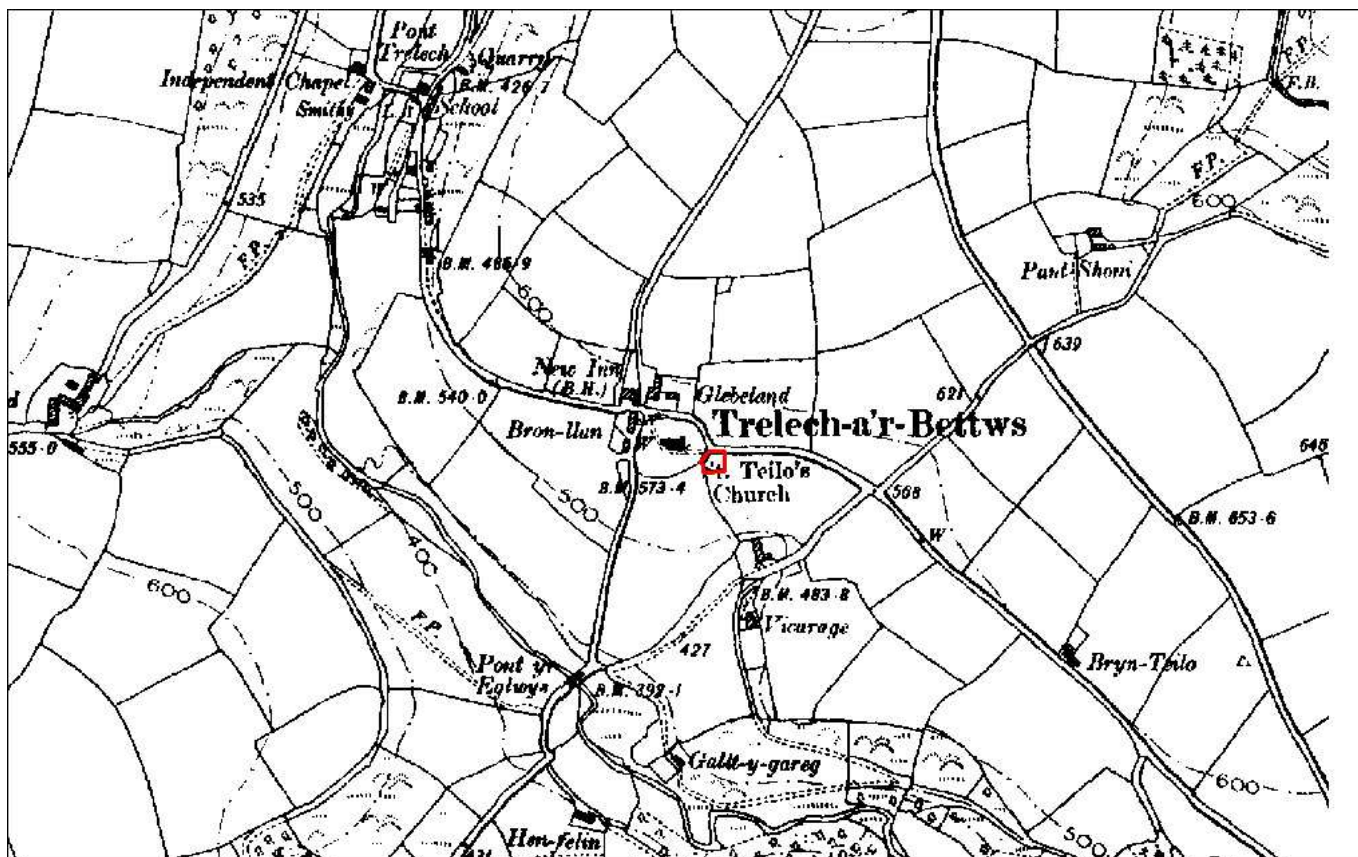
- 2.3.7 No change is visible within either the development area boundary or within the immediate area surrounding the site.

Figure 7: Extract of 1907 1:10560 scale Ordnance Survey Map.

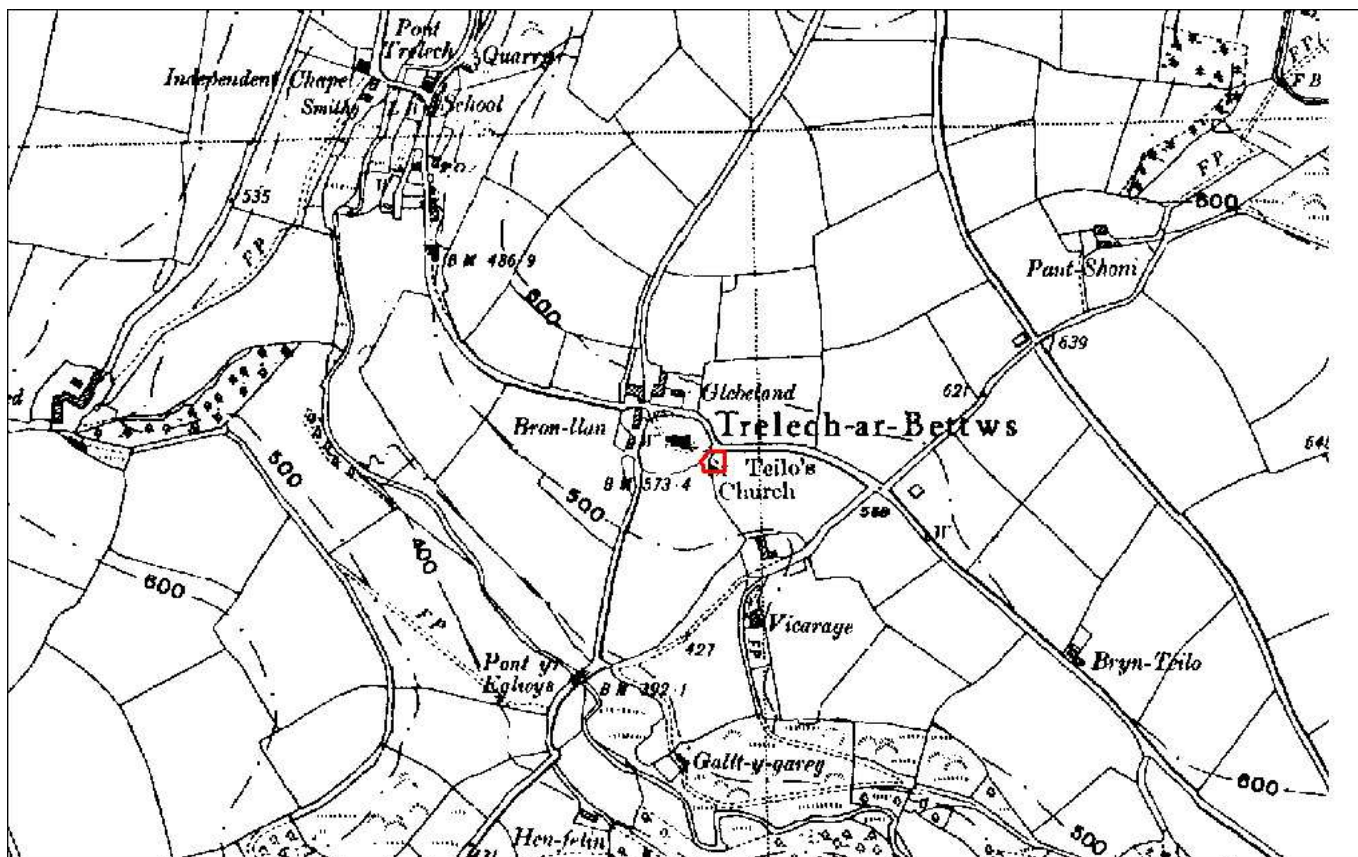
- 2.3.8 The site remained undeveloped in 1953 with no change in the boundaries of the field in which it is located. The New Inn building remains but is not marked as an inn any longer, suggesting that it had closed by this time. The animal pound also remains, but is not named. The Vicarage, Glebelands and Bronllan are all shown unchanged.

Figure 8: Extract of 1953 1:10560 scale Ordnance Survey Map.

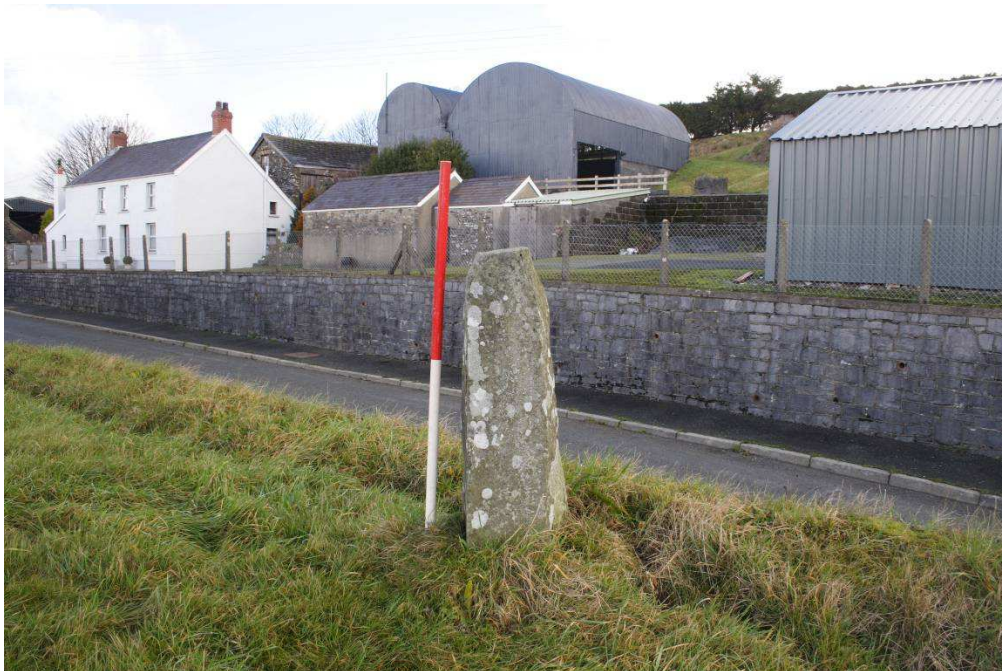
(*Taxatio*). During the medieval period churches such as Trelech a'r Bettws generated valuable income from Tithes and burial fees which usually passed to a wealthy patron such as a monastic house or individual (Cowley, 1977, 169). In the case of the church at Trelech a'r Bettws it is not known whether the patron was a monastic house. Documentary sources such as the *Valor Ecclesiasticus* of 1535, that detail monastic property held on the eve of the dissolution of the monasteries, may reveal whether Trelech a'r Bettws church was under the patronage of a monastic house, but this research has not been undertaken to date. All that survives from the medieval church is a possible cross base (PRN 8070) located on the north side of the churchyard.

Photo 2: Possible medieval cross base in St Teilo's churchyard

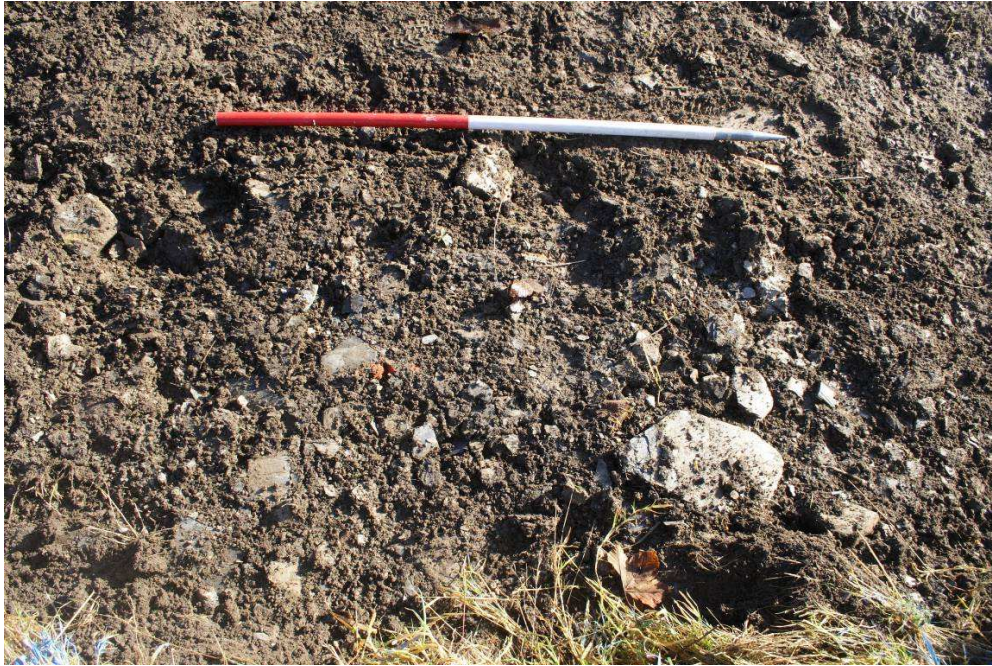
- 4.1.3 A spread of building rubble (2003) was identified in the northwest corner of the site adjacent to the watercourse that forming the west boundary of the development area. The deposit consisted of fragmentary roofing slate, red brick, building stone and coal fragments and is considered to be of industrial to modern period date

Photo 3: Industrial to modern period rubble spread (2003)

- 4.1.4 The spread of rubble is considered to be of low archaeological significance. No further archaeological features or deposits were revealed during topsoil stripping of the site. A single piece of industrial to modern period white ceramic material was recovered from the topsoil, along with heavily corroded ironwork, considered to be part of agricultural machinery. These finds were noted but not retained. Also noted in the topsoil were small limestone fragments suggesting that the agricultural process of liming had taken place across the site area, where lime is spread on the field to fertilise the soil, probably during the late 19th to early 20th century.

- 5.2 Rubble spread (2003) is considered to be of industrial period or modern date and is likely to represent some form of strengthening of the side of the watercourse. Potentially it may relate to the construction of a culvert at the north end of the watercourse that carries it beneath the adjacent road. The rubble spread (2003) is considered to be of low archaeological significance.

- 6.2 A spread of building debris (2003) identified during the initial topsoil stripping of the site is considered to be imported material used to strengthen the side of the watercourse running along the western boundary of the development area. It is considered that rubble spread (2003) dates from the industrial to modern period and is of low archaeological interest.

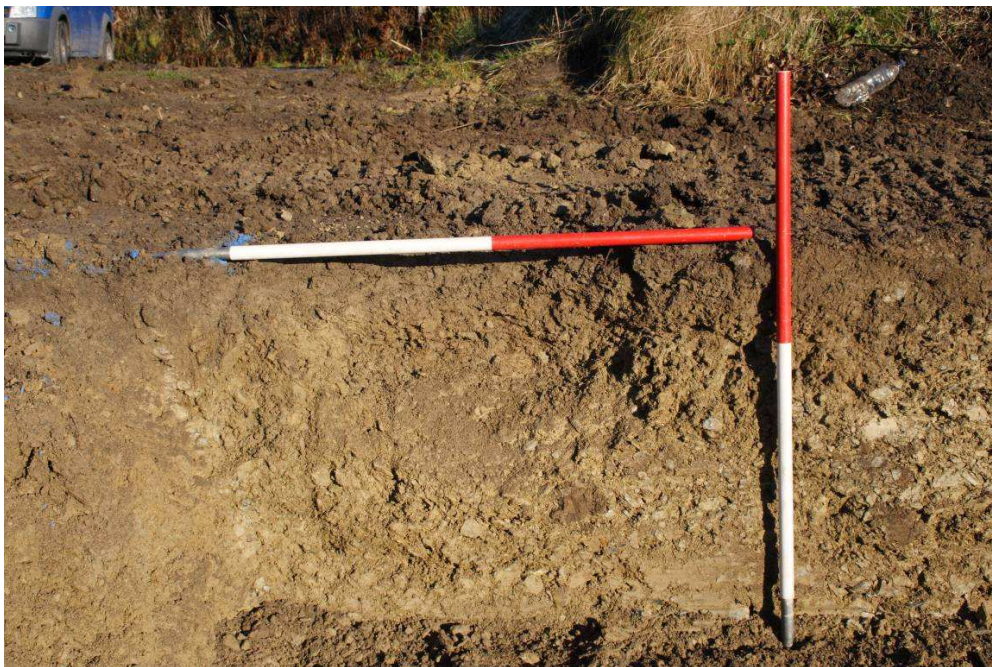
- 4.2.2 A single north – south U shaped linear feature [2004], filled with loosely compacted mid grey stony clay silt (2005) was revealed within the footing trench at the north end of the development area. The full extent of the feature is unknown as it continued beyond the sides of the foundation trench. The feature was not identified in the opposing side of the foundation trench, or in further foundation trenches to south. The feature could have been part of one of the ditches seen in the trenches during the evaluation.

Photo 4: South facing section of linear feature [2004]

- 5.5 Linear feature [2004] is considered to form part of the boundary ditches or possible enclosure elements identified during the previous trial trench evaluation of the development area. The loose nature of the fill (2005) within the linear feature compared to the firm red clay fills revealed during the field evaluation may indicate that the feature represents one of the previously excavated sections, most likely the boundary [1007] (Ratty, 2008, 6). It was not possible to confirm this given the limited area of the foundation trench. No further traces of the boundary ditches or possible enclosure elements were revealed during the archaeological watching brief.

- 6.3 Linear feature [2004] is considered to form part of the possible medieval boundary ditches or enclosure elements that were previously identified during the course of the trial trench evaluation of the development area in 2008. The loose nature of the fill of the feature, suggests that [2004] is part of boundary ditch [1007] which was partially excavated in 2008. The limited size of the foundation trenches, the fact they were excavated using a toothless bucket and the loose character of the subsoil/natural geology was not very conducive to identifying archaeological features. It is possible that the further archaeological features were present in the site area but were not identified. Linear feature [2004] is considered to be of moderate archaeological interest.

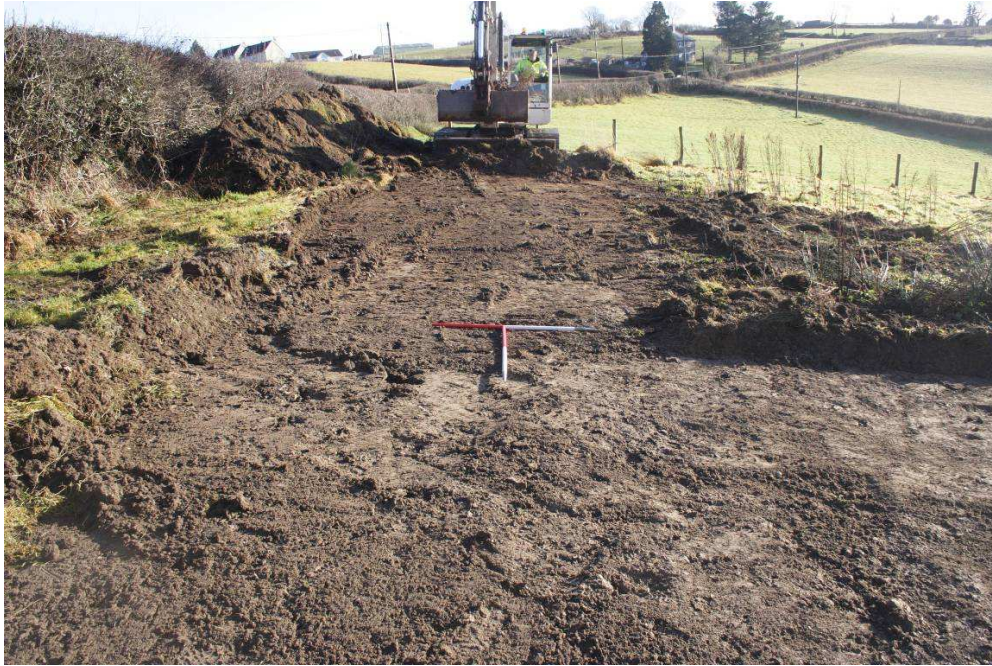
- 4.1.1 A site visit was made on January 18th 2011 to monitor the initial topsoil stripping of the development area. The topsoil stripping was undertaken with a tracked 360° excavator using a toothless grading bucket. During the later stages of topsoil stripping, a wheeled dumper was used to transport the soil to the southwestern end of the site for storage. The topsoil was stripped to a maximum depth of c.0.32m below the present ground surface of the development area.

Photo 5: East facing view of development area during topsoil stripping

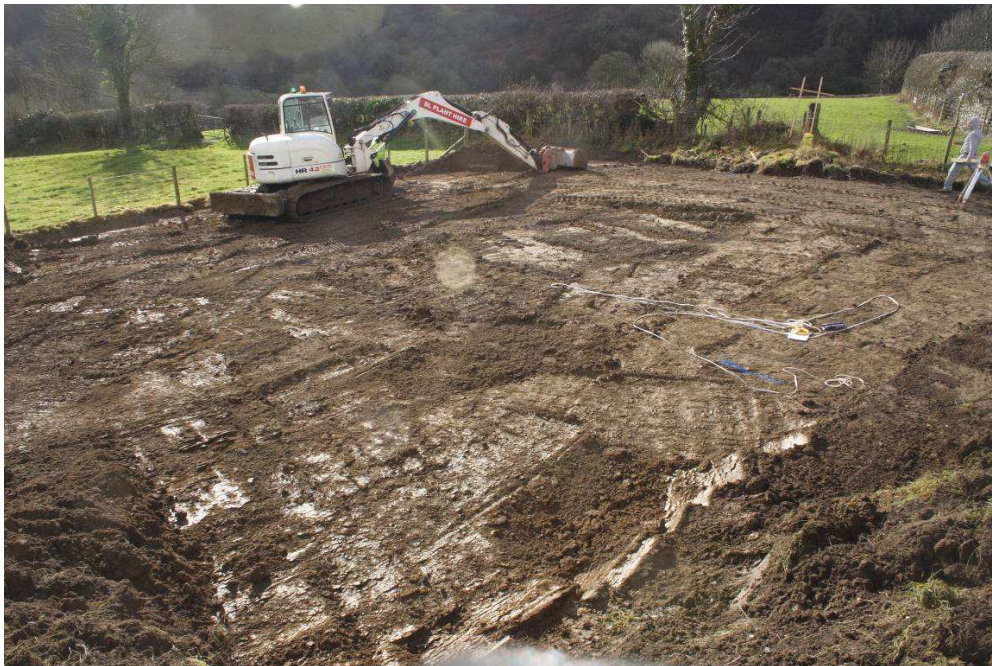
- 4.1.2 No trace of the boundary ditches of the possible enclosure or field system were revealed during the topsoil stripping of the development area. This was unsurprising as the evaluation indicated that they lay at a depth below the base of the topsoil, sealed by a later accumulation of soil c.0.5m below the present ground surface (Ratty, 2008, 16).

Photo 6: South east view of development area following topsoil stripping
