# **EXCAVATION OF A BRONZE AGE ROUND BARROW (PRN 55928) AT PANT Y BUTLER, LLANGOEDMOR, CEREDIGION, 2010**

Prepared by Dyfed Archaeological Trust  
For: CADW

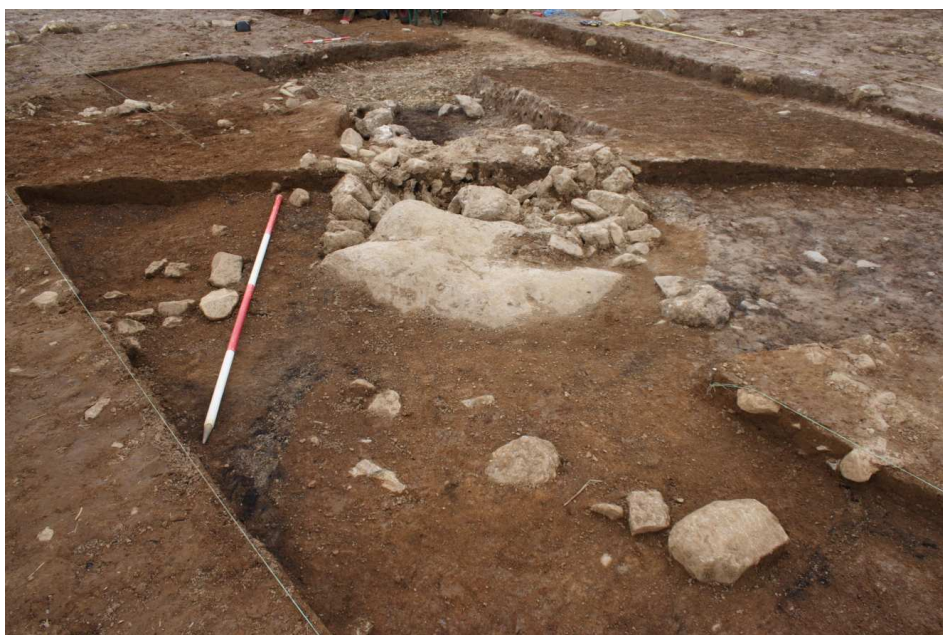
*Photo 8. After the removal of mound material (32) small areas of burnt wood and charcoal were exposed, including what appeared to be the remains of a burnt 'plank' (102) seemingly in the same alignment as the edge of grave cut (43), and that of the burnt 'plank' (23) recorded in 2009. Photograph taken looking northwest.*

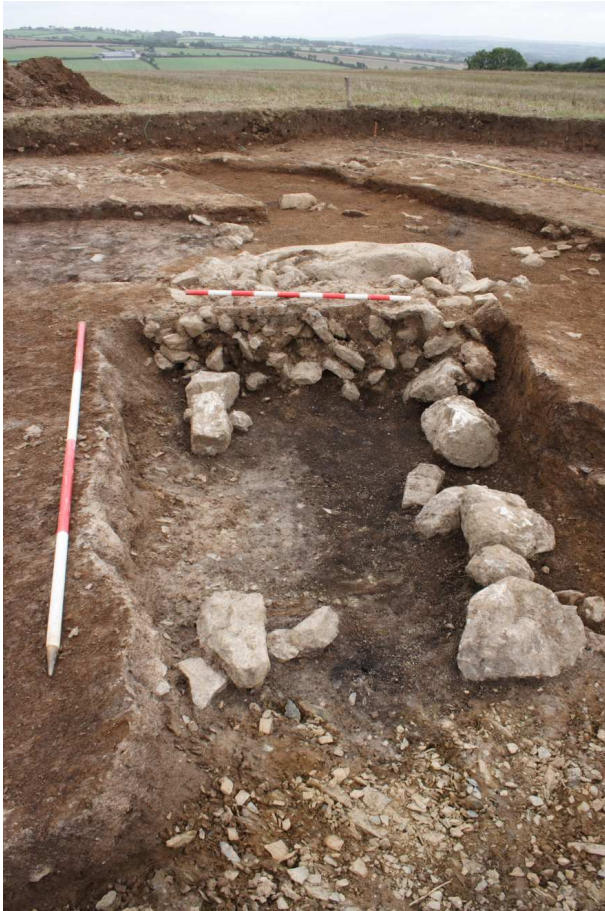
*Photo 9. The western half of grave cut (43) after the removal of stone fill (44). The large quartz stones (46) that lined the long edges of the grave can be seen and lying at the bottom of the grave cut upon the bedrock and butting up against the stones is a very thin dark organic layer (45). Photograph taken looking east.*

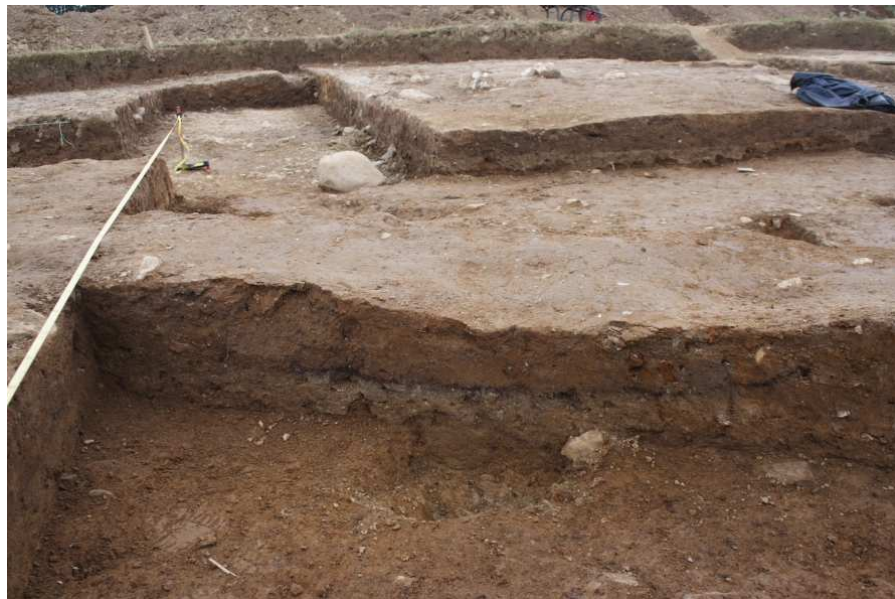
*Photo 12. Part of east facing section of baulk south of grave cut (43) showing how areas of burnt material lay immediately above the lighter coloured turf layer (26). Photograph taken looking west.*

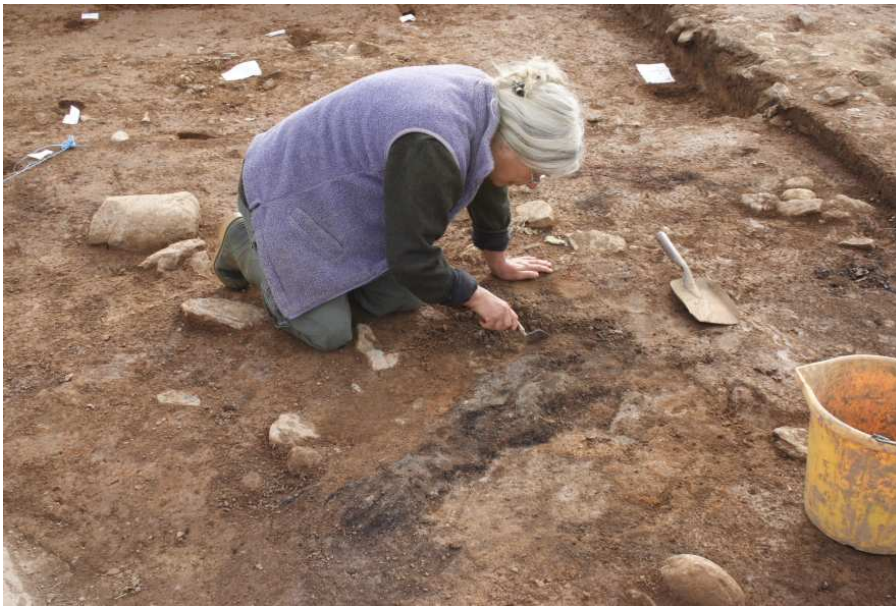
*Photo 13. Exposing the burnt wooden 'plank' (101). Photograph taken looking east.*

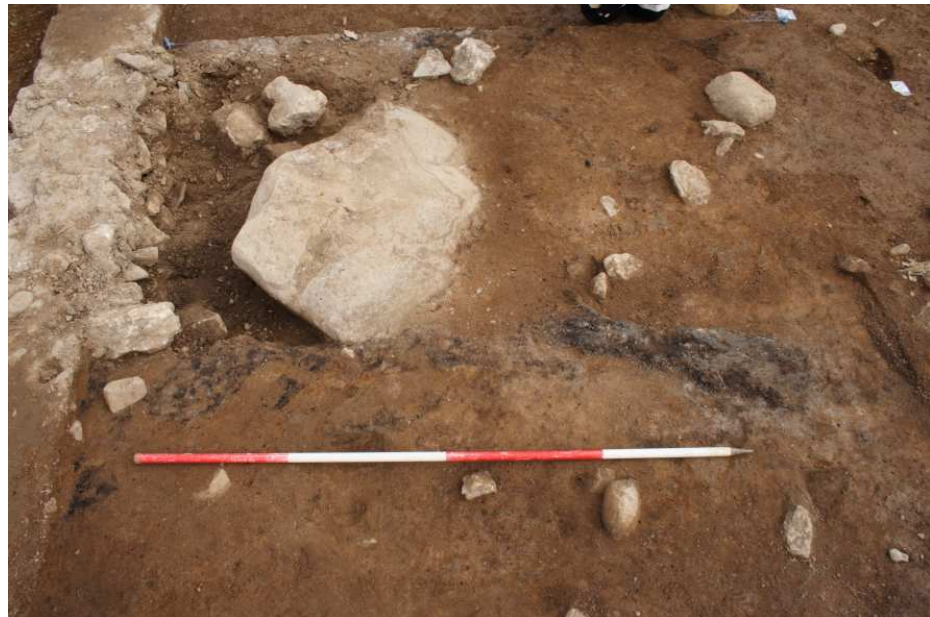
*Photo 14. The burnt wooden 'plank' (101) fully uncovered. Photograph taken looking north.*

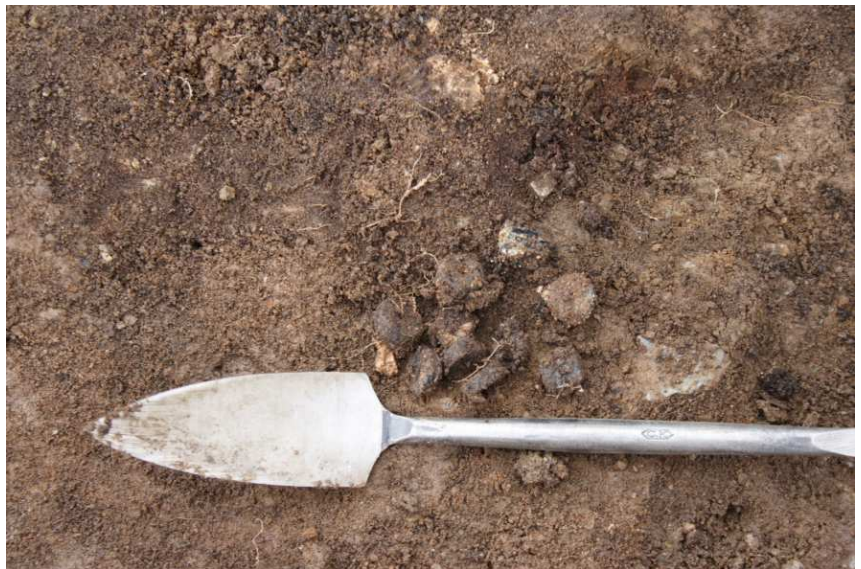
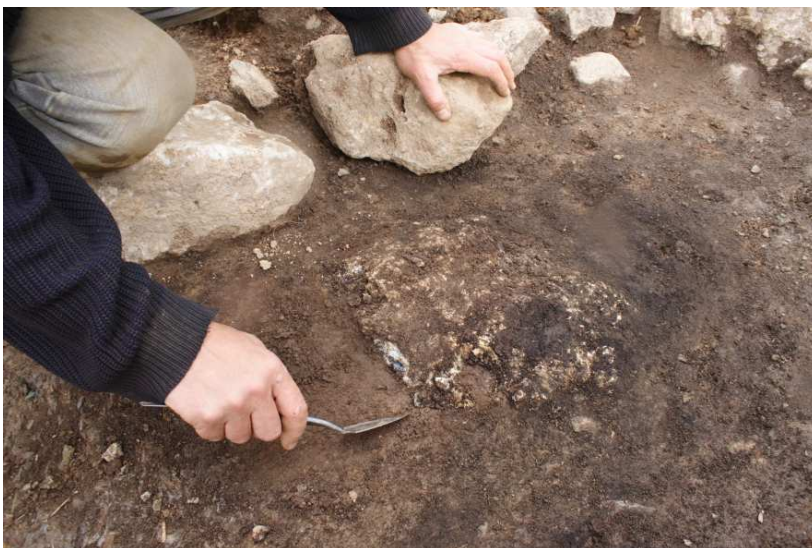
*Photos 19-21. The cremation deposit (108) during excavation and the beads (SF 121) as they appeared within the deposit.*

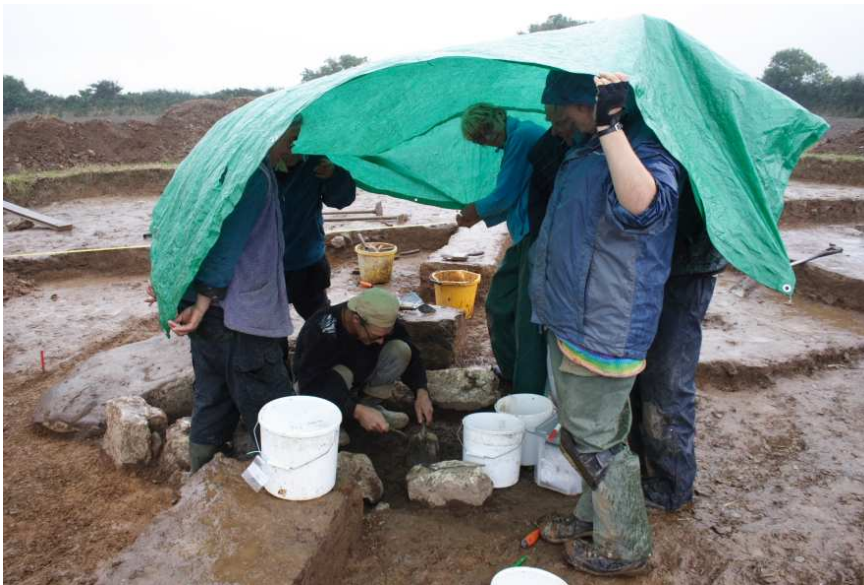
*Photo 22. Above – excavating the cremation deposit (108) in rather wet conditions.*
