**ST CYNLLO'S CHURCH,
LLANGYNLLO, CEREDIGION:
ARCHAEOLOGICAL WATCHING BRIEF
(SN 35218 43940)**

RHIF YR ADRODDIAD / REPORT NO. 2011/31
RHIF Y PROSIECT / PROJECT RECORD NO. 100748

ST CYNLLO'S CHURCH, LLANGYNLLO, CEREDIGION: ARCHAEOLOGICAL WATCHING BRIEF

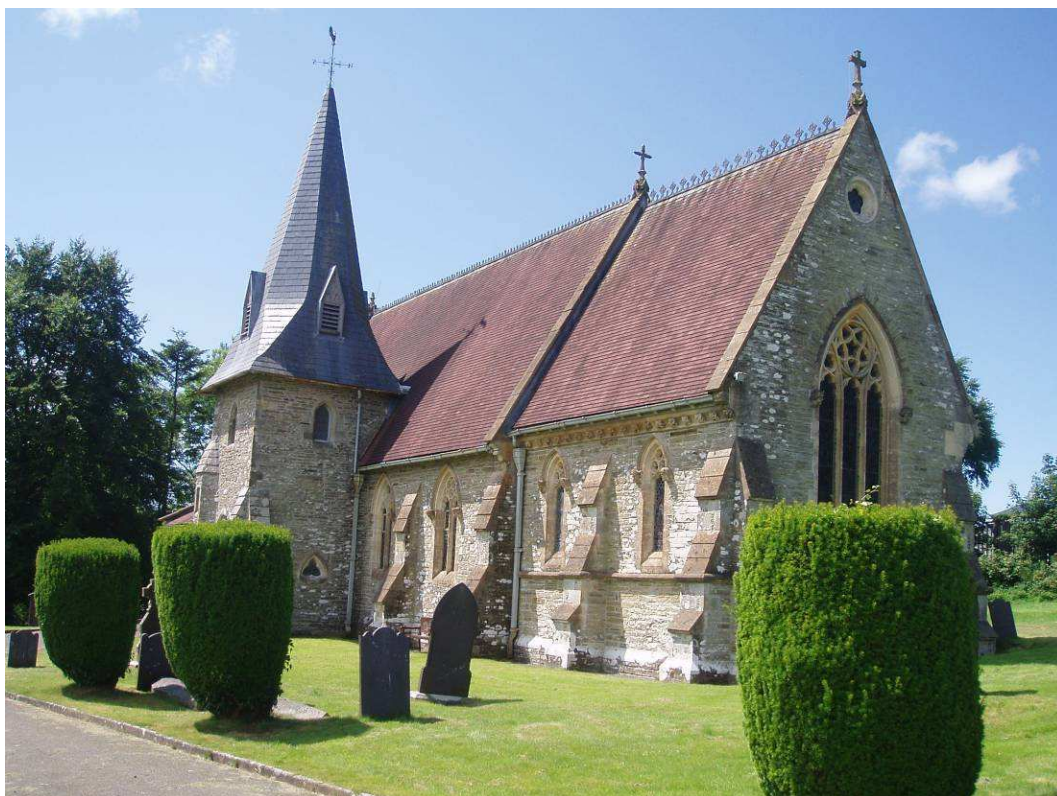
Photo 1: St Cynllo's Church (PRN 16053)

| PRN | Site Name | Description | NGR |
|---|---|---|---|
| 16053 | St Cynllo's (see photo 1) | Post-medieval Building Built in 1867-70 by John Middleton of Cheltenham architect to replace an earlier 1810 church. listed building II* | SN 351874 3946 |

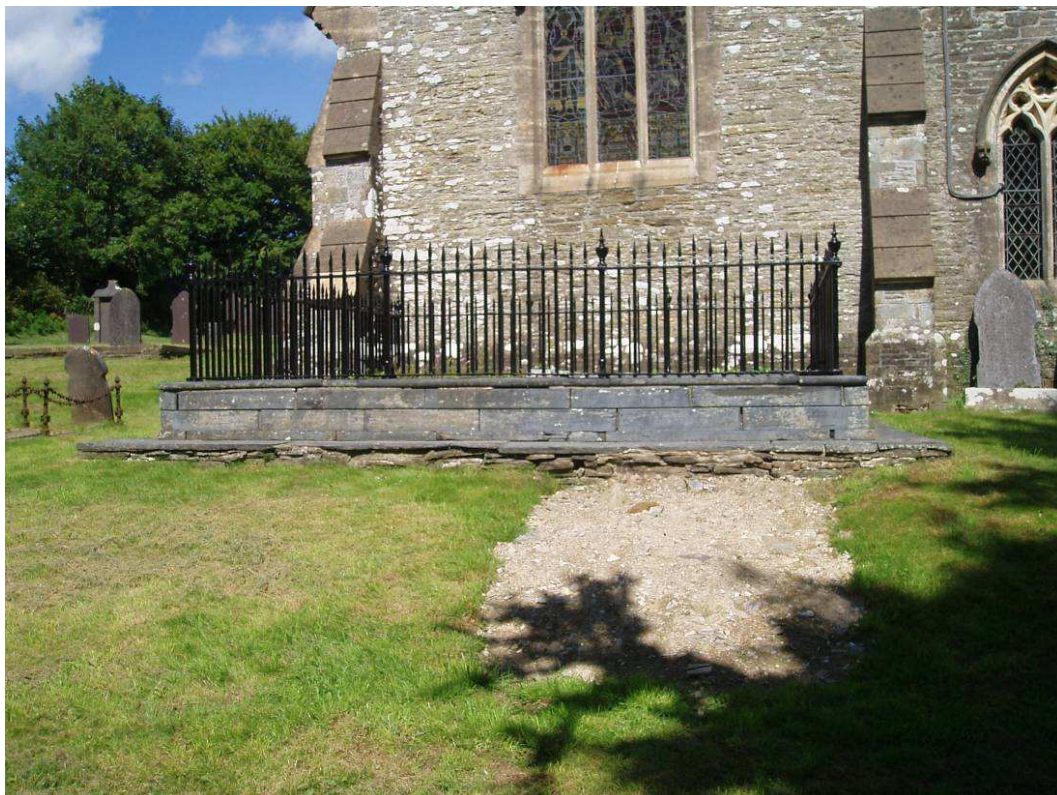
Photo 2: Bronwydd Enclosure (PRN 57807),
entrance to vault visible as ungrassed area

| PRN | Site Name | Description | NGR |
|---|---|---|---|
| 57807 | Bronwydd Enclosure W of Llangynllo Church (see photo 2) | Post-medieval Grade II listed enclosure around vault ³ | SN 35152 43931 |

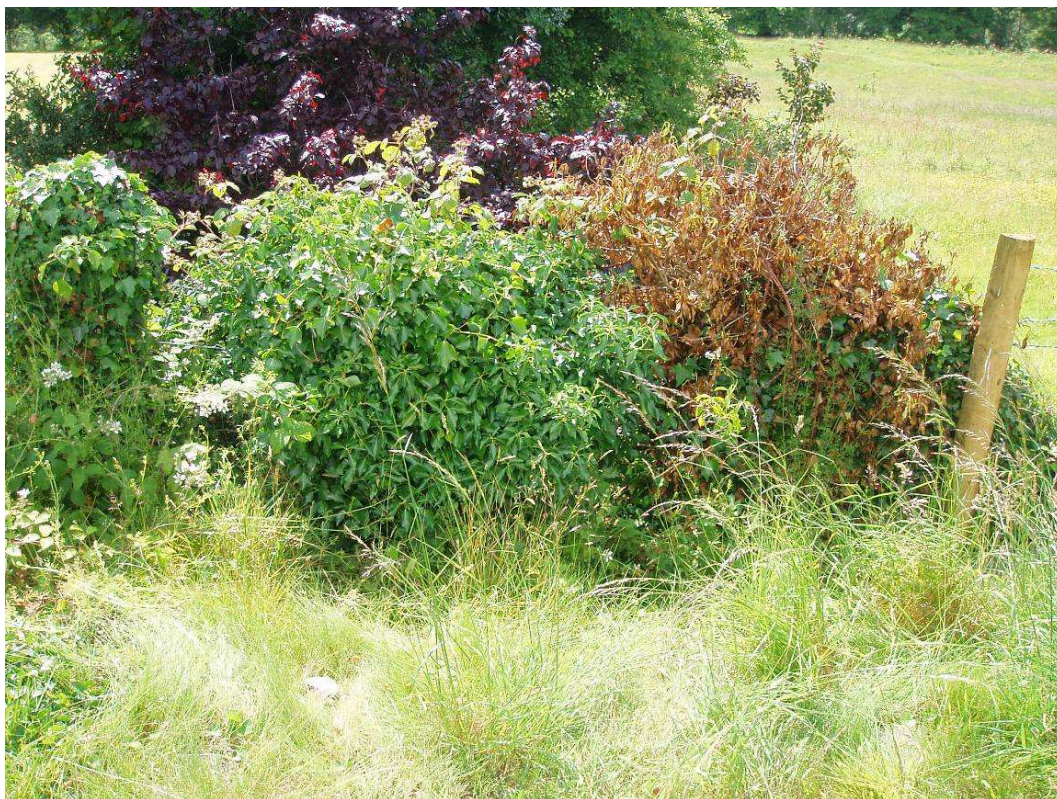
4.1 The first site visit was undertaken on 29th June 2011 following communication from Wendy Campion of Ceredigion County Council who also attended the site with a representative from the Church in Wales and an ecologist. On arrival it was found that the excavation area was laid to grass and adjacent to a pair of gate piers which were obscured by overgrown vegetation (see photo 3).

Photo 3: Pre-excavation view of investigatory area

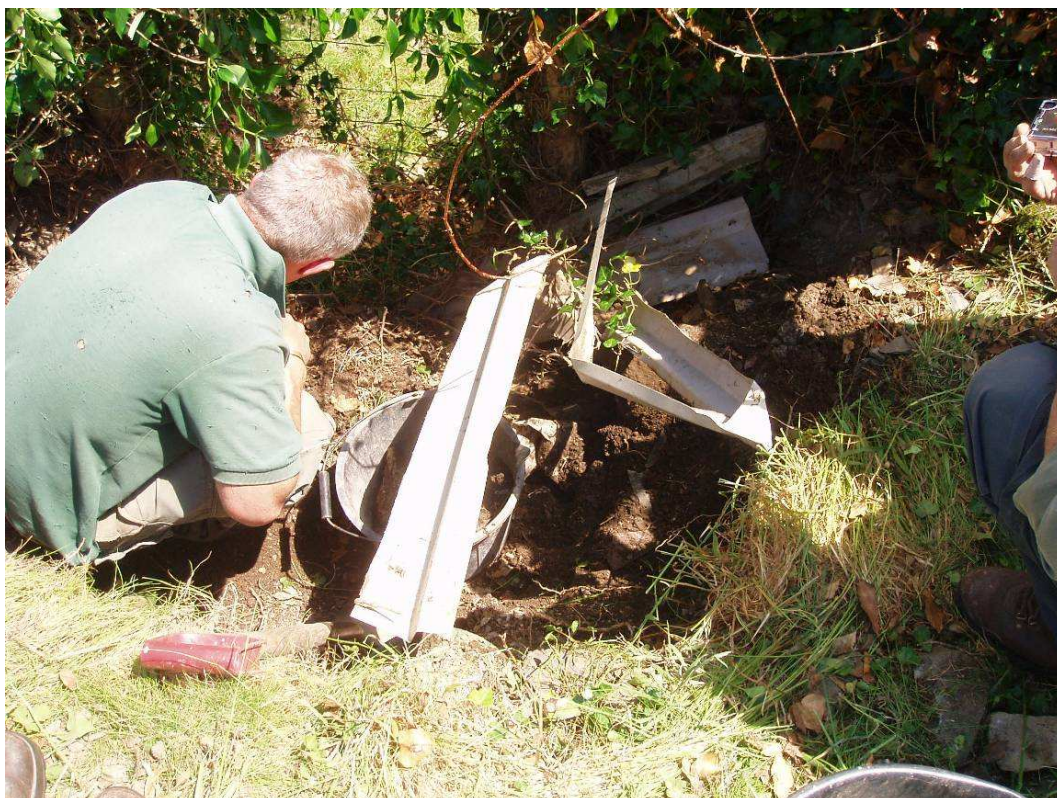
4.2 The archaeologically monitored works involved the removal by hand of modern material that blocked the former stairway and entrance. The material included corrugated metal cladding, solidified cement bags, plastic and decaying wreaths (see photo 4). Excavation work continued by hand with the assistance of the attending ecologist who ensured that no slow worms were disturbed during the course of the works. The material removed from the excavation area was sorted with large stones being retained, and modern debris separated and removed from the site by the contractor undertaking the excavation work. Smaller stones and soil, which consisted of a friable mid brown clay silt containing abundant roofing slate fragments (100), was deposited to the west of the excavation site on an area devoid of vegetation. This was undertaken at the request of the attending ecologist to minimise any disturbance to the wildlife habitat.

Photo 4: General working shot showing modern cladding

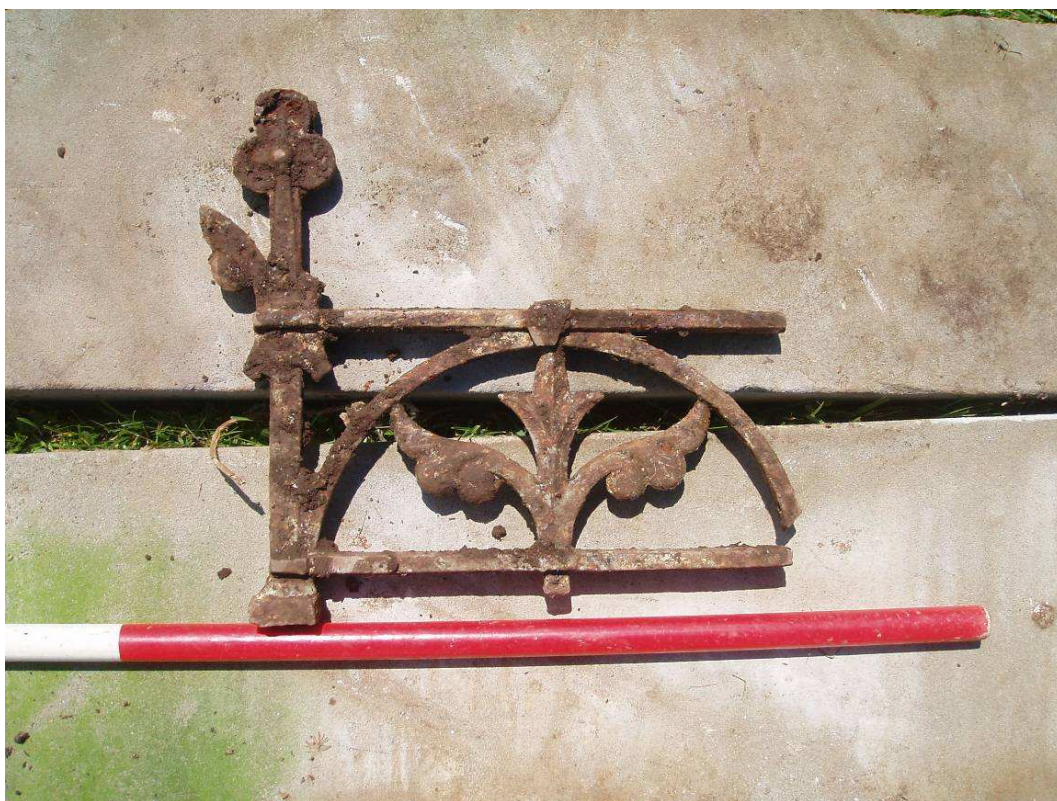
4.4 A short section of 19th century cast iron grave furniture (see photo 5) was recovered from the excavation area along with some fragmentary red clay roofing tile. These tiles were produced by the Somerset Trading Co of Bridgewater (see photo 6) that are likely to date from the earlier part of the 20th century. Two dressed sandstone slabs were also recovered and are considered to be former window sills (see photo 7). As excavation continued, two 1.02m wide slate steps were revealed, at a depth of 1.42m below the present ground surface, along with a pair of 0.64m high dry stone and slate slab side walls (101).

Photo 5: 19th century grave furniture fragment

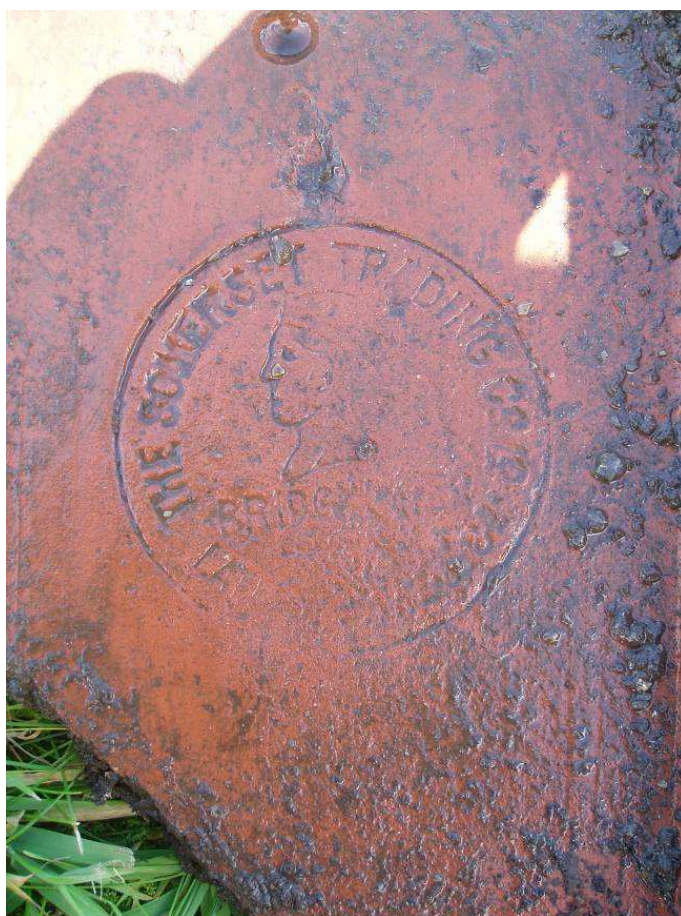
Photo 6: Detail of Somerset Trading Co Bridgewater mark on clay tile

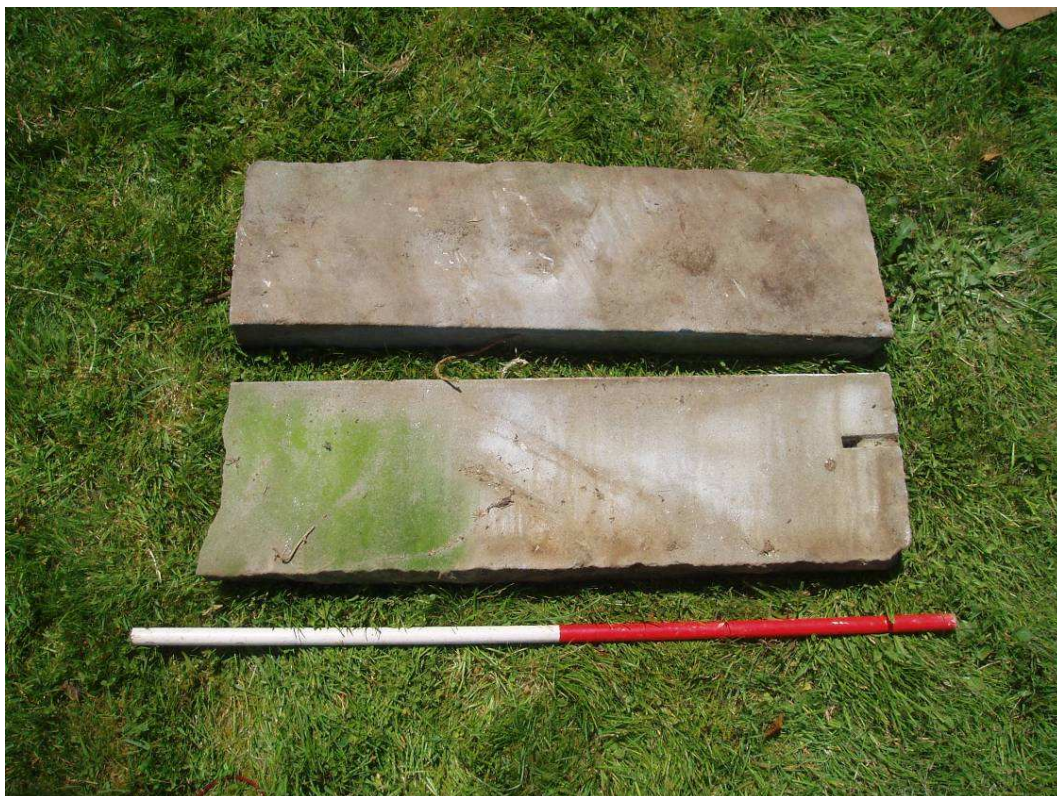
Photo 7: Dressed sandstone former window sills

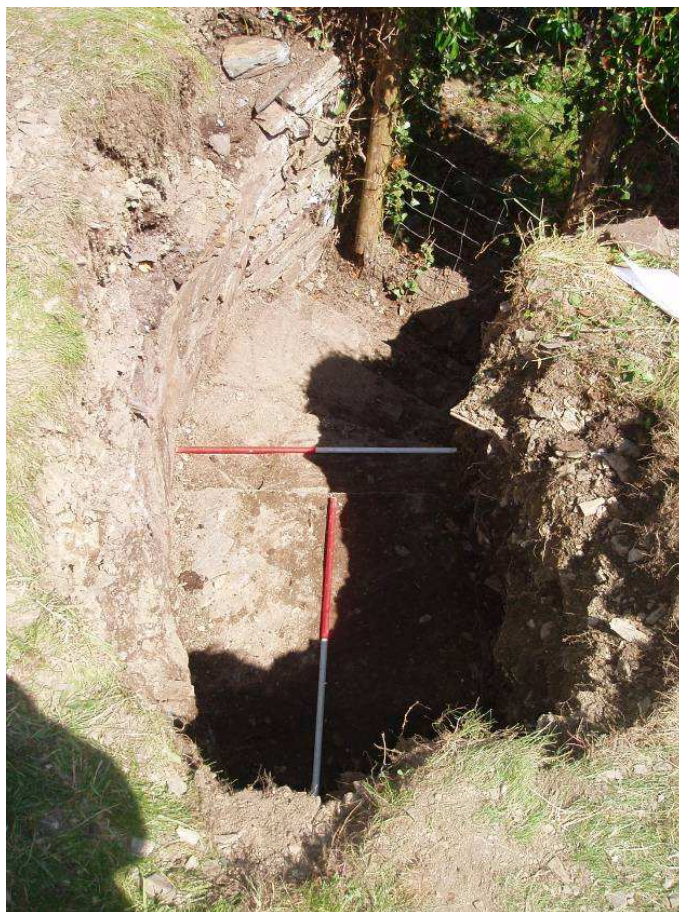
4.5 A second site visit was undertaken on the 30th June 2011 to monitor the continuing excavation work. The further excavations revealed a further three slate steps and indicated that the dry stone side walls turned and followed a northwest to southeast alignment (see photos 8 – 9). Much of the infill of the structure consisted of modern debris and plastic which was recovered from the top of the steps, suggesting a relatively recent infilling of the structure. A number of wrought iron spiral shaped artefacts were recovered which were found to have originally formed part of the decorative railings surrounding a tomb immediately to the northwest of the Bronwydd vault at the west end of the church.

5.3 The full extent of the step structure (101) is unknown, although it is considered to continue towards the southeast. No secure dating from the structure was recovered from the excavated area, although it is likely that it is contemporary with the late 19th century rebuilding of the church. It is considered that structure (101) was infilled relatively recently and the area around it landscaped at the same time. The presence of cement bags, plastic sheeting, roofing tile and slate may suggest that it was deposited following restoration work to the church in 1996, but it has not been possible to fully substantiate this.

Photo 8: Overall view of steps and walls (101) facing south

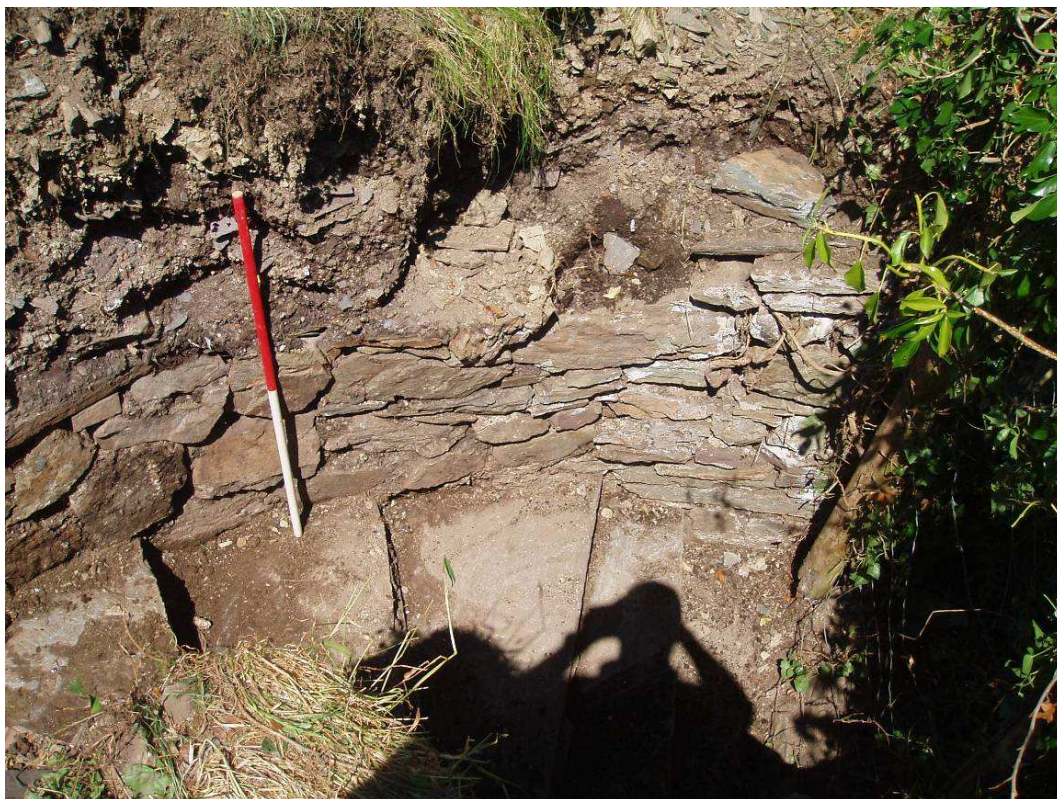
Photo 9: Detail view of steps and walling (101) facing east

| Number | Description | Depth |
|---|---|---|
| Structure 101 | Steps and walling Flight of five slate steps with dry stone and slate slab walling. Full extent of structure unclear as it continued beyond area of excavation. | 0.64m |

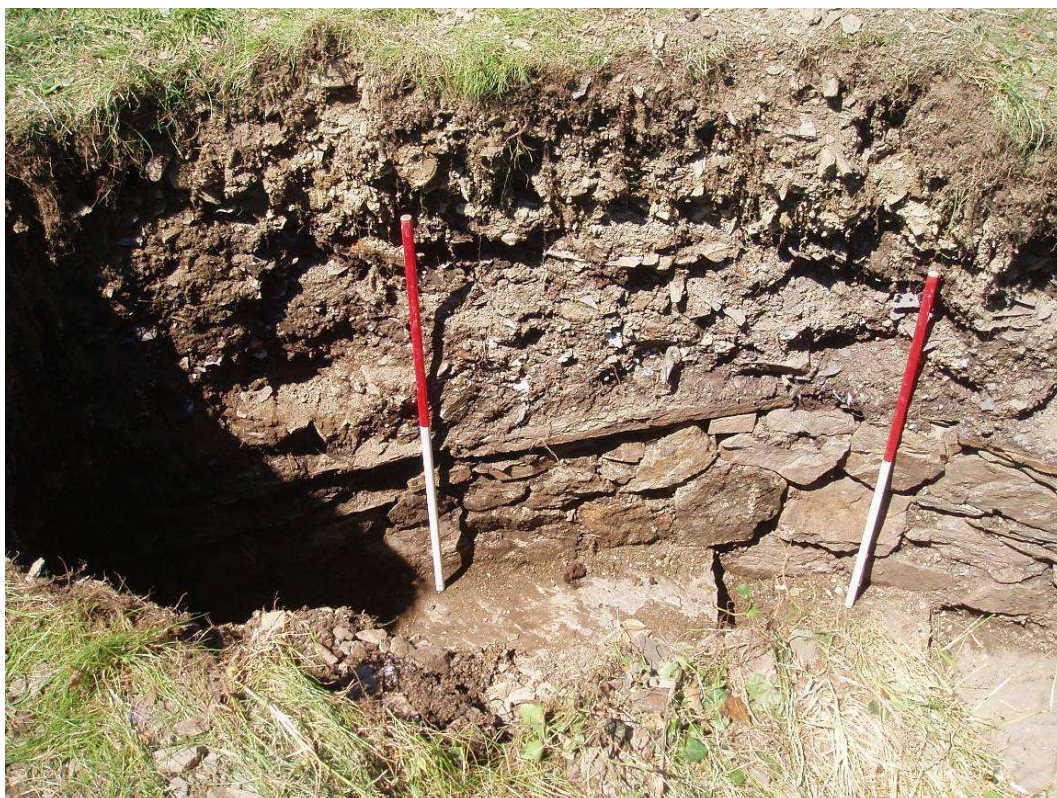
5.4 The structure (101) appears to have been deliberately infilled with modern debris, although the reason for this is uncertain. The area surrounding the structure is also considered to have been landscaped at the same time as the steps were infilled.

Photo 10: South east facing section showing modern make up above walling

| Number | Description | Depth |
|---|---|---|
| Layer 100 | Fill of structure 101 Friable mid brown clay silt containing abundant roofing slate, occasional small to medium stone, rare large stone. 19 th century iron grave furniture, architectural fragments and modern debris recovered. | 1.46m |
