# **KINGSFOLD JUNCTION, MAIDEN WELLS, PEMBROKESHIRE: ARCHAEOLOGICAL WATCHING BRIEF 2011**

RHIF YR ADRODDIAD / REPORT NO. 2011/38  
RHIF Y PROSIECT / PROJECT RECORD NO. 102244

# KINGSFOLD JUNCTION, MAIDEN WELLS, PEMBROKESHIRE ARCHAEOLOGICAL WATCHING BRIEF

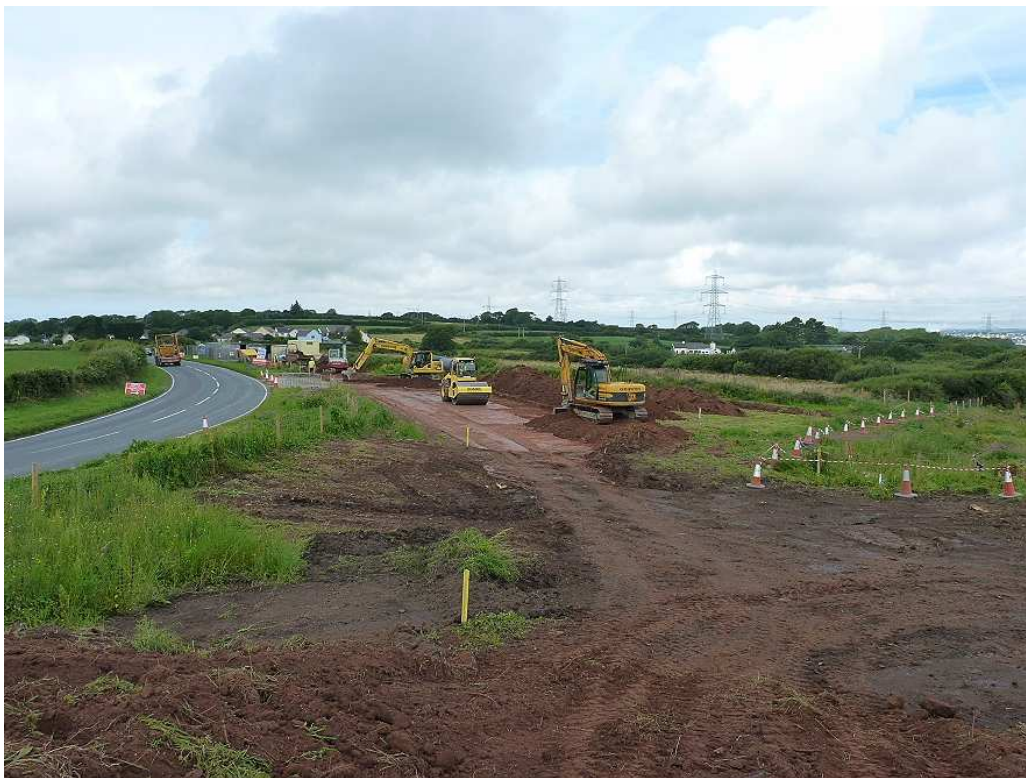
**Photo 1:** General view of development looking WSW during topsoil strip

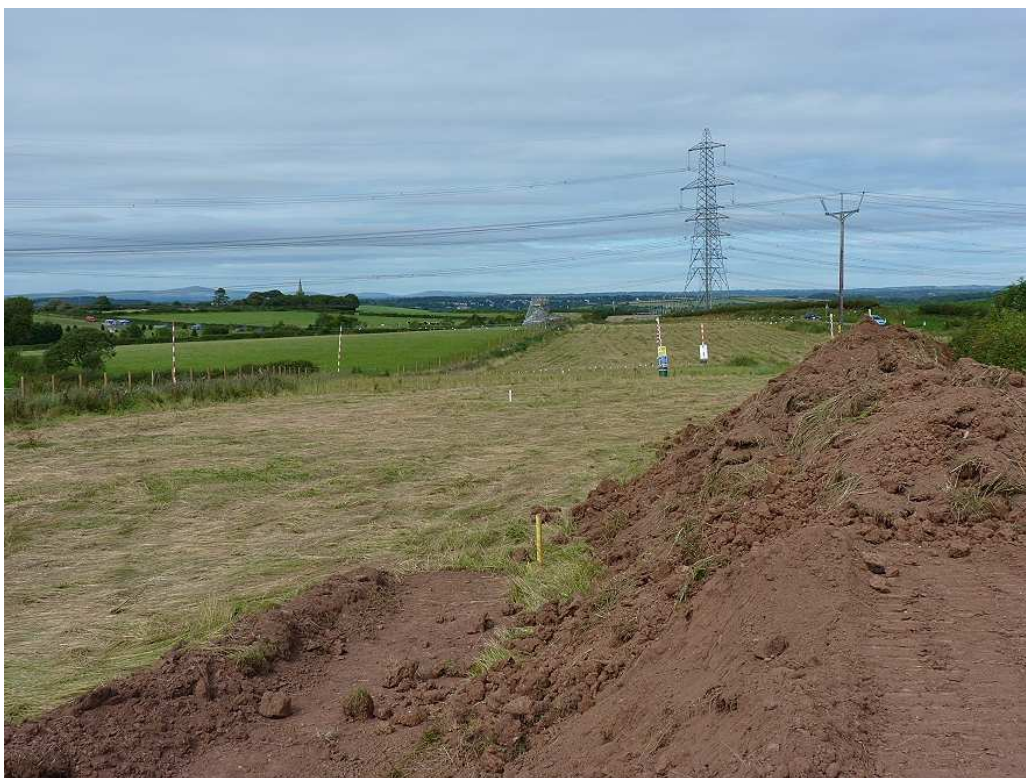
**Photo 2:** General view of central field, looking northeast

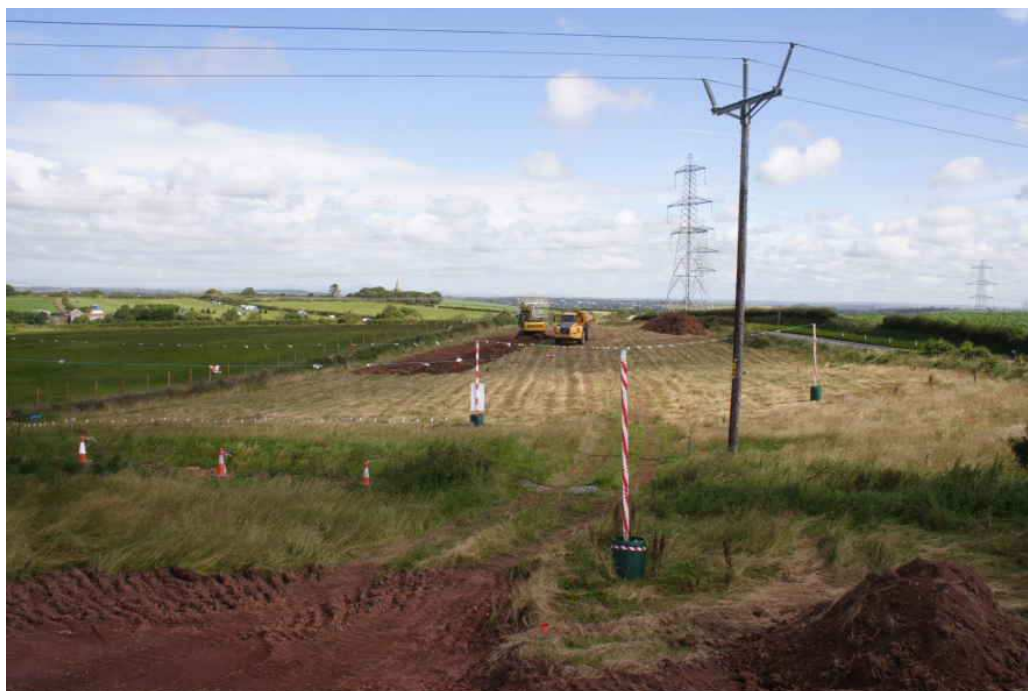
**Photo 3:** General view looking northeast of eastern field during topsoil strip

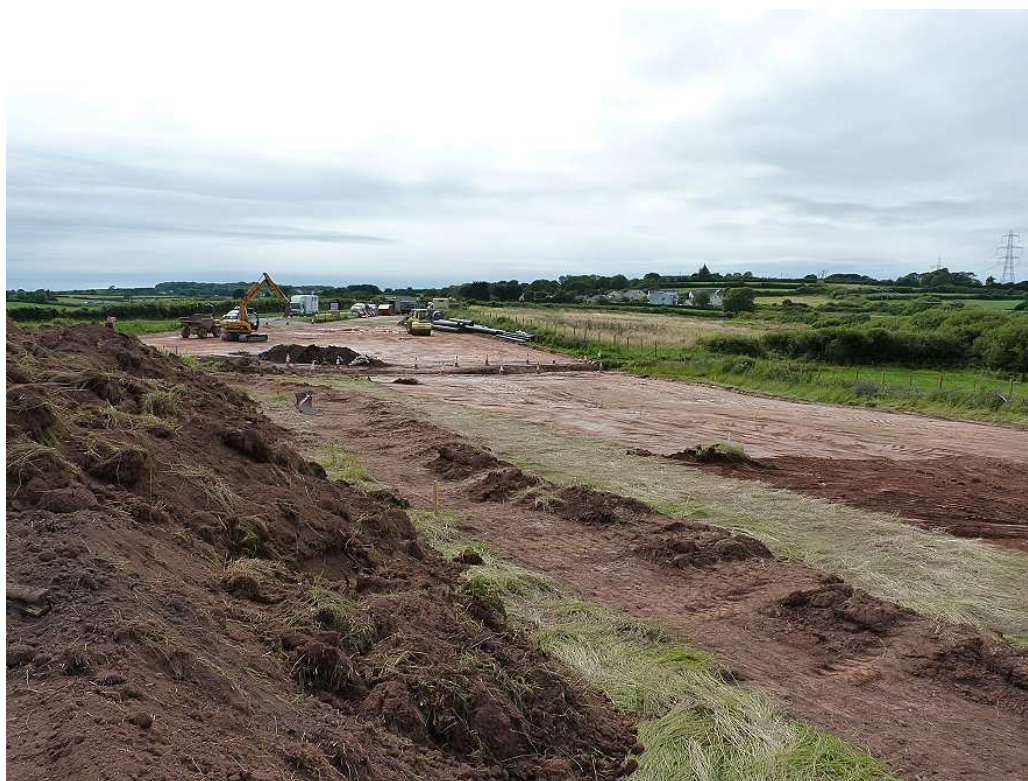
- 4.10 The topsoil across the three fields (100, 101 & 102) appeared fairly consistently to be comprised of a friable mid reddish-brown clayey-silt, averaging c.0.3m in depth (photos 4 – 6). The depth varied slightly, generally shallower (averaging c.0.2m deep) in the western field, and also becoming shallow across the highest ground within the central field. This topsoil appeared to represent a well-mixed ploughsoil across all three fields. A wide selection of pottery and glass fragments were recovered throughout the topsoil across all three fields, although generally becoming sparser to the north. The finds consisted of a wide spread of mainly domestic wares. The earliest material is represented by a small selection of glass and pottery dating to the 18<sup>th</sup> century, with one small sherd of Devon gravel-tempered ware that may be earlier in date. Such sherds are known from the 16<sup>th</sup> century onwards, although more common in the 17<sup>th</sup> and 18<sup>th</sup> centuries. The bulk of the material was clearly 19<sup>th</sup> and 20<sup>th</sup> century in date, the most recent recognisable fragment being a piece of glazed earthenware with a design by Kathie Winkle, datable to between 1964 and 1978.

**Photo 4:** Looking WSW across site during topsoil strip,  
onsite spoil heap shown on left

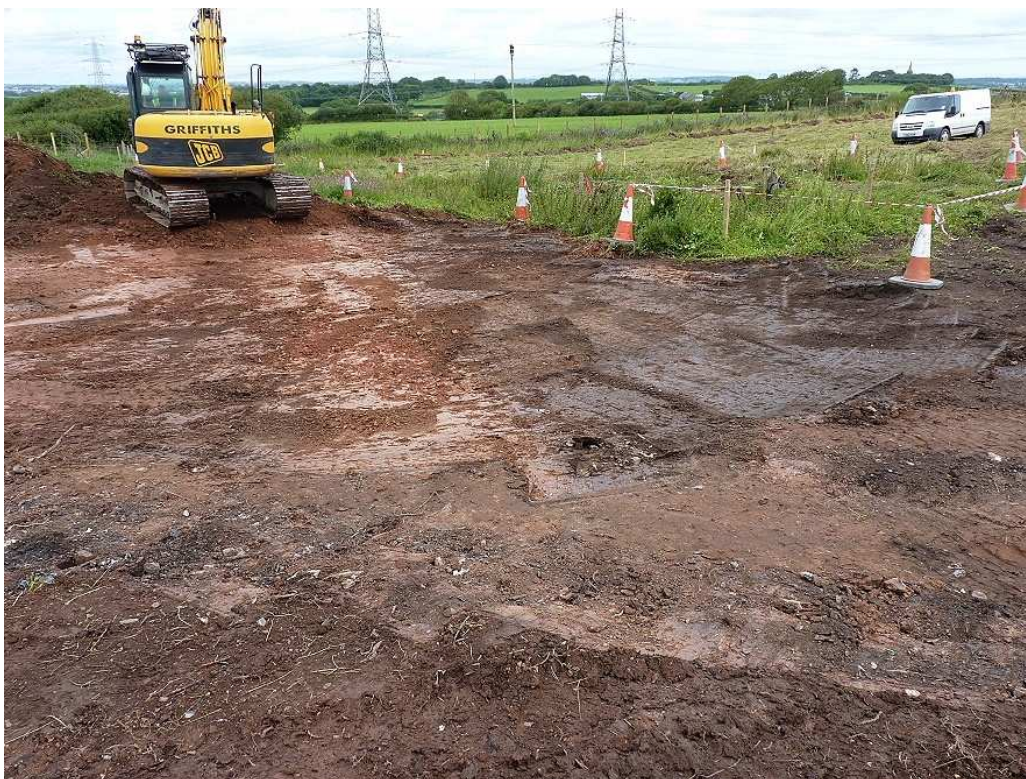
**Photo 7:** Looking north, showing the distinction between subsoil 109 to the left, and topsoil 103 within former cottage enclosure on the right

- 4.3 This topsoil (103) consisted of a dark grey-brown clayey-silt with frequent flecks of charcoal and was heavily rooted in places (photos 7 – 9). There was a distinct straight edge to this deposit that appeared to correspond to the division between the western field and the triangular cottage enclosure. This darker topsoil occurs only within this former cottage enclosure and most likely represents a garden soil (regularly worked, cultivated and manured). An initial spoil heap was sited in this area and it was heavily used by machinery making it difficult to identify individual features within this deposit. The area had clearly been used as a dumping ground during the later 20<sup>th</sup> century, as modern plastic material was recovered from the deposit along with a mix of 19<sup>th</sup> and 20<sup>th</sup> century pottery and glassware, including some complete bottles dating from the late 19<sup>th</sup> to late 20<sup>th</sup> century.

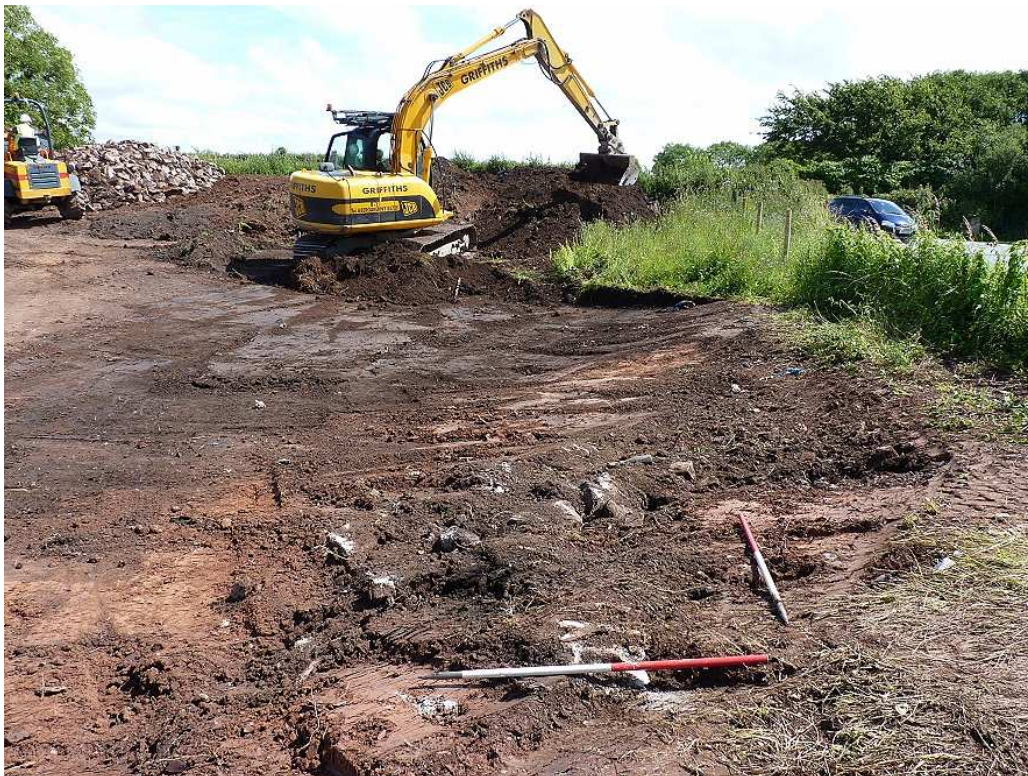
**Photo 10:** Looking east at stone and mortar spread 104 in relation to the edge of the former cottage enclosure, as defined by the darker soil above. 1m scales

- 4.4 A small patch of mortared stonework (104) was recorded just beyond (to the south of) the southern corner of this triangular area (photos 10 & 11). This patch measured c.2.3m by c.1.2m, located close to the roadside verge. The ground was disturbed and the stonework also included large pieces of concrete indicating a more recent date for this material.

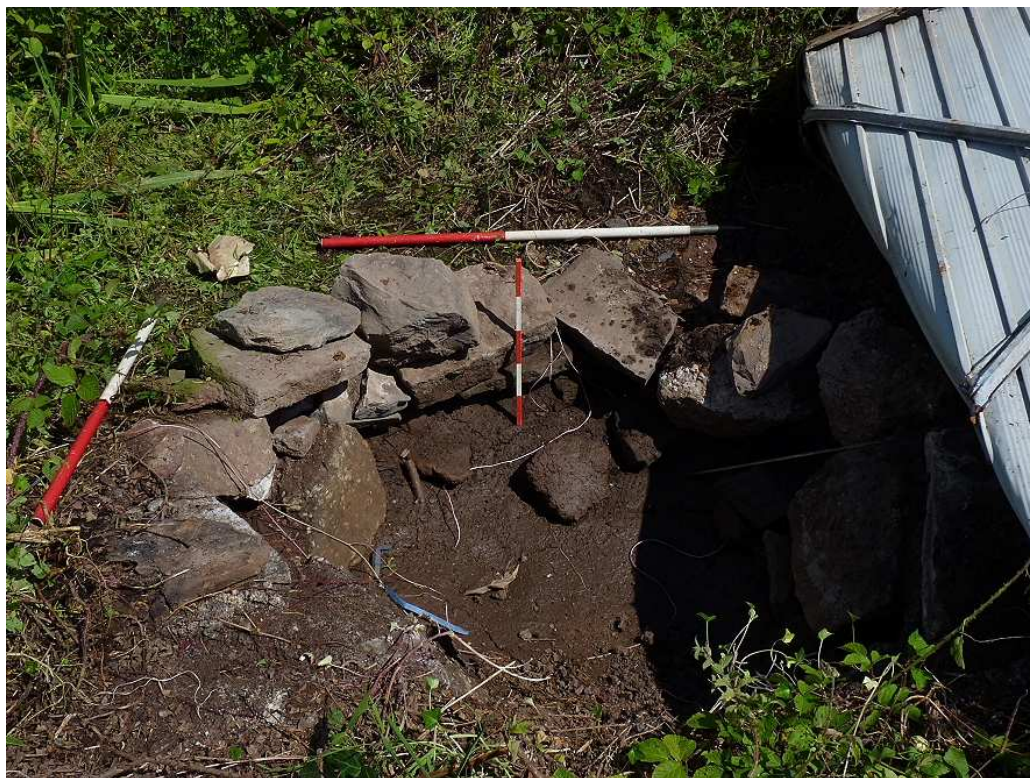
**Photo 12:** Looking east at well 105. 1m and 0.5m scales

- 4.5 Remains of the well marked on 19<sup>th</sup> and 20<sup>th</sup> century maps were still visible within this triangular enclosure (105). The remains comprised a roughly circular ring of unworked large sub-angular stones enclosing an area at most 1.3m in diameter (photos 12 & 13). Roughly two courses of stonework remained visible above the ground, of drystone construction, incorporating the remains of a rusted iron strap along one side, although this did not appear to be structural. The stone appeared to be a mix of greystone, similar to the material from which it appears the cottages were constructed, with the occasional block of conglomerate which may have been locally sourced.

- 4.6 The well appears to have been out of use for some time, and modern rubbish had been dumped in the vicinity. The interior of the well was 0.5m deep, and filled with a very soft dark brown-grey silty clay (106) with no obvious inclusions. When probed, this deposit proved to be c.0.4m deep, overlying large stones (presumably the main backfill of the well – possibly originating from demolition of the adjacent structure).

- 4.8 The ditch was cleaned out by machine and then lined and infilled with stone to provide a modern drainage channel, the upper section of the well was also removed and capped with further material and stone, although lower deposits are likely to remain intact.

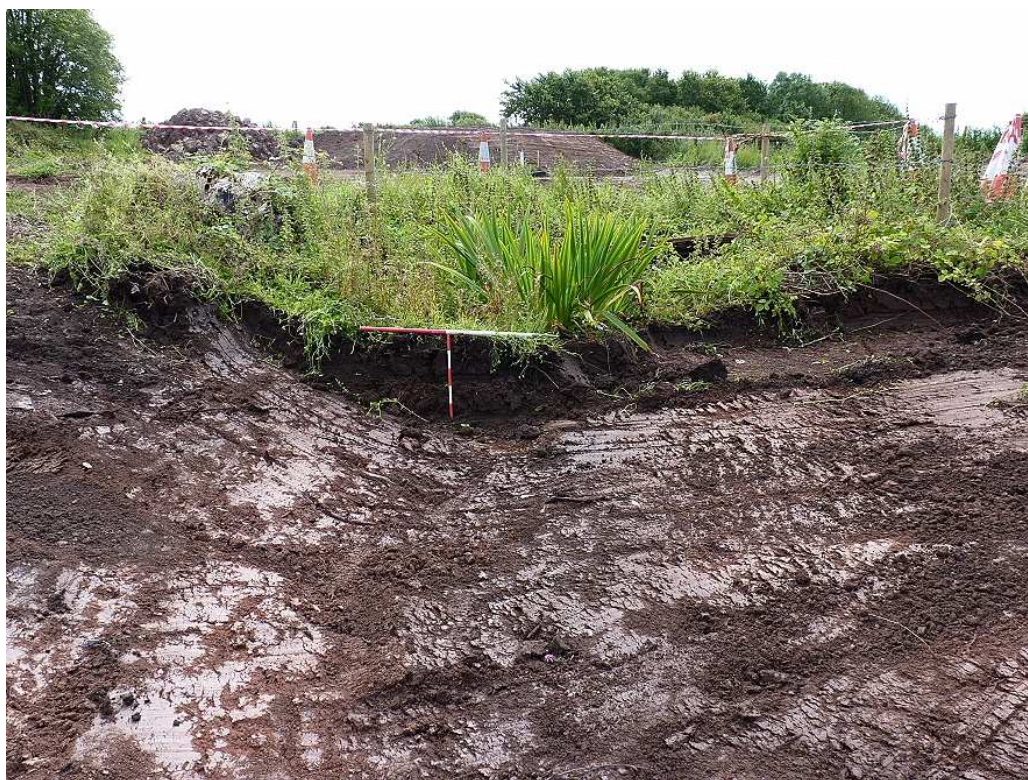
**Photo 14:** Looking SSE along the machine-cleaned drainage channel 108 for well 105, showing infill 106. 1m & 0.5m scale

- 4.7 A shallow U-shaped ditch (108) drains the well, running northwest for several metres before curving around to the north to join the field boundary ditch (119) of the central field (photo 14). This drainage ditch was 2.7m wide and at most 0.6m deep, although it had largely filled with a dark-brown clayey silt (107).

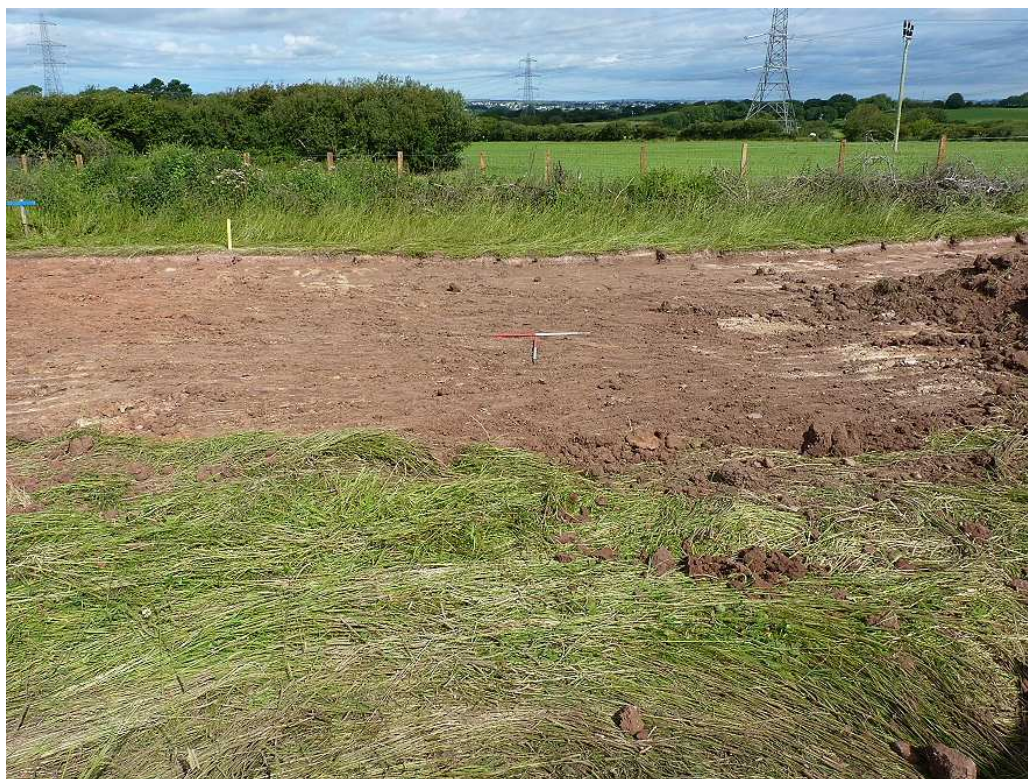
**Photo 15:** Looking NNW at palaeochannel 112. Scale bars are placed in the centre of the channel, which is defined by the lighter clay (113) visible on either side. 1m scales

- 4.12 The field boundary drainage ditch (119) was replaced by a deeper culvert (photo 19). Excavation revealed a typical sequence of subsoil deposits (109 & 110), described below. However, c.16m to the northeast of this drain, and following a similar SE – NW alignment was evidence of a palaeochannel (112) cutting through the subsoil deposits (photos 15 – 17). The channel appeared as a 5m wide, roughly linear band of firm light grey-brown silty-clay (111), delineated on either side by light grey-yellow sandy clay (113). This light coloured sandy-clay appears to be the same as the subsoil (114), the colour indicating leaching or mineralisation over time due to the passage of water along the palaeochannel. The channel

extends c.14m from the northwestern edge of the development area before becoming lost. The channel was not excavated further so a depth was not recorded, and no archaeological material was noted within the fill. The alignment suggests it may be connected to the spring marked a short distance (c.20m) to the northwest.

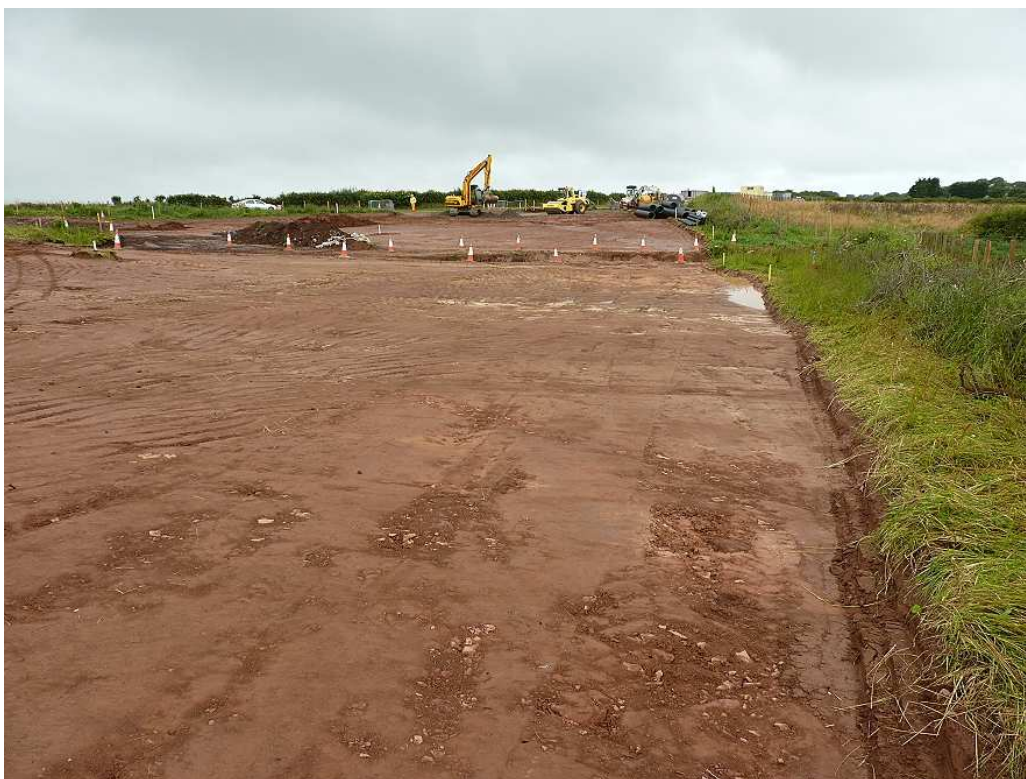
**Photo 17:** Looking SW at palaeochannel 112 after rolling, still visible as a darker strip that is gathering water

- 4.1.5 To the north of the palaeochannel the upper subsoil (photos 17, 18 & 22) appeared to be a more greyer reddish-brown clayey silt (114). This however returns to a more typical mid orange-brown sandy-clayey-silt (115) towards the summit of the higher ground within this central field and then appears fairly consistently to the north (numbered as 117 in the eastern field). The underlying subsoil within the central (116) and eastern (118) fields, where it was exposed, consists of a very stony deposit of shattered sandstone with reddish-brown sandy-silty-clay (photo 21). This deposit was only exposed on the higher ground, presumably where overlying deposits had thinned out due to ploughing and soil creep down slope.

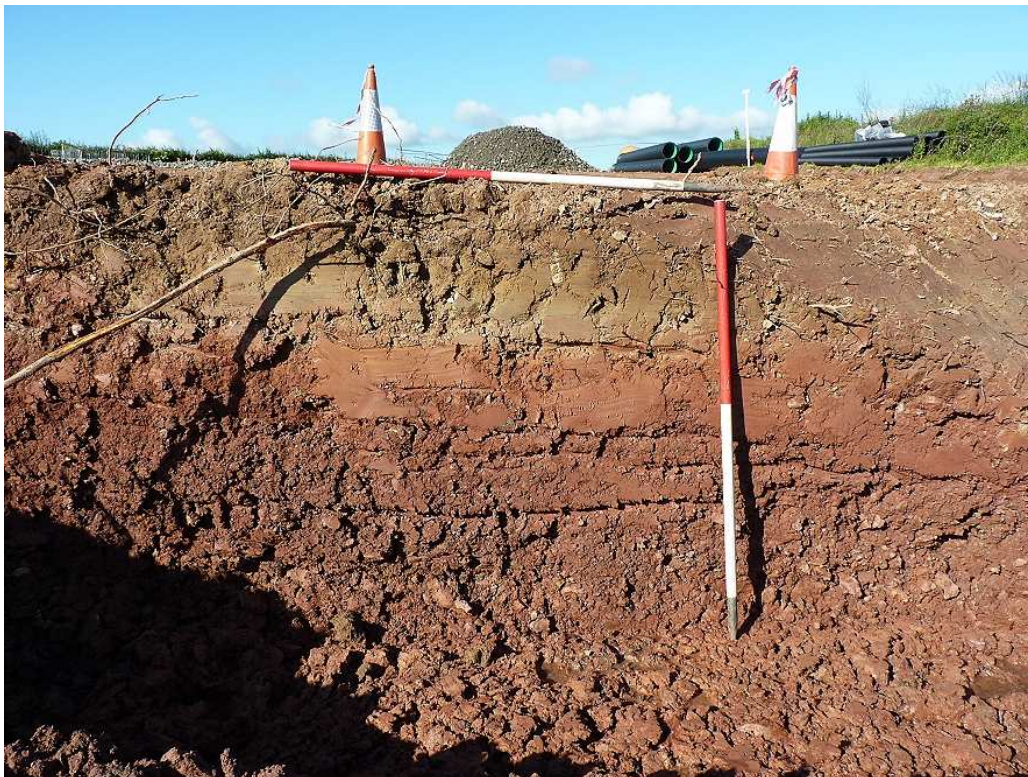
**Photo 20:** East facing section of the culvert dug between the western and central fields, showing deposits 103, 109 and 110. 1m & 0.5m scale

- 4.14 In the western field the upper subsoil (109) consisted of a dark brown-red sandy-silty-clay with the occasional medium to large sub-angular stone inclusion. This was revealed to be c.0.2m deep within the section of the excavated culvert between the western and central fields (photo 20). It was also shown to overlie a mid reddish-brown sandy clay (11) with more abundant (c.30%) medium to large sub-angular stones. This underlying deposit was at least 0.55m thick, but the base was not reached. Both these deposits extended as far as the palaeochannel (112).

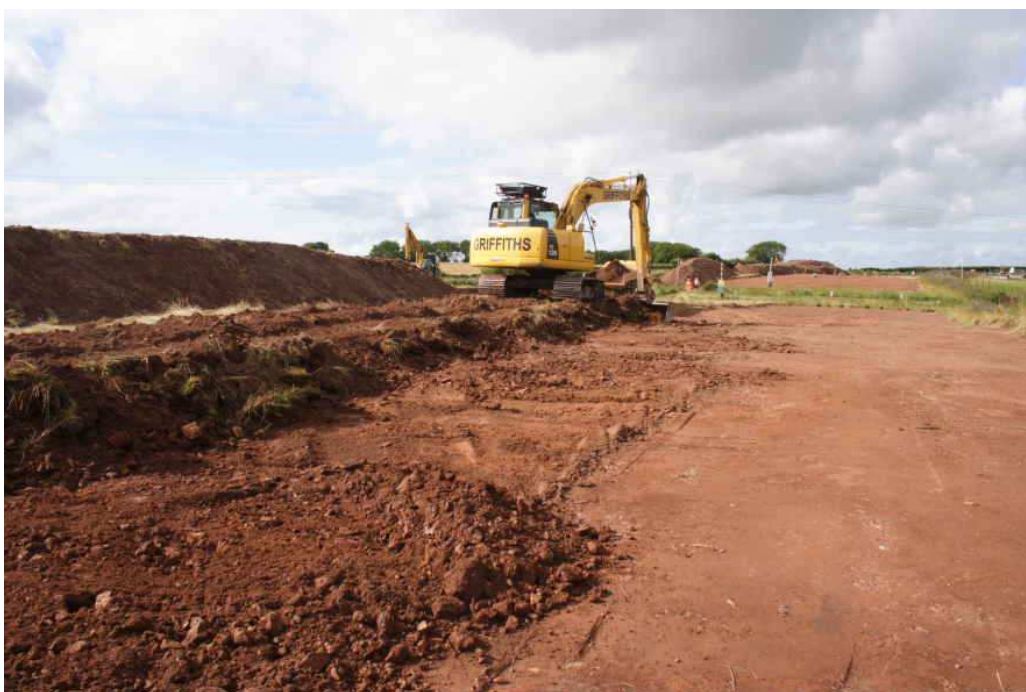
**Photo 22:** Looking SW across the eastern and central fields after topsoil strip

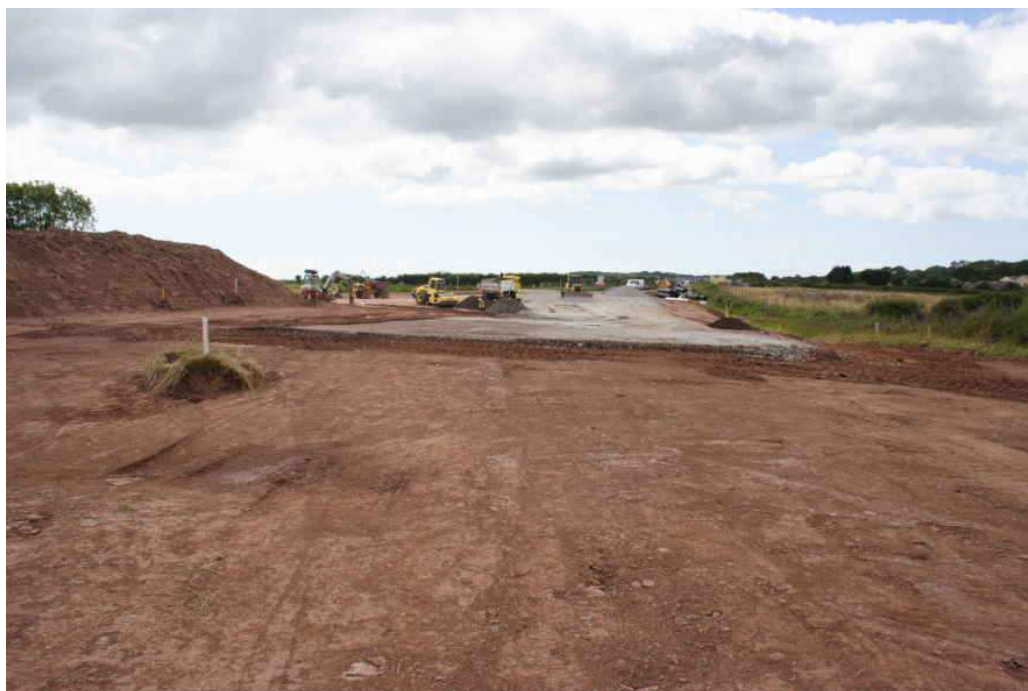
- 4.1.6 Archaeological observation finished on the 12<sup>th</sup> August 2011 (Photo 23) when the entire area to the north of the C3183 had been stripped.

**Photo 23:** Looking WSW across the western field after the topsoil strip
