DALE ROAD, HUBBERSTON, PEMBROKESHIRE: ARCHAEOLOGICAL WATCHING BRIEF

RHIF YR ADRODDIAD / REPORT NO. 2011/41 RHIF Y PROSIECT / PROJECT RECORD NO. 102247

Awst 2011 August 2011

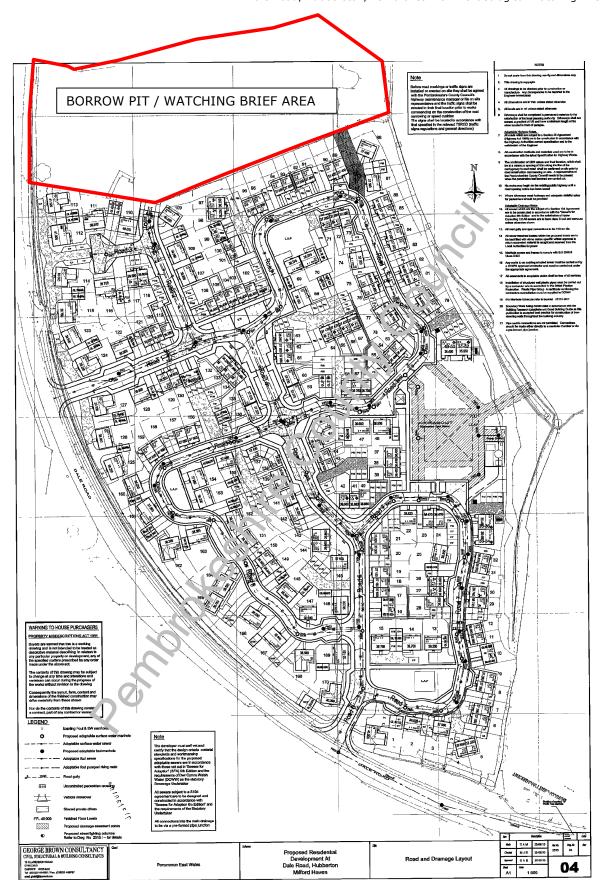
Figure 2: Development plan (from PCC planning application information) showing area of borrow pit to the north of the residential development area

- 2.1.1 The proposed residential development area lies on land to the northwest of Hubberston on the Dale Road, opposite (east of) the Milford Haven Golf Club (NGR SM 8868 0658; Figure 1).
- 2.1.2 The site has undergone various changes and developments over time, including the construction of a ports centre and numerous sports pitches, which have led to a large proportion of the land surface and underlying deposits already having been disturbed or completely destroyed. The northern part of the site, proposed as a borrow pit, however, appears to have been little disturbed (Figure 2). A stream runs along the northern boundary of the development area.

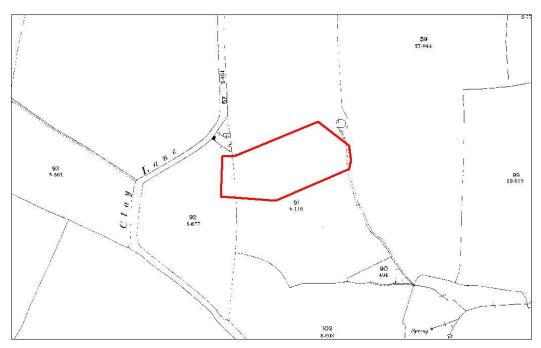
Figure 3: Extract of 1875 1:2500 scale Ordnance Survey Map of the area, with red boundary marking the area of the watching brief on the site of the borrow pit

- 2.2.3 Ordnance Survey mapping of the area indicates that the borrow pit site was undeveloped land from the late 19^{th} century until the latter part of the 20^{th} century (Figures 3 & 4).

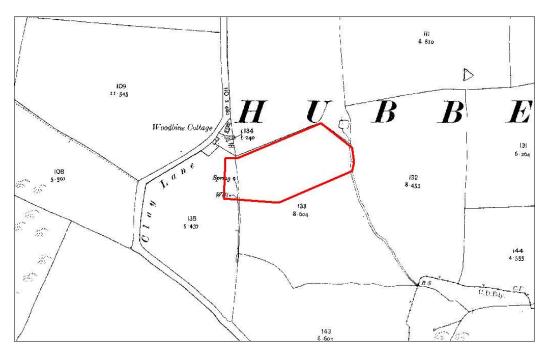
Figure 4: Extract of 1908 1:2500 scale Ordnance Survey Map of the area, with red boundary marking the area of the watching brief on the site of the borrow pit

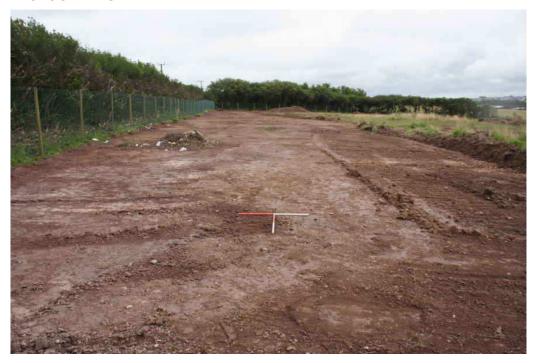
Photo 1: Site boundary stripped prior to arrival.

- 4.1 A single site visit was made on 4th August 2011 to monitor topsoil stripping of the proposed borrow pit site.
- 4.2 On arrival if was found that a 13m wide strip had been excavated around the boundaries of the borrow pit site (Photo 1). A walk over of the stripped area revealed no archaeological features or deposits. A number of sherds of white ceramic plate bearing the Esso logo were found on the surface, these were not retained.

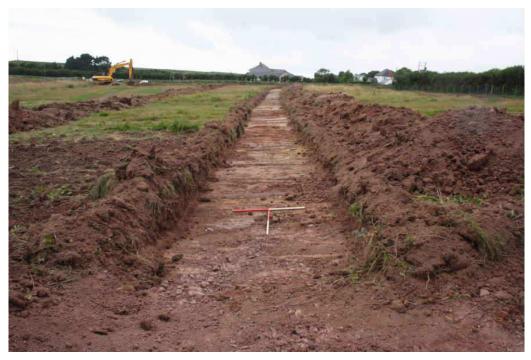
Photo 2: Trench 1 facing west.

- 4.4 To provide the best indication of the presence or absence of archaeological remains within the remaining area to be topsoil stripped, it was agreed to excavate three $100m \times 2.2m$ wide trenches aligned west– east across the area. These trenches were spaced approximately 10m apart and excavated using a flat bladed bucket under constant supervision of the attending archaeologist (Photos 2, 3 & 6).

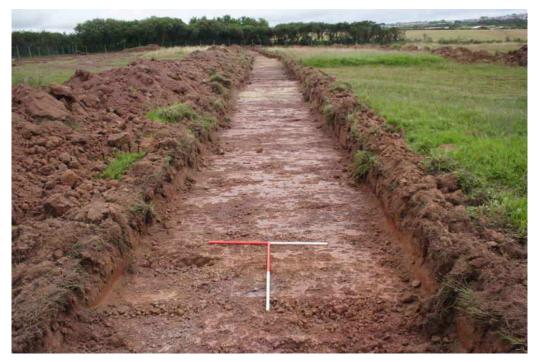
Photo 3: Trench 2 facing east

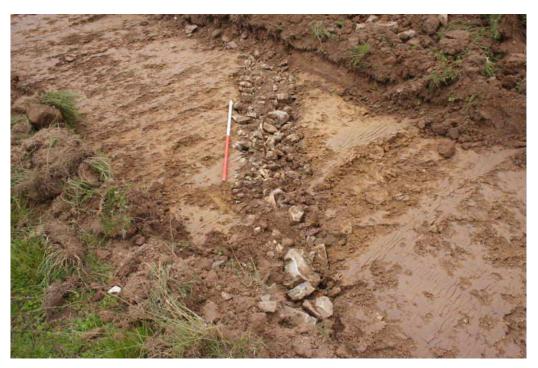
- 4.5 No archaeological features or finds of high archaeological significance were revealed within any of the trenches excavated across the site. However, a series of modern land drains were exposed, although these are considered to be of low archaeological interest (Photos 4 & 5).

Photo 4: Modern land drain, trench 2.

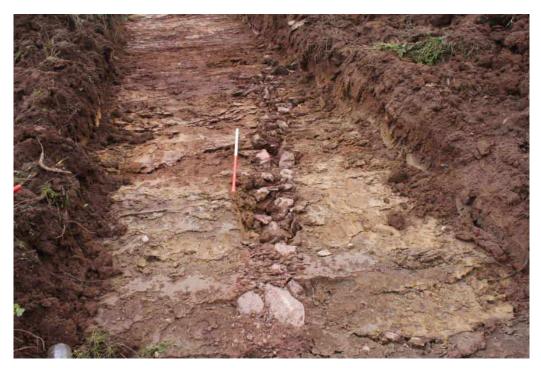
Photo 5: Modern land drain at east end of trench 2

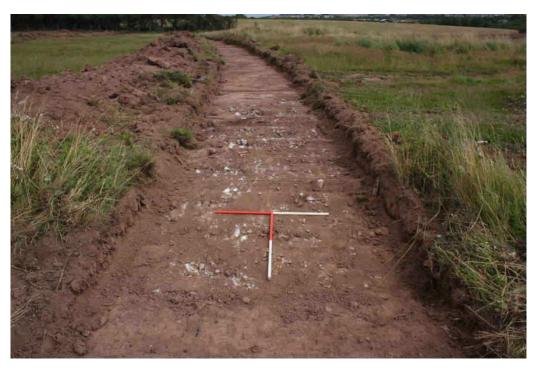
Photo 6: Trench 3 facing east.

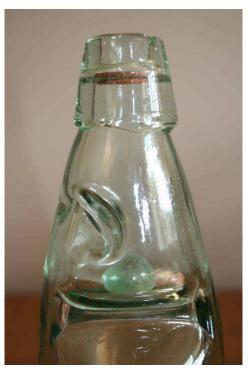
- 4.6 A quantity of golf balls were recovered from the topsoil, but these were not retained. In addition, two aqua codd bottle necks were recovered. This form of bottle were first patented by Hiram Codd in 1871 and continued in use in the mineral water trade in the UK up until the 1940s. They generally came in both 10oz and 6oz capacity. The bottle was sealed by a marble enclosed within the neck, and when the bottle was filled, the marble held in place at the bottle mouth by the pressure of the carbonated drink, the seal being completed by a rubber washer. When opened, the marble would drop into the neck and was retained by two lugs for ease of pouring. Colloquially this form of bottle is also known as a 'pop alley bottle', with alley referring to the marble. There is some suggestion that the term 'codswallop' owes its origin to the bottle, with wallop being a term for beer. The term may possible have been coined by beer drinkers as a sarcastic play on words for the non alcoholic contents the codd bottle was designed to hold.

Photo 7: Example of Codd bottle neck showing marble stopper, retaining lugs and rubber washer seal.

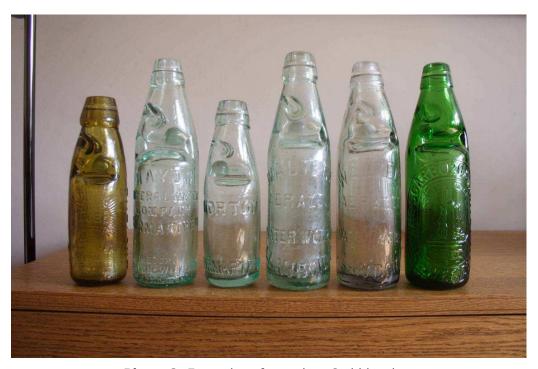
Photo 8: Examples of complete Codd bottles.

(6oz amber; 10oz and 6oz aqua; 10oz aqua machine made, 10oz clear; 10 oz green)
