**STACKPOLE WALLED GARDEN,
STACKPOLE PEMBROKESHIRE:
ARCHAEOLOGICAL
WATCHING BRIEF
(SR 9724 9603)**

Prepared by Dyfed Archaeological Trust
For: Mr Ian Wilshaw
Pembrokeshire Mencap Ltd

RHIF YR ADRODDIAD / REPORT NO. 2011/42
RHIF Y PROSIECT / PROJECT RECORD NO. 102248

STACKPOLE WALLED GARDEN, STACKPOLE, PEMBROKESHIRE: ARCHAEOLOGICAL WATCHING BRIEF

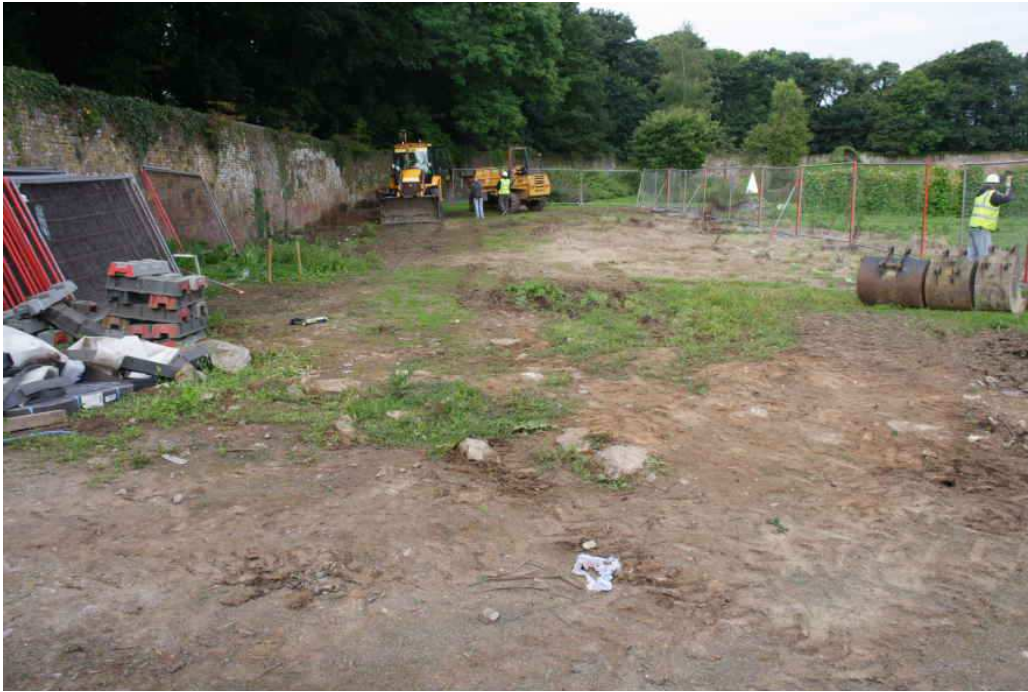
Photo 1: Pre excavation view of development site.

4.1 The first site visit was undertaken on 31st August 2011 following communication from the on-site contractor that works were due to commence. On arrival it was found that an area measuring 29m x 9m had been marked out and was ready for topsoil stripping (photo 1). A rapid walkover of the area showed that a modern concrete block path (photo 2) ran across the site in an east – west direction and is considered to have been constructed following lease of the garden in 2000.

4.4 The topsoil stripping of the site revealed a dark brown garden soil (100) of moderate compaction containing much modern debris in the form of modern brick, drinks cans and plastic sheeting, sand and builders chippings. This overlay a firm mid brown clay silt (101) containing industrial period brick fragments, coal and mortar flecks (photos 1, 2, 3 & 4). No archaeological features or deposits were revealed.

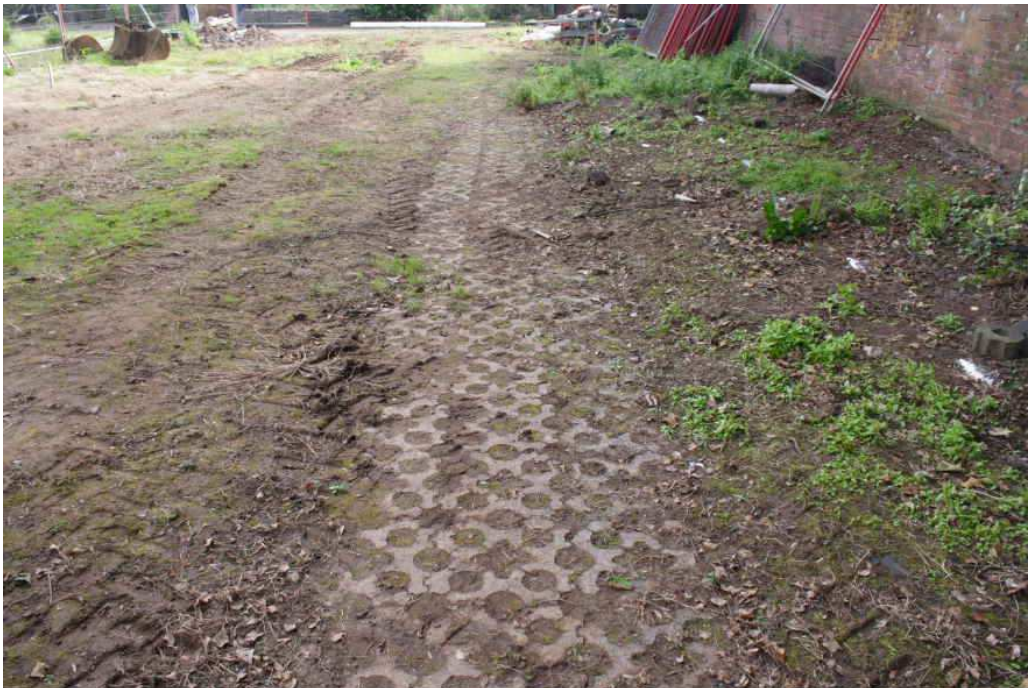
Photo 2: Modern concrete pathway running across site.

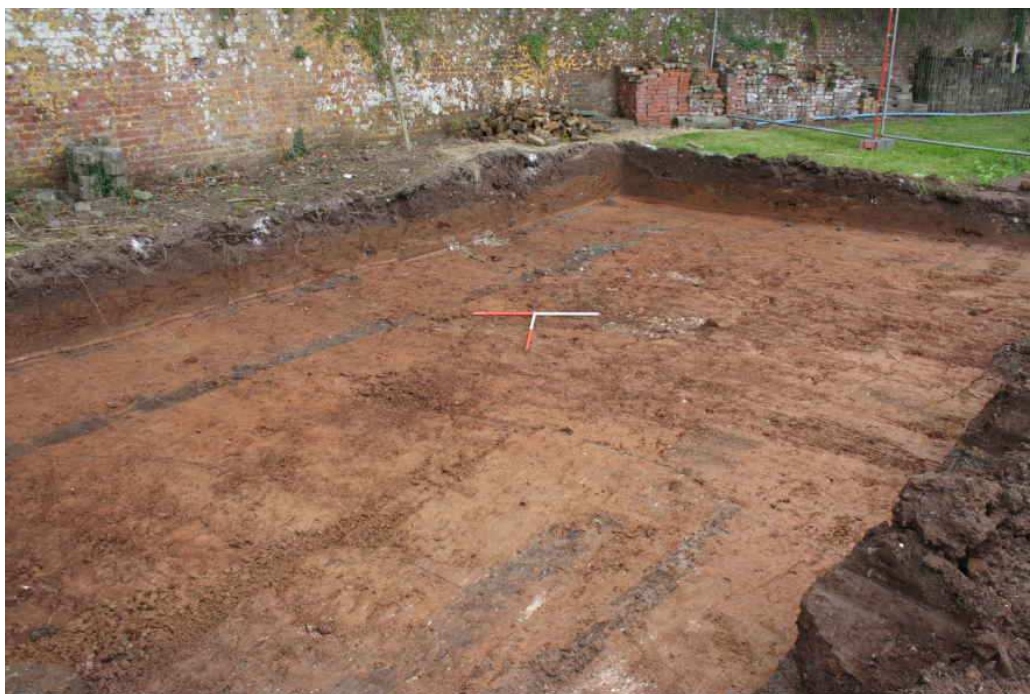
Photo 3: Area following stripping.

4.5 A second site visit was undertaken on the 1st September 2011 to monitor the continuing excavation work, which had the potential to expose, damage or destroy archaeological remains. The excavations revealed no archaeological features or deposits within the stripped area (photo 3). A decision was made to excavate a test pit on the northern boundary of the excavation area to determine the nature of deposit (101). The test pit measured 2.2m x 1.2m and was excavated to a depth of 1.1m where natural limestone bedrock (103) was revealed. It was found that (101) was 0.55m deep and overlay a firm mid brown clay (photos 5 & 6). It was also possible to view that the industrial period brick, coal, and mortar fragments were only present at the interface with overlying garden soil (100). A single piece of un-stratified North Devon gravel tempered ware, dating between 1680 and 1750 was also recovered from (101), but this must have been a residual find as it was mixed in with the industrial period material.

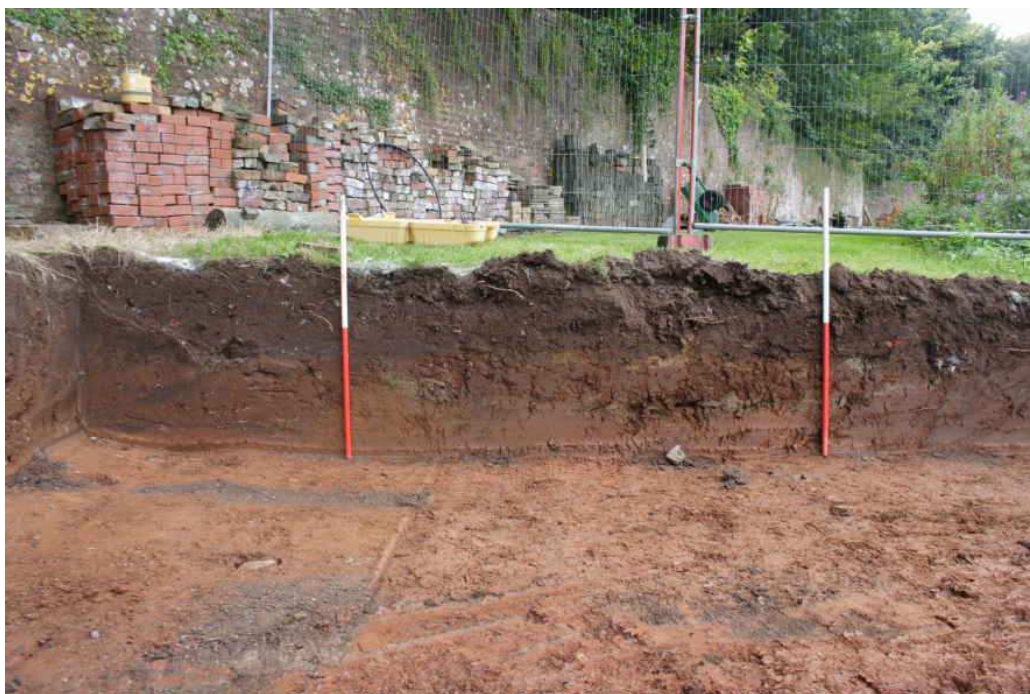
Photo 4: East facing representative section.

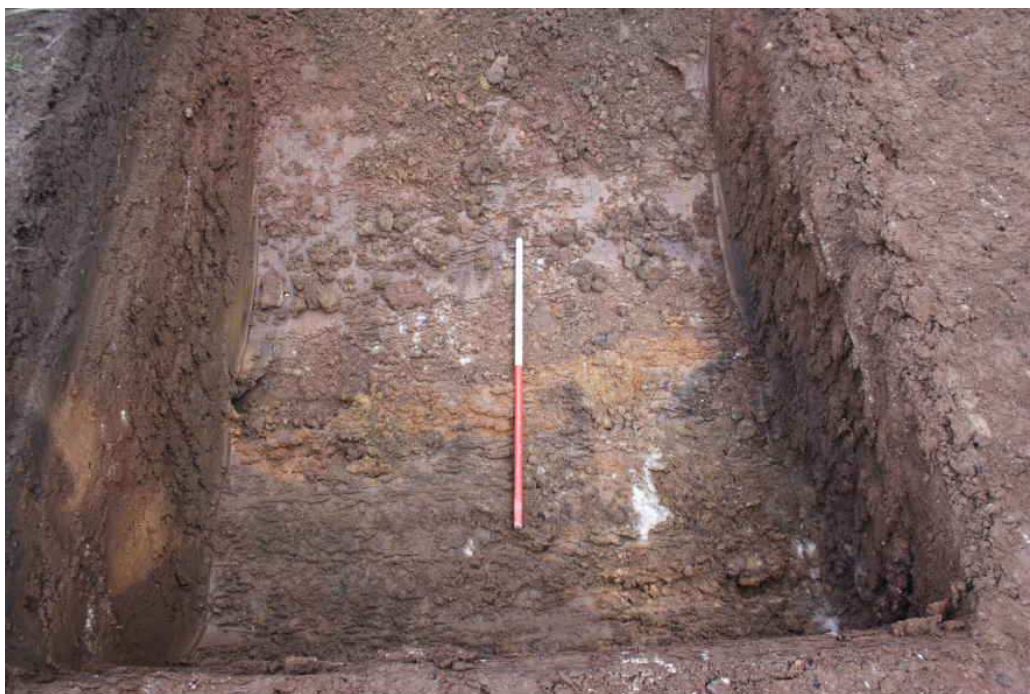
Photo 5: Test pit showing natural deposits.

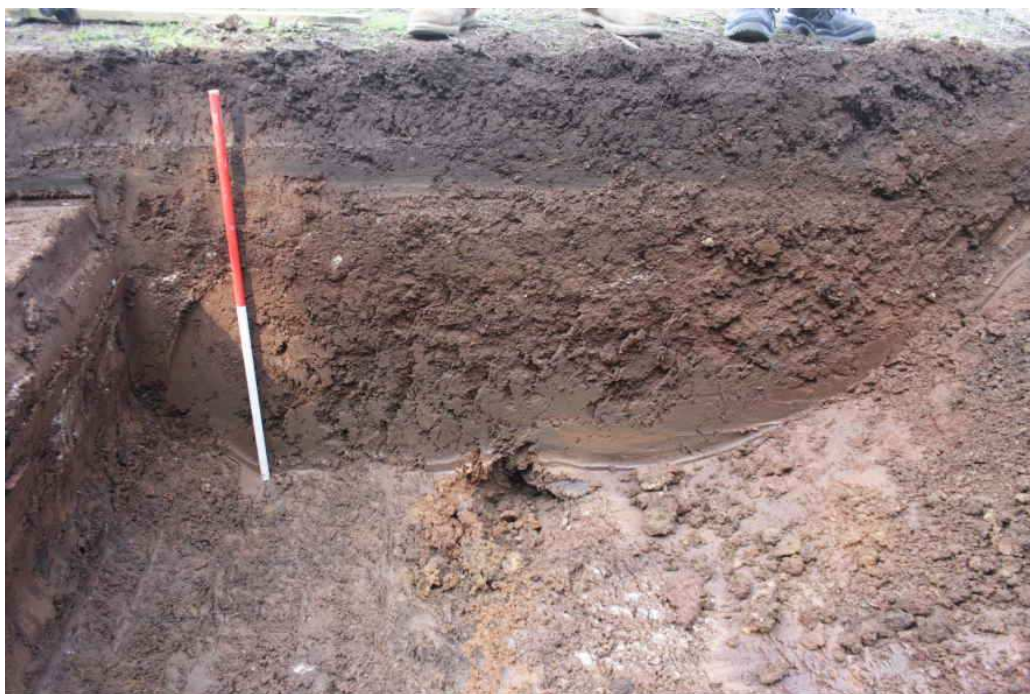
Photo 6: South facing section of test pit.

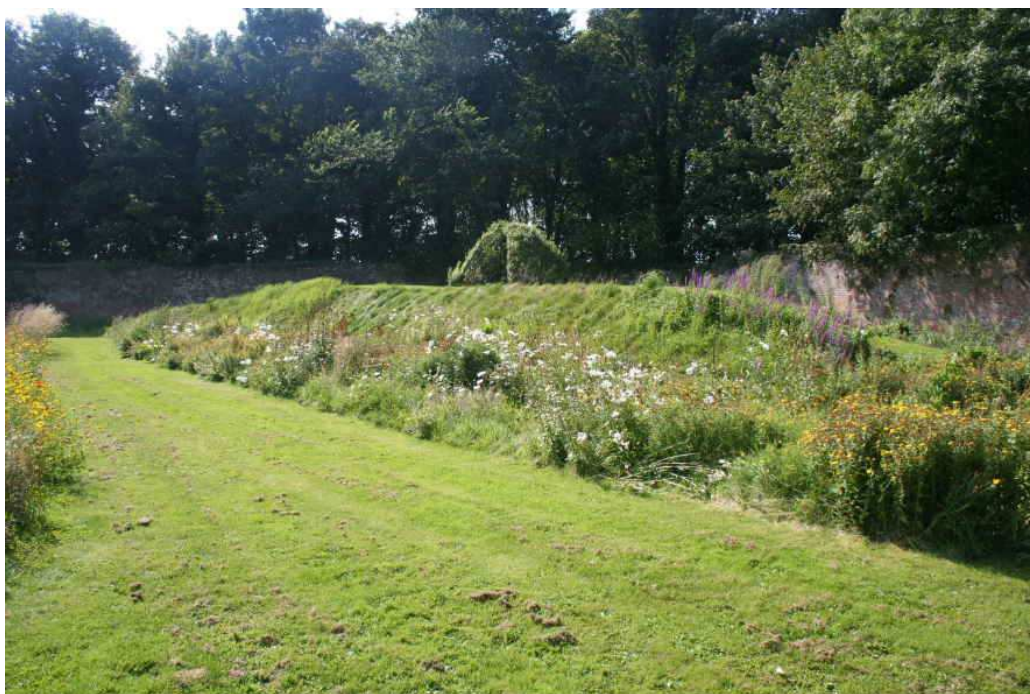
Photo 7: Banked area constructed from modern debris removed from garden.

4.6 A conversation with Mr Ian Wilshaw revealed that prior to the garden being leased by the Mencap Garden Project the whole of the southern compartment of the garden had been completely stripped of topsoil to a depth of c.0.5m and when it was taken over was found to have been used as an illegal dump. Following lease of the garden, a large quantity of soil was donated by contractors working on a nearby road scheme to replace the material removed from the garden. The modern, illegally dumped material and a quantity of this imported soil was used to construct a substantial bank that currently stands in the south west corner of the garden (photo 7). A further conversation with one of the gardeners revealed that whilst industrial period finds of pottery, glass, and clay pipes were routinely made in the north compartment of the garden, no such finds were made in the southern compartment. It was also discovered that the southern compartment had been ploughed and rotivated to improve the quality of the imported soil and that each year 80 – 100 tons of manure were spread on the garden to bring the quality of the soil in the garden up to that found in the northern compartment.

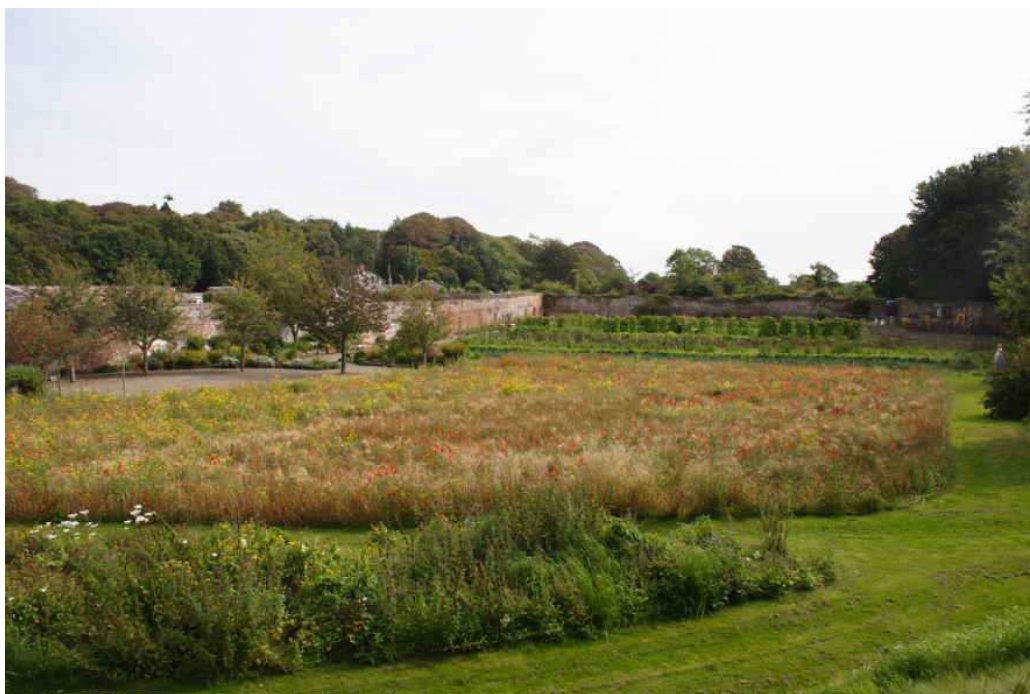
Photo 8: General view across southern compartment of garden.

4.7 It is considered that previous clearance work on the site had destroyed any surviving buried garden features or structures, not only within the application area but over much of the southern compartment of the garden as a whole (photo 8).
