LAND AT BRYNHEULOG, ROMAN ROAD, LLANGUNNOR, CARMARTHEN: ARCHAEOLOGICAL WATCHING BRIEF (NGR SN 4160 1912)

Prepared by Dyfed Archaeological Trust
For: Redrow Homes South Wales

RHIF YR ADRODDIAD / REPORT NO. 2011/43
RHIF Y PROSIECT / PROJECT RECORD NO. 102249

Hydref 2011
October 2011

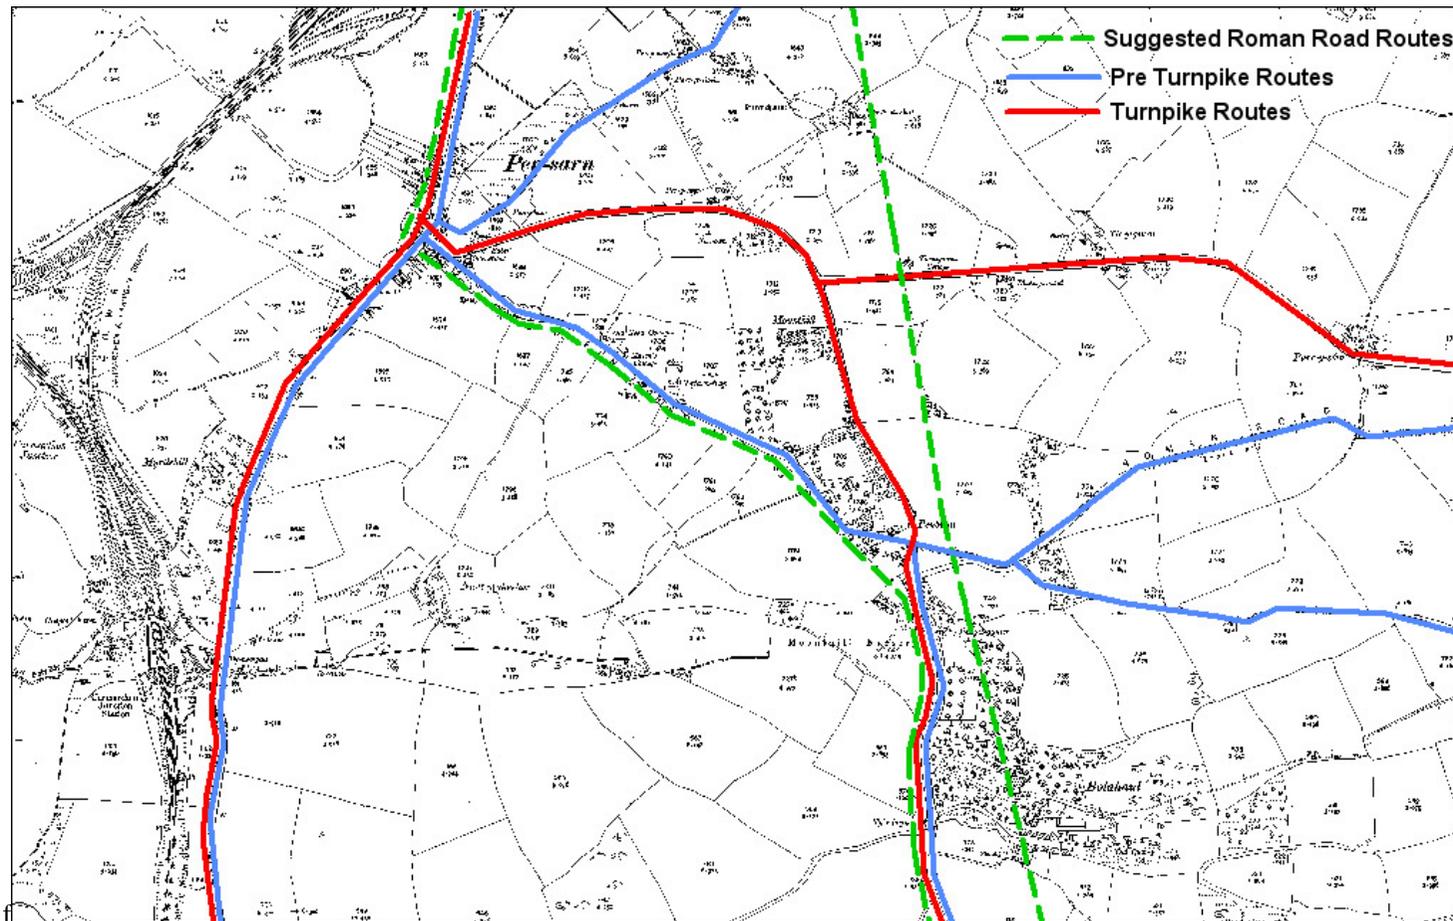
Figure 8: Historic road routes in close proximity to development.
(based on 1906 1:2500 scale OS map)

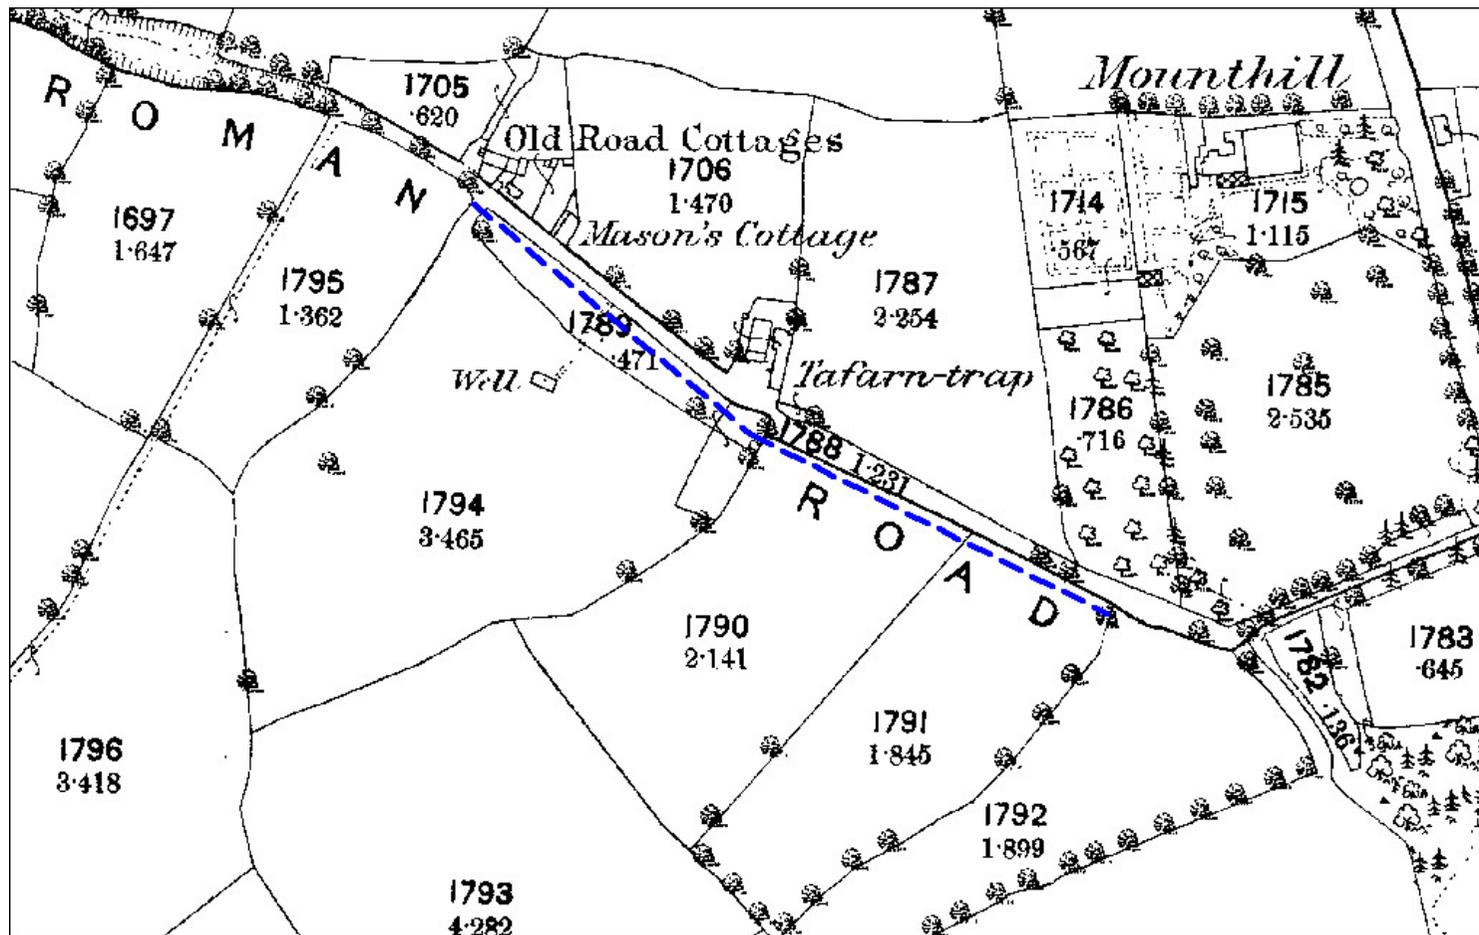
Figure 11: Route of earthwork (205) in blue shown on 1906 Ordnance Survey Map.

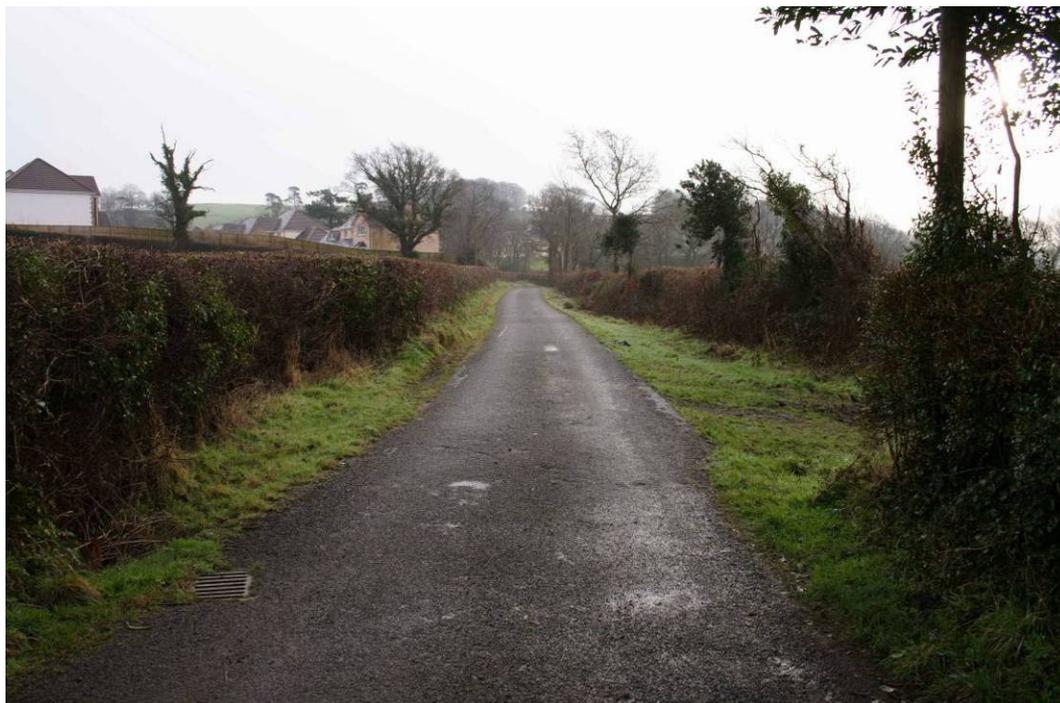
Photo 1: View along 'Roman Road' facing east.

2.2.6 The proposed development site is bounded on the southwest by the unclassified road traditionally known as '*Roman Road*' (see photo 1). It is thought that this road follows the suggested route of the Roman road between the forts of Carmarthen and Lougher (Schlee, 2004, 13). The road has been marked as '*Roman Road*' on maps since the latter part of the 19th century (Ordnance Survey, 1890).

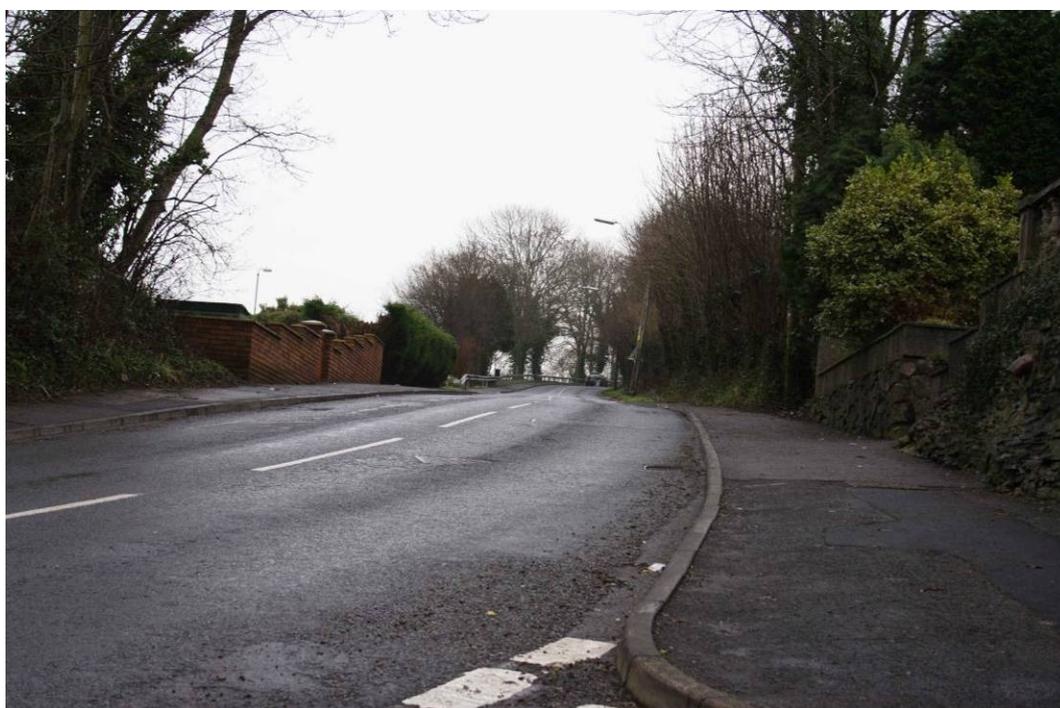
Photo 2: Former turnpike route now Babel Hill.

2.2.8 '*Roman Road*' formed part of the main 18th century route south out of Carmarthen. It was superseded by the construction of the turnpike road, modern day Babell Hill/ Rhiw Babell (see photo 2), sometime between 1779 and 1798 by the Kidwelly Turnpike Trust (Evans, 1988, 59).

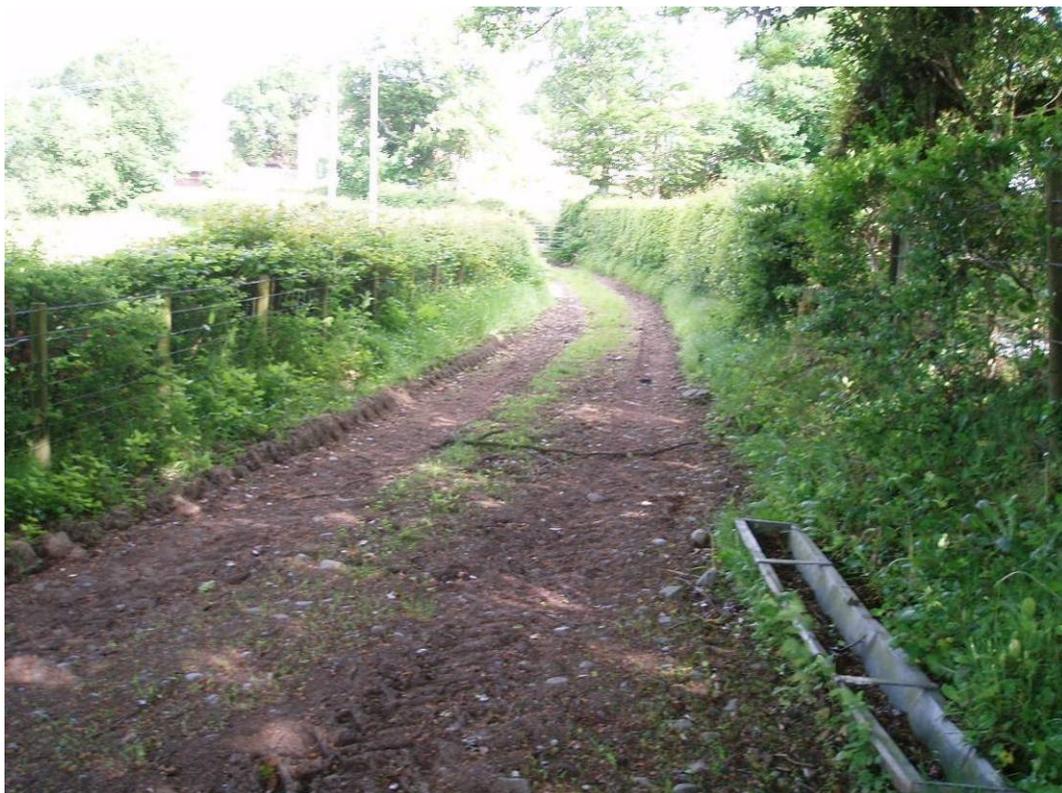
Photo 3: Pre turnpike route surviving as track near former Penbryn Manor site.

2.2.10 Further research has revealed that the road originally turned SE, a section of which still survives as a farm track (see photo 3), before passing immediately to the E of the site of Penbryn Manor (see photo 4) and (demolished in the late 1990s and replaced by a substantial modern house) from there the road branched towards both the south and east.

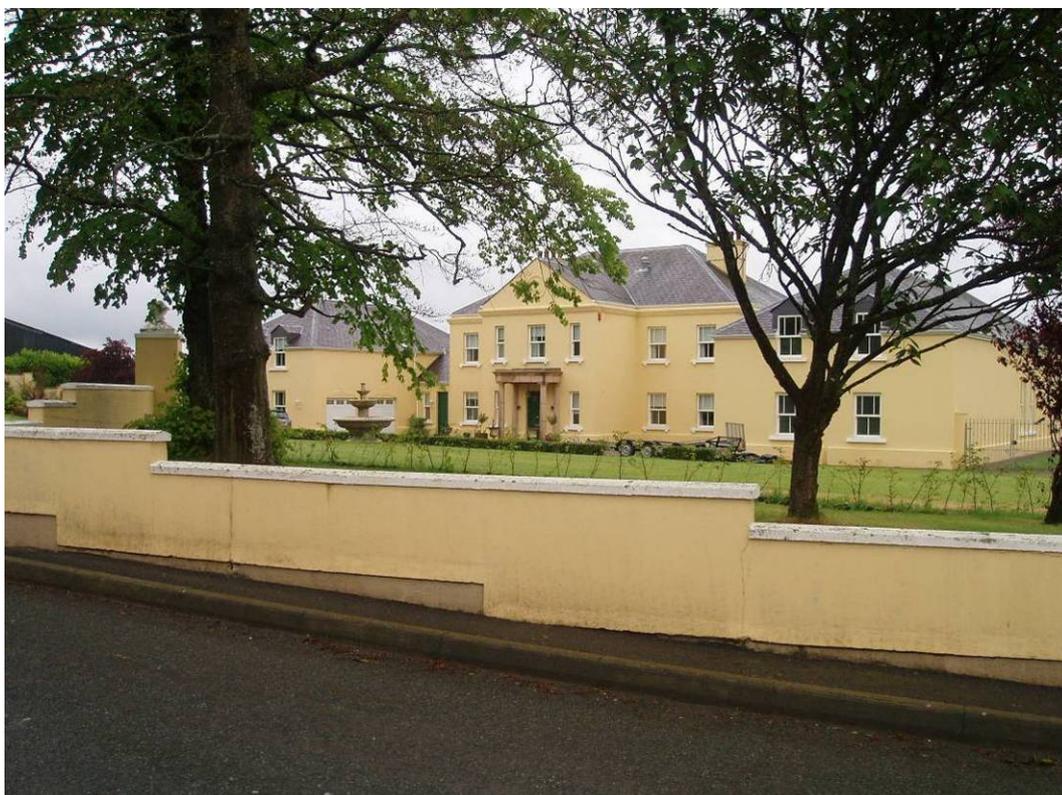
Photo 4: Modern dwelling occupying site of Penbryn Manor.

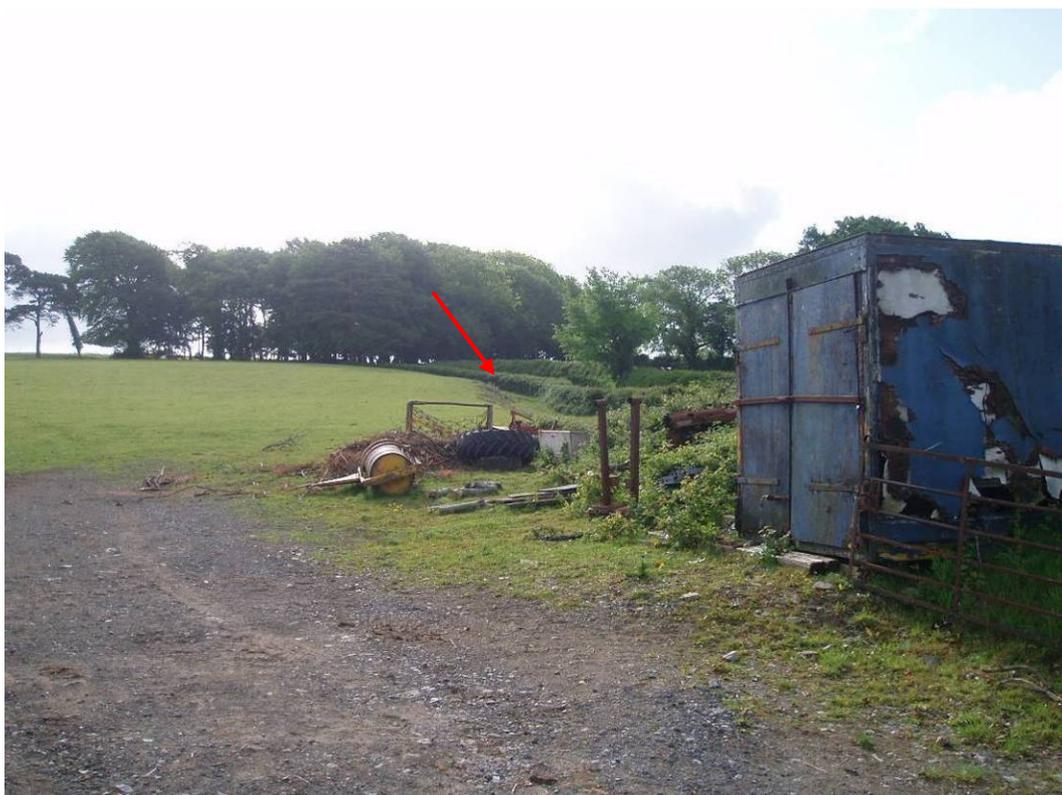
Photo 5: Pre turnpike road to east of development site.

2.2.11 The branch heading south followed the same route as that of Bolahaul Road and eventually led to Llanelli. The eastern branch, which led to Swansea and Neath, originally connected with present day Heol Login at a point to the west of the property known as Caeaugwynion. Late 19th and early 20th century mapping of the area show a c.0.5km long trackway which is marked as '*Roman Road Track of*'. Modern aerial photographs and Ordnance Survey mapping of the area do not indicate the presence of any trackway in the area. However, LIDAR digital imaging of the area does show that the former road survives for much of its route as a depression in the ground surface (LIDAR tile SN4218 25th January 2004). A brief site visit revealed that the road survives as a hollow way and is visible from the adjacent Mount Pleasant road (see photo 5)

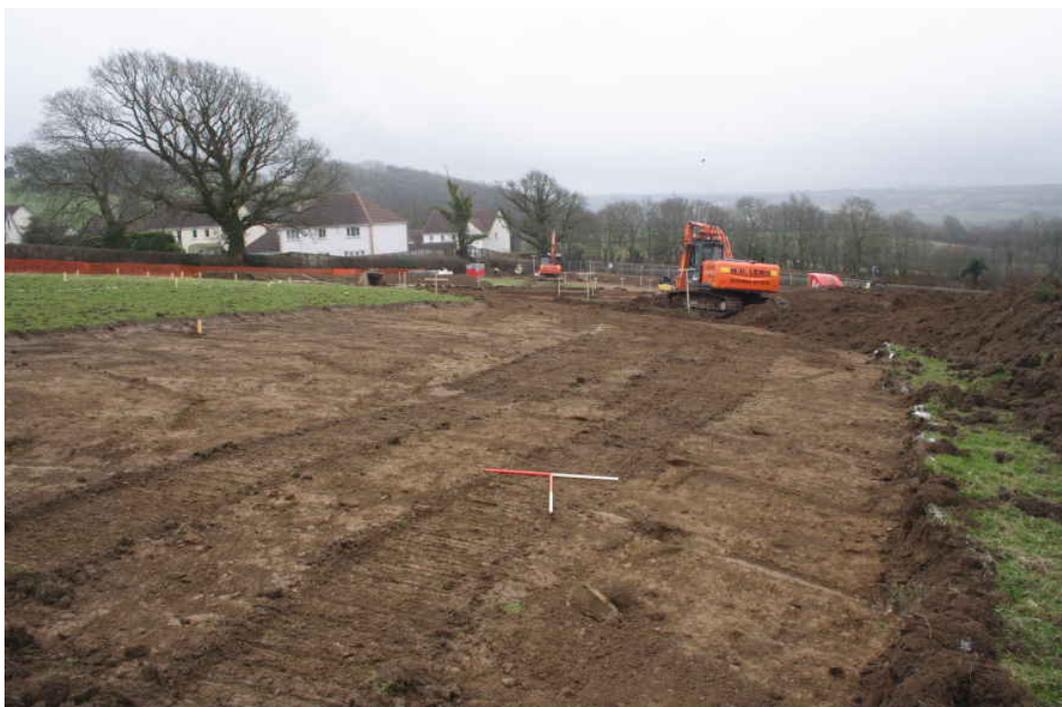
Photo 6: Site during topsoil stripping, facing SE.

4.1.1 Topsoil stripping of the development site was monitored over five days during February 2011. The programme of topsoil stripping was undertaken by a pair of 360° tracked excavators using toothless grading buckets.

4.1.2 A consistent stratigraphic sequence of dark red brown clay silt ploughsoil (100) overlying mid yellow natural clay (101) was revealed across the development site. At the top of the hill small areas of bedrock were revealed (102). The depth of the ploughsoil varied between 0.2m at the top of the hillslope up to 0.40m at the bottom of the slope along the frontage with Roman Road. The increase of soil depth in this area is probably as a result of colluvial build up (hillwash). Finds from the ploughsoil consisted of 18th - 19th century ceramic material and bottle glass fragments, but these were not retained.

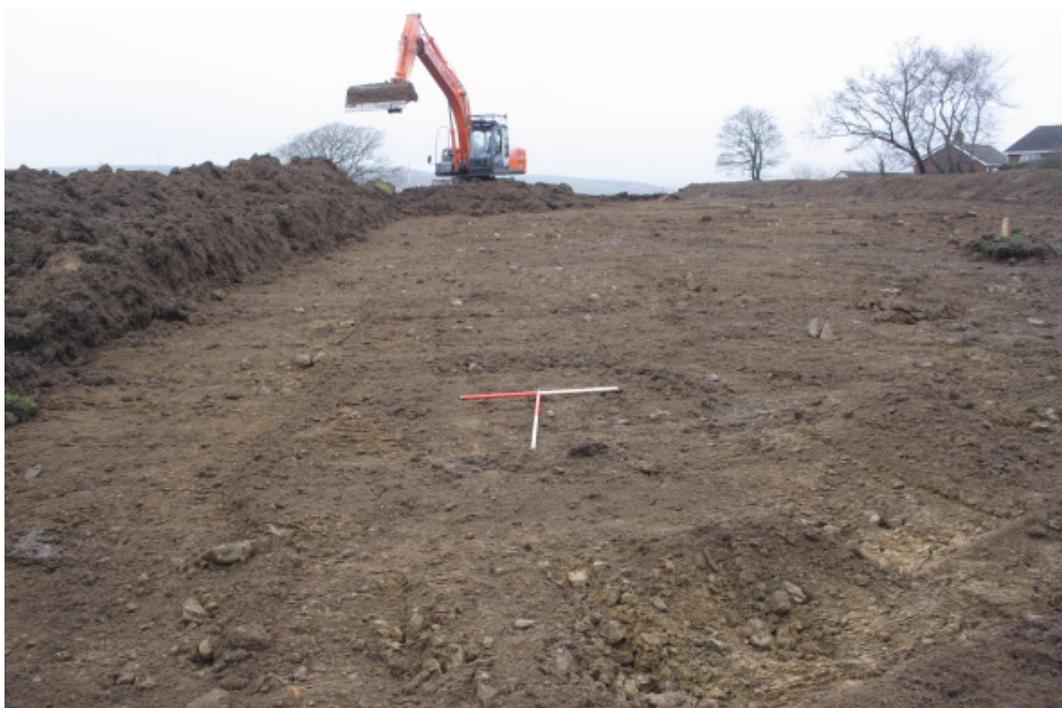
Photo 7: Site during topsoil stripping facing N.

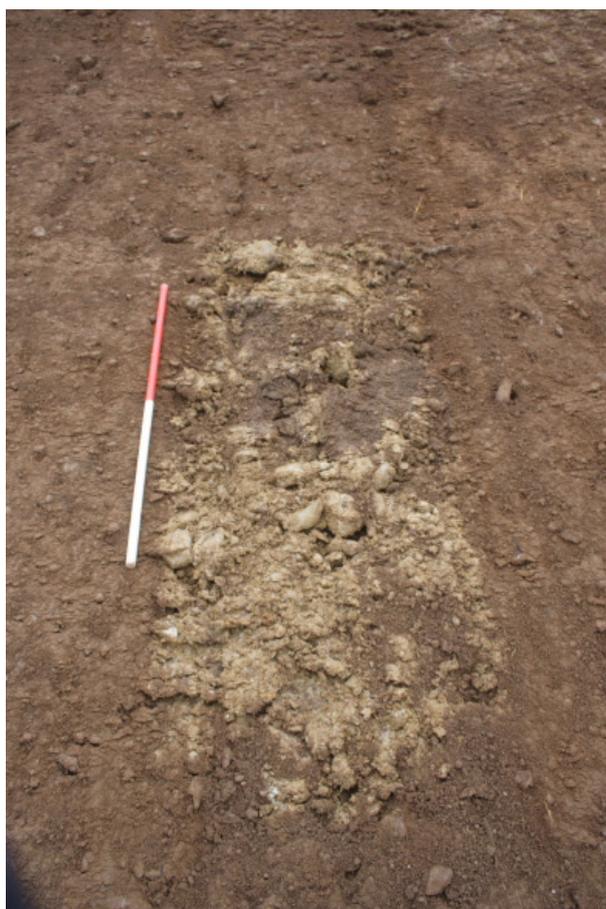
4.1.3 No features of Roman or medieval date were revealed during the topsoil stripping programme. A single rectangular cut feature [104] was revealed towards the southern end of the development site, which on partial excavation was found to be modern, the fill (103) containing plastic fragments and partially decomposed vegetation (photo 8). No topsoil stripping was undertaken in the vicinity of the site of Mason's Cottage as this lay outside the boundaries of the new development.

Photo 8: Modern feature [104]

5.1.1 Topsoil stripping of the site revealed a single archaeological feature [104], which on partial excavation was found to contain plastic fragments and partially decomposed vegetation indicating a modern date. The feature is related to recent agricultural use of the site and is of low archaeological interest.

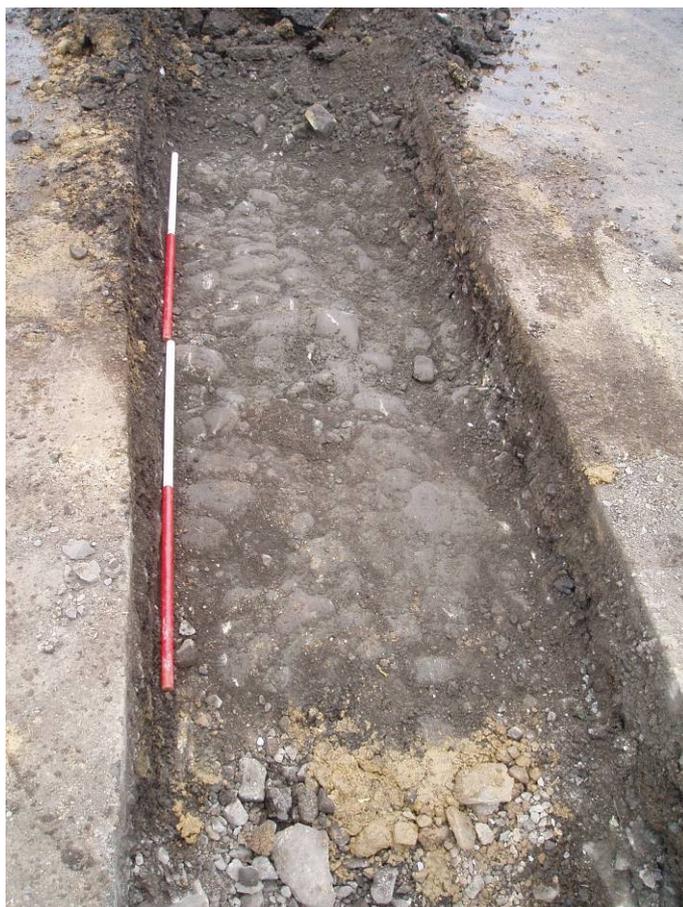
4.2.6 Inspection Chamber 3 was located immediately outside Brynheulog Farm at NGR SN 4159 1902 and measured 2.5m x 1.75m with a depth of 1.8m. During excavation a 1.7m wide cobbled surface (200), set on a bed of crushed shale (201) overlying natural clay (202), was revealed in the NW section of the trench at a depth of 0.18m beneath the present road surface (photos 9 and 10).

Photo 9: Cobbled surface (200) facing NW.

4.2.7 Following identification and recording of the cobbled surface within the section it was agreed with the contractor that a section of overlying tarmacadam would be lifted to expose more of the surface. Removal of the tarmacadam revealed that cobbled surface had a width of 1m, but was partially obscured by tar/bitumen. The full extent of the cobbled surface was unclear as it extended beyond the edges of the excavated area.

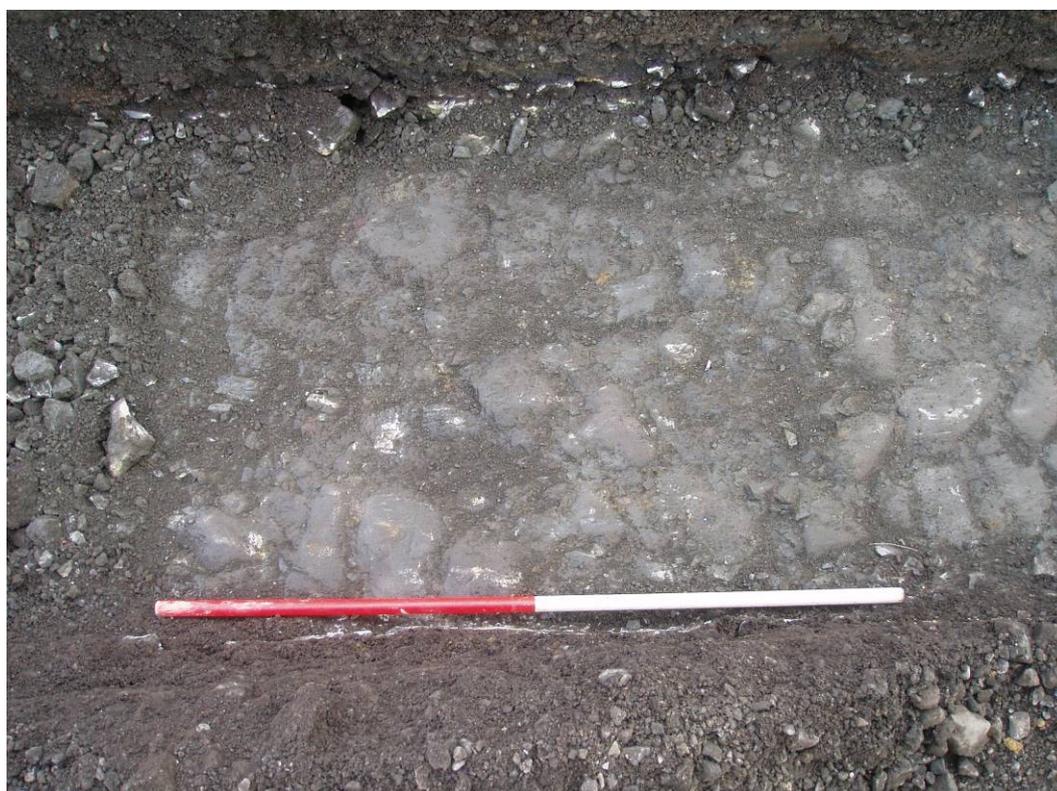
Photo 10: Detail of cobbled surface (200)

provide a well drained platform for the road surface which generally consisted of layers of compacted stone with a pronounced camber (Morriss, 2005, 110). No evidence for a camber was noted on cobbled surface (200) with the only evidence for any form of layering being the underlying crushed shale bedding, laid directly upon the natural clay. Earthwork (205) may suggest a potential agger, but this has not been confirmed. On some minor Roman routes an agger was often not constructed and the road surface consisted of single layers of gravel and stone laid directly onto levelled clay or soil (Morriss, 2005, 111).

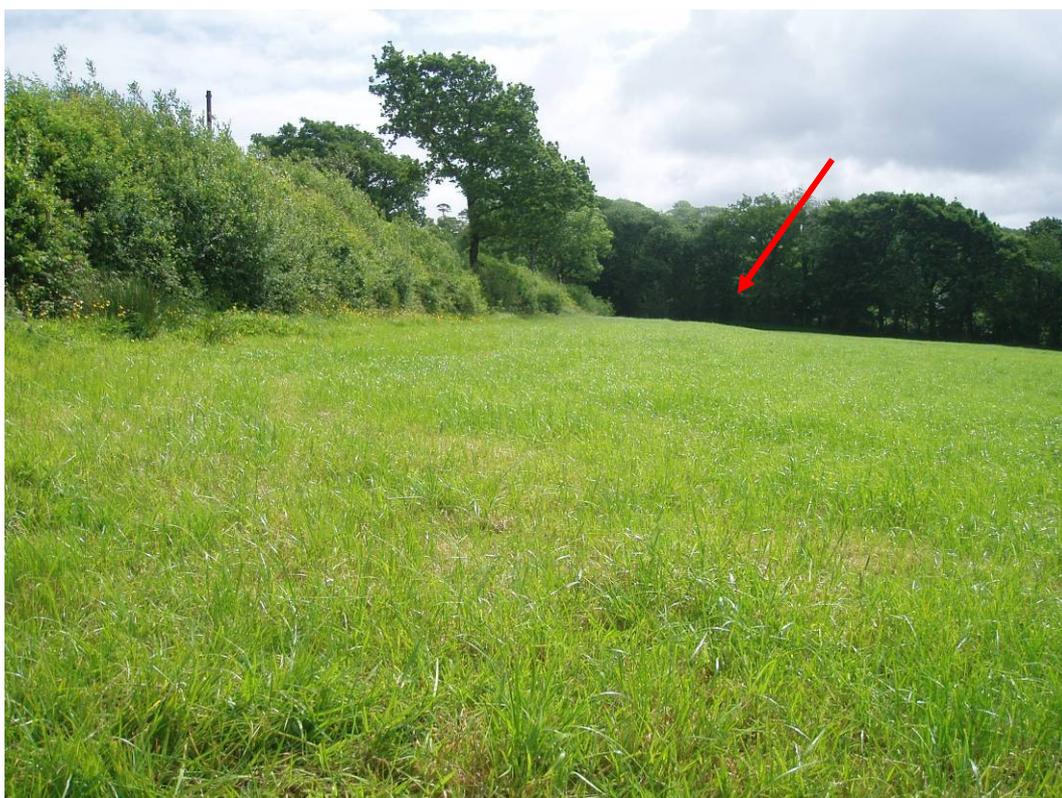
4.2.13 During a break in the excavations for pipe connection works a visit was made to the fields immediately to the SE of 'Roman Road'. Here it was revealed that a broadly flat topped earthwork (205), c.0.5m high, with a width of c.4m, ran for a distance of c.155m (NGR SN 4150 1907 – SN 4169 1894) parallel to the line of 'Roman Road', and is separated from it by hedgebanks (photos 11 & 12).

Photo 11: Earthwork (205) facing SE

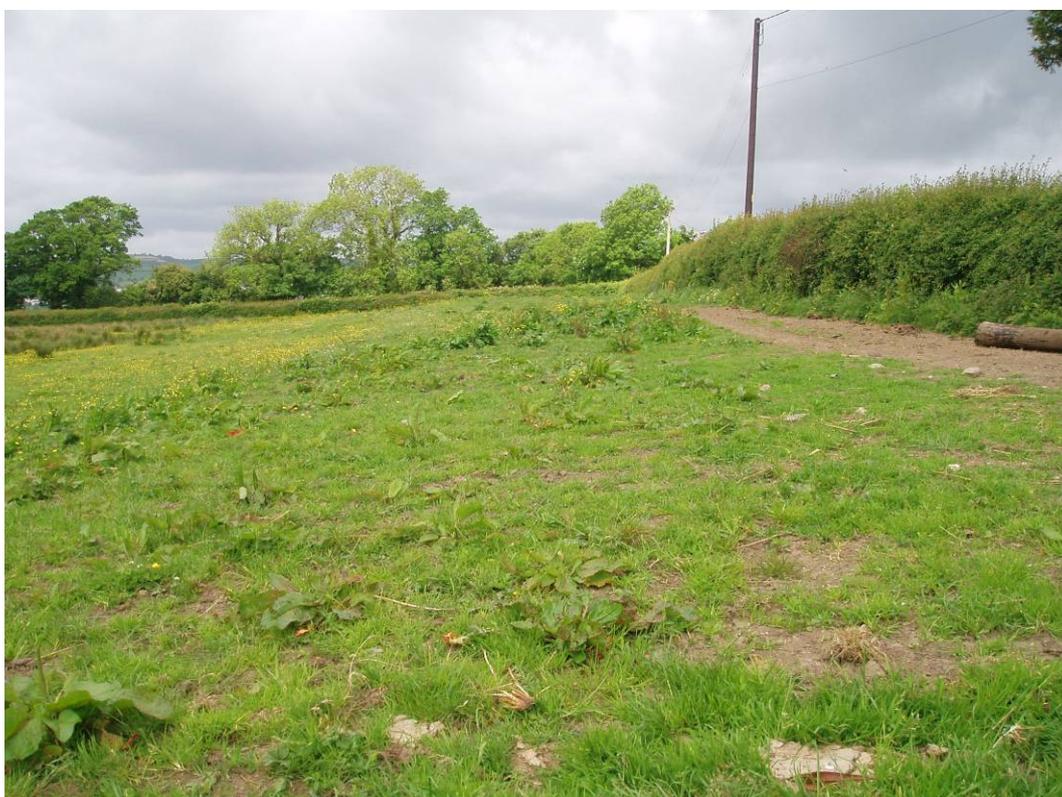
Photo 12: Earthwork (205) facing NW
