STACKPOLE COURT, STACKPOLE, PEMBROKESHIRE: COMMUNITY ARCHAEOLOGICAL EXCAVATION

Prepared by Dyfed Archaeological Trust
For: The National Trust

RHIF YR ADRODDIAD / REPORT NO. 2011/46
RHIF Y PROSIECT / PROJECT RECORD NO. 102353

Medi 2011
September 2011

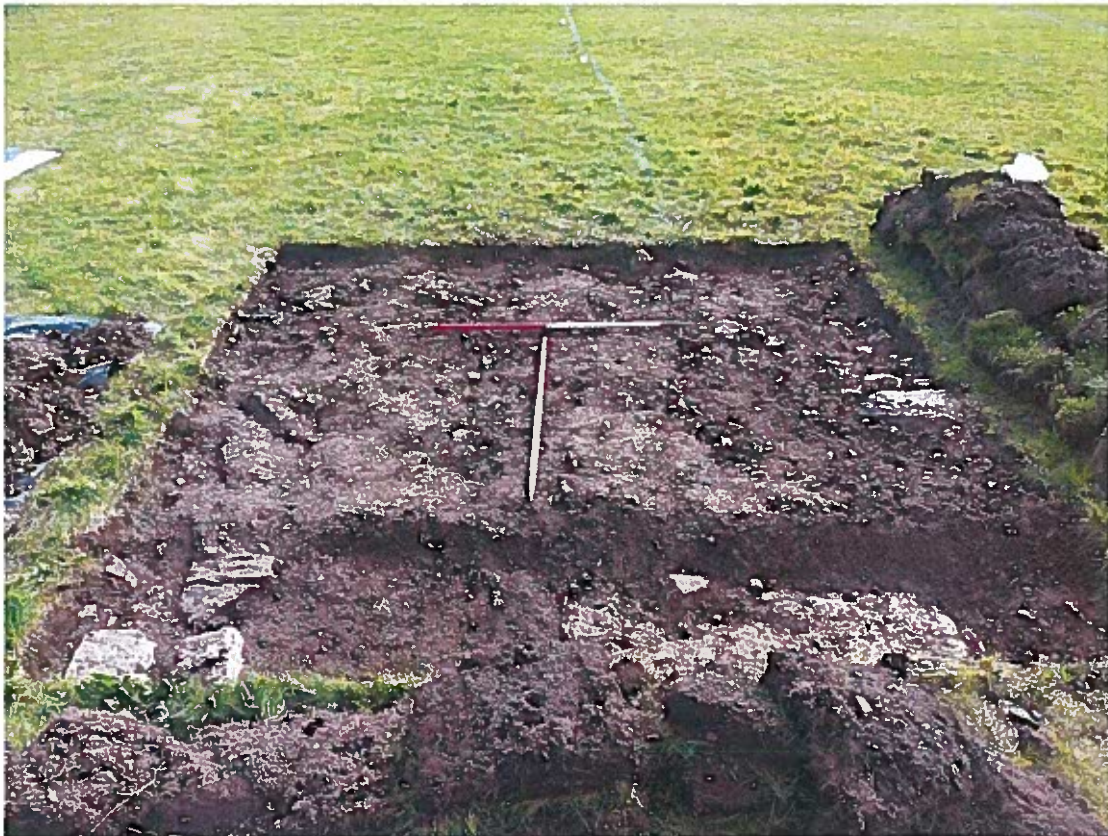
Photo 3: Trench 1, looking SSW. 1m scales.

Almost immediately large stones became apparent just below the turf amongst the topsoil (photos 3 & 4). It was not possible within a single day to fully remove the topsoil from the entire trench but these large stones occurred on or close to the anticipated lines of walls (walls 105 and 106), and therefore it is thought likely they represent remains of these walls.

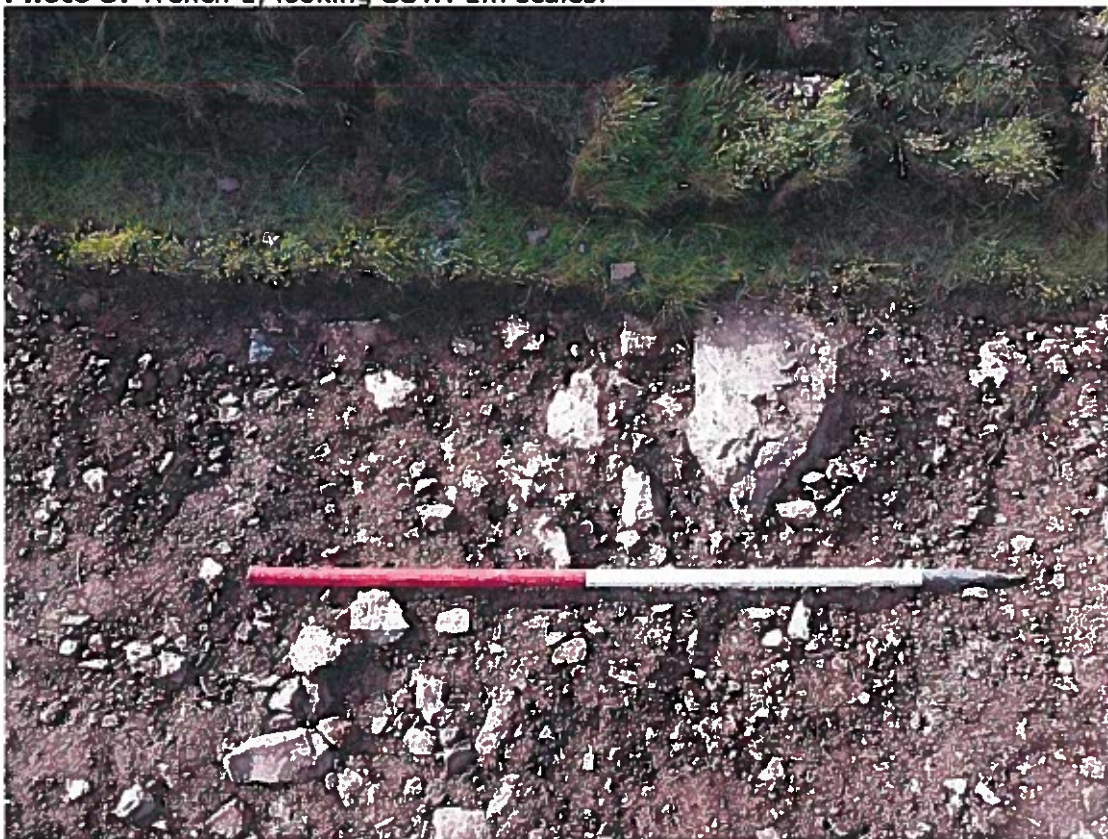
Wall 105 (photo 4) comprised two large stones situated tight against each other, the largest measuring 0.4m by 0.25m. No mortar or further structural features were noted but topsoil was not fully removed from this area. The largest stone lay just 0.45m to the north of the anticipated line of a side wall to the main entrance corridor. This side wall ran in a WNW – ESE direction and was anticipated to meet the main eastern wall of the mansion.

Photo 4: Possible wall remains of wall 105. 1m scale.

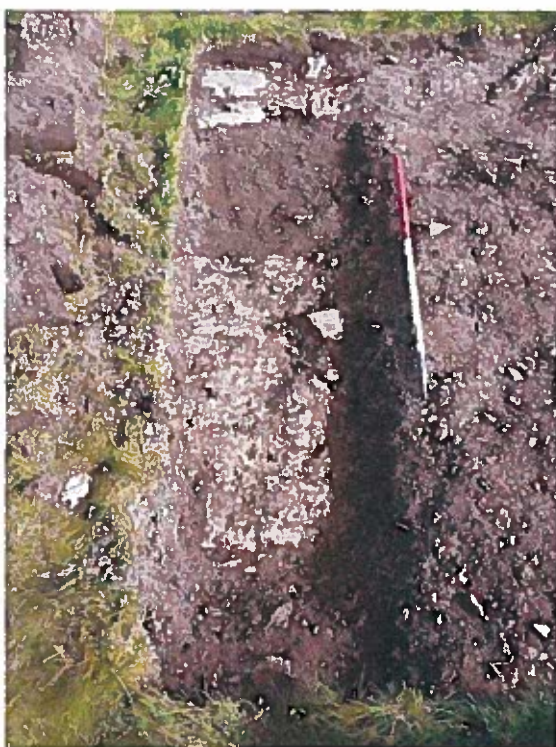
The topsoil was fully removed from a strip 0.6m wide along the northern edge of the trench (photo 5), which revealed clearer evidence of structural features.

Photo 5: Area where topsoil 100 has been removed, showing wall 102 and possible wall 104 beyond. 1m scale.

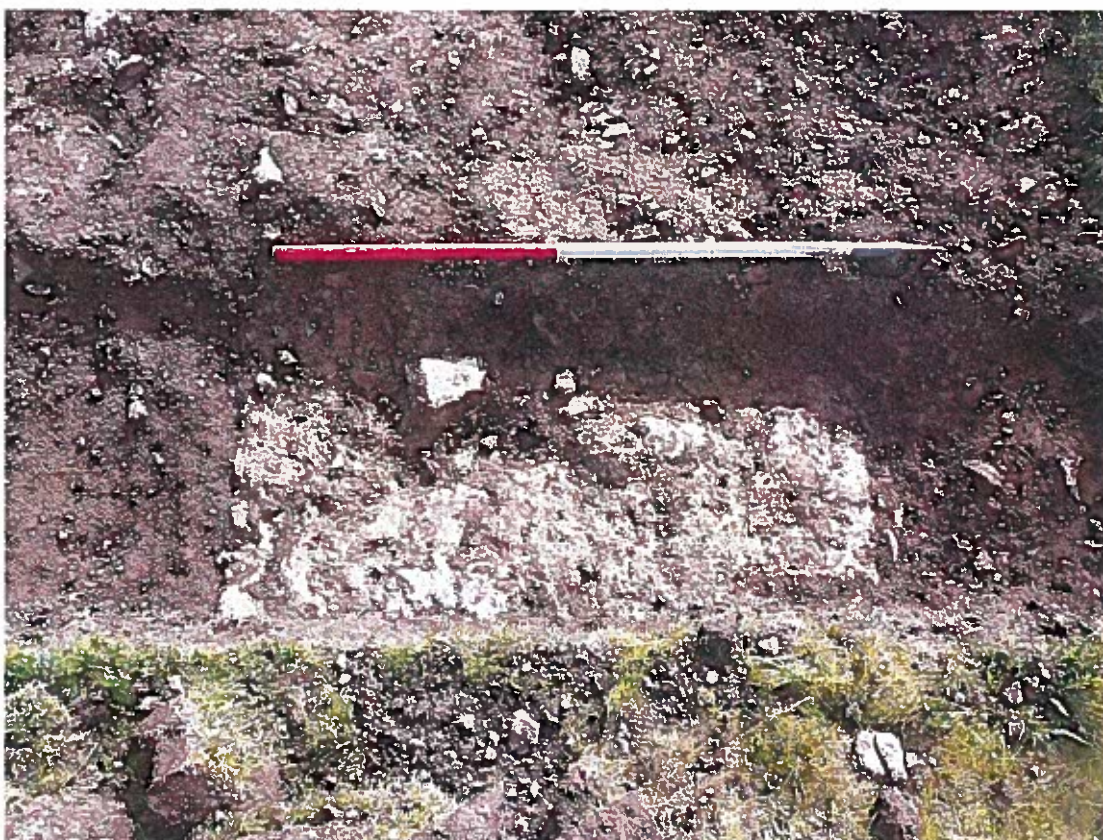
Running in a NNE – SSW direction were the remains of a wall (wall 102 – photos 5 & 6). The wall consisted of large roughly hewn grey stone, roughly faced on both sides, with a rubble core set in a compacted yellowy lime mortar. The wall was 1.1m wide, and located on the alignment expected for the external eastern wall of the main mansion building.

Photo 6: Wall 102. 1m scale.

Trench 1 revealed the remains of the outer eastern wall of main mansion building, measuring 1.1m wide. It was not possible to excavate around the wall to determine if any courses of solid dressed stonework survived, but as none were apparent and the presence of other ground deposit indicates the wall had been demolished to foundation levels. The wall line was within 0.25m of the line laid out from known surveys and plans of the building, suggesting these plans are reasonably accurate tools for locating the layout of the building.

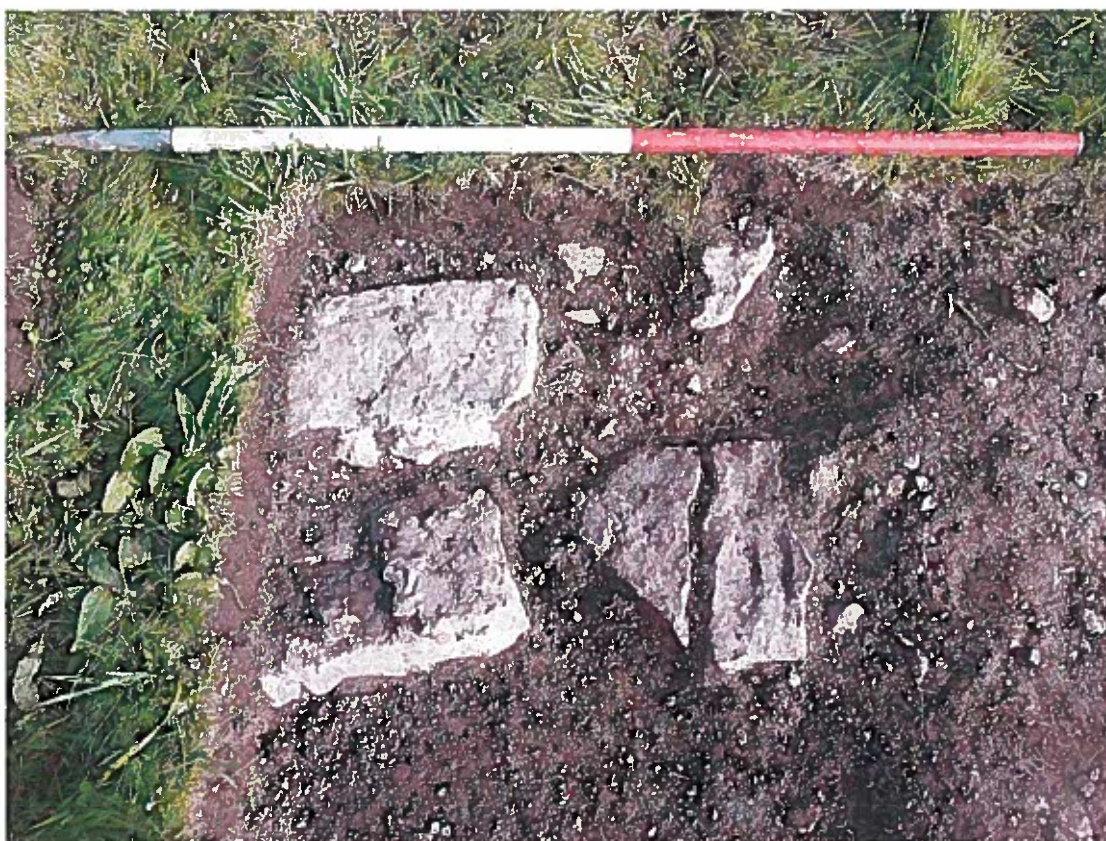
The eastern edge of layer 103 was defined by a structural deposit of large, roughly hewn, grey-stones (?wall 104 – photo 7). These stones were unfaced and roughly set into a rubbly lime mortar. This deposit was at least 0.55m wide but extended beyond the limits of the trench, similar stones were visible amongst the topsoil along the same alignment throughout the trench. It followed the same alignment as the main mansion wall (102) but had an uneven surface. This may represent further foundations, but whether it is another wall or a pathway around the outside of the building is unclear. This feature does not appear on known plans of the site.

Photo 7: Possible wall or footpath foundation 104. 1m scale.

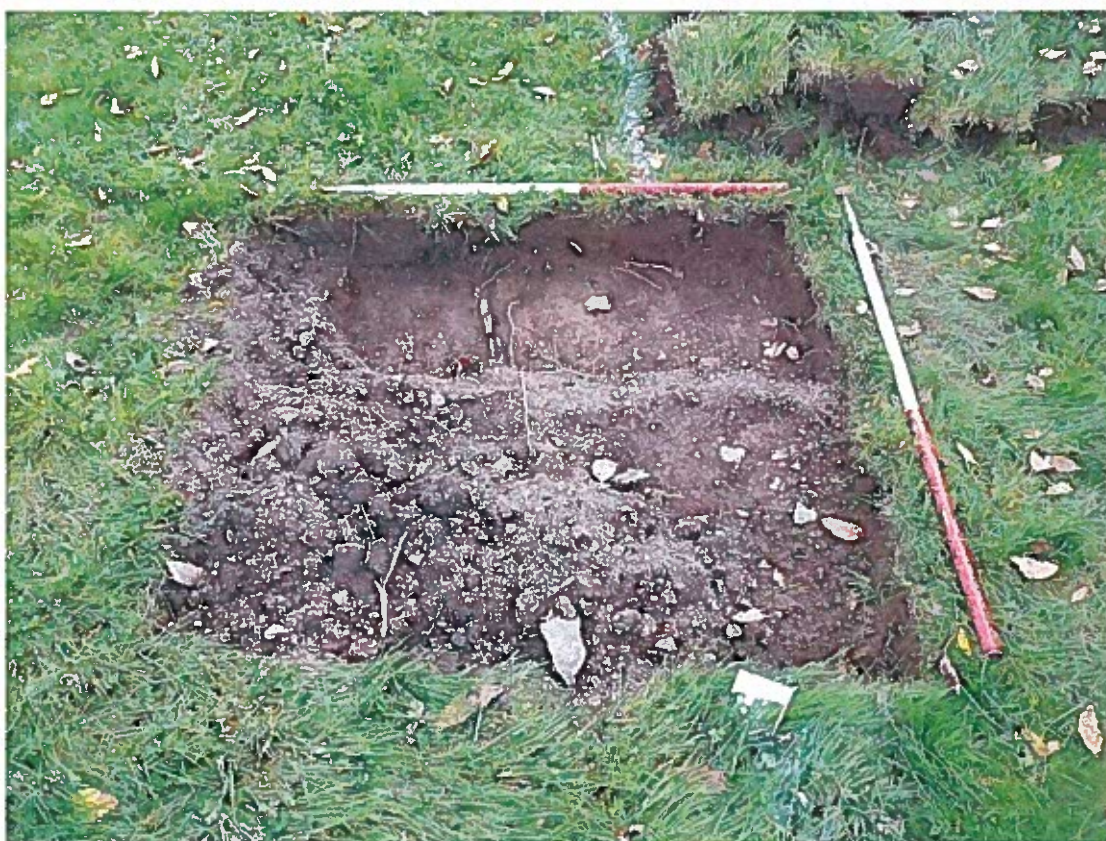
This trench contained a similar topsoil deposit of friable mid grey-brown clayey-silt (layer 200) with moderate inclusions of medium to large sub-angular stone and fragments of brown-glazed drainage pipe (photo 8). This deposit was slightly deeper at 0.18m thick.

Photo 8: Trench 2 under excavation, looking SSW. 1m scales.

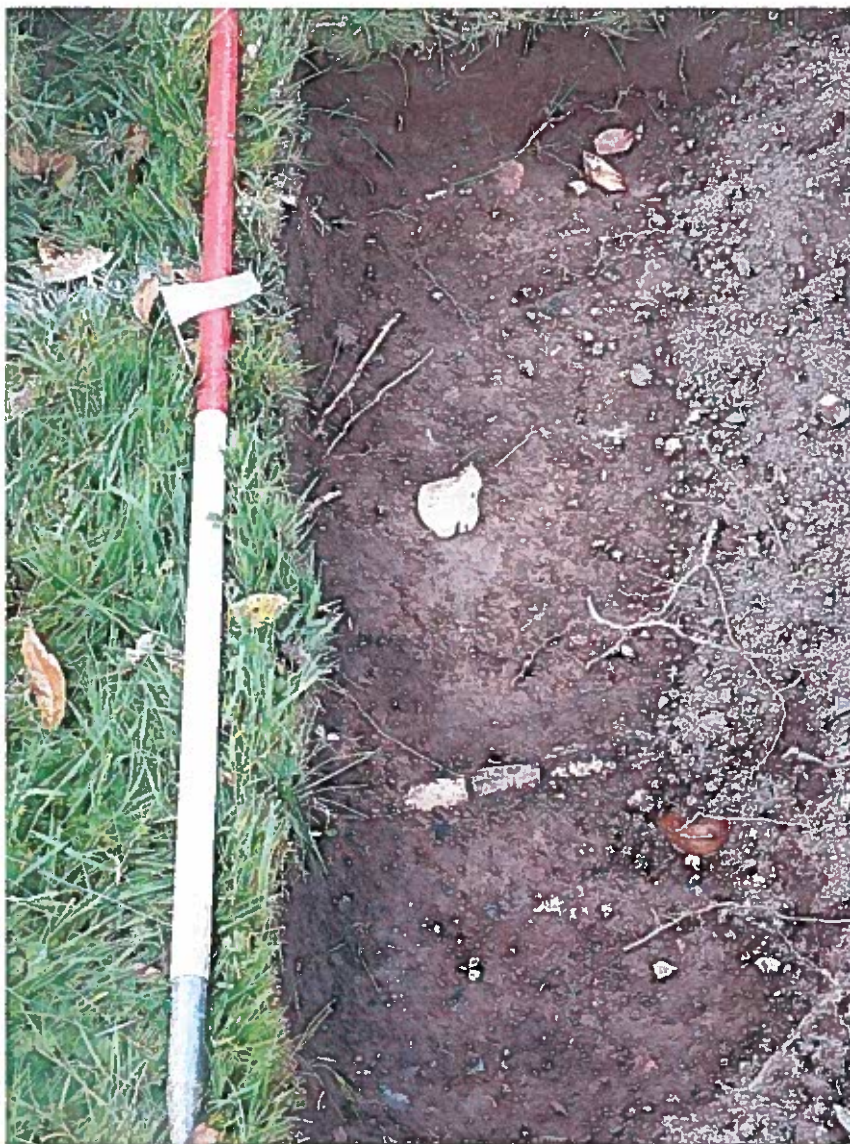
Underlying the topsoil was a deposit of light-brown sandy-clay (layer 201), containing the occasional medium sub-angular stone and fragment of brick (photos 8 & 9).

Cutting through this deposit were the broken remains of a glazed clay drainage pipe (photo 9), running in a roughly NNW-SSE direction along the supposed wall line.

Photo 9: Deposit 201 and remains of the drain within Trench 2. 1m scale.

Trench 2 did not reveal the line of the expected western wall of the kitchen area of the service wing. The presence of a drain may be part of post-demolition drainage works on the site suggesting expected wall remains may still be buried at greater depths. It was suggested that the ground level in this area was originally much lower, as shown by the roofline of the bakehouse visible on a nearby wall, and the ground level had been built up after the demolition of the house. The lack of any walls remains within Trench 2 may be proof of this.
