TWENTIETH CENTURY MILITARY SITES: AIRFIELDS

A THREAT-RELATED ASSESSMENT 2011-2012

RECOMMENDATIONS

DYFED ARCHAEOLOGICAL TRUST
RHIF YR ADRODDIAD / REPORT NO. 2011/48

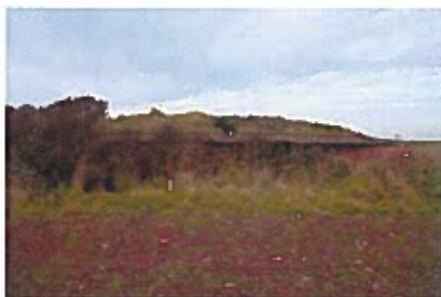
PRN – 101389

Pillbox, located within hedge to the east of Angle airfield. Similar to pillbox located to the NW of the airfield except the roof is modified to carry the turf over the embrasures and continue the hedgeline. (Duplicate PRN 44601). A Pyper 2012.

Semi-sunken, irregular hexagonal plan, integral 'D' shaped Anti-Aircraft Light Machine Gun pit against N wall, fair-faced brick, flat turf covered concrete roof on corrugated steel sheeting. Roof maintains line of hedge to the east. Wide splay embrasures fitted with Turnbull mountings. RJC Thomas description 1994. When visited in 2011 it appeared intact, with turf covering. A Pyper 2012.

The pillbox is a rare survival of a type which was designed in 1940-1 specifically for defending airfields. It is also unusual in that the design has been modified to blend into the hedgebank. A Pyper 2012.

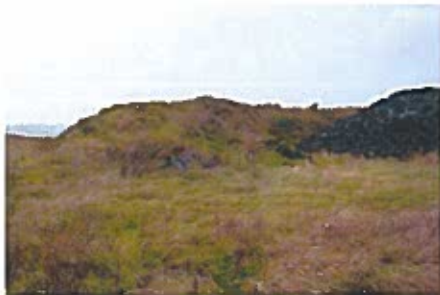
PRN – 101390

E-shaped dispersal pen located to the south side of the perimeter track on Angle Airfield, though central spine is long gone. Built to accommodate 2 fighter aircraft. See description by RJC Thomas in 1993. Visited in 2011 when the concrete hardstanding was in use as a silage clamp. Last remaining dispersal pen on the airfield, originally there were 6, others remain as crop marks or slight depressions. A Pyper 2012.

Duplicate of PRN 44602. Depressed 'V' plan earth banked hardstanding built to shelter 2 fighter aircraft. The central earth bank traverse which divided the pen has been removed. Integral parabolic pre-cast concrete Stanton air raid shelter. Built per A.M.W.D.drawing 16330/41. RJC Thomas 1994.

Threat Details – The hard standing of the pen is currently used as a silage clamp. A Pyper, 2012.

This dispersal pen should be considered for scheduling on the basis of rarity. There are known dispersal pens at RAF Fairwood Common, Swansea, but these are different in form and lower banked. The higher banks at RAF Angle are probably an adaptation to local conditions, and the high winds prevalent on the coast. One of six originally, this is the last surviving in near intact condition, though its long term survival is not assured. A Pyper 2012.

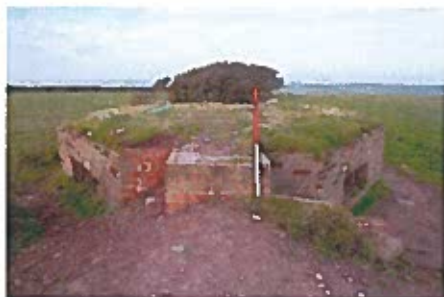
PRN – 101392

A brick and concrete pillbox located to the northwest of Angle airfield, semi sunken within a hedgebank northeast of South Studdock Farm. Similar in construction to PRN 101389 at the eastern side of the airfield. Visited Nov 2011, A Pyper. Semi-sunken, irregular hexagonal plan, integral 'D' shaped AALMG pit against N wall, fair-faced brick, flat turf covered concrete roof on corrugated steel sheeting. Protected entrance in S wall. 4 wide splay stepped embrasures fitted with Turnbull mountings. RT 1993

This pillbox survives in good condition and has group value with the pillbox PRN 101389. A Pyper 2012.

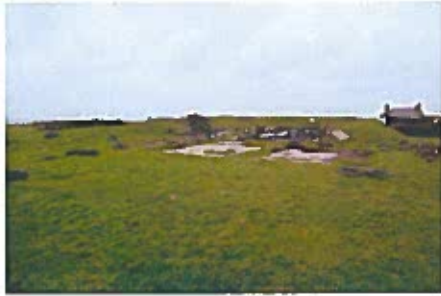
PRN – 102483

Site of former blister hangar, now a U-shaped earthwork bank enclosing a rectangular concrete pad. Visited 2011, A Pyper 2012.

The concrete pad for the blister, its earthwork bank surrounding it and the apron to the front survive. Located in a field for grazing at time of visit in 2011. A Pyper.

Site of former blister hangar which appears to be one of the few remaining earthwork structures of this type. A Pyper 2012.

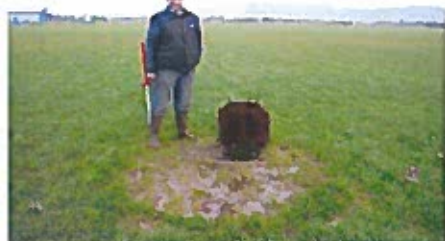
Apparently intact, this Pickett Hamilton fort is one of two surviving examples which have been recorded at Pembrey airfield. This type of pillbox appears to be very rare in Wales. A Pyper 2012.

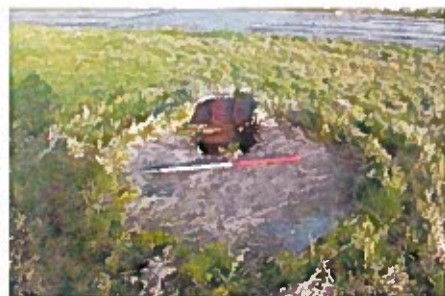
A sunken, circular, concrete pillbox, flush with the ground surface. Concrete top 2m in diameter with metal hinged trap door 0.56m square with canted corners. Located adjacent to the perimeter track at the northern extent of the runways. In 2011 the

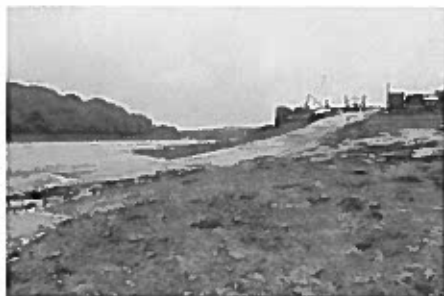
PRN – 26202

A slipway constructed for the establishment of the Royal Naval Air Station at Lawrenny Ferry (PRN 26201), also known as HMS Daedalus II established in 1941. The slipway was built 18ft wide (Fleet Air Arm, Handbook Royal Naval Air stations 1948-1955) and on aerial photographs appears approximately 80m long. It is constructed with concrete slabs. The winch has been dismantled in recent years. Now part of yacht club and still in use for winching boats. Visited in 2011. A Pyper 2012.

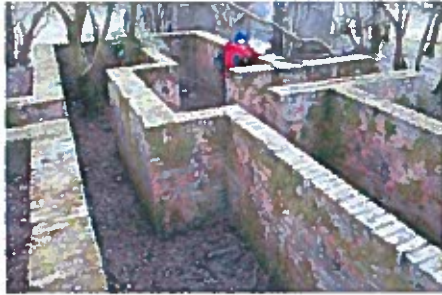
Blast shelter / Air Raid Shelter located to the rear of the technical area at Templeton airfield. Consisting of brick built walls 1.5m high with earth embankments around the exterior. Approximately 9.4 x 9.6m, two entrances one to the west and one to the east. This is a well-preserved example of a blast shelter of which few are known to survive. In 2011 the structure was intact, though young trees are growing within it. A Pyper 2012.

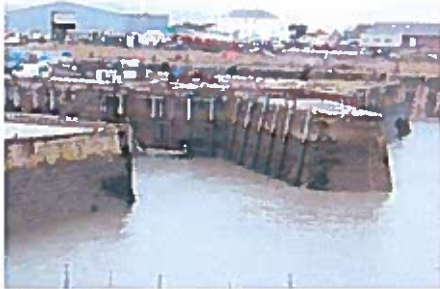
'Mole' or a concrete filled sandbag construction breakwater c1939. RAF launches were moored within. A Pyper 2012.

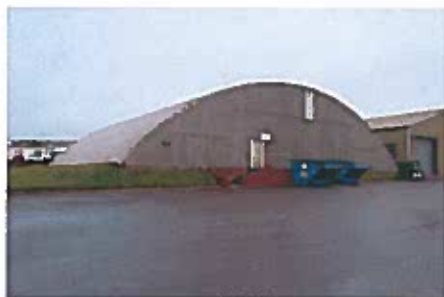
'Free Gunnery Trainer Blister', listed, no 5, on the Air Ministry plan of 1945. This building was used for the training of air to air gunnery, usually using projectors to project the images of attacking aircraft. In 2011 the blister was still intact and still has its number (5) on the front, south, elevation. A Pyper 2012.

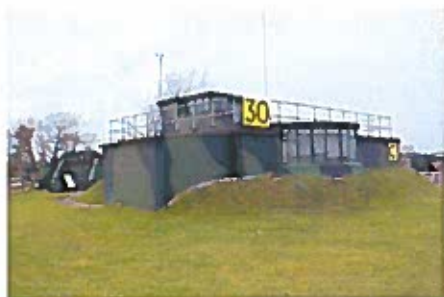
Control Tower at Carew Cheriton airfield. Between 2000 and 2004 local enthusiasts (The Carew Cheriton Control Tower Group) have renovated this uniquely designed, important building and restored it to its original specifications. It is now open to the public every Sunday between 1st July and 30th September and all Bank Holidays except Christmas and New Year, as both a visitor attraction and as an educational experience of WW 2 in the area. Richard Ramsey February 2011.

1938-45, Watch Office/Control Tower, now derelict. A single storey, square, brick built with flat concrete roof. Entrance in north east wall, metal framed bay window in south east wall. Small rectangular controller's post on roof. Stone and earth blast revetment against SW walls. RJC Thomas, 11.01.93.

This control tower has been painstakingly restored, retaining original fixtures and fittings or authentic replacements. It is a unique design.

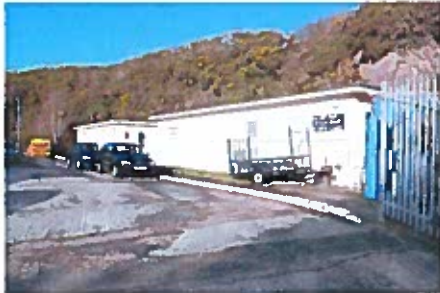
Group of five buildings comprising the pumping station for the RAF Fuel Reserve Depot at Haven's Head. This network of storage tanks and pumping station supplied high octane fuel to the military airfields of Pembrokeshire.

Built in 1936 it continued in use supplying RAF Brawdy until the 1970s. Between the row of three single storey, concrete buildings which lie at the foot of the slope is a shelter, with the pipelines connecting the fuel tanks at the top of the hill. A complex comprising five buildings in total, all constructed in reinforced concrete with smooth concrete render with horizontal rebates and a flat topped roofs.

Complex of five intact buildings; all in use and in good condition. Windows and doors have been modified. A Pyper 2012.

This group of five buildings is thought to be very rare, if not unique survival of a pre-war pumping station to supply fuel to the military aviation sites around Pembrokeshire. The buildings survive intact and in good condition with only minor modifications. As a discreet complex they have group value. A Pyper 2012.

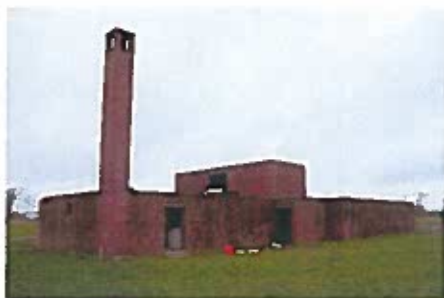
Identified on the Air Ministry plan of 1948 as 'Decontamination Centre. Type H.' This is a large red brick complex designed to take both men and women through gas decontamination rapidly. In 2011 the building appeared remarkably intact with external hand rails and ventilation cowls. A Pyper 2012.

Former Airfield. Large red brick-built decontamination centre survives intact except for its doors. Much of the internal fittings survive, including shower cubicles, toilets and wash basins. Outside the NW end of the building a series of rails still stand, which have guided people into two decontamination suites. The building layout is symmetrical about its long axis. NAP 1996

Threat Details – No longer in use, this building does not appear to be maintained and therefore will only deteriorate through neglect. A Pyper 2012.

This appears to be the only surviving example of a gas decontamination centre in Wales. It survives in almost intact condition with handrails and ventilation cowls. A Pyper 2012.

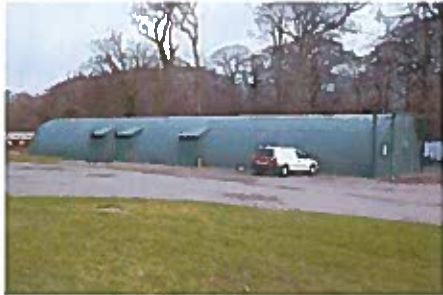
Former maintenance block at Haverfordwest airfield. A Nissen type hut, 24ft wide with curved corrugated iron sheeting. Three side entrances and a sliding double doorway at the south end. Painted green. 'Built per Air Ministry drawing 12784/41.' (RJC Thomas, 22.01.93.)

Part of showground complex of buildings when visited in Nov 2011. A Pyper.

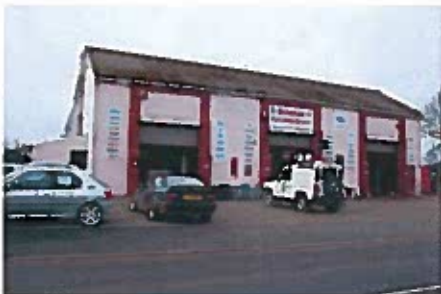
Turret instructional building, Type 'A', with 3 bays. For the instruction of air crew in a simulated gun turret. One and a half storey, rendered 'temporary brick' construction, 1/2--5--1/2 bay rectangular plan, pitched corrugated asbestos gable roof. Built per Air Ministry drawing 11023/40 (RJC Thomas). When visited in Nov 2011 it was in use as a garage workshop. A Pyper 2012.

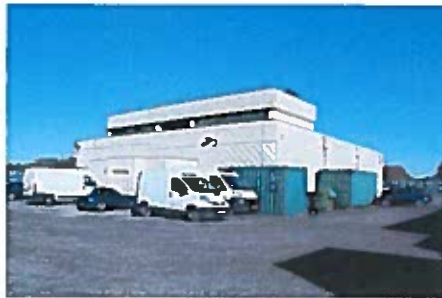
'UNITER' building, this is a 'hardened' building - one designed to resist the effects of conventional high-explosive bombs and nuclear weapons, and to remain functioning post strike. It formed part of a national military microwave communications system

established during the early 1980s with a network of associated steel communication towers acting as relays and hubs (Information from RJC Thomas pers. com). In 2012 the compound was in use as a storage facility and the building itself is a sandwich factory. A Pyper 2012.

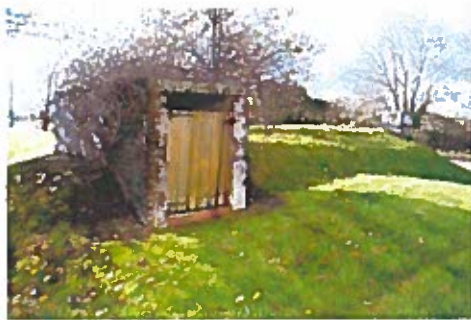
A Stanton semi-sunken concrete air raid shelter with an arched interior, covered externally with turf. The entrance is constructed from brick and concrete at the east end with a concrete 'chimney' escape hatch at the west end. Well preserved. Visited on 26th Oct 2011. A Pyper 2012.

A reinforced formed concrete shelter with an arched interior, covered externally with turf. The entrance is constructed from brick and concrete. PR 2004 based on DS 2004.

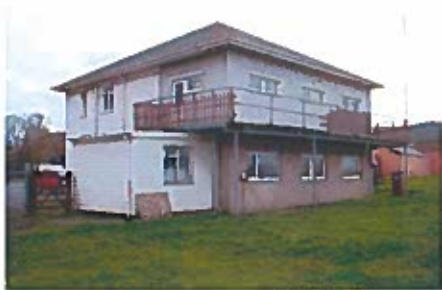
Former control tower for Haverfordwest airfield, numbered as 33 on Air Ministry Plan. "Two storey, brick built, square plan, three bay main elevation with concrete balcony, flat concrete roof, beneath a secondary hipped slate roof" (Roger Thomas). Ground floor windows to west have been lowered. Visited in 2011 when it was still in use as showground office. A. Pyper 2012.

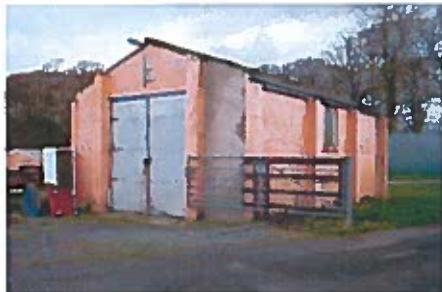
Single storey, though high sided, temporary brick constructed shed of 3 bays and corrugated asbestos roof. Window in side centre bays and a double doorway in the gable end. Identified as number 31 on Air Ministry Drawing - Fire Tender Shed. When visited in Nov 2011 it was in use on Pembrokeshire showground. A Pyper 2012.

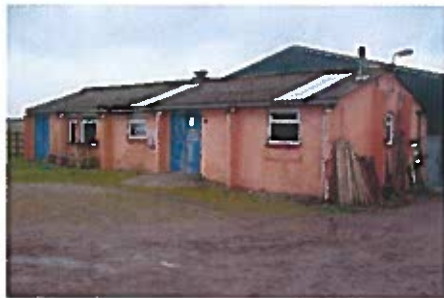
One storey, temporary brick construction of five bays with corrugated asbestos roofing. Windows replaced with UPVC. Now forms part of Pembrokeshire showground. Marked on Air Ministry Drawing as number 30 - Gas Defence Building. Visited in Nov 2011. A Pyper 2012.

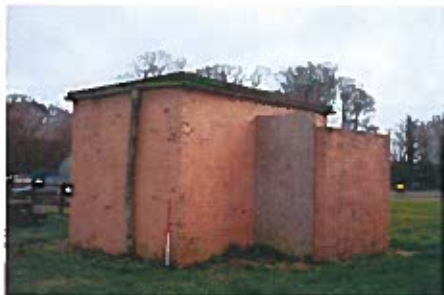
Former 'Speech Broadcasting Building' on Haverfordwest airfield. Brick built with flat roof and a blast wall around the entrance. When visited in Nov 2011 formed part of the showground buildings. A Pyper 2012.

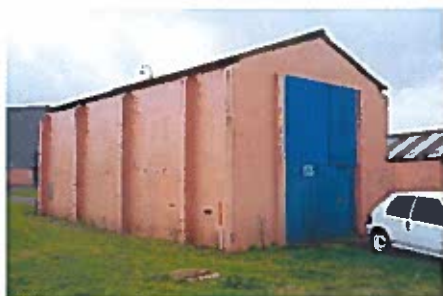
PRN – 28503
NAME – RAF HAVERFORDWEST
TYPE – Shed
CONDITION – Intact
NGR – SM96091868
COMMUNITY – Rudbaxton
COUNTY – Pembrokeshire

Former floodlight trailer and tractor shed at Haverfordwest airfield. One storey, though high sided, 3 and half bay temporary brick and corrugated asbestos shed. Three blocked windows in either side. Double doorway in north and south gable ends. When visited in Nov 2011 forms part of complex of Pembrokeshire showground buildings. A Pyper 2012.

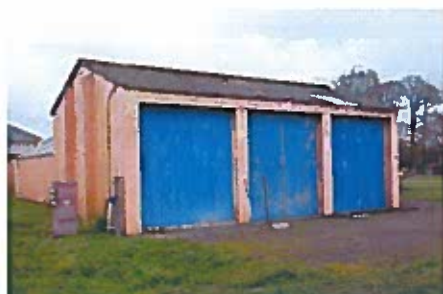
PRN – 28504
NAME – RAF HAVERFORDWEST
TYPE – Storehouse
CONDITION – Intact
NGR – SM96081868
COMMUNITY – Rudbaxton
COUNTY – Pembrokeshire

Former 'Night Flying Equipment' store on Haverfordwest airfield. 'Temporary brick' construction with corrugated asbestos roof. Three bay with large double doorways in the south elevation. Part of Pembrokeshire showground complex when visited in Nov 2011. A Pyper 2012.

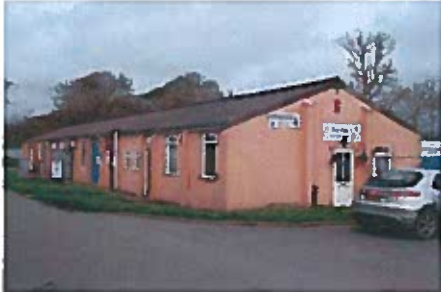
Former armoury, associated with Haverfordwest airfield. See Roger Thomas' description. When visited in Nov 2011 was in small business use. Addition of new door and window inserted into south gable end. A Pyper 2012.

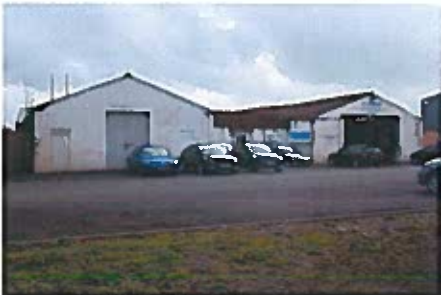
Former 'Main workshops' associated with Haverfordwest airfield. See Roger Thomas's description. When visited in Nov 2011 in use as a garage and workshop. A Pyper 2012.

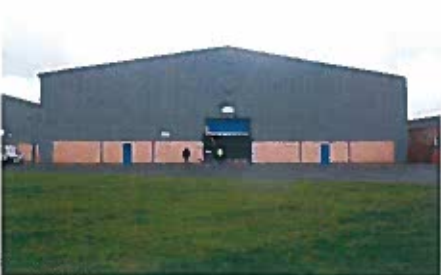
Former Aircraft Hangar, T2 type. When visited in Nov 2011 the hangar was reclad, although the steel framework still intact. In use as go-karting circuit. A Pyper 2012.

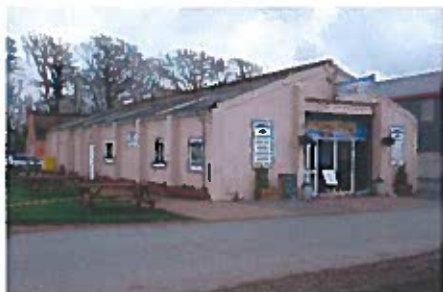
Former 'Towed Target Store' on Haverfordwest airfield. See Roger Thomas's description. When visited in Nov 2011 it was in use as a cafe, with UPVC windows and doorway in west gable end. A. Pyper 2012.

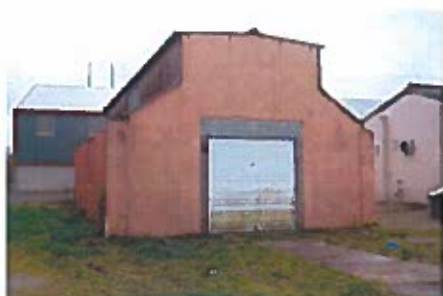
Former 'parachute store' at Haverfordwest airfield. See Roger Thomas's description. When visited in Nov 2011 it had a replacement garage 'up and over' door in the north gable. A Pyper 2012.
