**BRICKYARD LANE, CARMARTHEN,
CARMARTHENSHIRE:
ARCHAEOLOGICAL WATCHING BRIEF
(SN 4041 1872)**

RHIF YR ADRODDIAD / REPORT NO. 2011/56
RHIF Y PROSIECT / PROJECT RECORD NO. 102581

Rhagfyr 2011
December 2011

BRICKYARD LANE, CARMARTHEN, CARMARTHENSHIRE: ARCHAEOLOGICAL WATCHING BRIEF

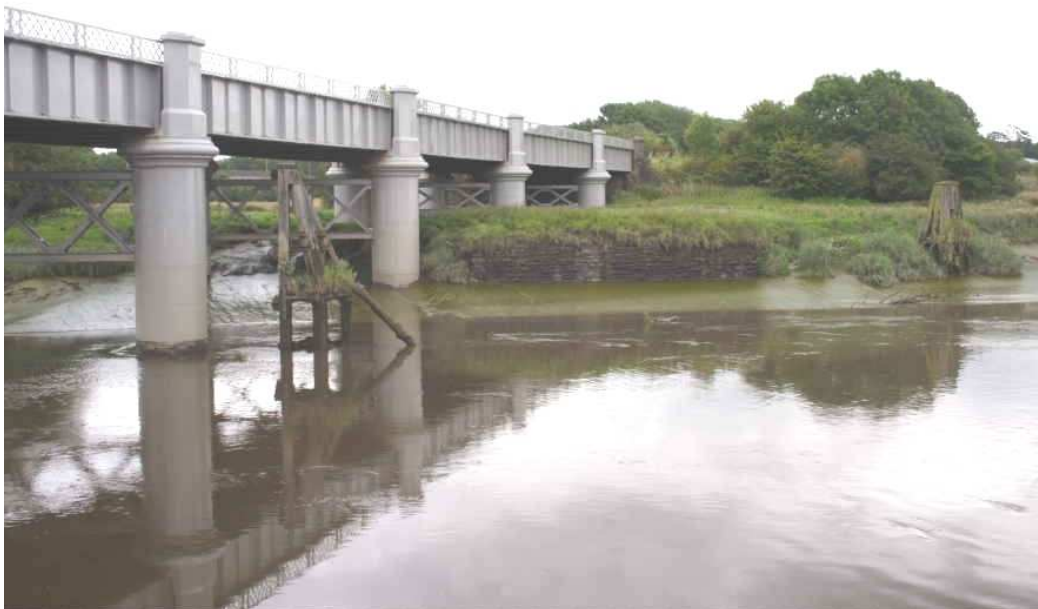
2.2.6 In 1852 the South Wales Railway arrived in Carmarthen and was extended to Haverfordwest by 1854. The railway runs to the north of the development area and originally crossed the River Tywi on a two span hydraulically powered drawbridge, designed by Brunel that could be opened to allow shipping to access the Quay (see photos 1 & 2). Due to it being painted white the bridge became known locally as 'White Bridge', a name which remains in use today for the present bridge. Between 1908 and 1911 Brunel's bridge was replaced by the present rolling bascule bridge (see photos 3-5) and the railway slightly realigned to the north. Two of the three piers of Brunel's bridge survive on each side of the river bank (see photo 6). The present bridge was last opened in the 1950s to allow a private yacht to pass through.

Photo 6: Surviving pier of Brunel's bridge, with Bascule Bridge

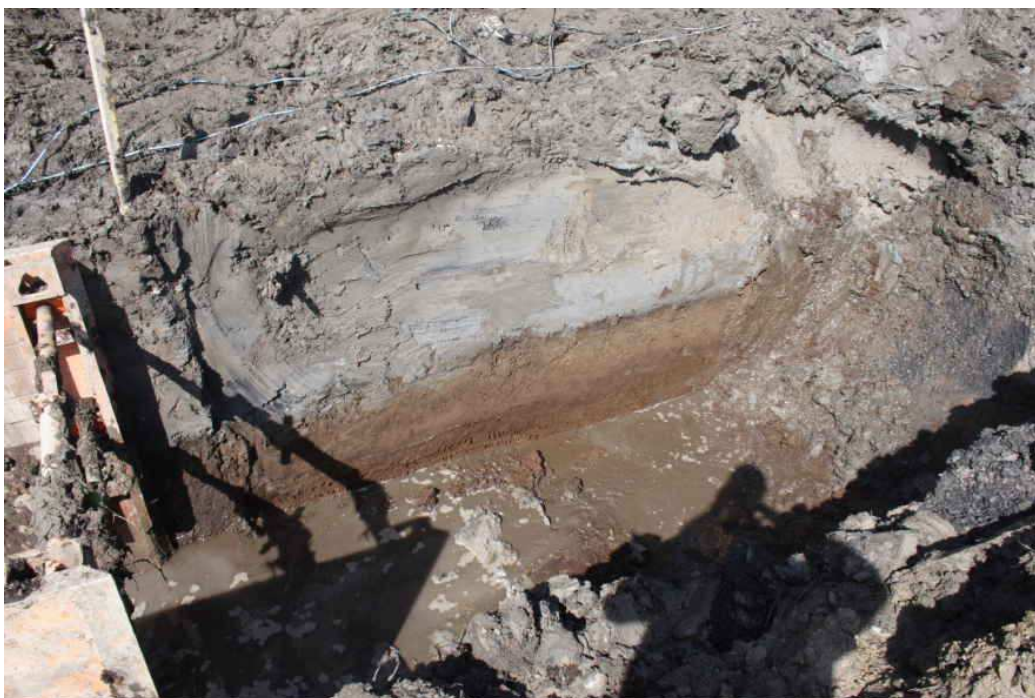
4.2 The excavations were undertaken to a depth of 2.5m. Archaeological monitoring revealed 2.1m thick alluvial deposits (100) overlying an organic rich peat horizon with a visible depth of 0.4m (101) (see photos 7 –8). The depth and unstable nature of the sides of the excavation area meant that it was not possible to access the excavated pipe trench on health and safety grounds and due to water ingress. It was therefore not possible to record further details of the deposits.

Photo 7: East facing representative trench section

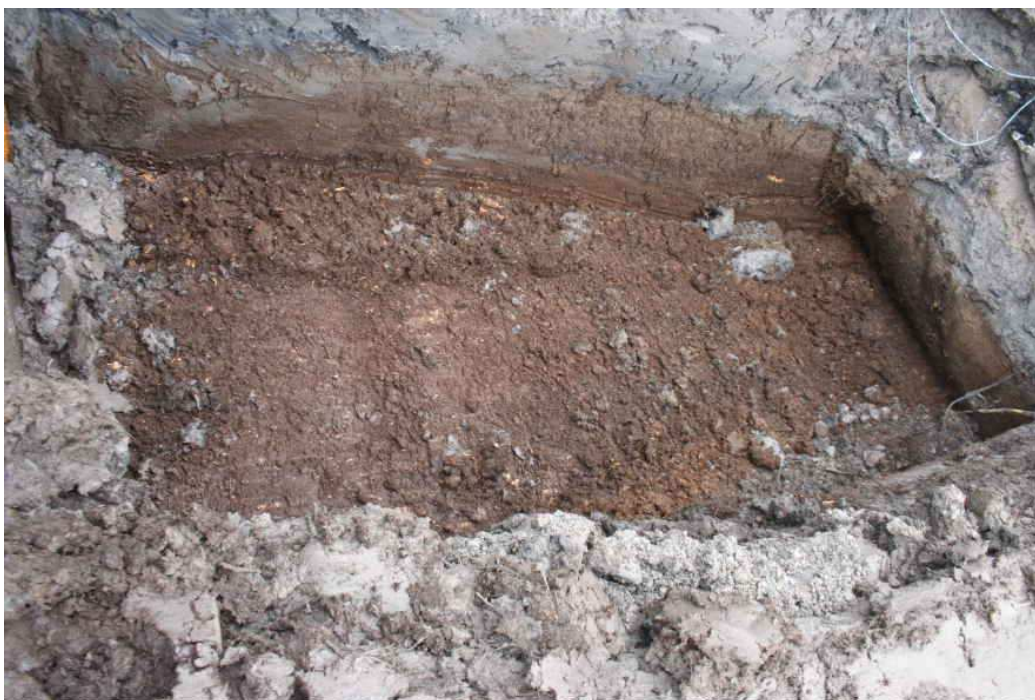
Photo 8: Detail of peat deposit (101)

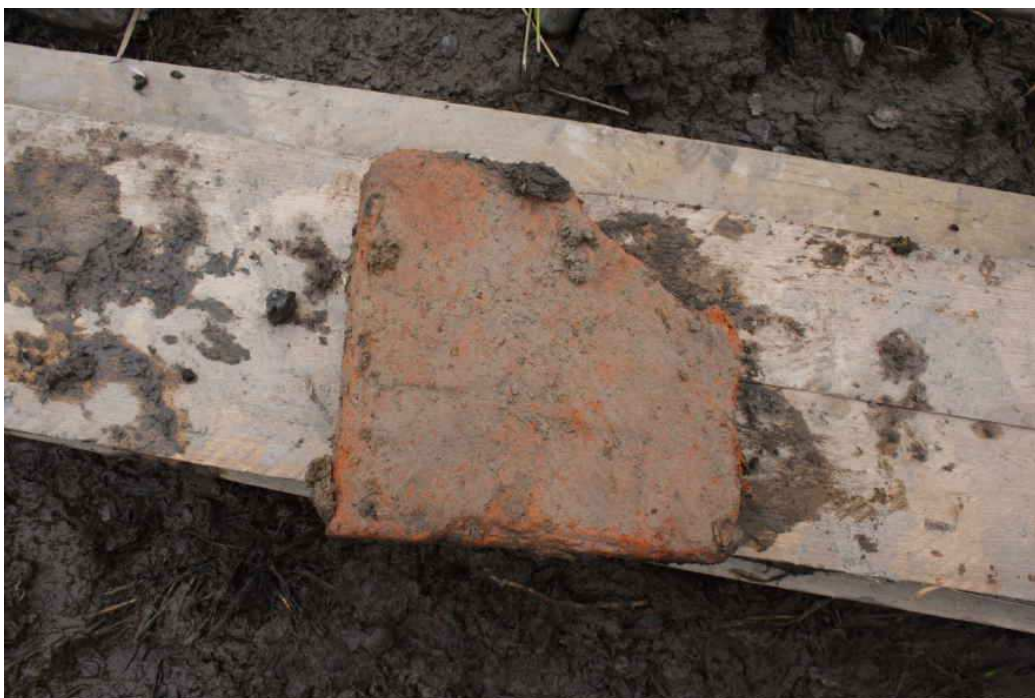
4.4 No archaeological features or deposits were revealed. The same sequence of alluvial deposits and peat were observed. Occasional finds of 18th and 19th century ceramic material including quantities of fragments of handmade red brick and a single terracotta floor tile (see photo 9) were recovered from the upper levels of the alluvial deposits. These probably originate from the demolition of Rhydygors Mansion in 1972.

Photo 9: Terracotta floor tile recovered from (100)

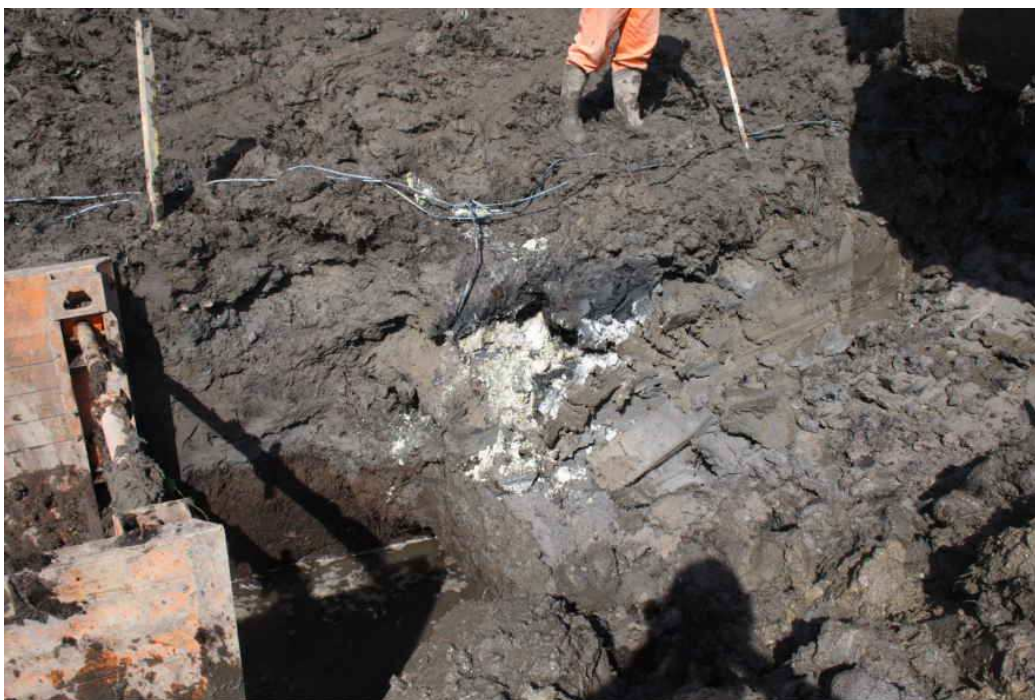
4.5 Also revealed during the course of the excavation works was a large heavily degraded battery connected to electric cabling (see photo 10). This is material likely to have been recently dumped and is of no archaeological interest.

Photo 10: Degraded heavy duty battery and electrical cabling

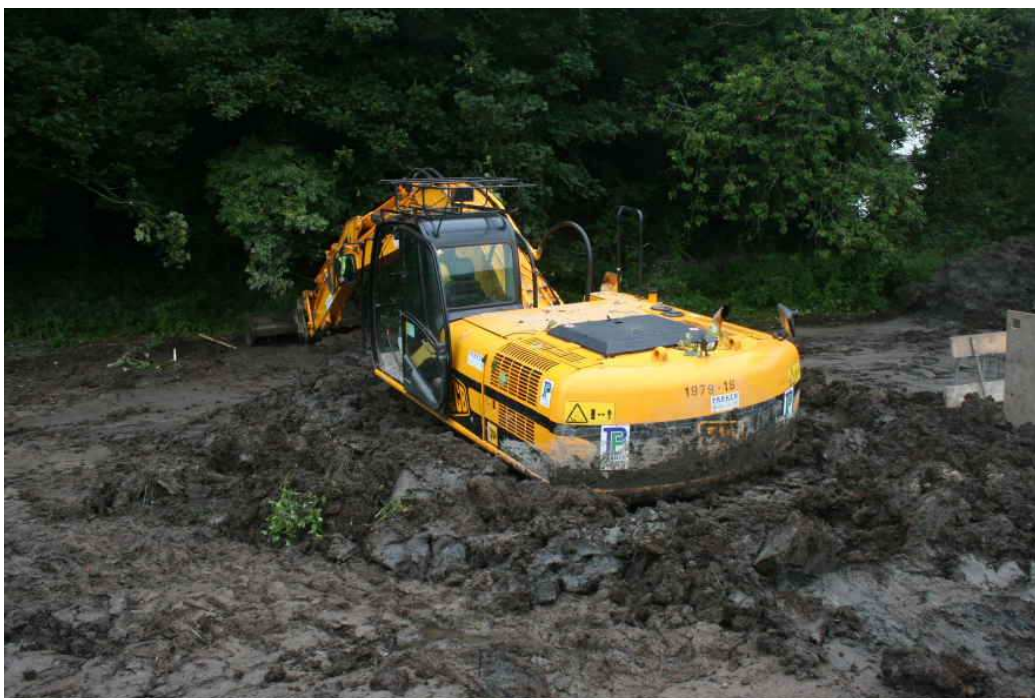
4.6 As work progressed conditions within the excavation area deteriorated with the tracked 360° excavator often sinking into the alluvium over the tops of the tracks to a depth of c. 0.8m – 1m, and having to haul itself out using its bucket. This resulted in it becoming impossible to ascertain the presence or absence of any archaeological remains that may have been present in the upper levels of the alluvium (see photo 11) due to the disturbance.

Photo 11: Tracked excavator releasing itself after sinking
