RICHMOND PARK FOOTBALL GROUND, CARMARTHEN: ARCHAEOLOGICAL EVALUATION

RHIF YR ADRODDIAD / REPORT NO. 2012/15
RHIF Y PROSIECT / PROJECT RECORD NO. 102642

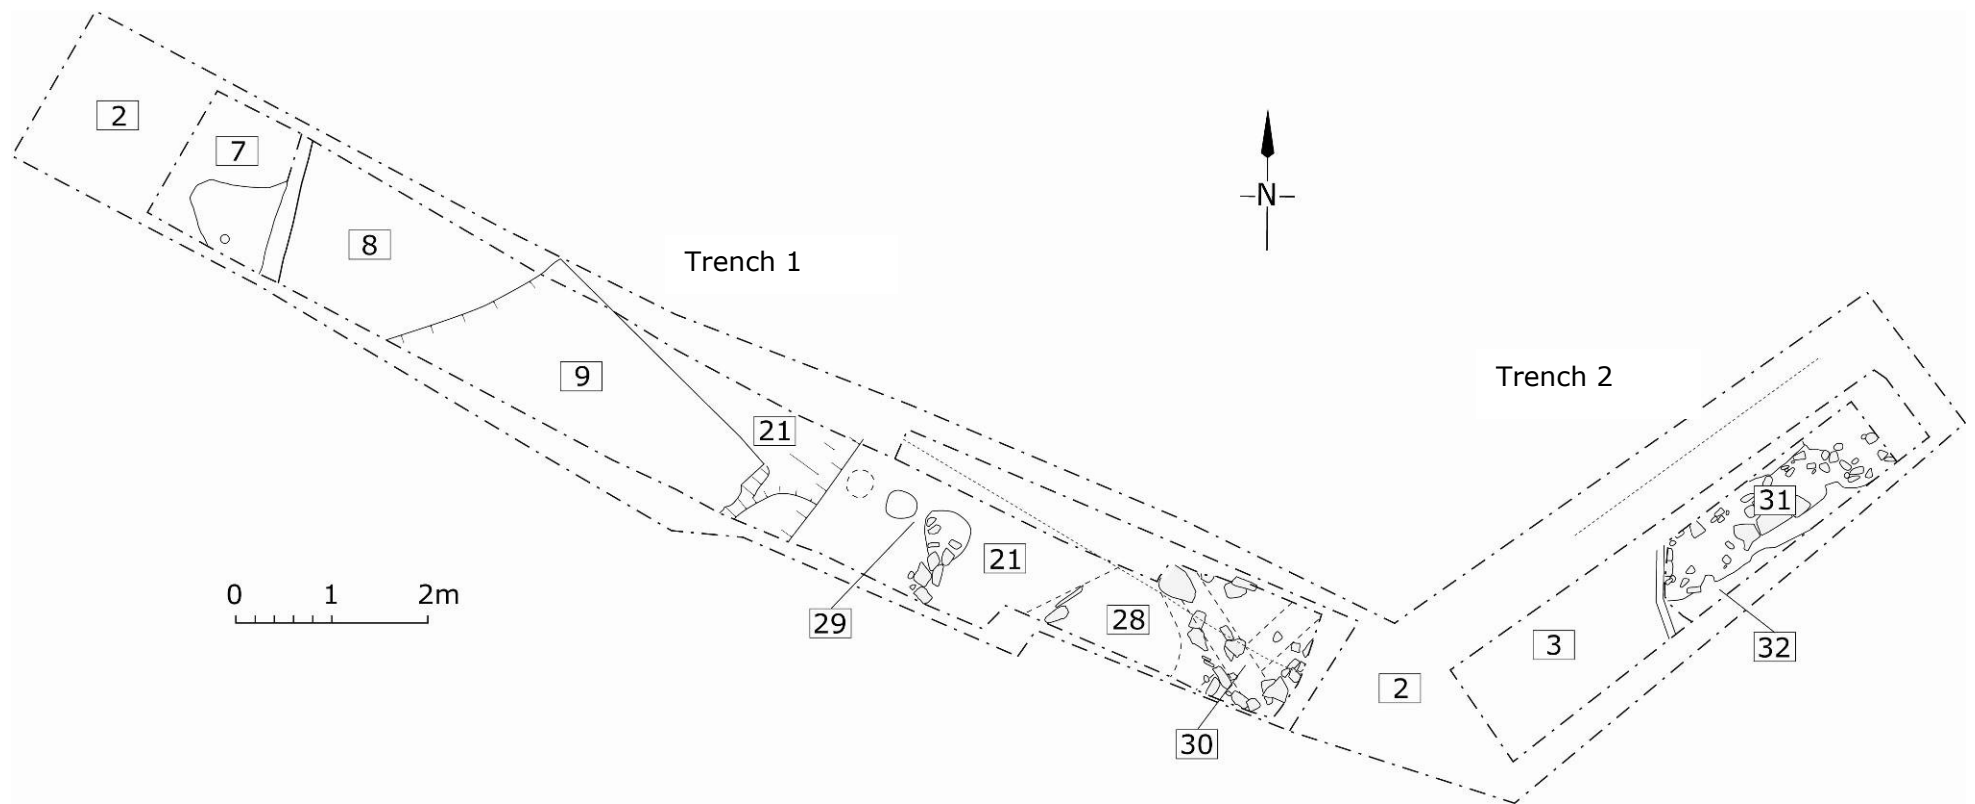
Figure 3: Trench Plan

Although the evaluation was envisaged as a single trench, because of the presence of live water and electricity services, and the presence of large quantities of buried concrete posts, the trench was divided into two areas (see Figure 3).

Trench 1 ran in an approximately east - west alignment. Over the majority of the trench it appears that there have been several episodes of modern excavation, rubbish disposal and ground level raising (contexts 1, 2, 3, 4, 5, 6, 7, 9, 13 and 22). Much of this material contains very recent debris including metal, plastic and wood (see Photos 2-8).

The Roman deposits and features revealed in the base of the trench (contexts 15, 16, 17, 18, 19, 20, 21, 28, 29 and 30) appear to represent parts of several buildings, consisting of post holes and beam slots or drainage gullies (see Photos 1 and 4). Due to the limited areas exposed of the Roman remains, it is difficult to interpret the features with any certainty. On balance, it is possible that the Roman deposits in Trench 1 represent the interior of a building or buildings.

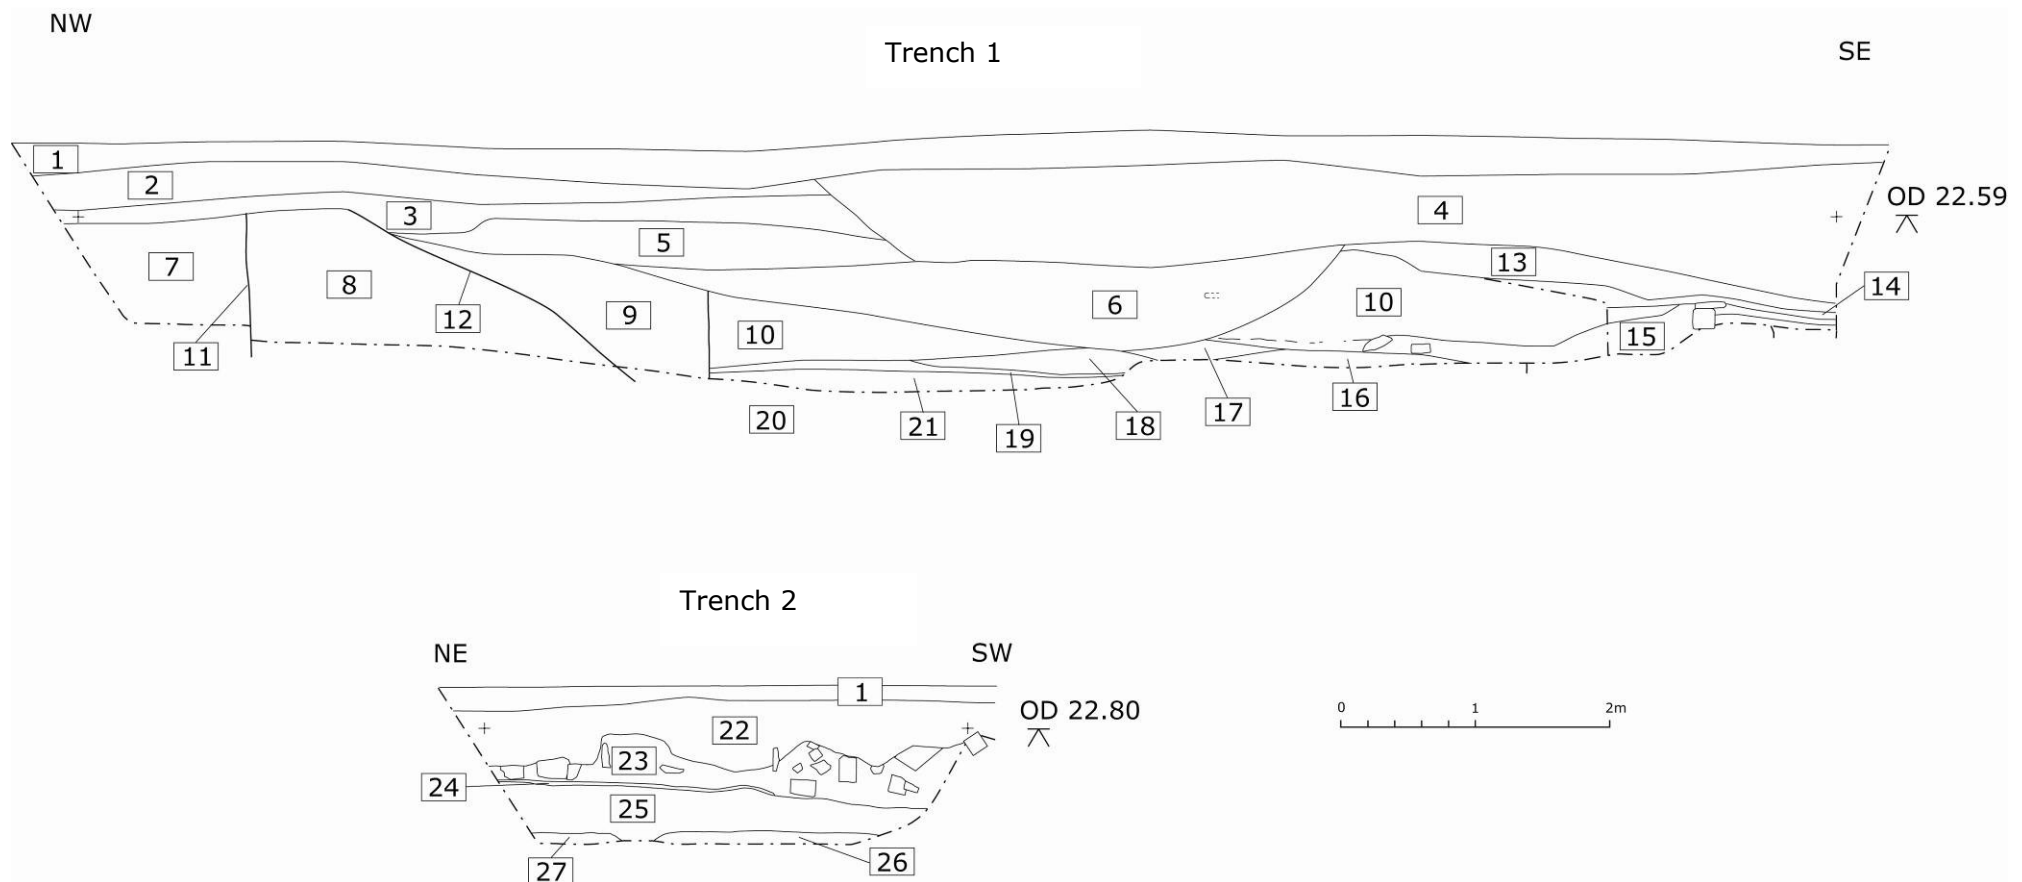
Figure 4: Trench sections

Because of the complicated sequence of later cuts and dumps of modern date, the deposits revealed in the sides of the trenches (sections) do not necessarily represent the sequence of deposits across the whole of the proposed development area.

Context	Period	Trench 1
1	Modern	Chippings, scalpings and hardcore surface
2	Modern	Very dark grey mixed layer with grit, gravel and other debris
3	Modern	Layer similar to 2 but more compact
4	Modern	Redeposited beige clay with modern metal, wood and plastics
5	Modern	Grey brown clay silt with grit, stones and brick fragments
6	Modern	Pipe trench fill. Loose, dark grey soil with modern debris.
7	Modern	Pit fill loose dark grey soil with wood, concrete and plastics
8	19/20 th C?	Homogenous 'garden soil with, gravel, stone, oyster shell and white glazed ceramics
9	Modern	Pit fill similar to 7
10	19/20 th C?	Similar 'garden soil' deposit to 8
11	Modern	Pit cut
12	Modern	Pit cut
13	Modern	Dark grey silty clay with occ. Brick fragments. Similar to 5
14		19/20 th C? deposit of stone, slate and white glazed ceramics
15	Roman?	Mixed sized river gravels, grit and silt. Disturbed surface?
16	Roman	Mid beige clay with crushed tile/brick, shale and occ. stones

17	Roman	Mid grey brown clay silt no inclusions
18	Roman	Similar to 17 but with brick/tile frags/burnt clay
19	Roman	Mottled deposit of mixed burnt and not burnt clay.
20	Roman	Mid grey brown silty clay with occasional pebbles
21	Roman	Pale yellow silty clay. Relatively clean but probably not natural
28	Roman	Charcoal deposit. Hearth?/pit fill?
29	Roman	Group of post holes some with stone packing. Represents part of a building?
30	Roman	Group of linear features some with stone packing. Represents part of a building?
Context	Period	Trench 2
22	Modern	Very dark brown silt with coal, mortar and plastics
23	Modern	Very sandy light brown mortar rich soil with mortar and concrete fragments, modern brick and wood
24	19/20 th C?	Thin layer of very dark brown clay silt. Fibrous matter and pea grit. Surface/buried turf?
25	19/20 th C?	Dark brown clay silt, coal frags, mortar, small stones. Garden soil?
26	Roman?	Brown silty clay virtually no grit. Occ stone and mortar lumps.

27	Roman?	Light brown silty clay, no stones, mortar lump.
31	Roman	Exterior cobbled surface set in brown clay, patched with sandstone slabs and overlain by mortar fragments
32	Roman	Possible beam slot or other linear feature

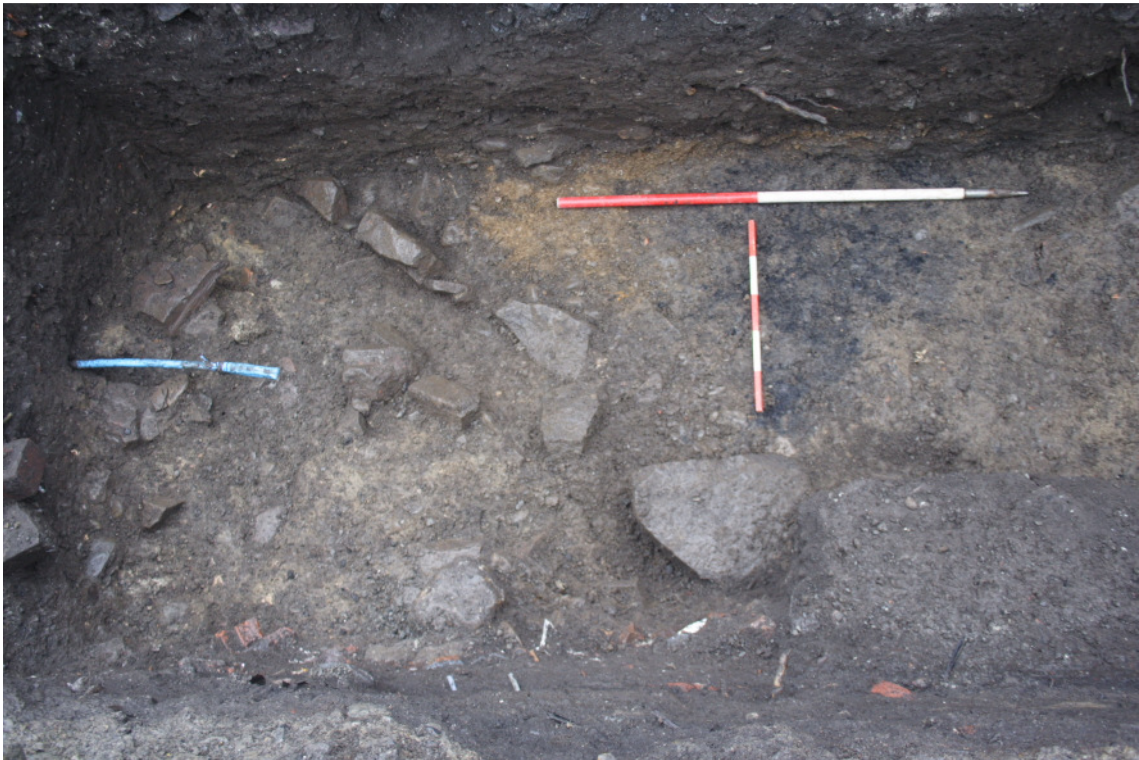
Photo 1: Trench 1. East end, looking south showing roman building remains

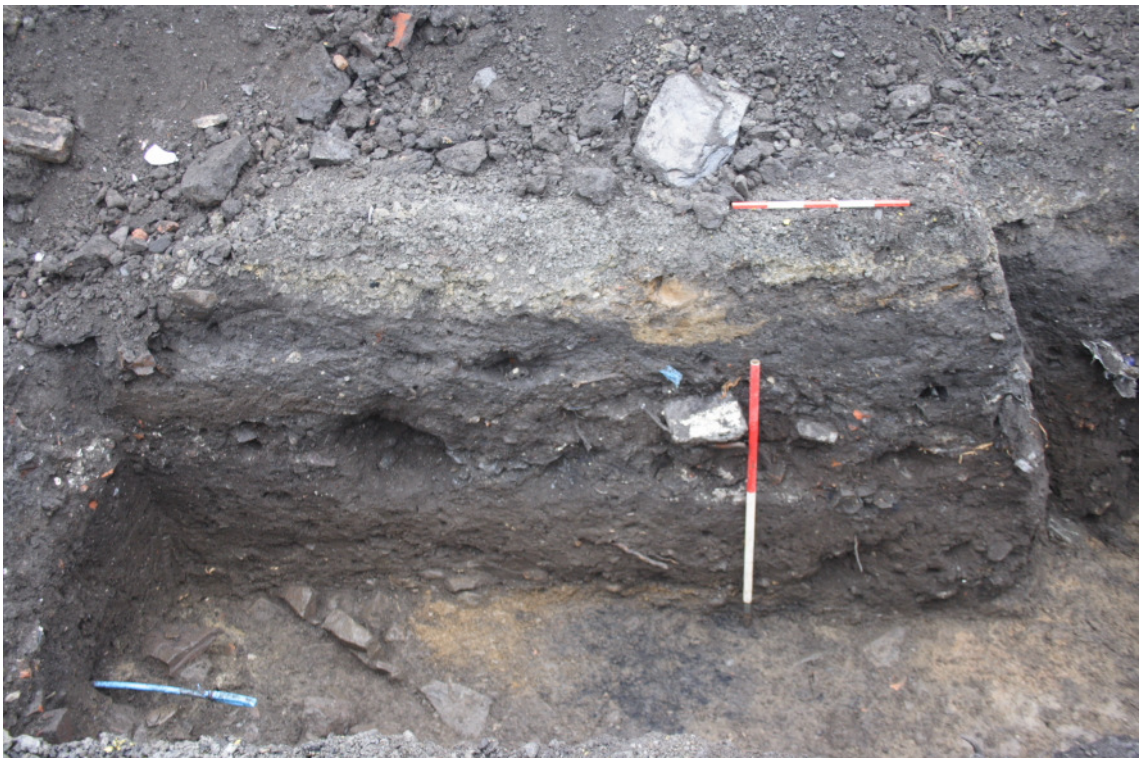
Photo 2: Trench 1. East end, trench section looking south

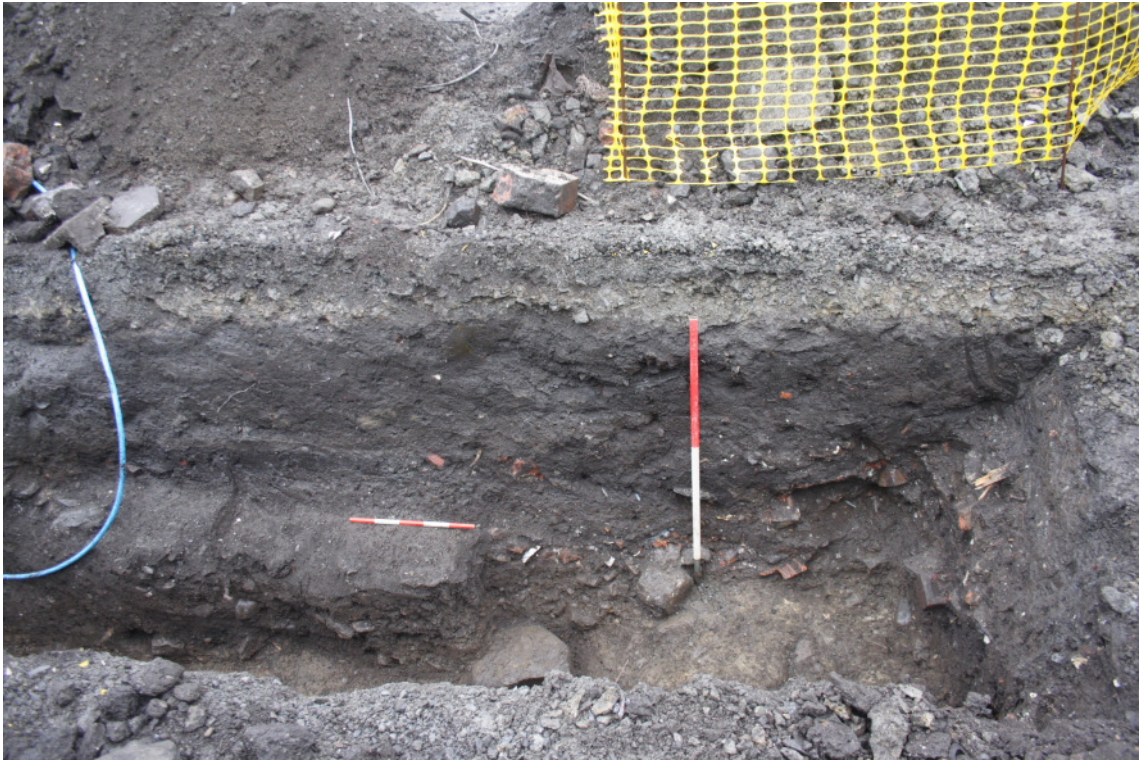
Photo 3: Trench 1. East end, trench section looking north

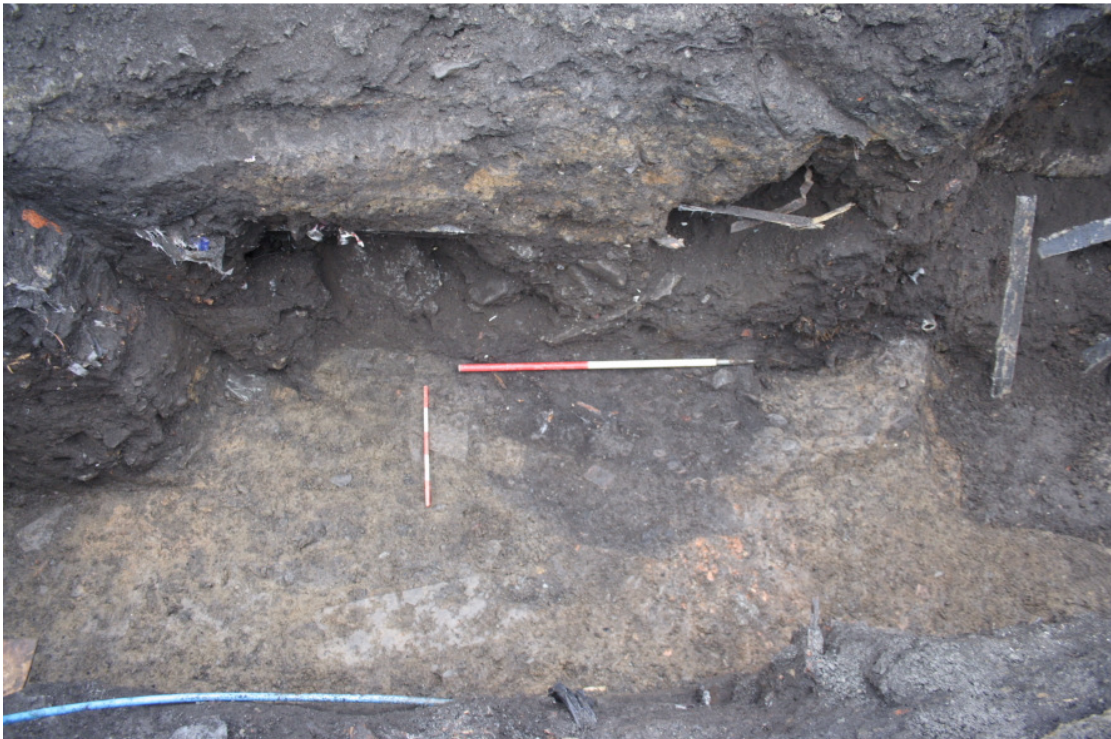
The recently deposited material contains quantities of concrete, metal rods and decomposing wood (see photos 4-8). These deposits are very loose and contain many voids. This is unsuitable material over which to build a raft foundation, and as a result the modern material will have to be removed and replaced with a more compact material.

Photo 4: Trench 1. Mid way, looking south, showing modern overburden directly above Roman deposits

In areas where the dark earth has been partly or totally removed, levels will need to be raised with imported material to provide a sufficient depth of 'cushioning' material to protect the Roman deposits.

From the evidence recorded within the trial trenches, it seems reasonable that up to 0.80m of overburden could be removed from the entire footprint of the building without revealing or damaging Roman deposits. This would leave a minimum of 0.40m of dark earth and other layers above the Roman deposits. This approximate level is indicated with a dotted horizontal line on Figure 5. Below this level, where deposits of loose material need to be removed, the resulting voids are likely to expose Roman period archaeology in the cut edges, and possibly even in plan, in the likely event that the depth of Roman deposits is substantial. Where this occurs, following archaeological recording, the voids will need to be backfilled up to the general foundation base level with imported materials.

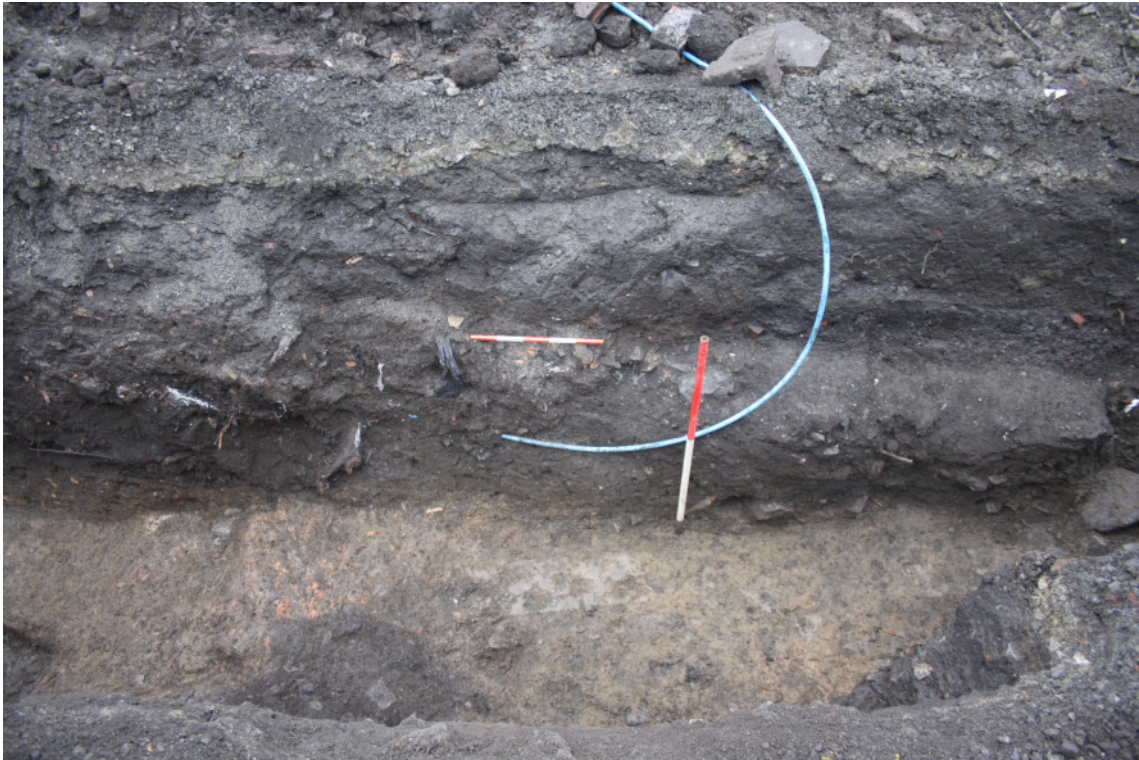
A modern blue plastic water pipe serving the nearby temporary toilets runs through the eastern half of the trench at between 1.20m and 1.30m below the present ground surface.

Photo 5: Trench 1. Mid way, looking north, showing modern fill of pipe trench directly above Roman deposits

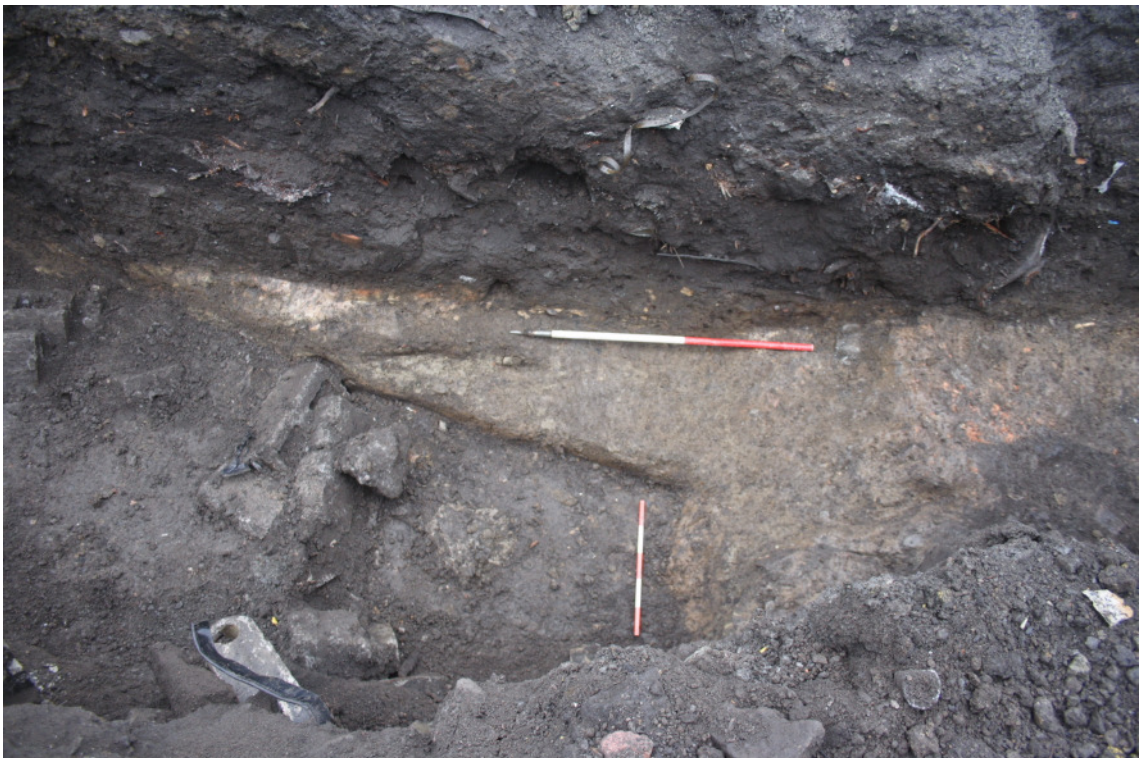
At the western end, and in the middle of the trench two modern rubbish pits (Cuts 11 and 12) have cut through the dark soil deposit and the underlying Roman deposits (see Photos 6, 7 and 8). As a result, in situ Roman deposits were only encountered in the eastern half of the trench at a depth of 1.3m below the present ground surface (see Photos 1-7). It was not possible to ascertain the dimensions or extent of either of these large and deep pits within the excavated area. A number of modern concrete posts were present in the fill of the larger feature (cut 12) (see Photos 6, 7 and 8).

Photo 6: Trench 1. Mid way, looking north, showing fill of modern rubbish pit cut into Roman deposits

In areas where modern cuts have cut into or through the Roman deposits, the modern pit fills will need to be removed and replaced with a sufficient depth of suitable materials to provide a sufficient depth of 'cushioning' material to protect the Roman deposits.

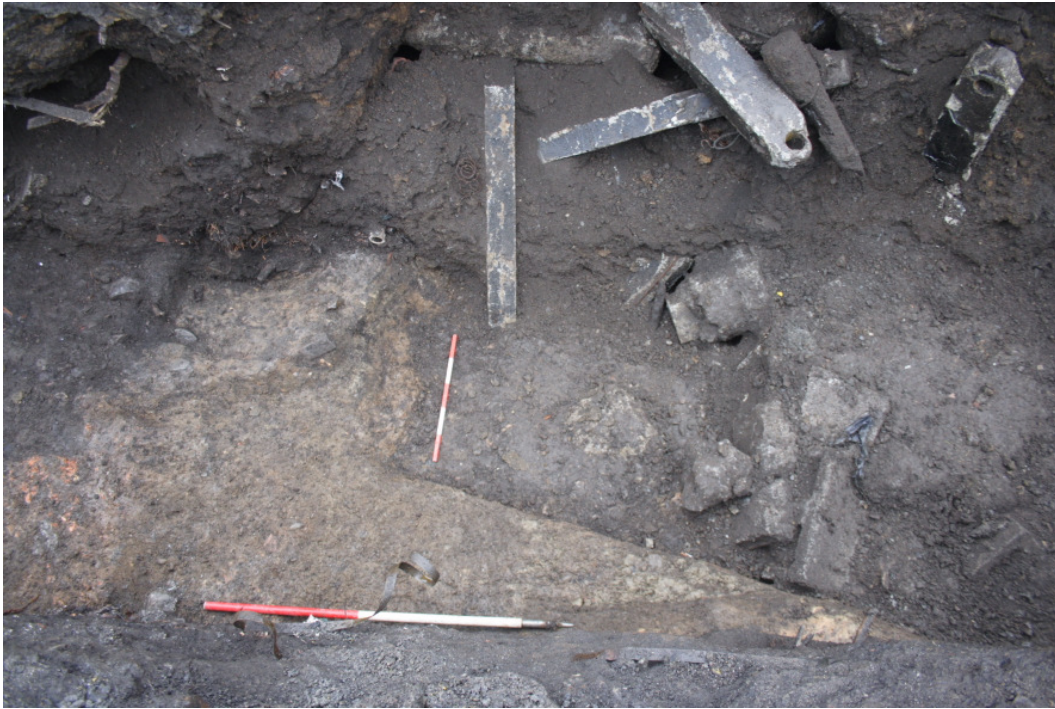
Photo 7: Trench 1. Mid way, looking north, showing fill of modern rubbish pit cut into Roman deposits

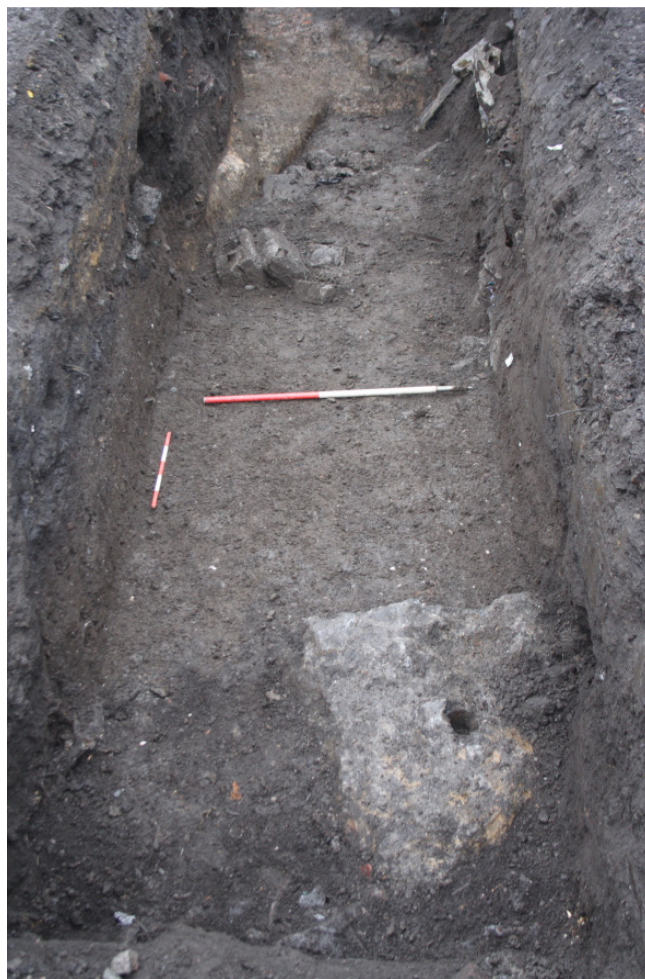
Beneath these modern dump deposits an older deposit of dark grey homogenous material (contexts 8 and 10) was revealed (see Photo 8). Apart from where it was truncated by modern features (Photo 8), this deposit covered much of the area of the trench and sealed what have been interpreted as Roman deposits. Similar deposits are found in many urban environments sealing Roman layers. Where these can be shown to be pre-medieval these deposits are traditionally referred to as 'dark earth'. The dark soil at this site contains 19th or 20th century ceramics and is probably the result of a build-up of domestic refuse, gardening and agriculture which has probably developed over a considerable time.

Photo 8: Trench 1. West end, looking east, showing fill of modern rubbish pit cut into Roman deposits (foreground), with dark earth (beneath scales)

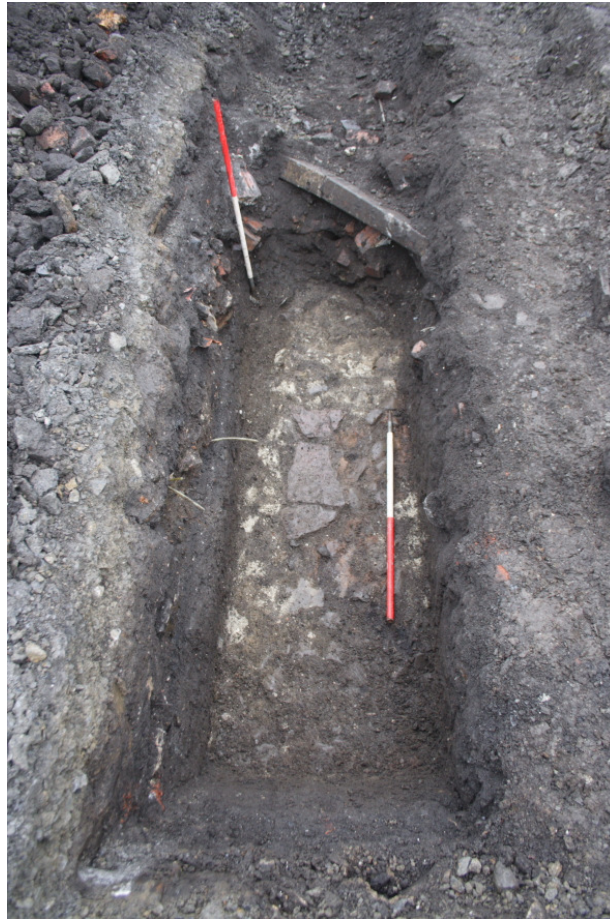
In Trench 2 there was a depth of modern overburden (contexts 2 and 23) from 0.60m to 0.90m thick. Directly beneath the overburden was a thin mortar deposit (24) and a layer of possible 'garden soil' (25) between 0.40m and 0.20m thick. Deposits 26 and 27 appear to be occupation or demolition debris overlying a cobbled yard surface (31), all of which are considered to be of Roman date. Against the southern edge of the trench, part of what could be a beam slot wall

foundation was exposed (31), again probably indicating a Roman structure (see Photos 9 and 10).

Photo 9: Trench 2 looking southwest showing Roman yard surface

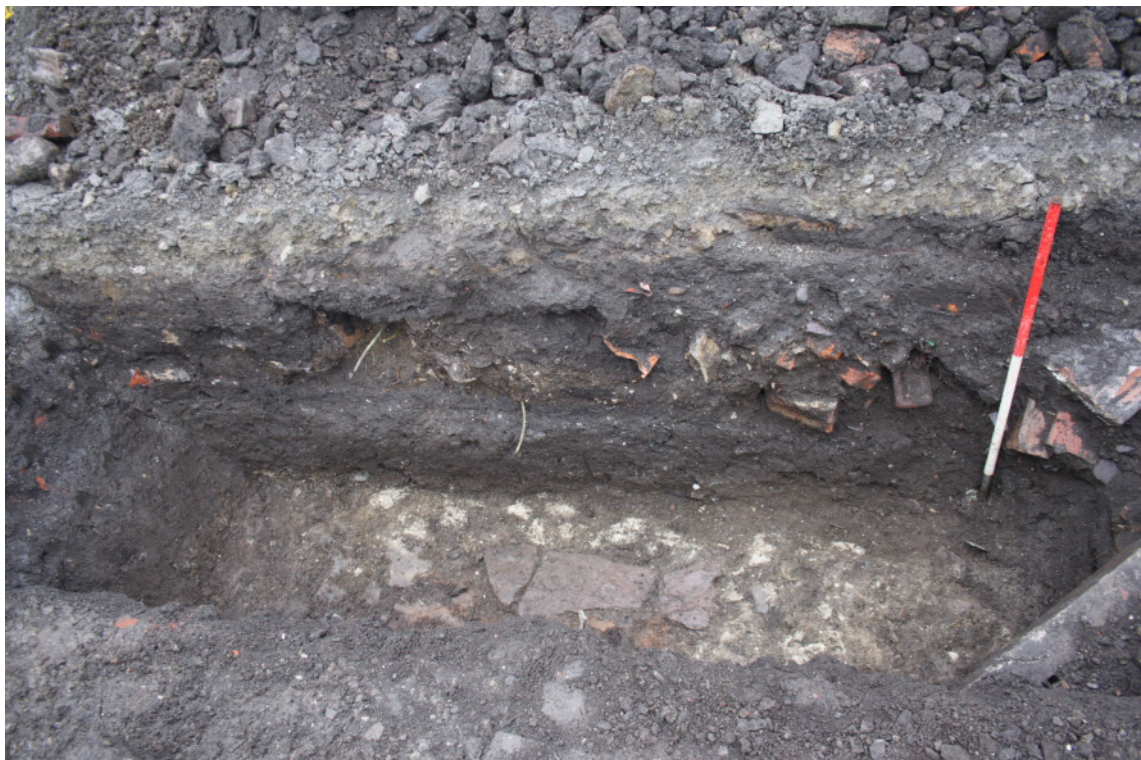
Photo 10: Trench 2 looking southeast
