# **131 PRIORY STREET, CARMARTHEN: ARCHAEOLOGICAL EVALUATION**

**FEBRUARY 2012**

Prepared by: Dyfed Archaeological Trust  
For: Harold Metcalfe Partnership

RHIF YR ADRODDIAD / REPORT NO. 2012/16  
RHIF Y PROSIECT / PROJECT RECORD NO. 102643

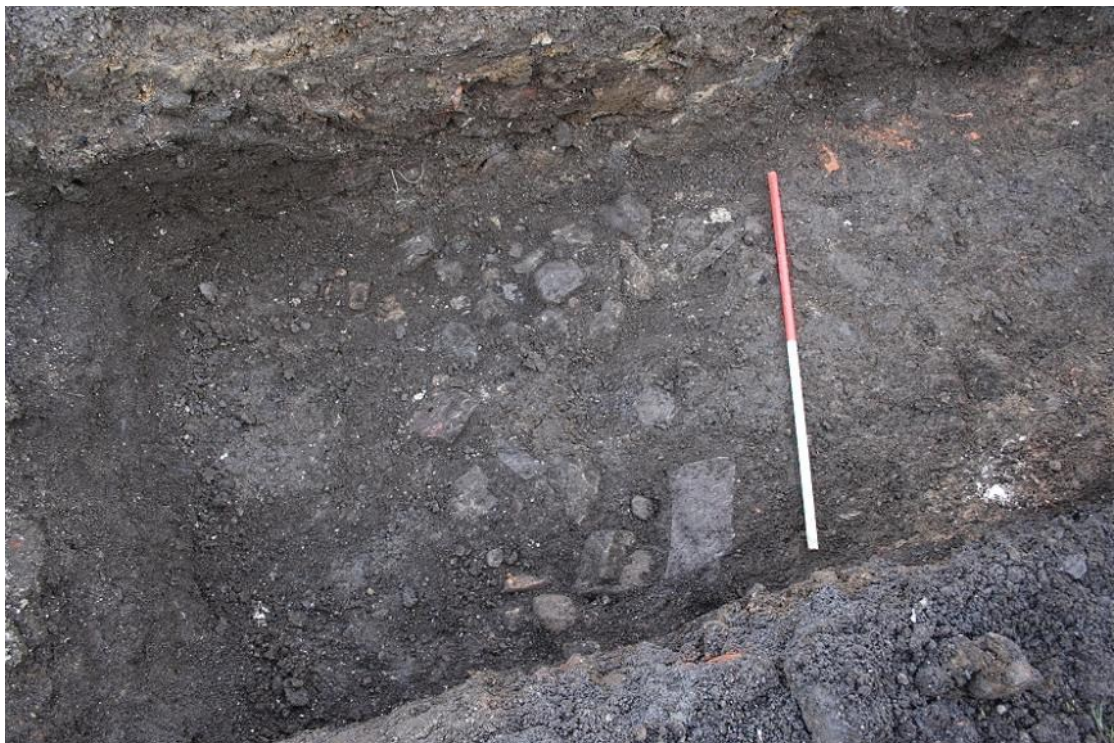
**Photo 6:** Stony-filled linear feature 121 within Trench 1, viewed from the west.  
1m scale.

- 4.1.4 At the northwestern end of the trench layer 111 appeared to overlay a deposit of large sub-angular and sub-rounded stones and boulders (120) that appeared to sit within a linear cut (121), aligned roughly WSW-ENE. One section revealed this linear feature to be cut from relatively high in the sequence, although this was not apparent in the recorded section, suggesting layer 111 may thin to the northeast. 19<sup>th</sup> century pottery was also recovered from the stony infill (120).

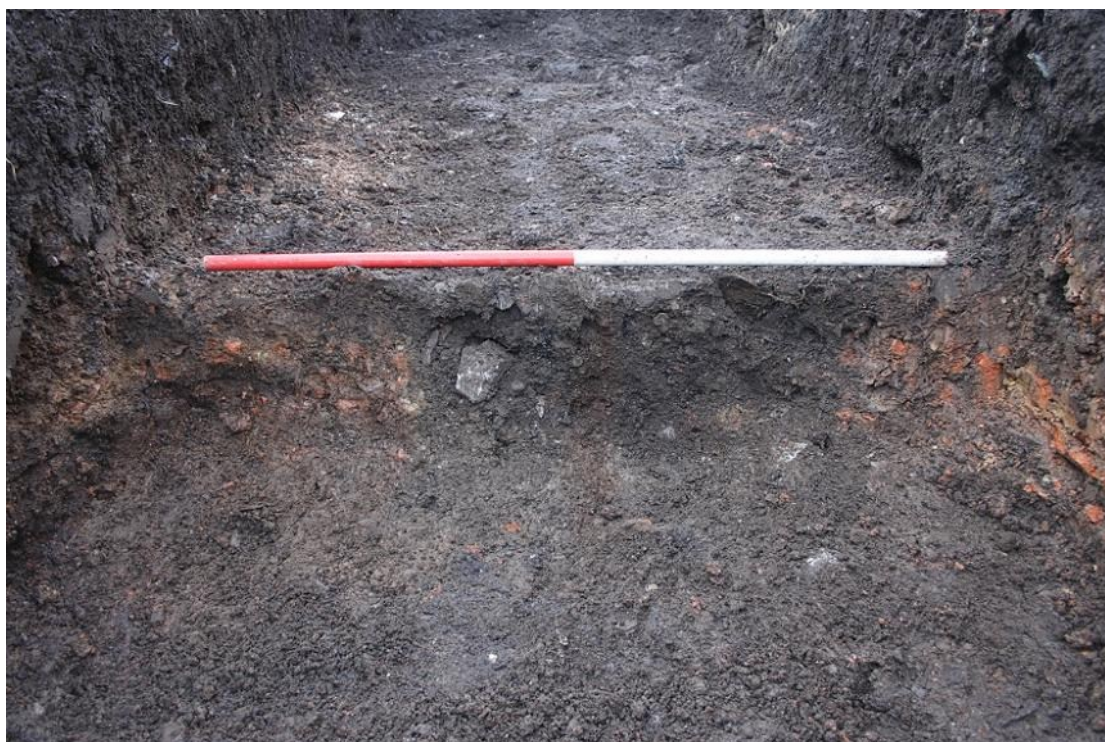
**Photo 7:** Feature 123 within Trench 1, cutting through Roman layers 116/119. 1m scale.

- 4.1.5 A linear feature (123) was also recorded aligned northwest – southeast, infilled with a silty-clay loam contained late post-medieval pottery.

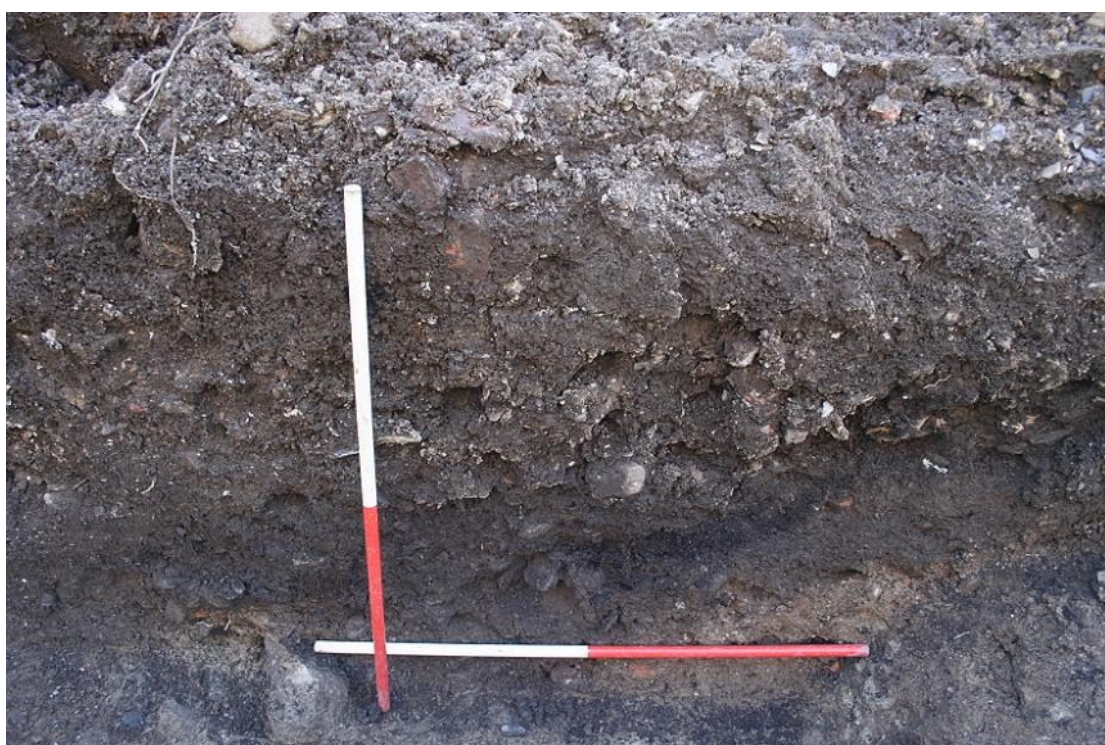
**Photo 8:** Part of the section of Trench 1, lighter yellowy-brown probable Roman deposits (107) visible at the base, overlaid by soils (106 & 105) and a thick deposit of modern topsoil (100). 1m scales.

Context 106 was a series of layers of silty-clay loams appeared consistently within all the trenches, underlying modern layers but overlying presumed Roman activity. 106 was a mid-brown deposit, 0.24m thick, which appeared to drop down towards the south-eastern end of the trench, possibly partly infilling a cut into presumed Roman deposits below. This deposit contained fragments of possible Roman ceramic building material, charcoal flecks and animal bone mixed in throughout. It was sometimes indistinguishable from the overlying late post-medieval loam (111)

- 4.1.7 There was a small charcoal-rich deposit (105), 0.43m wide and 0.06m thick, partially overlying it.

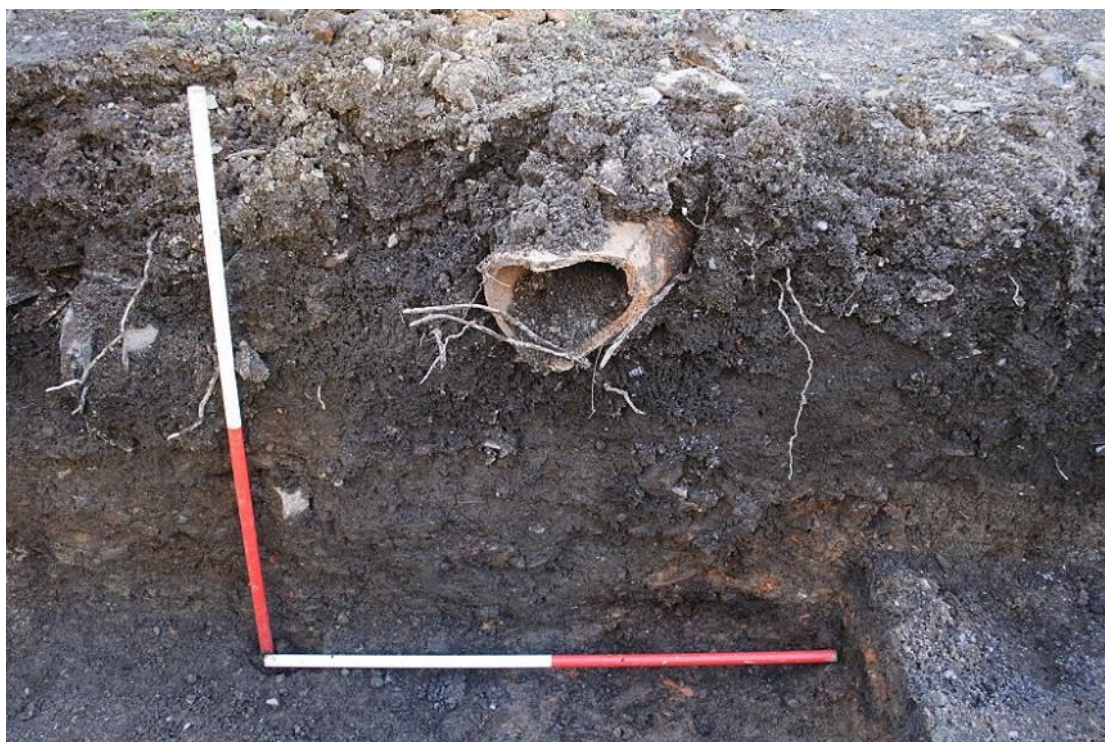
**Photo 9:** Part of the section in Trench 1, showing the ceramic drainage pipe (110) with lighter mottled Roman deposits visible towards the base of the section. 1m scales.

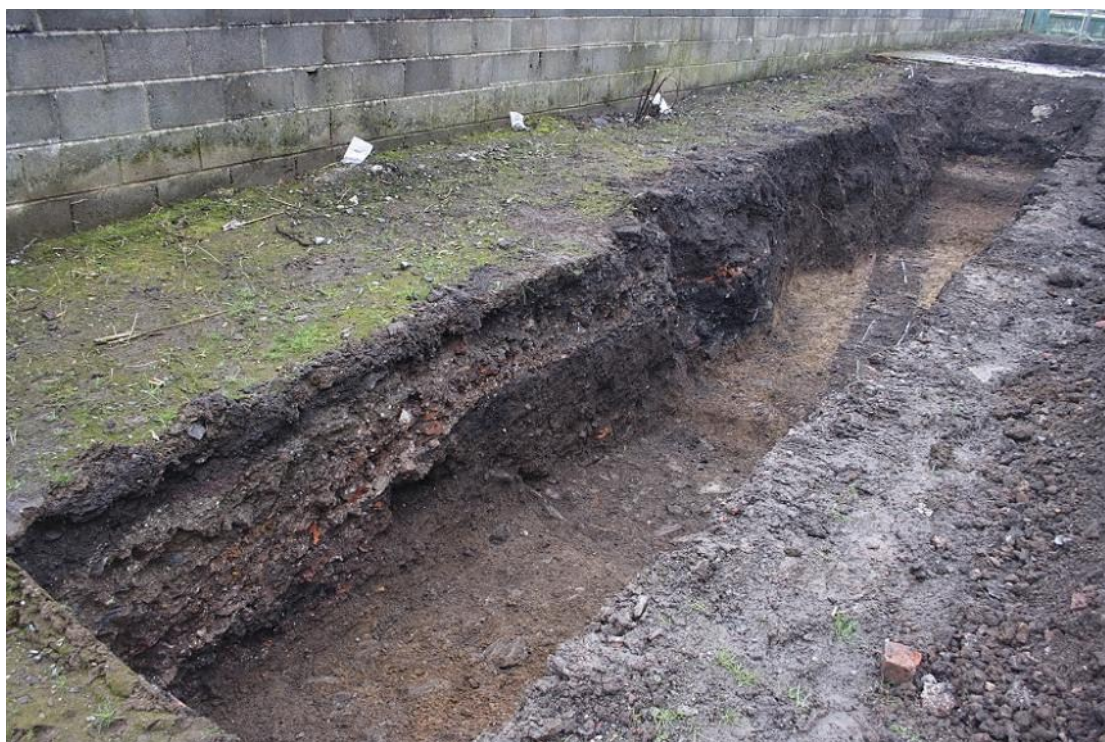
**Photo 12:** Section of Trench 2, viewed from the east. The thicker deposit of modern building rubble at the south-western end is clearly visible.

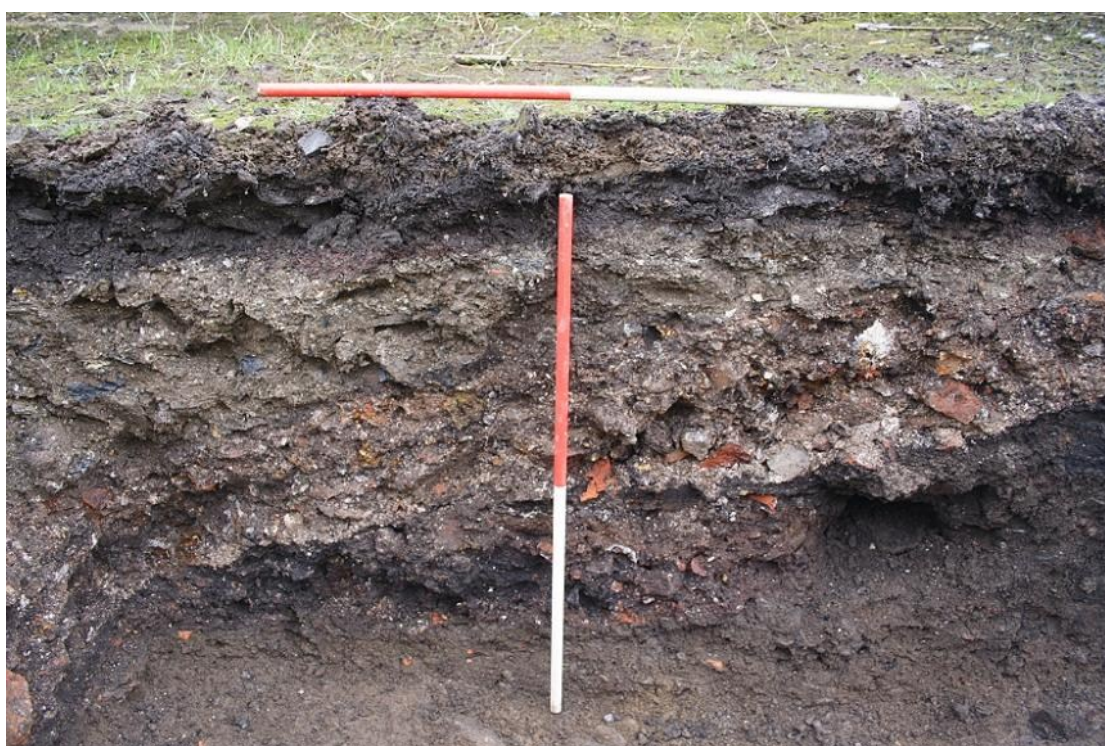
**Photo 14:** Northeast facing section of Trench 2, showing the thick modern rubble deposit (200). 1m scales.

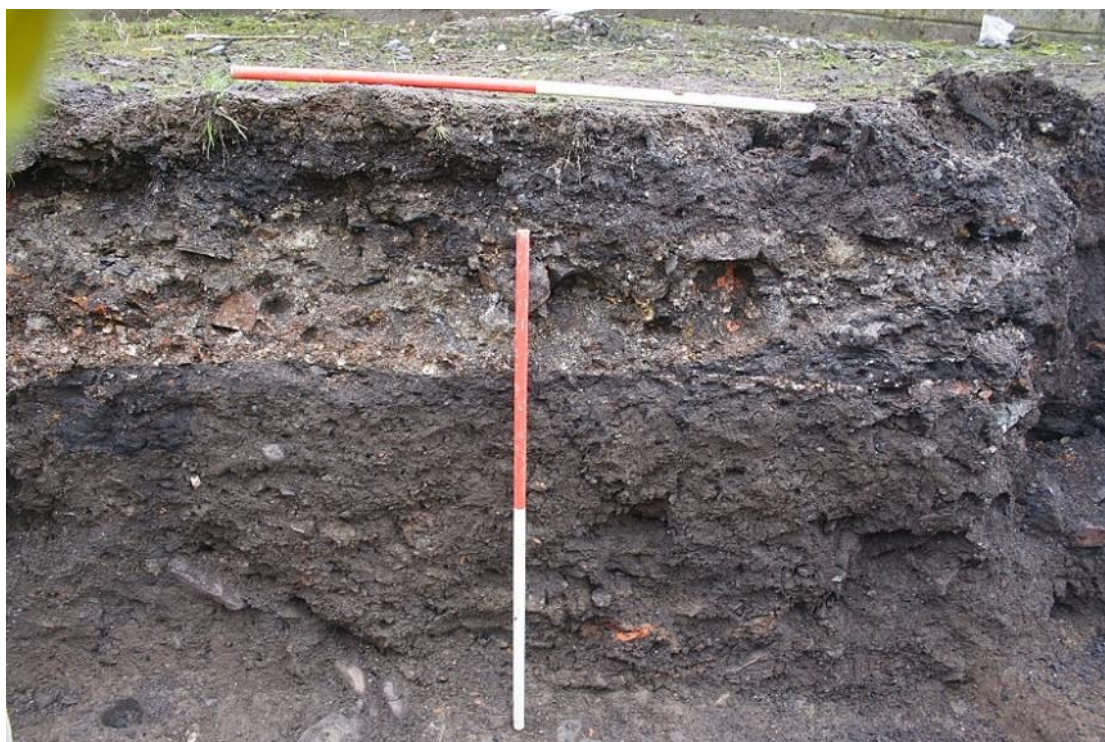
**Photo 15:** Typical section of Trench 2, showing a topsoil (100) with large quantities of building rubble, various soil deposits below (220) and presumed Roman deposits (219) at the base

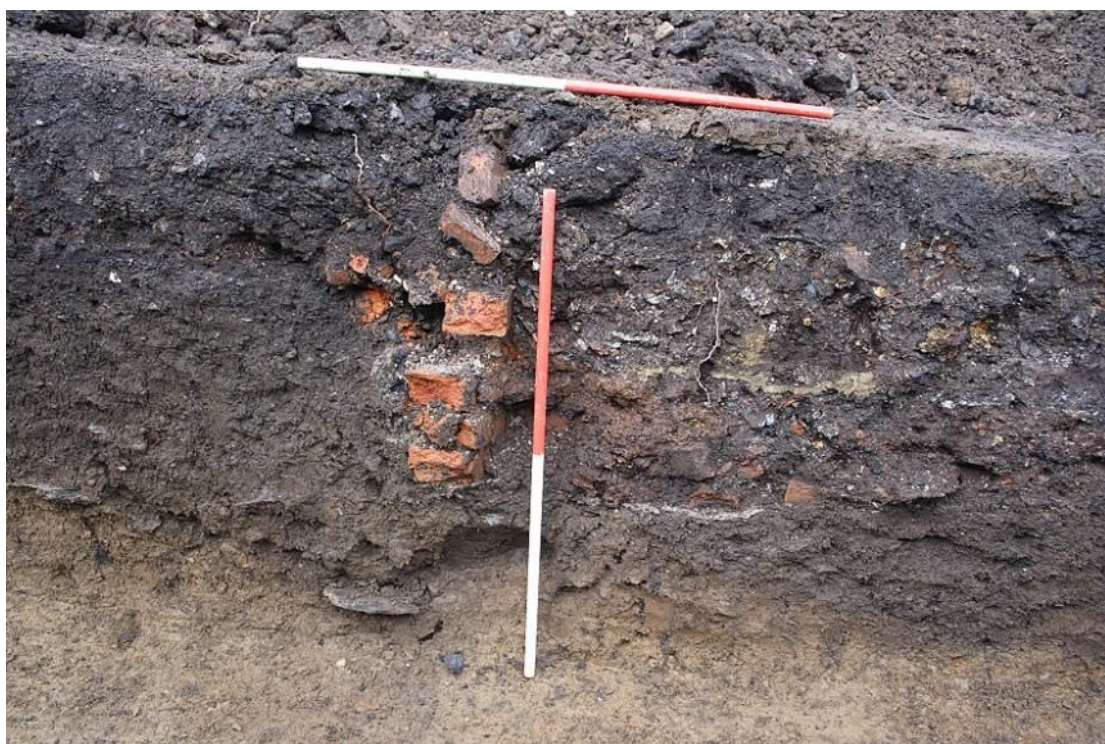
**Photo 16:** Modern/late post-medieval brick-built drain (223) in Trench 2. 1m scales.

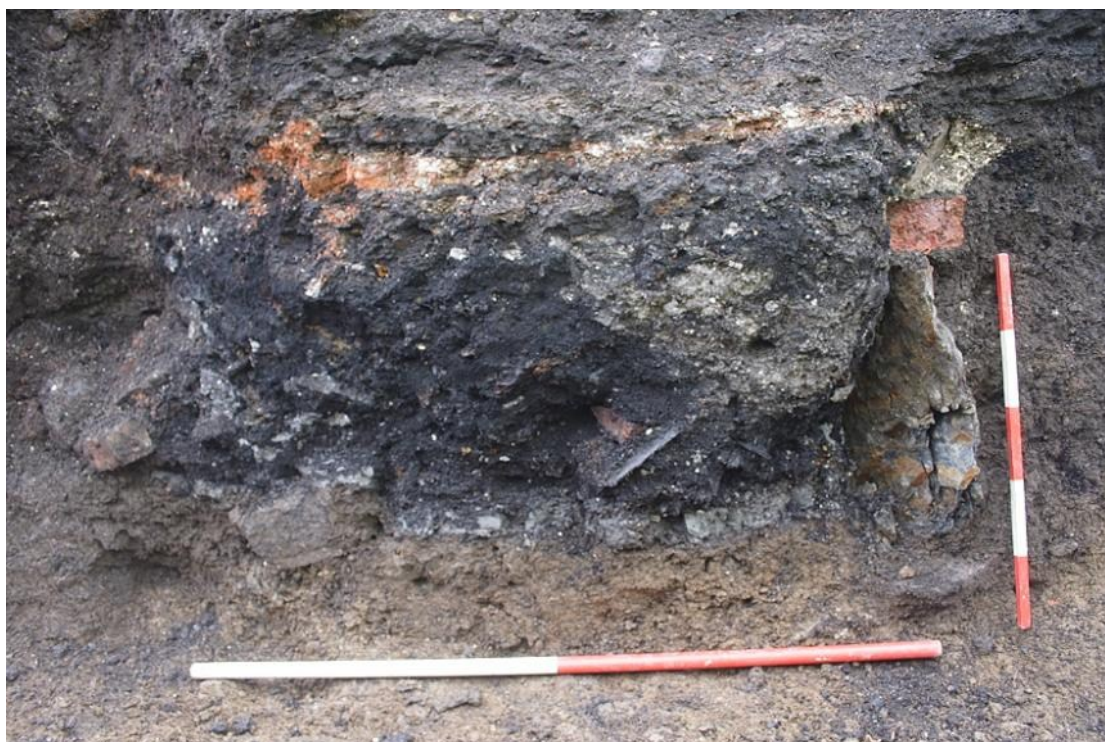
**Photo 17:** Late post-medieval feature 230 within Trench 2. 1m & 0.5m scales.

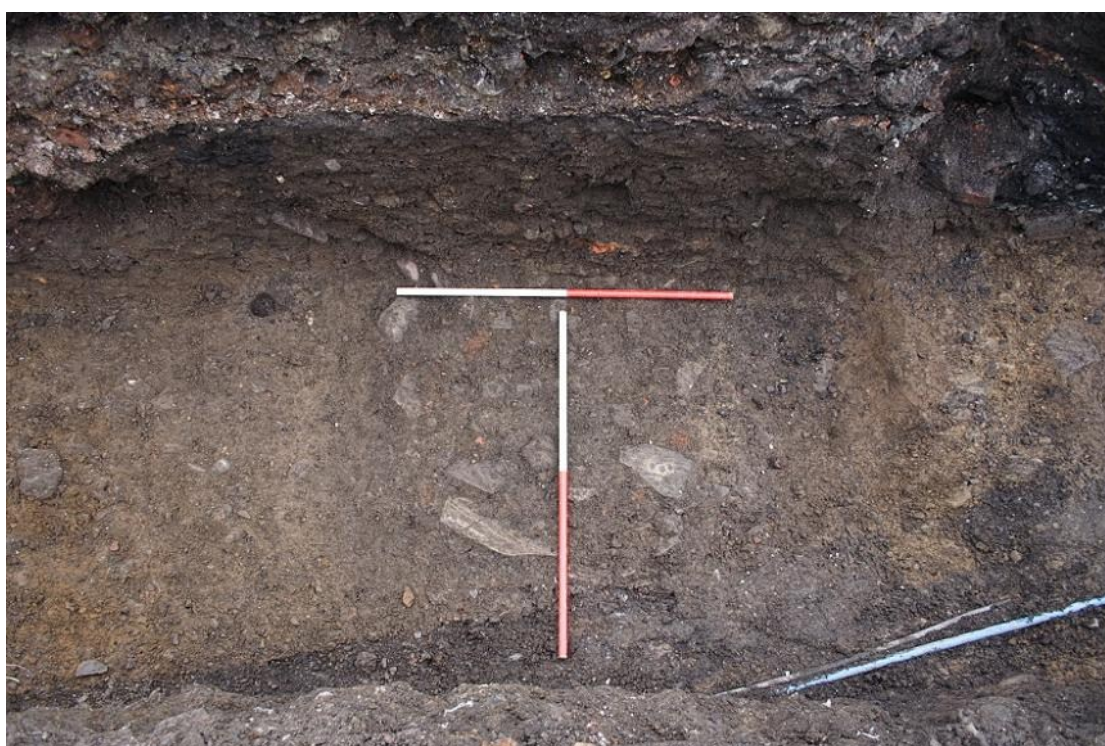
**Photo 18:** Linear feature 208, viewed from the northeast. 1m scales.

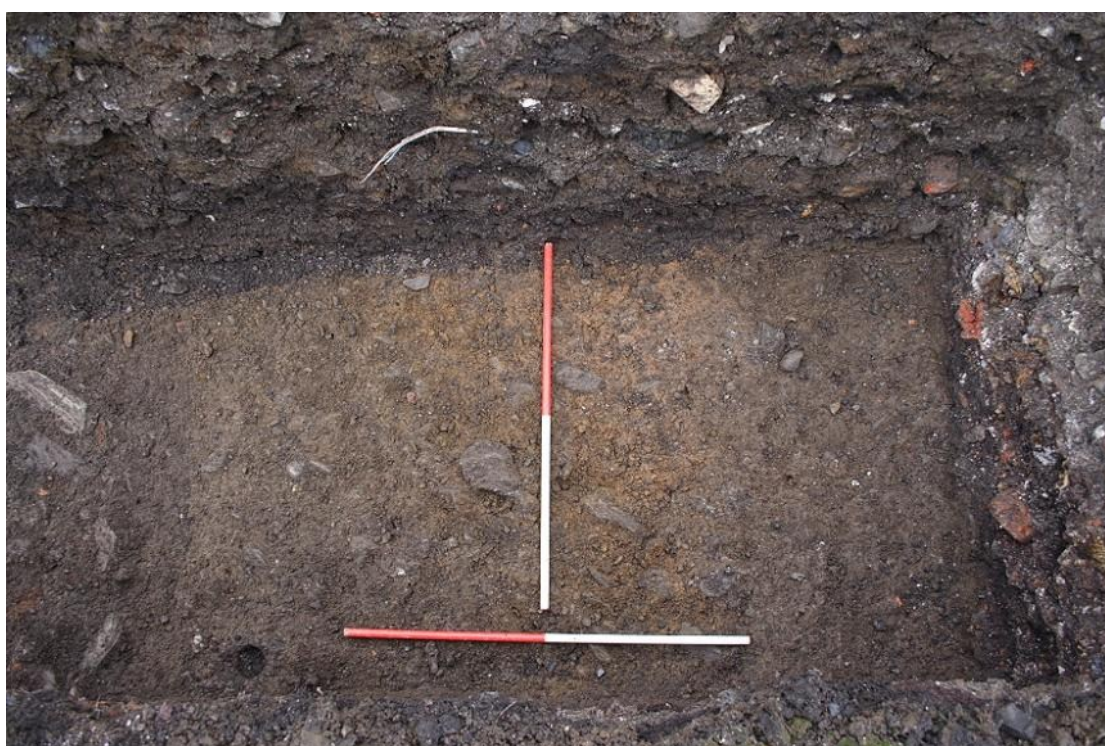
**Photo 20:** Archaeological layer 201, with possible subsoil (202) appearing in the centre. The stake/post hole 204 is also visible at the bottom left. 1m scales.

- 4.2.7 A post/stake hole (204) was recorded in the base of the trench, at a depth of 1m. It measured 0.07m in diameter, with vertical edges and filled with a loose dark-grey gritty material. The crisp edges and loose nature of the fill suggests this is likely to be a relatively recent feature.

- 4.2.15 Revealed in patches throughout the trench were natural subsoil deposits underlying these presumed Roman layers 201/219. At the south-eastern end of the trench this deposit (202) consisted of a mid orange-brown stony sandy-clay. Further to the northwest the underlying subsoil appeared to be a lighter yellow-orange clayey-sand (213). Roughly midway along the trench there was a patch where the sandy subsoil appeared reddened (218). This was not investigated closely and was truncated by the modern services.
