MEDIEVAL AND EARLY POST-MEDIEVAL MILLS

A THREAT-RELATED ASSESSMENT 2012-14

Prepared by Dyfed Archaeological Trust

RHIF YR ADRODDIAD / REPORT NO.2014/7
RHIF Y PROSIECT / PROJECT RECORD NO. 102665

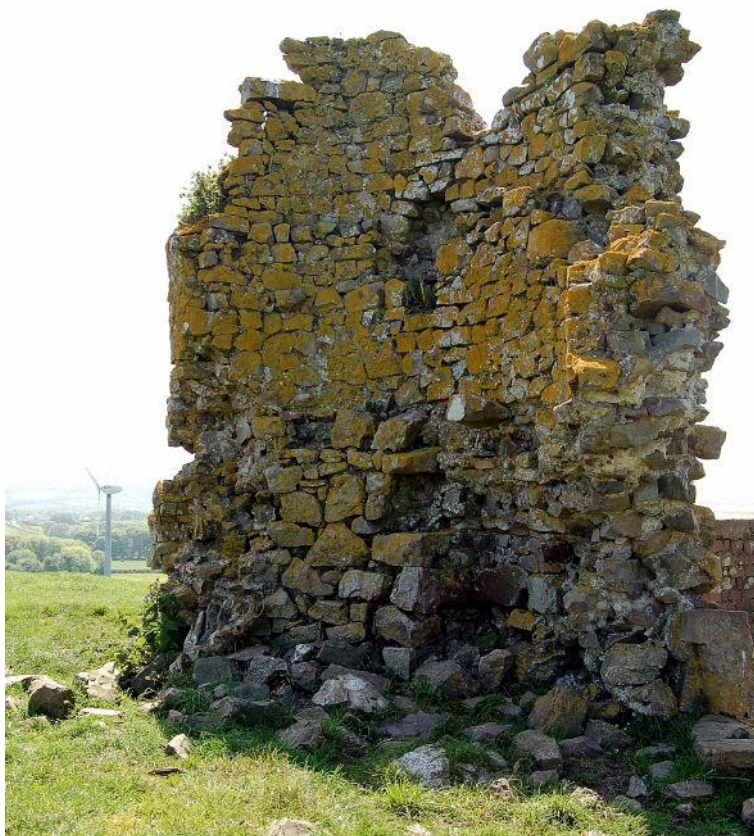
The ruins of an old windmill (PRN 3528) near Carew, Pembrokeshire

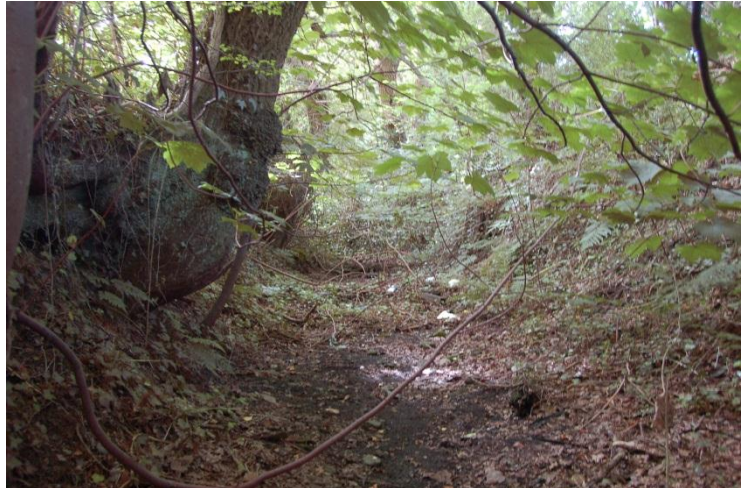
The mill-race was recorded during the Cadw funded Mills Survey of 2012-14. It is diverted from the Afon Gwili to the north of Carmarthen and a public footpath runs alongside it for most of its course. It ranges in character from a substantial, in parts 4m wide at base, steeply cut earthwork to a much narrower, shallower channel, some 1.5 - 3.0m wide at base. A construction bank runs along the eastern side of the race and, for some stretches, the footpath appears to run along the top of it. The race still carries water between the river and Dolgwili Road. Its course appears to be lost to the south of the hospital, where the A40 cuts across it and rear gardens of properties along Brynderwen have encroached upon it. The final section as it approaches the recorded location of the former Priory Mill is also difficult to trace as modern development has altered its course or destroyed it completely (M.Ings, 2012)

The watercourse started from the River Gwili at Bronwydd and followed the natural contours along a man-made ditch to the mills at SN422229 PRN 42. (TAJ,1980). There is no mention of the construction of this watercourse that stretches well over two miles to the head weir near Bronwydd. But the fact that mills are shown at the Priory in the TAXATIO ECCLESIASTICA (1291) and numerous references to a mill ditch in the cartulary of the priory is ample proof to how this watercourse is at least of medieval origins. Its later use as a source of power for a furnace and tin mill meant that it probably saw considerable rebuilding and continuous repair and it is known that the head of weir was raised in c1760 by 21 inches. The cause is easily traced although both the weir and where the watercourse entered the site of the mill have been largely obliterated. (T James, 1976)

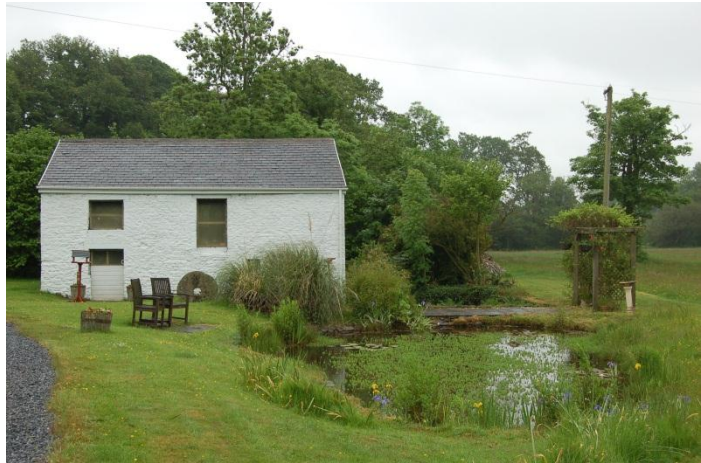
infilled with bricks where it was once affixed. Four millstones survive, positioned around the garden. The weir on the Afon Gwili, where water is diverted into the mill-race, is still intact and comprises undressed stones and pebbles of varying sizes bonded together. The entrance to the mill-race was also evident with a stone wall some 4-5 courses high. The sluice recorded on the 1906 O.S. map has gone. (M.Ings, 2012)

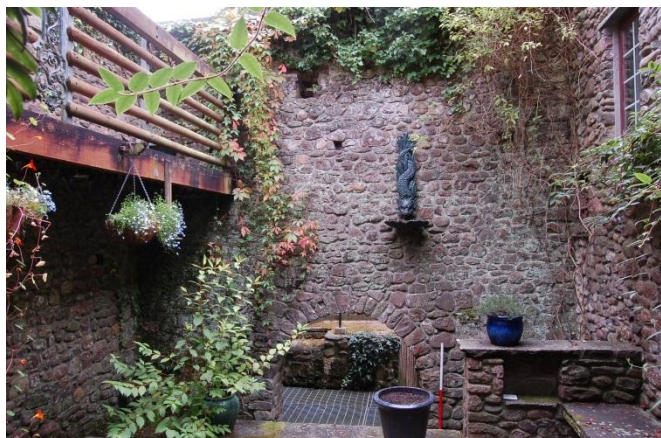
The site was visited as part of the Cadw funded Mills Survey of 2012-14. The current owner has researched the history of the mill and has found it referenced in the 1326 Black Book of St Davids. The mill is shown on an 1816 map of Estates and the town of Llangadog and on the 1841 tithe and apportionment for the Parish of Llangadog. It ceased working in 1957 and was badly damaged by fire in 1970. The ruins have been converted into an enclosed patio by the current owners. A pair of mill stones has been incorporated into steps down to a gateway through the end south wall, where an overshot wheel was originally attached. This drove two pairs of stones. A walkway now leads over the water-filled wheel-pit and tail-race, which runs down to the river

to the west of the mill. The mill pond, located to the right of the property entrance alongside the road, has been infilled by the current owners. The pond supplied water for two leats; one to the wheel-pit, which is now grassed over as a lawn although an overflow ramp survives, and the other to an undershot, iron wheel used to power an electrical generator, located north of the main mill complex. This was installed in the early 20th century and was still working in 1958 when it was bought and destroyed by the Electrical Light Company. The foundations of the generator still survive (M.Ings, 2012)

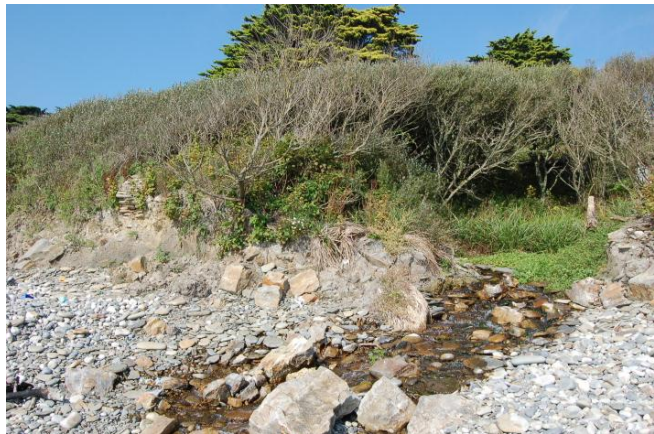
The foundations of what is presumed to be Marros Mill have been observed eroding at

with thick vegetation and it is possible that this obscures further remnant of the building. The small pond noted in 1988 is still preserved, although it is not clear whether or not this is associated with the mill. The nearby farm building, shown on the historical OS. maps to the northwest of the mill, stands as a roofless ruin (M.Ings, 2013)

Remains of walls and floors etc eroding out at top of storm beach. Presumed remains of Marros Mill (KM 1996) Marros Mill is shown as disused in 1891. There is change of alignment of the coast edge by the 2nd edition (A.Gale Feb 1995) Foundations of what were presumably the old mill can be seen eroding at the rear of Marros Beach about 50m to the south of the occupied house. The majority of this mill has been washed away but part of the north wall and traces of a flag stone floor can be seen at SN20650748. To the north of this structure is a small almost totally silted-up pond. The occupied house marked on OS maps is of 19th century date (K.Murphy Dec 1988) The farmer's mother has photographs of the mill (05-07-85)

Several highly ruinous mills are located on the coastal edges, including Greatmire Mill (PRN 32632) in Pembrokeshire and Marros Mill (PRN 11656) in Carmarthenshire. These sites are quickly being eroded away and it is recommended that they are comprehensively recorded before being lost completely.

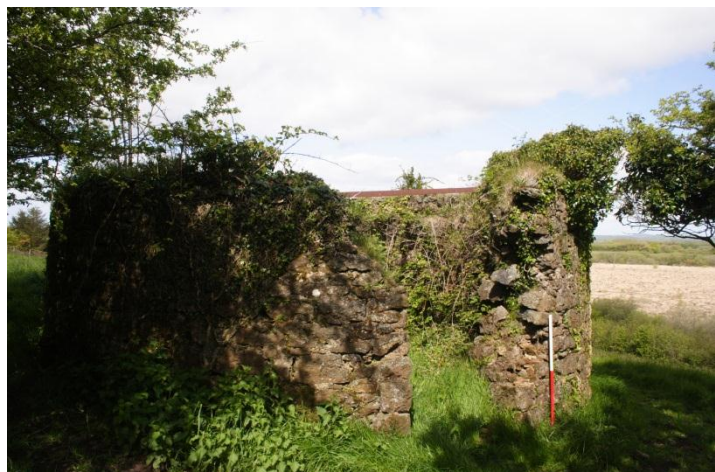
particularly from the internal, southeastern wall (M.Ings, 2012)

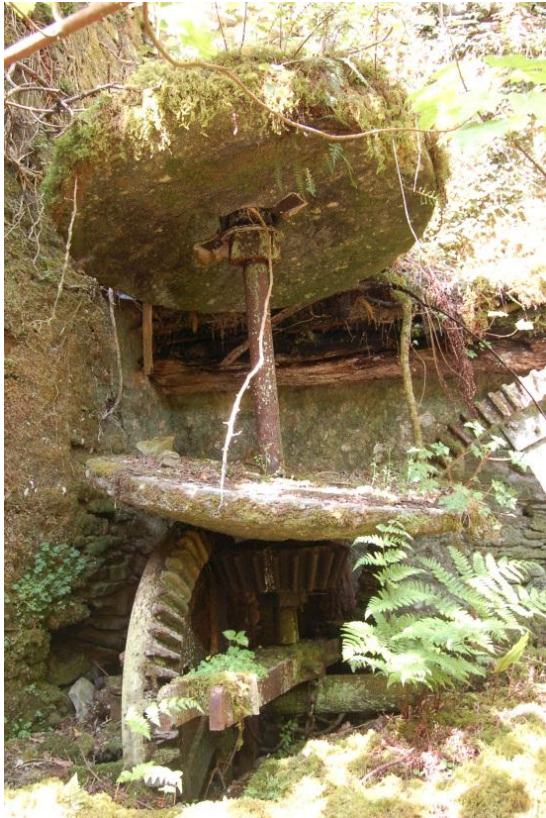
The site was visited during the Cadw funded Mills Survey of 2012-14. The mill is now a substantial ruin with many walls standing to full height, although completely unroofed and with several areas of masonry tumble. The main structure is a two-celled, gable-ended building on a levelled platform above the river. The wheel-pit is located adjacent to the north side wall and water from the mill-race diverted from the Dewi Fawr would have powered an overshot wheel. This has now gone and the wall masonry is partially collapsed where it was originally affixed.

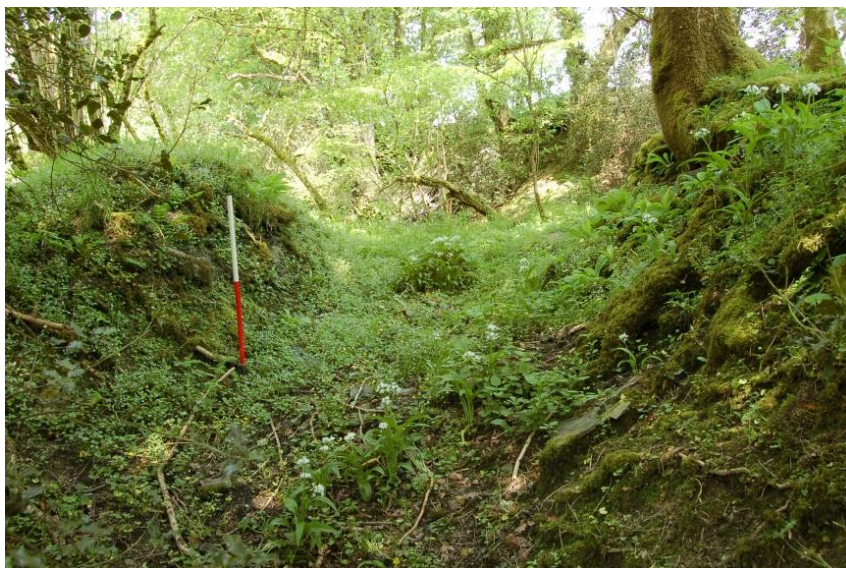
slight remains of a small, square structure shown on the historical Ordnance Survey maps. Extensive earthworks are also preserved in the vicinity of the mill, although these too were somewhat obscured by vegetation. The mill-race was traced back towards the stream, as far the farm boundary. It runs along the base of the natural, slope with an earthwork bank created on the western side. Two possible holding ponds were apparent above the mill, both now very silted. A channel appears to lead down from the northernmost pond, past the small, square structure - possibly infrastructure for a sluice? - and on to the northwest corner of the mill (M.Ings, 2012)

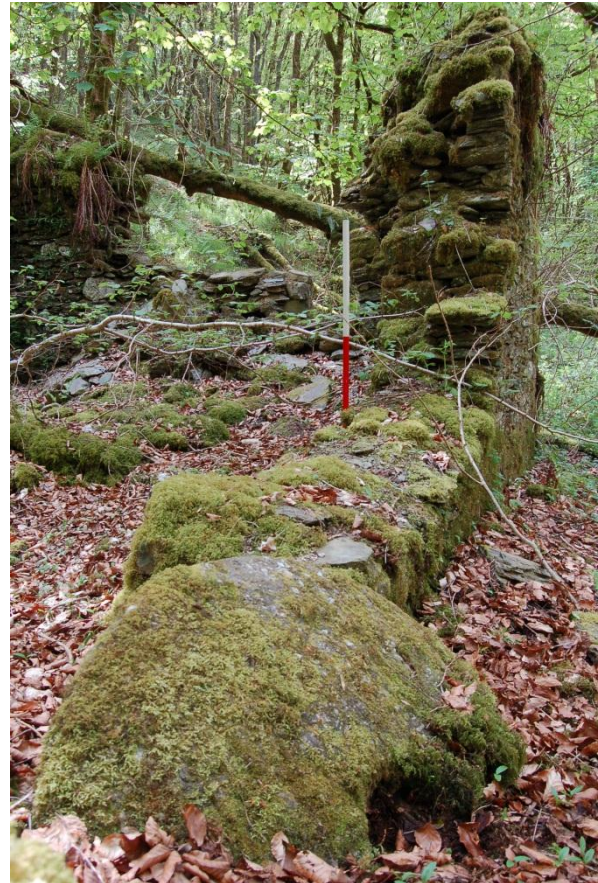
The site was visited during the Cadw funded Mills Survey of 2012-14. The ruinous building stands within thick woodland, beside the river, on a levelled platform built into the bank. Several lengths of walls stand to almost full height but falling trees have caused extensive damage. It appears to comprise a two-cell structure, although the partitioning wall is almost completely destroyed and much of the interior is obscured by stone tumble. There is a possible entrance in the north-facing wall and the remnant of an arched window in the west-facing gable end. A broken millstone lies near the possible entrance. A further stone structure was noted close-by, to the southwest of the mill. This comprises a rear revetment wall built into the bank and two walls projecting out at right-angles. The function of this building is uncertain (M.Ings, 2012)

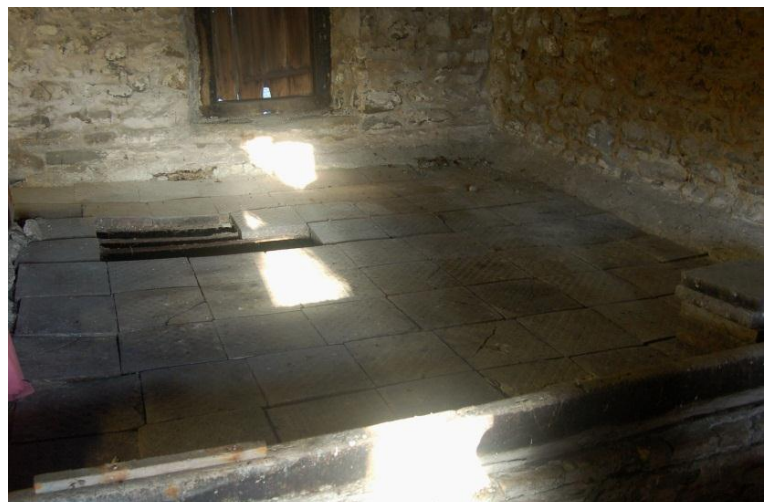
wheelpit against the western gable although the axle is now broken. The interior machinery, including the pit-wheel and gearing, appears intact. A corn-drying kiln is built into the northeast corner with a firebox and flue on the groundfloor below a drying surface of perforated tiles on the first floor. Three pairs of mill stones were housed within wooden hoppers on the first floor, supplied with grain from chutes from the second floor above. The holding pond, behind and above the mill, is now a neighbour's lawn having been filled in during the 1960s. This had caused a flooding problem to the rear of the mill so the council have had to redirect the mill race. The race is still evident, in part, as a hedge-side drainage ditch (M.Ings, 2013)

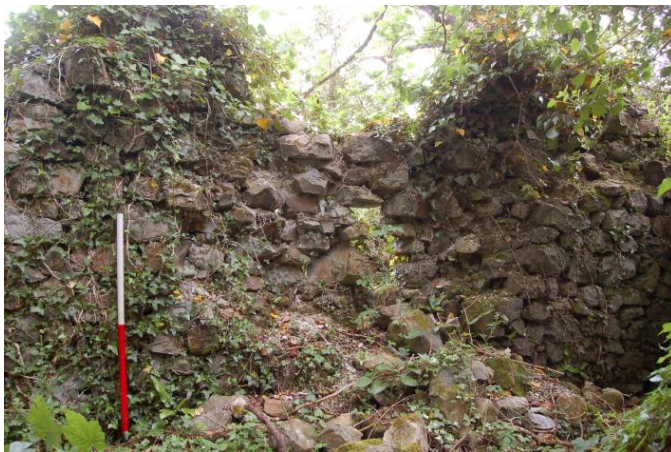
either side, while the east and remainder of the south wall are gone altogether. The wheel-pit identified in 1994 was not evident, although its recorded location, next to the west wall, was heavily overgrown. The cottage, aligned northeast-southwest, is better preserved, with gables standing to almost full height. There is a doorway in the north sidewall and a window in the opposite wall. An open-fronted extension is adjoined to the east sidewall (M.Ings, 2012)

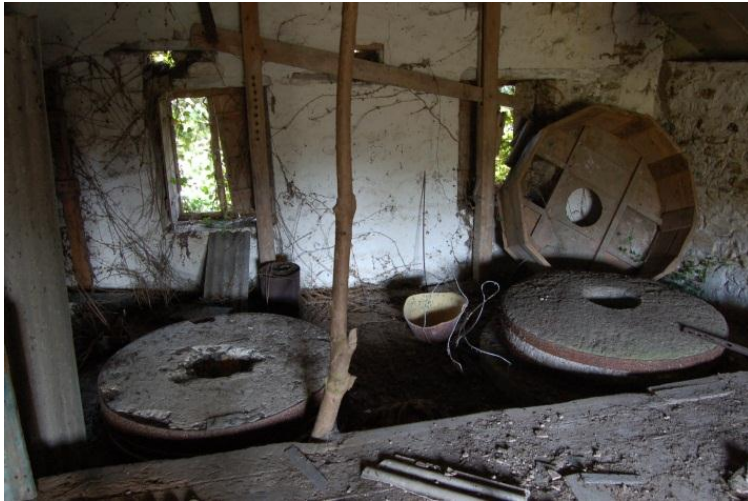
holding ponds and a leat diverted from the Afon Sannan to the north. The mill building is still shown on modern mapping but the associated buildings have largely gone (M.Ings, 2013)

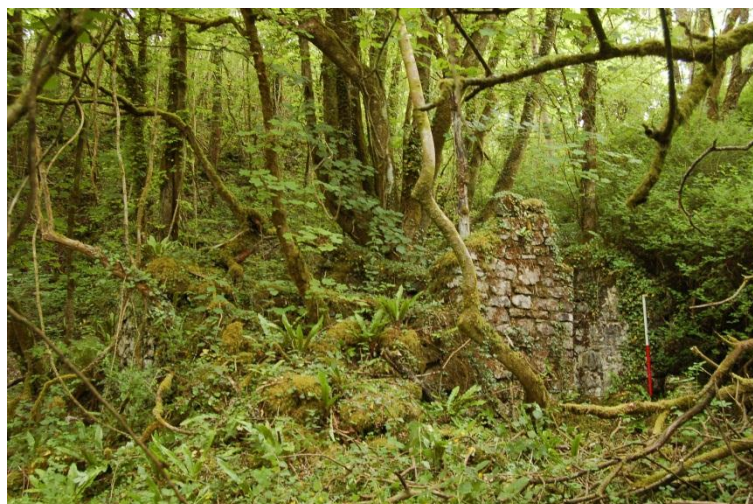
revetted bank that runs at right-angles to the river. The walls are in a ruinous state, generally standing approximately 1 metre high although some sections are higher, and the interior is obscured by tumbled masonry. A possible wheel-pit is sited alongside the west side wall, where there is evidence for a socket, and a stone-revetted channel leads from this to the river. No evidence for a mill-race feeding into this possible pit could be seen as the area is heavily overgrown. The cottage - possibly the mill-house - also appeared to be a two-celled structure with a walled garden along the west side and a chimney breast evident on the north gable. This gable stands to almost full height but the south and east walls are totally obscured by vegetation. The third ruin recorded on the modern map, located to the north of the cottage, was not seen (M.Ings, 2012)

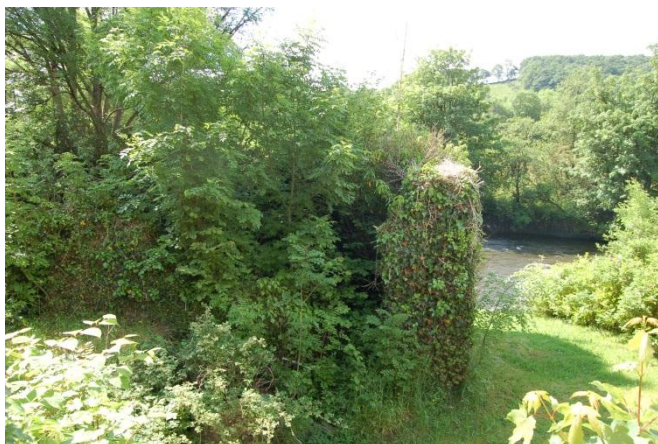
Access to the mill was not possible as the owners were away but an assessment was made from the roadside. It was evident that a substantial, roofless ruin of rubble stone with squared quoins survives located on a levelled platform on the slope above the river. The 1888 O.S. map depicts a 'T' shaped building but the ruins appeared to comprise a rectilinear of some 8x6 metres. However, the walls were largely obscured with heavy overgrowth and it was unclear whether the rear extension had collapsed or been dismantled at some stage. A possible blocked entranceway with a stone lintel was noted in the south wall, along with an aperture for either a doorway or window. There is also a window with a pitched stone lintel in the east side wall (M.Ings, 2012).

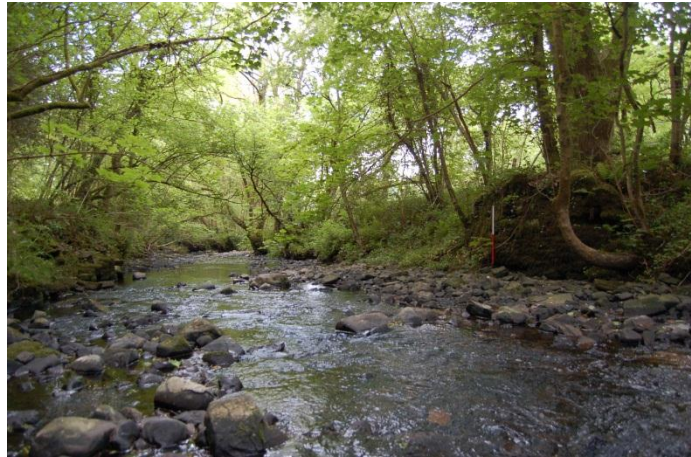
The site was visited during the Cadw funded Mills project of 2012-14. The supports for the aqueduct survive on either side of the river, comprising structures of semi-dressed stone blocks standing some 1.60metres high and 4.00 metres wide at the base. No evidence survives for any structure spanning the river (M.Ings, 2012)

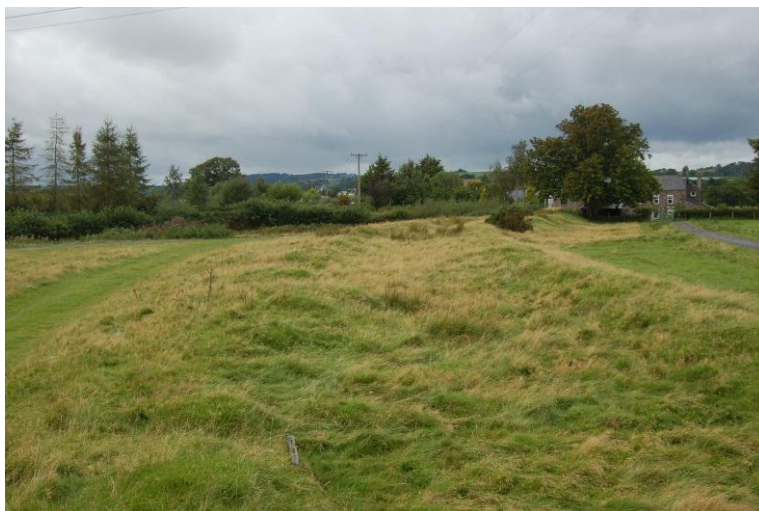
The site was visited during the Cadw funded Mills Survey of 2012-14. The mill-race is largely preserved as a distinctive, grassed-over earthwork running across the rough-grazing of Carreg-

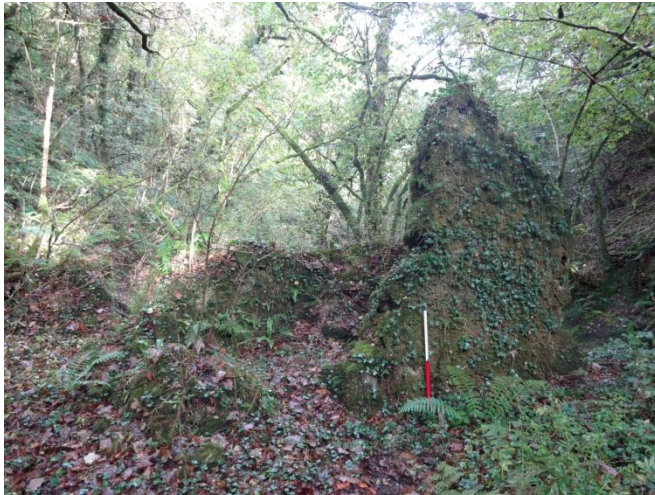
The site was seen during the Cadw funded Mills Survey of 2012-14. The mill-race survives as a distinct earthwork where it passes through scrub woodland, following the contour of the hill-slope above the river. The ditch is a metre wide and some 0.60 metres deep, although heavily silted, with a wide outer bank. The section across pasture fields to the river could not be traced, presumed infilled, and the last section closest to the mill was largely inaccessible due to heavy vegetation (M.Ings, 2013)

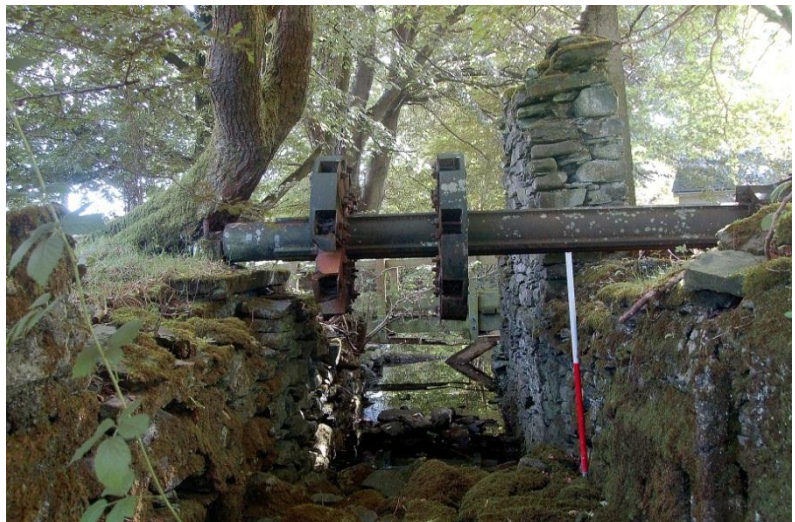
Ordnance Survey maps, powered by a mill race diverted from the Afon Teifi to the north. The mill buildings are no longer shown on modern mapping and it is recorded (RCAHMW, 1951) as a ruin and named Loventium Mill (M.Ings, 2012, from various sources)

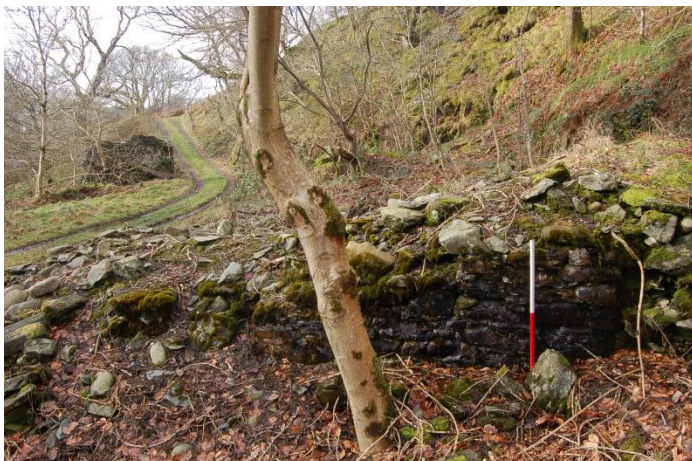
A smaller building to the west has largely disappeared, with only the western gable wall standing to c.2m in height. There is no trace of a third building shown on the parish tithe map, which stood a few metres to the east of the main building. It is worth noting that the level garden/yard area between the buildings and the Ystwyth to the south is evidently in part built up ground. The riverbank in front of the garden has been strengthened by revetting with large stone slabs.

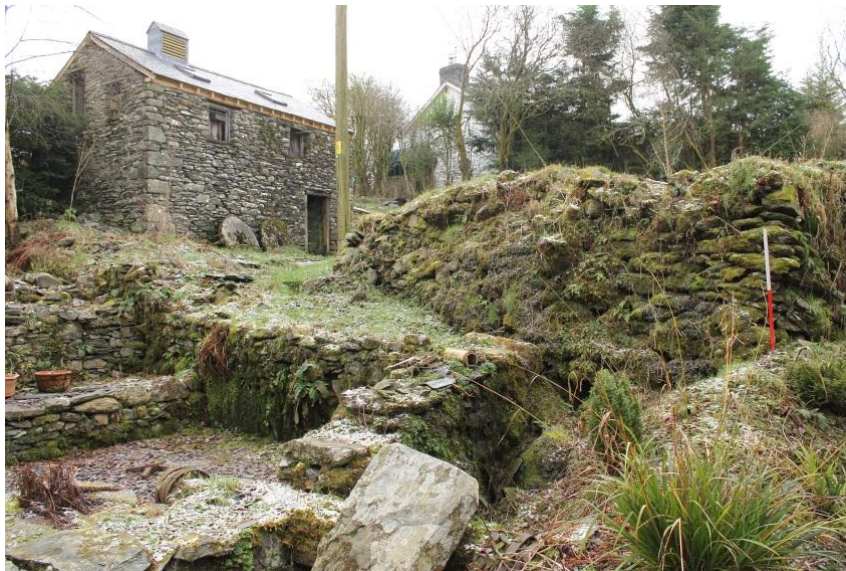
the mill survives, with the walls standing some 1.50 metres high. The wheel-pit still has the wooden wheel axle in situ, although the overshot wheel itself is gone. The tail-race runs into a culvert beneath the house driveway, partly supported by two of the mill-stones. A further pair of stones is still within the mill ruin and another pair are propped against the wall of the nearby corn-kiln (PRN 105370) The retaining wall of the

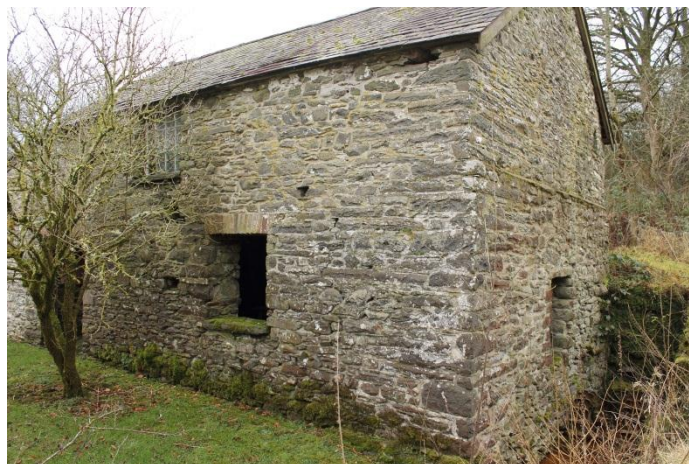
The site was visited as part of the Cadw funded Mills Survey of 2012-14. Unfortunately the current owners were away so a detailed survey of the site was not possible. The gable-ended mill building is of stone rubble with squared quoins and a slate roof. There is a doorway, groundfloor window and first floor window in the east-facing facade. It is built into a steep bank and the window apertures in the rear wall are into the first floor. A later stone building adjoins the south-facing gable. The wheel-pit is alongside the north-facing gable and the iron frame of a wheel is in situ. A low aperture is presumably where the wheel axle passed through the wall. No internal machinery was evident and the building looks to now be used as a workshop. The holding pond and mill race were not explored. Further information was supplied by the current owner (by email): there was a mill on the site at least as early as 1130, belonging to Strata Florida, but the date of the current building is not known. The overshot waterwheel disappeared a long time ago and the current Pelton wheel was installed relatively recently. There are plans to get the mill working again, with help from the Welsh Mills Society, through dredging the mill-pond and replacing the Pelton wheel (M.Ings, 2013)

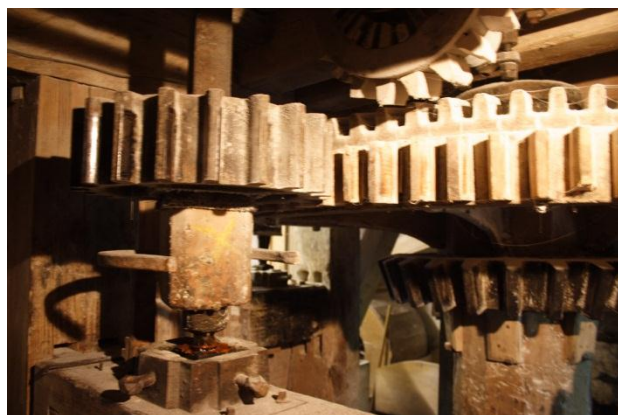
powers three pairs of stones, two of French burr for milling wheat and the third for oatmeal and animal feed. The original pond walls survive and it was cleared of debris and re-flooded in 1981. There is a lean-to oat drying kiln adjoining the mill (M.Ings, 2012, from various sources)

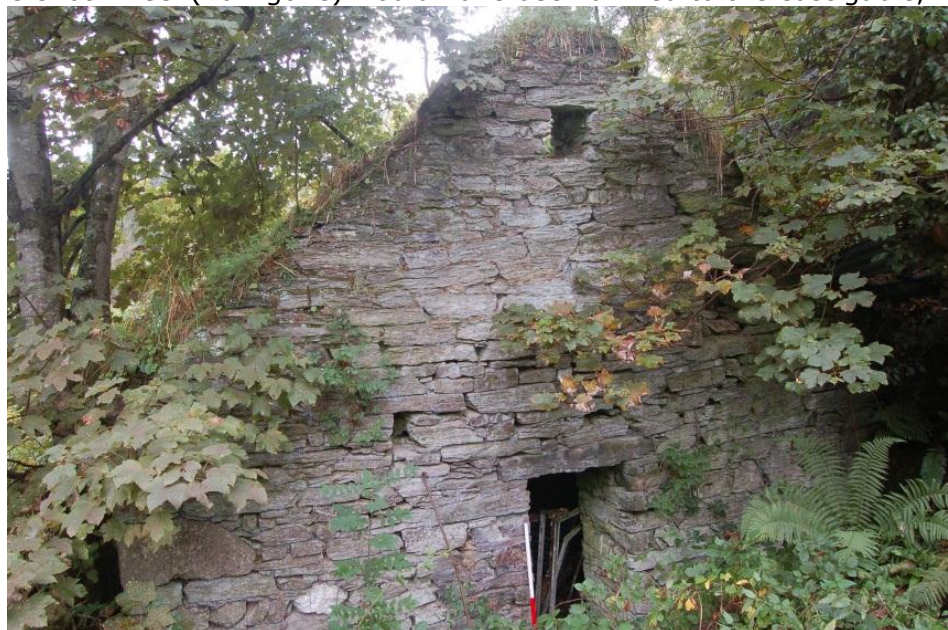
The building is now roofless and fallen sheets of corrugated-iron lie in the interior, obscuring any possible features.

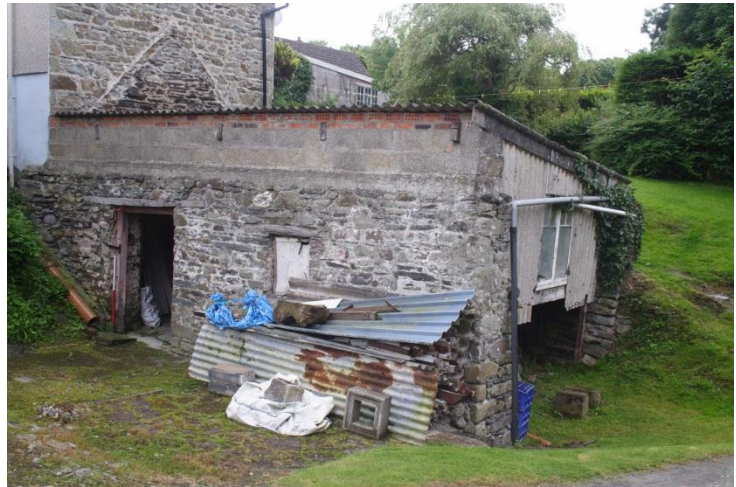
The site was visited as part of the Cadw funded Mills Survey of 2012-14. The plan of the mill survives, adjoining, and downslope from, the farmhouse but the pitched roof has been replaced, in the 1960s, with a flat roof of concrete, breeze-block, red-brick and corrugated iron. The shape of the original east gable is evident on the west gable end of the farmhouse. A.J.Parkinson noted (1984) that there was no lower gable and suggested that the mill may have been converted from a pandy, as several pandai are known with a similar lack of a gable. Too little now remains of the west end of the mill to determine its original appearance. An inscribed date of 1754 appears on the south face of the northeast stanchion, above the now infilled wheel-pit. The metal frame of the overshot wheel can be seen protruding from the ground. The two uprights of the hurst frame (the internal framework supporting the gears and millstones) are recorded as surviving in 1984 but were not seen during this visit. The wheel was powered from an adjacent pond, located to the south and above the mill, now filled in and grassed over. Water was diverted to the pond off the Afon Howni, to the south, and returned to the river to the northwest. The leat has now been infilled (M.Ings, 2012)

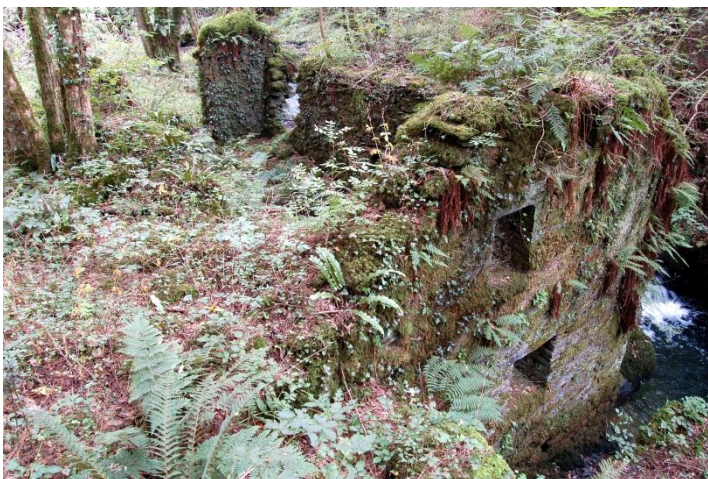
The site was visited as part of the Cadw funded Mills Survey of 2012-14. The mill is now a roofless ruin, within an area of woodland, and no machinery now survives. Roof slates and timbers lie within the interior. The two mill stones are now located near the entrance to the owner's house, named after the mill. The walls, of split slate rubble, stand to almost full height. There is an entrance-way, with a (now fallen) wooden lintel, in the east gable and a possible blocked doorway, with wooden lintel, in the south side wall. The river has caused relatively recent damage to the southeast corner. The wheel was affixed to the western gable and the stone-lined wheel-pit and inner axle-wheel pit are well preserved. The wheel was powered by a mill-race diverted from the Afon Cynllo. The race runs above and parallel to the river, well-preserved although very overgrown in part. It is culverted beneath the trackway that to the north of the mill, emerging at the wheel-pit. A second ruinous, gable-ended building is located to the northwest of the mill. The current owner said that he'd been told that it was possibly a corn-drier. Vegetation obscured the interior and nothing could be seen to confirm its function (M.Ings, 2012)

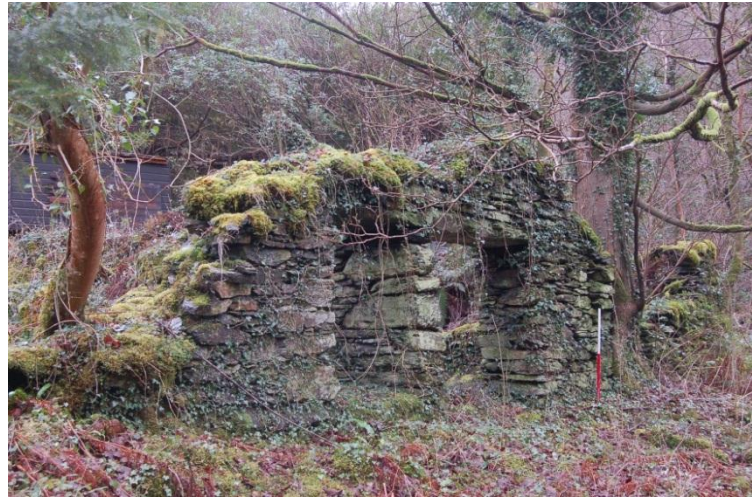
with stone lintels. Each cell is further divided east-west. These internal walls stand lower, at some 0.70m maximum. The interior of the building is obscured by tumbled masonry and thick vegetation and no features or preserved machinery could be discerned. The mill's name suggests that it is later than the 18th century corn mill, Melin-y-cwm (PRN 19569), further upriver (M.Ings, 2013)

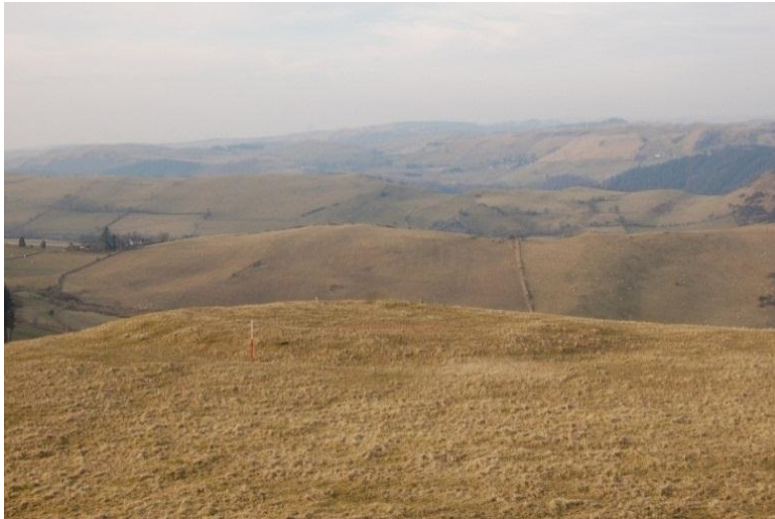
circular mound in the field has been interpreted as either the base mound for a mill, the remains of a Bronze Age ring barrow or a Roman signal station (M.Ings, from various sources, 2013)

The site was visited as part of the Cadw funded Mills Survey of 2012-14. It stands on the north side of Pen Felin-Wynt in an area of low-intensity grazing. The mound is well-defined, some 16 metres in diameter and

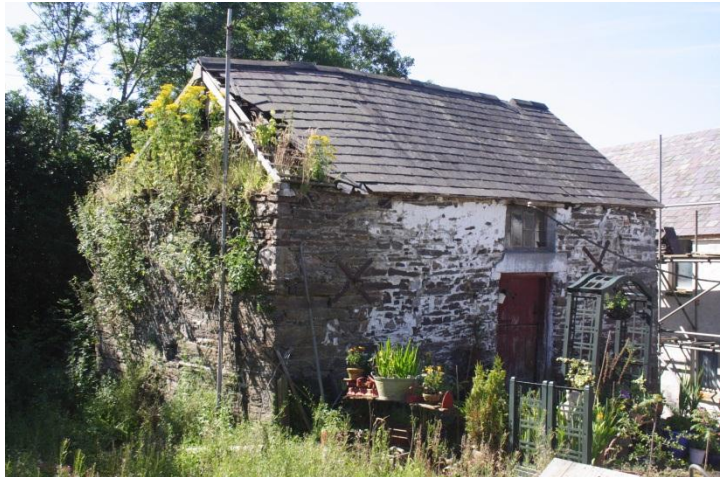
The site was visited as part of the Cadw funded Mills Survey of 2012-14. It is a complex comprising the corn mill, fulling mill (PRN 21369), a corn-drying kiln and farmstead. The two-storey mill is intact, built of local stone rubble with squared quoins and roofed with slate, although there is some structural damage, largely caused by a collapse of the first floor in the central section of the building. Iron cross ties have been positioned on the external walls to help consolidate the structure. The overshot wheel has now gone and the wheel-pit has been infilled. The internal machinery, thought to date to the mid-late 19th century (RCAHMW, 2002) is largely complete, including two pairs of stones within their wooden casings - French burr stones for grinding flour and Anglesey granite stones for grinding barley. The building was raised during the 19th century to create an attic over the first floor. Two further mill stones are propped up against the corn-drying kin, located just to the northeast of the mill (M.Ings, 2012)

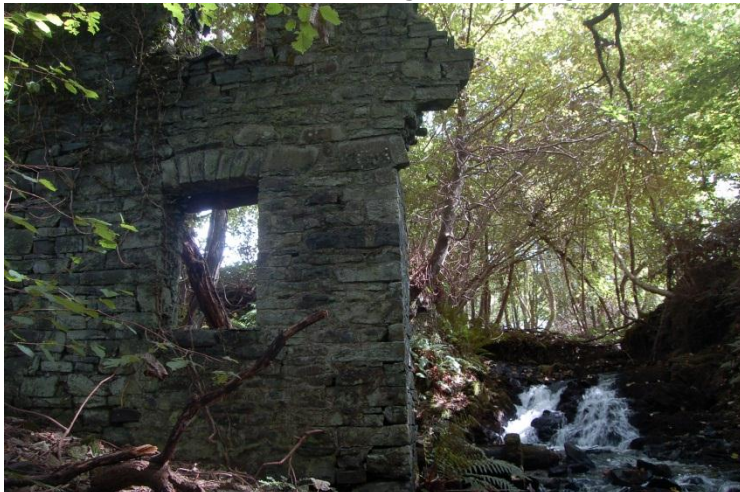
doorway, both with wooden lintels on the ground floor and a partially preserved square window on the first floor. The historic maps indicate that the mill originally extended over the current stream. Possible masonry is apparent on the far bank, below the waterfall, and it is clear that the first floor of the west wall once extended southward. The wheel would then have been enclosed by the mill building.

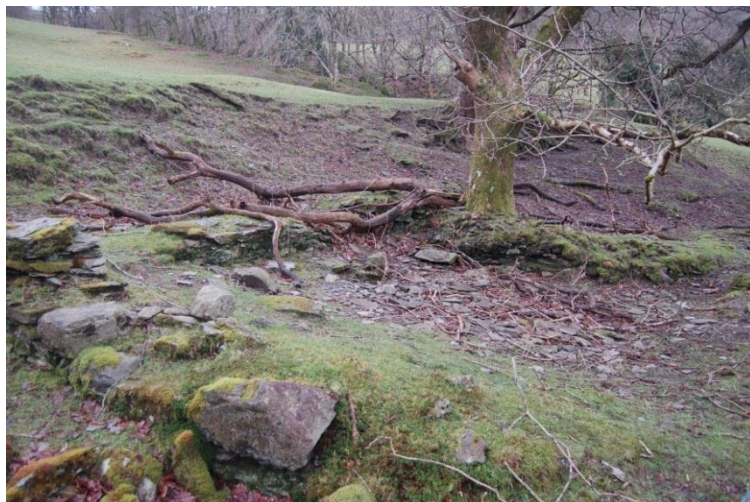
The site was visited as part of the Cadw funded Mills Project of 2012-14. It is located within the Nant yr Arian stream valley, built into a steep bank at the edge of a pasture field. The drystone walls, now standing no more than 0.50m, are incomplete and largely vegetated over. The building has two-cells. The footprint of the southeast cell is preserved, measuring approximately 6x6m, while a stretch of walling below the bank to the north is the only surviving remnant of the northeast cell. There are no surviving features to denote its function. It is likely that power was obtained by a leat diverted from the fast-flowing Nant yr Arian, to the southeast, but no earthwork could be discerned. A possible, now grassed over, trackway runs north-south, to the east of the building (M.Ings, 2013)

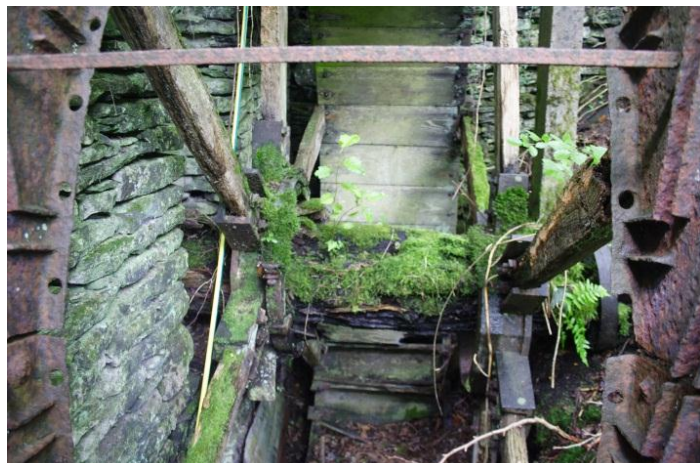
owner told me that the mill-race and mill-pond (above and to the northwest of the mill) have been infilled. The overshot wheel is still in situ, on the rear gable, with a launder in place above it. It was apparently converted to an overshot from a breastshot wheel in the 1830s. The current wheel is cast-iron and its shaft has been repaired at least three times. The internal machinery is mostly intact, with the hurst frame containing the iron pit wheel and stone nut on the the ground floor and a pair of millstones (one now propped against the wall) on the first floor. The roadside room of the building has a fireplace in the front wall. The owner believes this to have originally been an area for butter-blending and was separate from the mill - a doorway has since been inserted through the dividing wall. The adjoining corn-drying kiln, on the southeast side of the mill, is thought to be a later addition built between 1875 and 1905. The mill is currently used as a workshop and for storage (M.Ings, 2012)

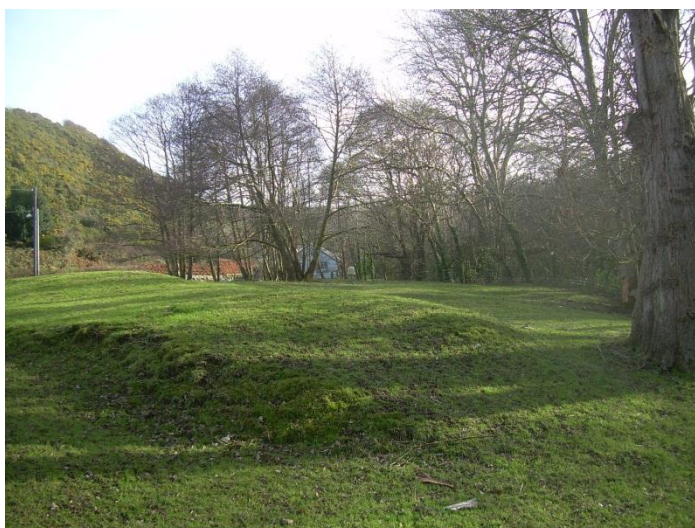
The site was visited during the Cadw funded Mills Survey of 2012-14. The building has now been reduced to a discrete earthwork, with sharp edges, under cover of grass within a pasture field. A resident living opposite the field had a photograph of the mill as a gable-ended, possibly two-cell structure with an undershot wheel. The mill-pond and mill race could not be seen and are presumed infilled when the field was turned to pasture (M.Ings, 2013)

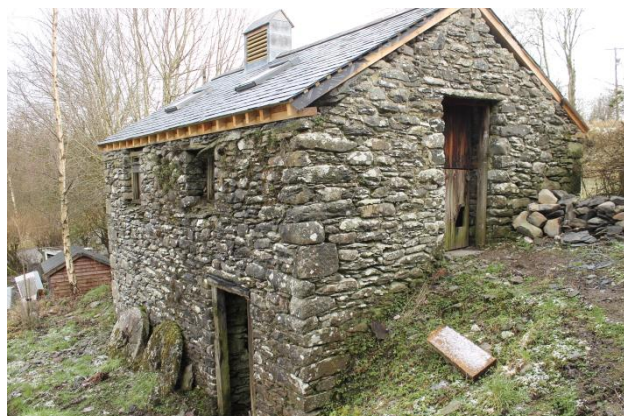
standing, gable-ended stone building located to the south of the now ruinous mill. The ground-floor space is mainly taken up by a large fireplace, with an arched beam, and the corn-drying floor is above. The clay tiles of this floor were taken up and are recorded in 1989 as being stacked inside the lower level. They have now gone. The current owner has recently re-roofed the building with slate. Two mill-stones are propped against the facade (M.Ings, 2013)

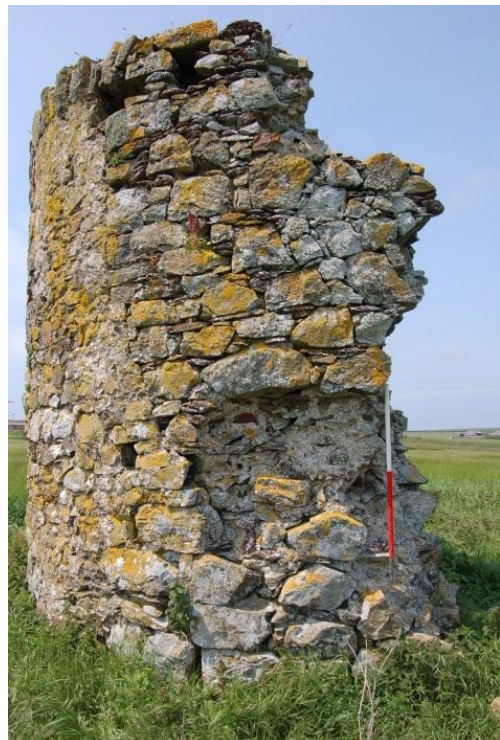
The site was visited as part of the Cadw funded Mills Survey of 2012-14. It was a round tower, of which approximately a third (on the south side) still stands to some 3 metres in height. It appears similar in dimension, structure and appearance to windmill sites PRN 26367, near Bosherton, and PRN 3528 at Minerton Farm, St Florence. It stands on a stone platform some 5 metres in diameter and is constructed of semi-dressed, mortared stone. A possible fireplace is located within the masonry at ground-level and a large recess, with a pitched stone lintel, is inserted at first floor level. Beam slots are evident either side. It stands on a hill top above Crabhall Farm and, at the time of the visit, it was within a field of barley (M.Ings, 2013)

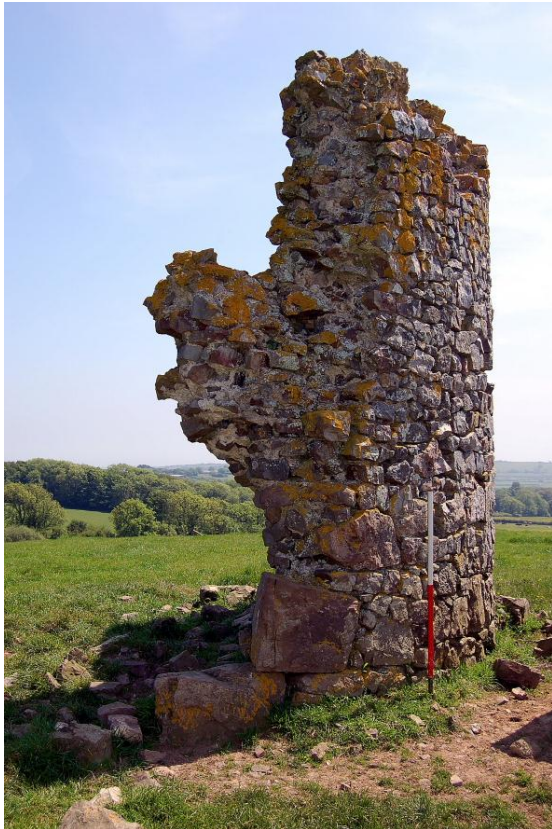
PRN 3528

18th century windmill, recorded on the historical Ordnance Survey maps as disused, adapted during the Second World War as a machine-gun post (M.Ings, 2012, from various sources)

18th-19th cylindrical Base of tower. Rough coursed rubble. Opposite doorways ground + first floor filled up. (?)

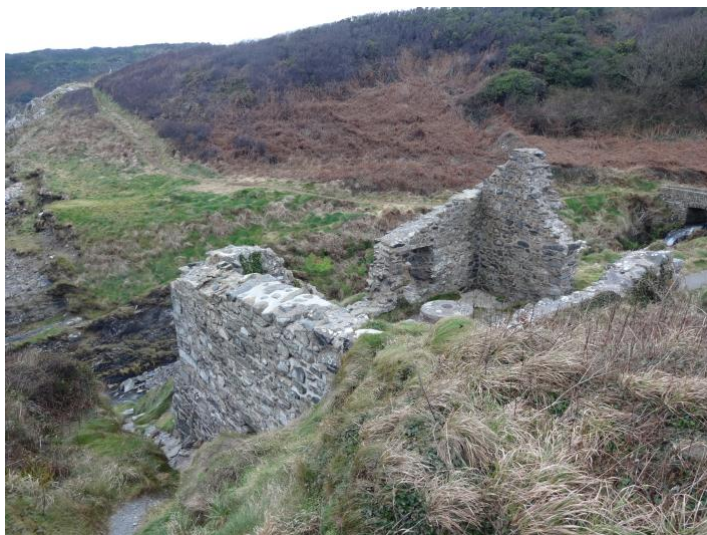
the mill pond to the southeast. The mill pond, as depicted on the 1889 1st edition Ordnance Survey map, is not within the scheduled area. Its location is undeveloped, covered with thick scrub and trees which obscured any definition of the feature. The pond was recorded in 1961 to be dry and partly filled in (M.Ings, 2013)

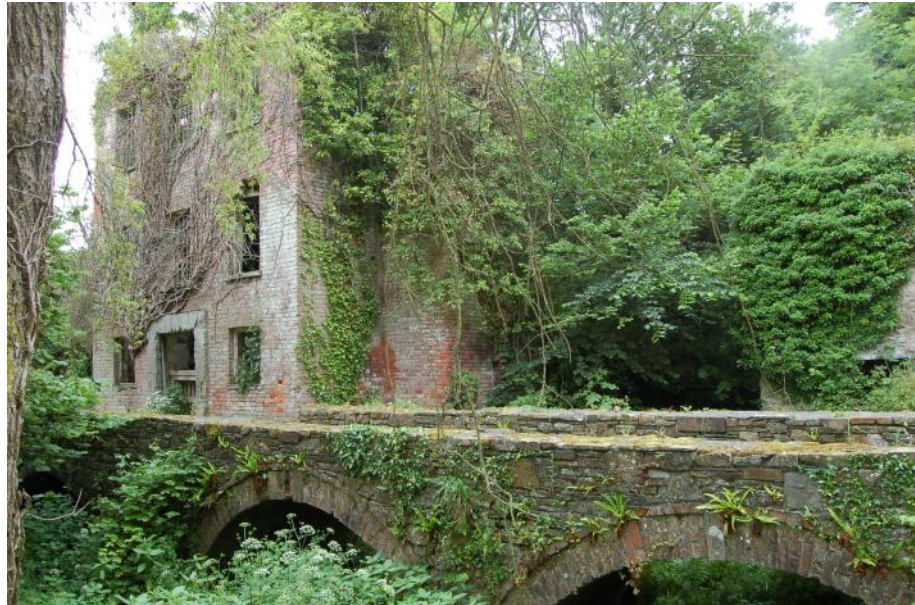
The site was visited as part of the Cadw funded Mills Survey of 2012-14. The owners were away but I was granted permission to view the ruin by a staff member from the business based at the mill house. However, the rear of the building and the mill race were inaccessible. The facade of the mill still stands three storeys high but the rear, seen through the window apertures is far more ruinous and overgrown, being taken over by woodland. The roof has now gone. Fireplaces were evident on the ground and first floors of the main entrance space, part of the later 19th century redevelopment of the paper mill. The main mill building is of red brick, with a later extension to the east side of masonry. The area of the wheel-pit was obscured by vegetation but the tail-race is still well preserved (M.Ings, 2013)

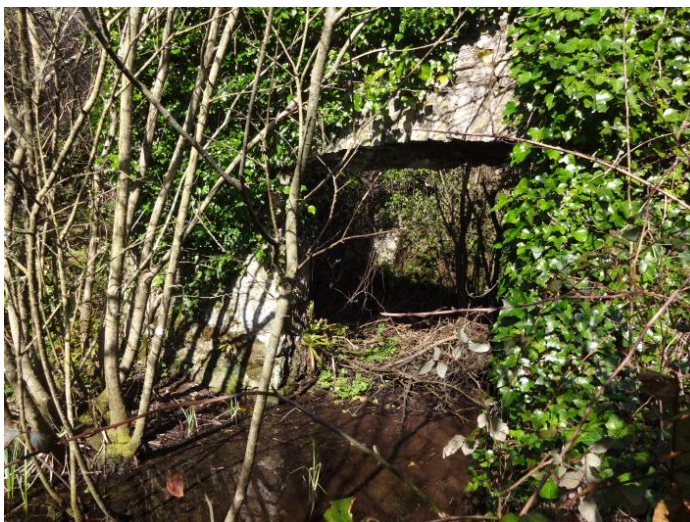
The site was visited as part of the Cadw funded Mills Survey of 2012-14. It is a gable-ended, two-celled building of rubble stone built into a steep bank, with an extension against the southwest-facing elevation. The walls have been consolidated and stand to approximate full height but the roof has gone. There is a doorway, with pitched-stone lintel, in the southeast-facing gable. A wide, arched aperture, for egress of the tail-race, is in the southwest-facing sidewall, through into the second cell at the northwest end of the building. The interior of this second cell proved inaccessible. This is where the overshot wheel was once housed and there is an axle aperture through the internal, dividing wall (M.Ings, 2014).

A three-storey building, now roofless. Some evidence of restoration on south-east end. Two-celled structure internally. No machinery or other features survive. No clear indication of where the wheel-pit was located. The mill is situated against an earth-built dam which would have contained a mill pond, now silted up (KM 1996)

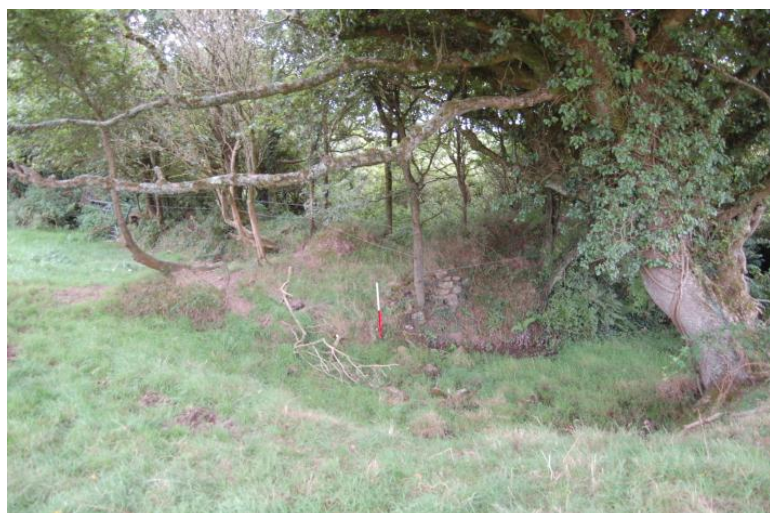
within a pasture field. Although little visible structure remains, with just one small section of masonry preserved, alongside the remnant of the wheel-pit, the platform where the building once stood is evident. The stone from the building has presumably been taken for use elsewhere. The earthworks delineating the extent of the mill ponds to the east of the mill also survive, although the easternmost is now in an area of fenced-off, thick vegetation. The mill-race
