MEDIEVAL AND EARLY POST-MEDIEVAL MILLS

A THREAT-RELATED ASSESSMENT 2012-14

Prepared by Dyfed Archaeological Trust

RHIF YR ADRODDIAD / REPORT NO.2014/7
RHIF Y PROSIECT / PROJECT RECORD NO. 102665

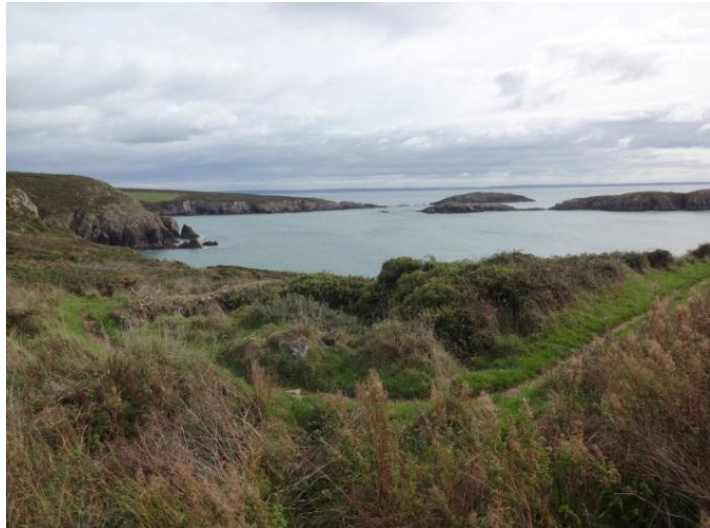
The site was visited as part of the Cadw funded Mills Survey of 2012-14. A local farmer suggested that it was once a gorse mill, preparing feed for horses. The site was as described previously, ruinous and heavily overgrown with vegetation that obscured the interior. The building is built into the hillside above Porth Henllys, with the Pembrokeshire Coastal Path diverted around it. The only masonry that can be seen clearly is the east-facing wall, which stands some 0.60m externally and 1.40m internally. The north-facing wall revets the hillside and does not survive above ground-level. There is a possible entrance-way in the northeast corner. The wheel-pit appeared to be located adjacent to the west-facing wall, although its edges could not be defined, and some masonry detached from the building (to the north of the footpath) may be associated with a sluice on the leat feeding down from the mill pond above - again, this was all under thick vegetation that prevented a clear view. The slope to the south of the mill drops away sharply (M.Ings, 2013)

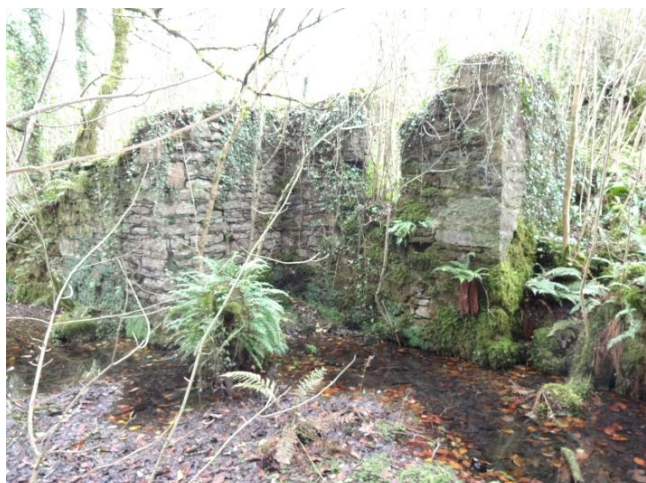
historic maps indicate the mill race to run down between two buildings before the tail race returns it to the stream. The building to the east is a two-cell structure. Some of the walls survive to almost full height, others, particularly the south-facing elevation, have collapsed. The interior is obscured by stone tumble, piled against the interior walls and preventing a view of the building floor, and vegetation. Many young trees are also growing within the ruins. A possible wheel-pit, which would have accommodated an overshot wheel, was noted alongside the west-facing end wall. Here there is an arched aperture through the wall - possibly where the wheel axle once fitted. A rectangular recess in the ground on the inside of this wall may indicate the position of a hurst-frame but no certain mill features were evident. The building to the west is more substantial and the walls survive to approximately full height, with two arched windows in the north-facing elevation and an arched doorway in the west-facing wall. The interior was inaccessible. This was thought to be a house associated with the mill, although it is possible that, given the plurality of the site name, it could be a second mill. No features to indicate it as such were evident. The historic maps suggest the mill race feeds into a holding pond, the flow then controlled by a sluice, to the south of these two buildings. There is a curving stone wall standing some 3 metres high which may be the retaining wall of the pond located above the mill. Thick vegetation prevented further exploration of this feature. The mill race could be seen surviving as an earthwork to the southwest of the buildings but could not be traced far due to access problems (M.Ings, 2014)

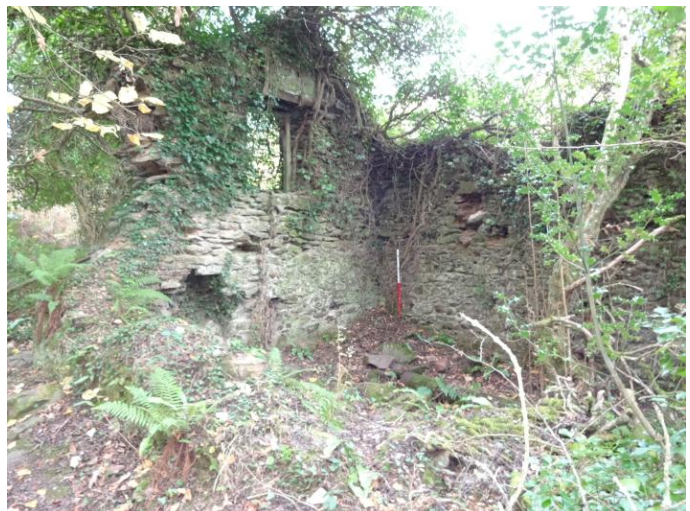
The site was visited as part of the Cadw funded Mills Survey of 2012-14. The mill building is as described in 1997, with the wheel-pit alongside the northwest-facing side wall. Iron brackets are affixed to either side of the pit where the wheel axle would have hung. The remains of the axle still lie within the mill ruins. The channel from the mill pond (PRN 34551) to the wheel-pit has been lined with bricks, possibly when the wheel was replaced by a turbine (M.Ings, 2013)

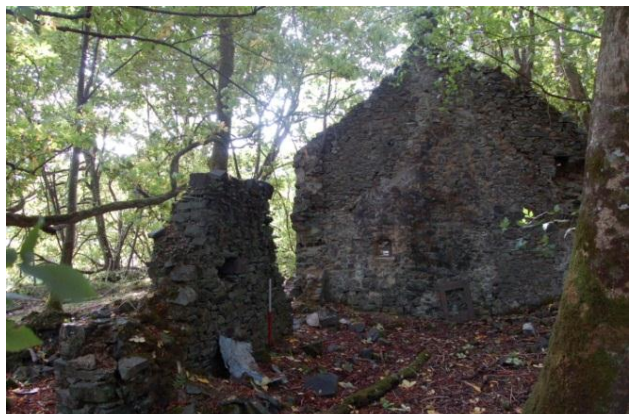
there is a further cottage on the other side. All are ruinous but the mill is the most damaged, with only a section of the southeast-facing wall standing to any height. The northwest wall, which revets the bank cut to form a building platform, survives only to ground level and the northeast-facing end wall has all but gone completely. In contrast, the adjoining dwelling, while roofless, survives to approximate full height. The mill-race, which survives for much of its length as a silted, vegetated earthwork, leads to the northwest corner of the mill, where masonry indicates the location of the wheel-pit alongside the northeast-facing wall. No machinery survives. The tail-race is still evident, running beyond the building to the southeast (M.Ings, 2013)

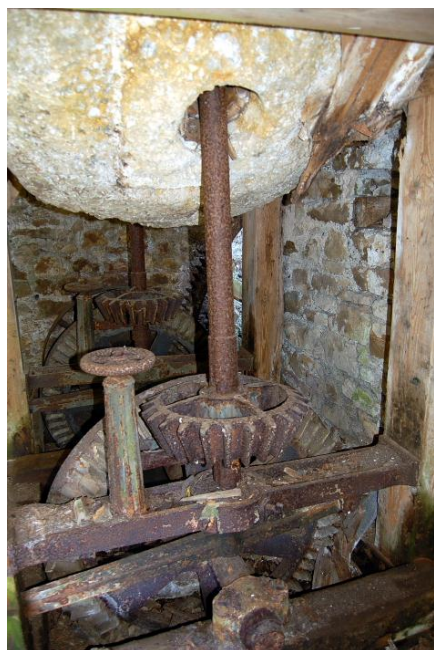
The site was visited as part of the Cadw funded Mills Survey of 2012-14. It is now ruinous but has been bought by the current owner with planning permission to restore it and he is embarking on a 15 year project to not only renovate the mill, but also the nearby mill house, cow shed and barn. The mill still stands complete but there are some structural problems and the roof requires repair. The iron frame of the waterwheel is still within the wheel-pit and much of the internal workings, including the axle-wheel, hurst frame and two pairs of mill-grit stones are preserved. A corn-drying kiln is located within the northeast corner. The mill-race and tail-race are preserved but do not currently hold water. The mill pond has recently been dredged. At some point in the future the owner hopes

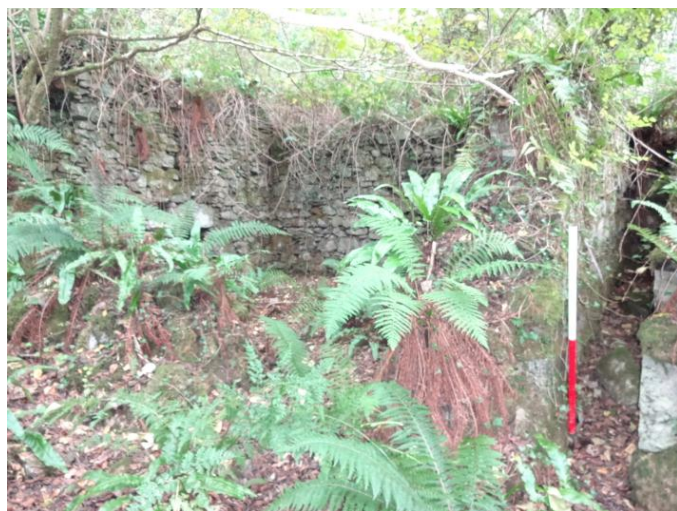
dwellings, to the south and two adjoining industrial buildings to the north. The mill stream is diverted off the river, to the south, towards the western industrial building, the wheelhouse. The wheel-pit, recorded to be on the southern side of this building, was totally obscured by thick vegetation at the time of the visit. The second industrial building was more accessible and the furnace was seen (as previously recorded) in the west wall, with an ash box sunken into the floor in front of it. Possibly this building was a corn-dryer (M.Ings, 2014)

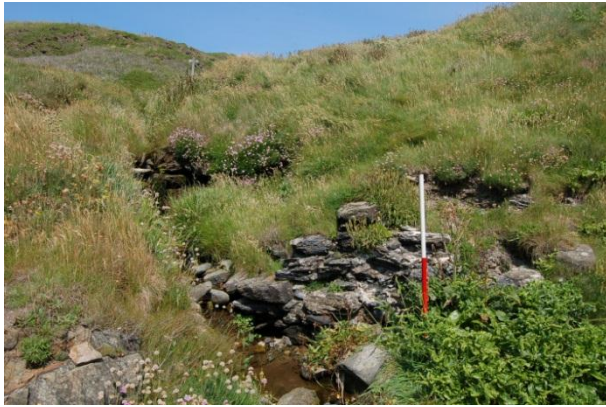
Greatmire Mill is recorded on the 1845 Marloes Parish tithe map and the 1875 1st edition Ordnance Survey map, by which time it is labelled as being in ruins. It is located just above the foreshore of Marloes Sands. Not shown on subsequent mapping. Possibly the same site as a medieval mill (PRN 12491) shown on Rees' map of Wales in the 14th century. Mortared masonry, with possible associated earthworks, was found at the location during a site visit in 1996

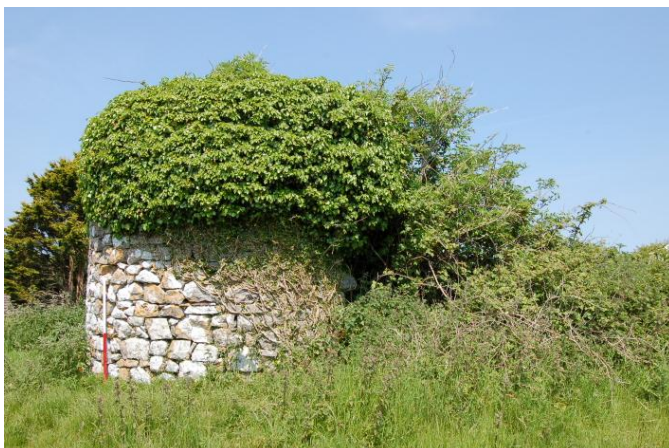
Site of a windmill with a straight-sided tower located near Tarr Farm, on the edge of Manorbier. It is recorded as "Old Windmill" on the 1866 1st edition Ordnance Survey map and presumed disused by this time. The site is still shown on the 1907 2nd ed. OS but not on modern mapping. The ruinous tower is evident on recent (2009) aerial photographs (M.Ings, 2013, from various sources)

The site was visited as part of the Cadw funded Mills Survey of 2012-14

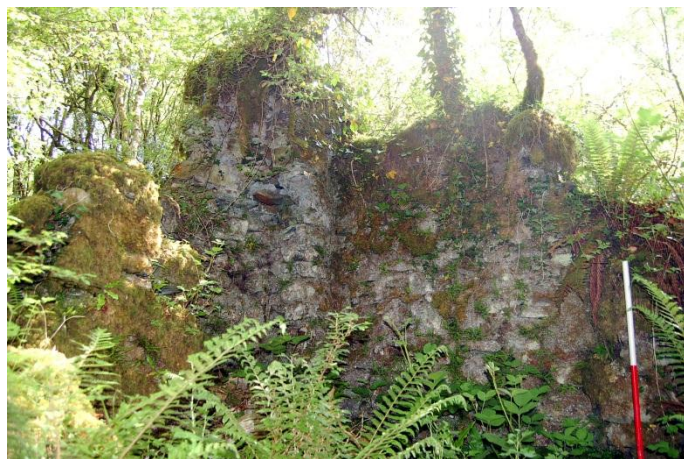
explored further. The interior was obscured by vegetation. The mill stands below a high revetment wall, possibly of the holding pond above. An enclosure or boundary bank was evident to the west of the mill, but again thick vegetation obscured its extent and function (M.Ings, 2013)

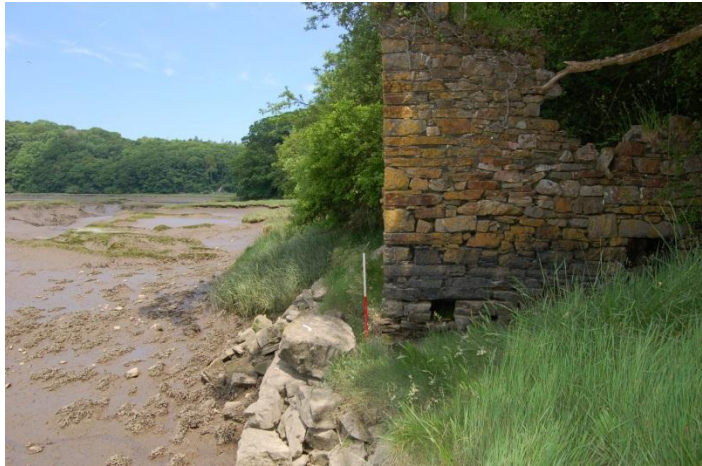
The mill was visited as part of the Cadw funded Mills Survey of 2012-14. It is built of semi-dressed stone right on the edge of the Minwear Pill mud-flats, on a stone-edged platform. It is now in a ruinous condition and the interior is obscured by stone tumble. A stone-lined wheel-pit is preserved alongside the south-facing end wall, which would have accommodated an overshot wheel. The square aperture for the wheel axle was evident within the wall but the wheel, recorded in 2000, has gone. The owner of Minwear Farm told me that when they first moved in there was a mill-stone at the site but this too has since disappeared. A possible internal division was noted, although heavy vegetation on the northwest corner prevented a clear view. A further section of masonry was recorded above the mill, within the woodland to the southeast, possibly the corner of a boundary wall. A holding pond (PRN 105998) is also preserved above and behind the mill, with a substantial bank on its southwestern side and a stone revetment wall to the north. This appeared to be fed by a leat running in from the southeast but it was unclear where this diverted water from as woodland undergrowth made it inaccessible (M.Ings, 2013)

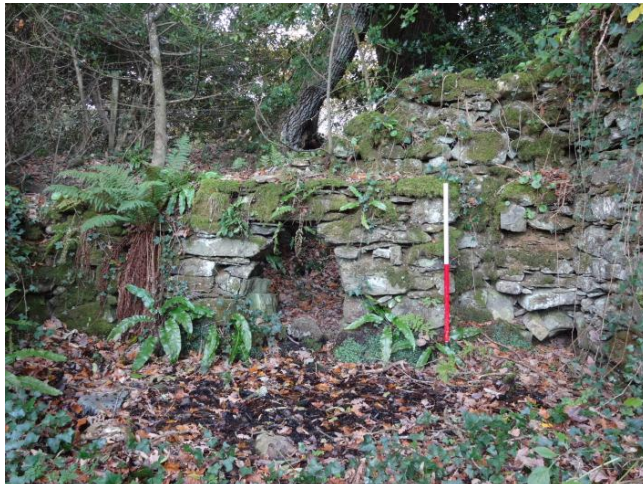
Recorded by the RCAHMS as a corn mill. Buildings appear to be roofless by at least 1907 and are shown as ruinous on modern maps (M.Ings, 2014)

The site was seen as part of the Cadw funded Mills Survey of 2012-14. There are three ruinous buildings, with the mill building standing to the southeast of a possible cottage and outbuilding. The footprint of the mill survives, with walls standing approximately 1m to 1.3m high although the north-facing end wall has largely collapsed. The interior is now obscured by stone

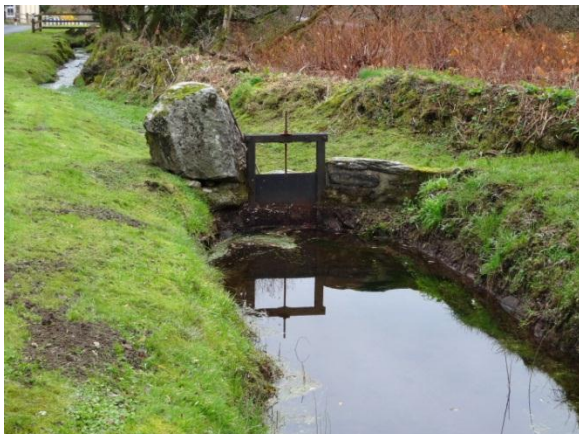
Mill race powering Maenclochog corn mill (PRN 20859) recorded on the historic Ordnance Survey maps. Possibly has medieval origins as a watermill (PRN 12573) is recorded in the vicinity on Rees' (1932) map of South Wales & Border in the 14th century (M.Ings, 2014)

The site was visited as part of the Cadw funded Mills Survey of 2012-14. The mill-race is preserved as a distinctive earthwork, still carrying water from the river to the wheel-pit, where it drained off along the tail-race. Part of the race is hidden beneath a grassed-over culvert, but on the long stretch that is visible there is a sluice gate still in position (M.Ings, 2014)
