MEDIEVAL AND EARLY POST-MEDIEVAL MILLS

A THREAT-RELATED ASSESSMENT 2012-13

INTERIM REPORT

RHIF YR ADRODDIAD / REPORT NO.2013/28

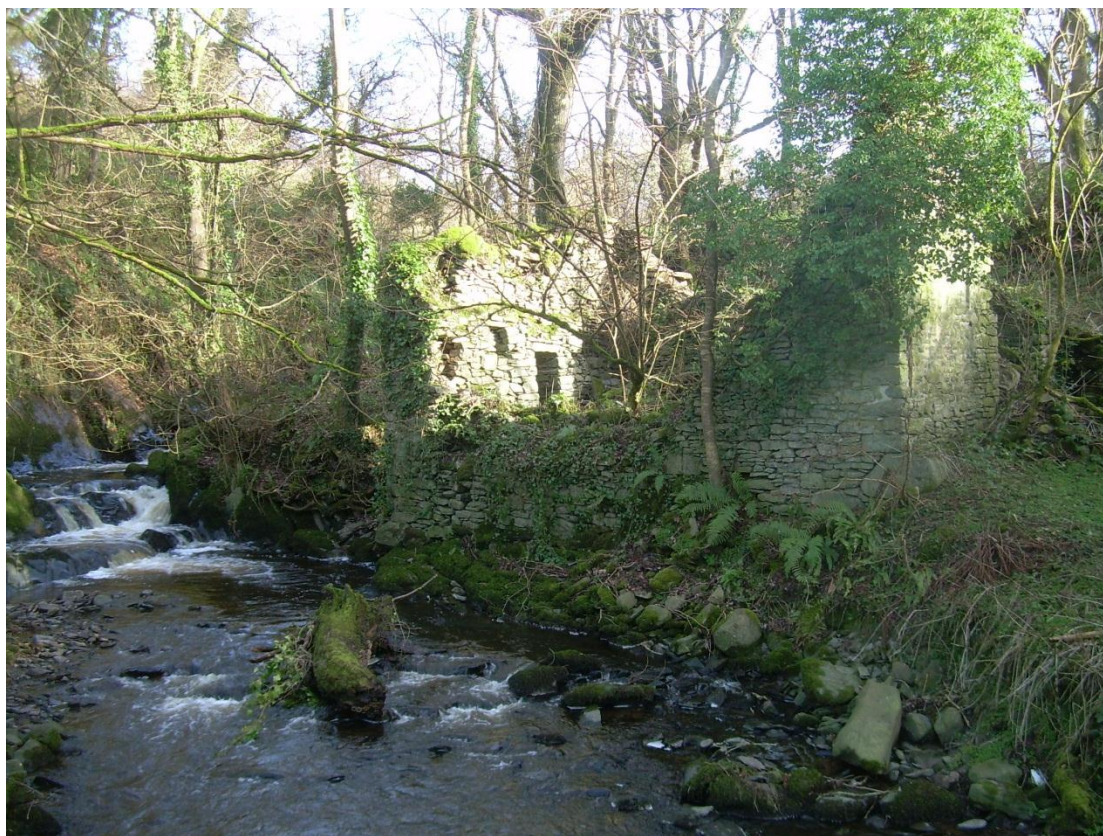
The ruins of Felin Fach (PRN 4807) on the bank of the Afon Peris, Ceredigion

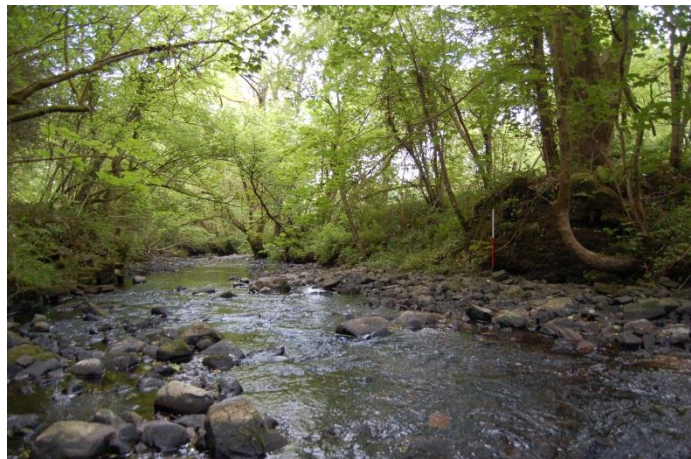
The site was visited during the Cadw funded Mills project of 2012-13. The supports for the aqueduct survive on either side of the river, comprising structures of semi-dressed stone blocks standing some 1.60metres high and 4.00 metres wide at the base. No evidence survives for any structure spanning the river (M.Ings, 2012)

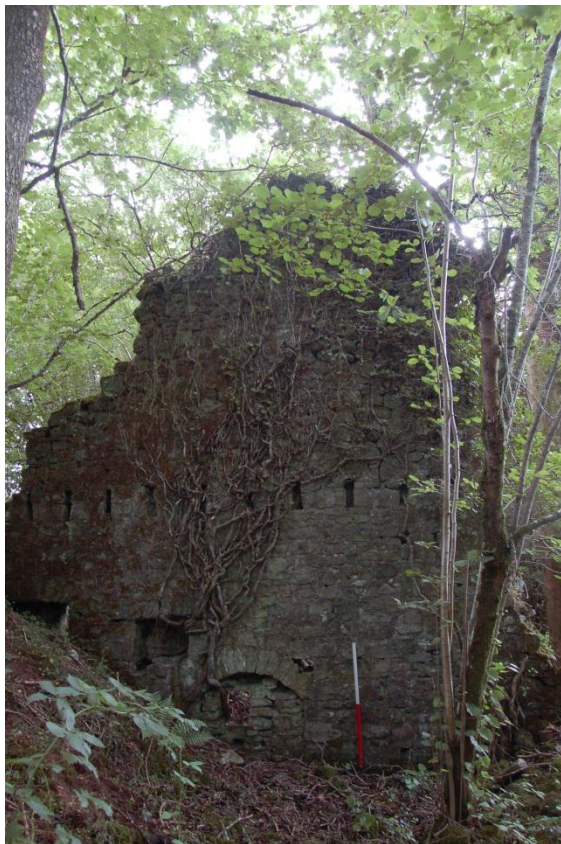
A possible mill ruin, located just north of Pont Gelli , has been suggested by a local historian Lewis J., 2012) as the site of 'Felin Arthur', referenced in the 1841 census. This building is recorded on the tithe map for Llandeilo Fawr and as a ruin on the historical Ordnance Survey maps (M.Ings, 2012)

framework for machinery internally. There is a second square aperture, with a pitched stone lintel, near the northeast corner - possibly providing access to control the waterflow from the launder. Presumably the mill was powered by a leat from the slope above and a channel running along the slope, parallel to the northern wall, leading to the northeast corner was noted. Although it could not be tracked back further into the woods, it possibly follows the current field boundary to the stream above. A steep hollow adjacent to the east wall may be the location of the wheel-pit, now heavily silted and vegetated. The only feature noted on the southwest wall was a ventilation loop (M.Ings, 2012)

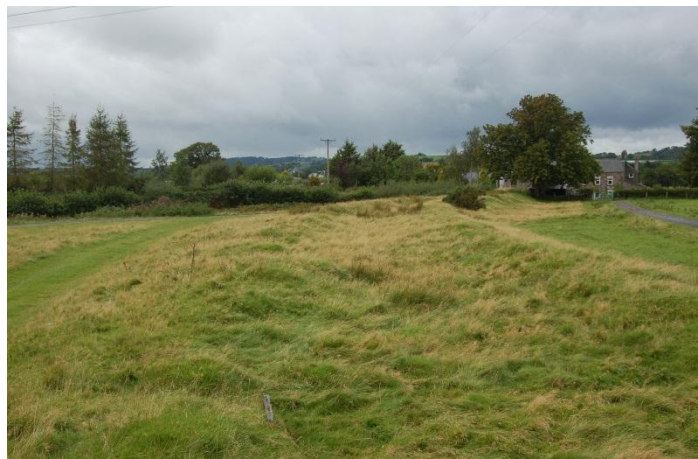
The site was visited during the Cadw funded Mills Survey of 2012-13. The mill-race is largely preserved as a distinctive, grassed-over earthwork running across the rough-grazing of Carreg-Sawdde Common. The original weir, where the mill-race is shown to divert from the Afon Sawdde on the historic Ordnance Survey maps, is no longer there, although a more recent weir has been established a little further upstream. In parts, the race is some 2m wide and 0.50m deep, while other sections are less distinct. As it approaches the mill it is raised on a wide, partially stone-revetted bank. The tail-race is also well preserved as it runs alongside the track to Godregarreg Farm. The section from the farm back to the river was not seen (M.Ings, 2012)

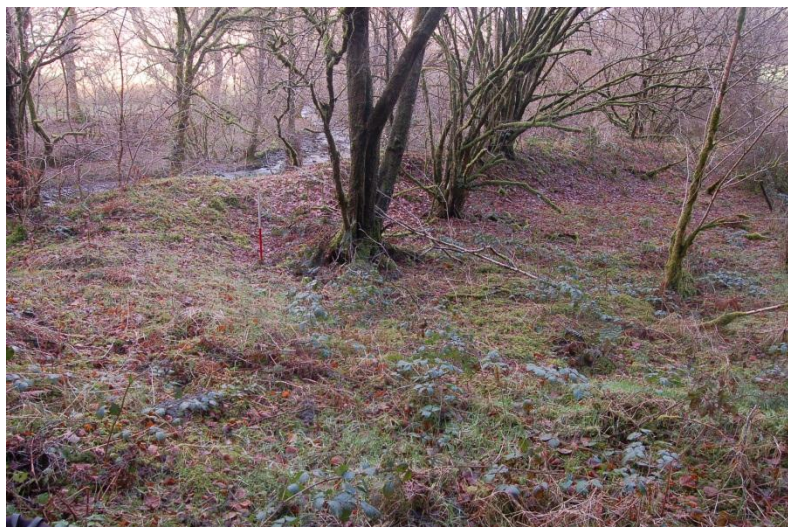
The site was visited as part of the Cadw Funded Mills Survey of 2012-13. The mill-pond is now within woodland above the Nant Peiran but survives as a substantial earthwork with a wide north and west bank still standing over a metre high. The interior is now silted and/or infilled and vegetated, although still boggy in part. It is located above and behind the former site of the mill building and is linked to the Nant Peiran by a mill-race (PRN 105376) to the north (M.Ings, 2013)

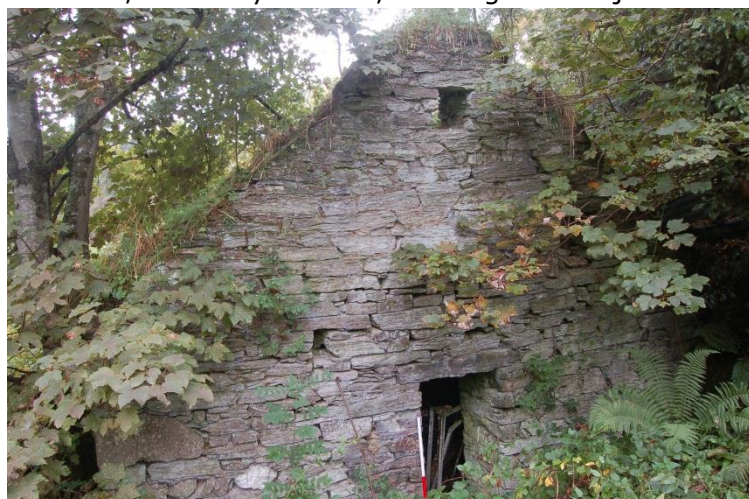
Felin Ganol - Middle Mill - is recorded as a corn mill on the 1889 1st edition and 1906 2nd edition Ordnance Survey maps, associated with several other buildings, possibly representing a farmstead complex. Water power was provided by a leat that led from a pond created on the stream flowing east and south of the mill. Modern mapping still depicts the complex of building, although in a partially ruinous state (M.Ings, 2012) The site was seen as part of the Cadw funded Mills Survey of 2012-13. It is now within thick woodland and was very overgrown at the time of the visit. The two-storey mill, of semi-dressed stone blocks and squared quoins, is built into a natural slope and it is probable that an overshot wheel (now gone) would have been affixed to the east gable, which stands to almost full height. The leat is carried along a terrace cut into the hillslope northeast of the mill and channelled, via a stone trough, to the top of the wheel-pit. The building is now roofless and fallen sheets of corrugated-iron lie in the interior, obscuring any possible features. A pair of granite mill stones have been incorporated into the patio of the nearby house, named after the mill. It was evident that a further, now very ruinous, building once adjoined the mill to the south, although this

was largely obscured by impenetrable vegetation. Access to this building through the south side wall of the mill had been blocked up, possibly after the adjoining building became disused. The masonry of this dividing wall has been damaged by a falling tree and it has collapsed at its western end. Upslope of the mill to the north is the ruin of a substantial, three-celled longhouse, aligned east-west. This building is again roofless.

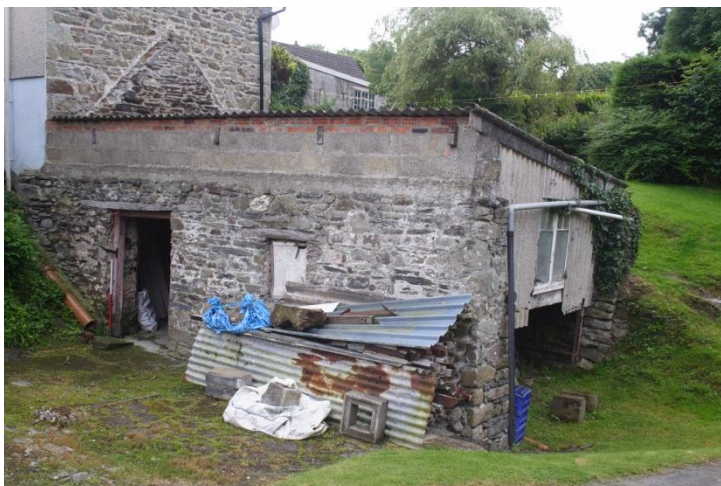
The site was visited as part of the Cadw funded Mills Survey of 2012-13. The plan of the mill survives, adjoining, and downslope from, the farmhouse but the pitched roof has been replaced, in the 1960s, with a flat roof of concrete, breeze-block, red-brick and corrugated iron. The shape of the original east gable is evident on the west gable end of the farmhouse. A.J.Parkinson noted (1984) that there was no lower gable and suggested that the mill may have been converted from a pandy, as several pandai are known with a similar lack of a gable. Too little now remains of the west end of the mill to determine its original appearance. An inscribed date of 1754 appears on the south face of the northeast stanchion, above the now infilled wheel-pit.

The metal frame of the overshot wheel can be seen protruding from the ground. The two uprights of the hurst frame (the internal framework supporting the gears and millstones) are recorded as surviving in 1984 but were not seen during this visit. The wheel was powered from an adjacent pond, located to the south and above the mill, now filled in and grassed over. Water was diverted to the pond off the Afon Howni, to the south, and returned to the river to the northwest. The leat has now been infilled (M.Ings, 2012)

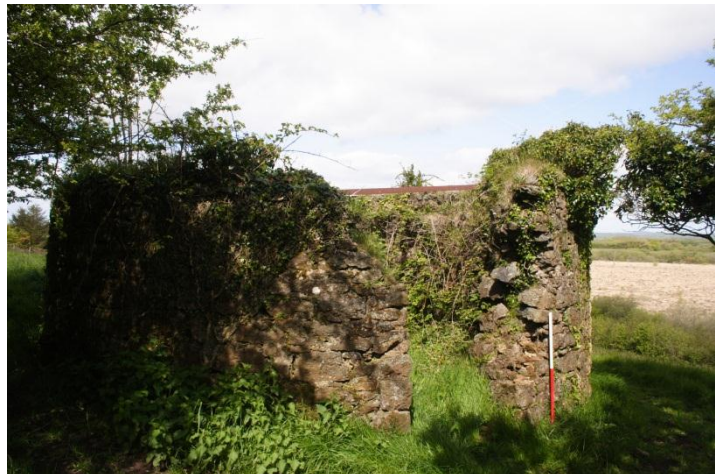
It stands at the top of a fairly steep, north-facing slope, within a pasture field. There is an entrance to the east and a window aperture opposite. Two iron bracing-bars span the structure and masonry has evidently fallen, particularly from the internal, southeastern wall (M.Ings, 2012) "On the roadside leading from Llangynnock to Carmarthen will be found the ruins of a windmill. No one now living remembers it at work; it is said, however, to have been in use about 90 years ago. The then miller was a noted character...." TCASFC 1909-10 vol.5, p.74

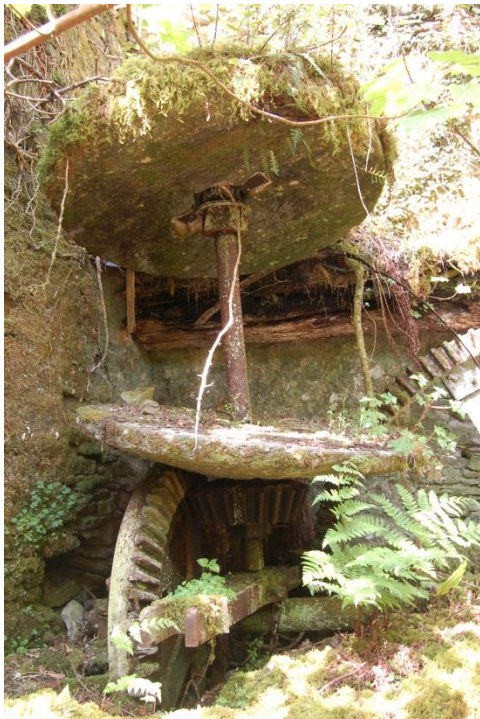
The site was visited during the Cadw funded Mills Survey of 2012-13. The mill is now a substantial ruin with many walls standing to full height, although completely unroofed and with several areas of masonry tumble. The main structure is a two-celled, gable-ended building on a levelled platform above the river. The wheel-pit is located adjacent to the north side wall and water from the mill-race diverted from the Dewi Fawr would have powered an overshot wheel. This has now gone and the wall masonry is partially collapsed where it was originally affixed. Some internal machinery survives including an iron pit wheel, still in situ, the face-wheel and, on a vertical shaft, the stone-nut and a pair of millstones. The second cell of the main building, adjoining the mill to the south, contains a possible chimney breast on the dividing wall, suggesting it may be an

adjoining mill-house. However, tumbled masonry obscured the northeast corner and prevented a clear look. Two extensions adjoin the possible mill-house, one abutting the south gable, and the other, half-gabled, on the west side. Three outbuildings adjoin the south extension and there is a further outbuilding to the rear of the mill, cut into the bank. The mill-race is obscured by dumped material at the point it reaches the wheel-pit and by thick vegetation elsewhere (M.Ings, 2012)

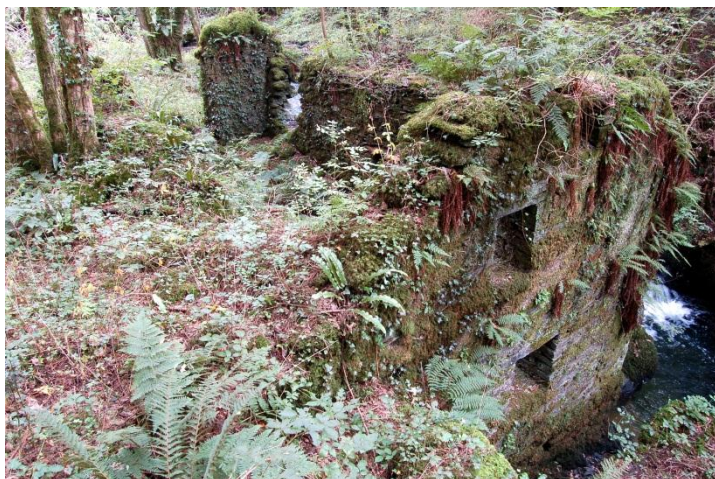
Felin Cwrrws is shown on the historic Ordnance Survey maps and is recorded (Parkinson, 2004) as a ruined water-powered corn mill that was in use until around 1940. It had an overshot wheel, a single pair of stones and a pre-spur wheel gear. Parkinson classifies it as a Vitruvian Mill (M.Ings, from various sources, 2012)

The site was visited as part of the Cadw funded Mills Survey of 2012-13. The mill is now a roofless ruin, within an area of woodland, and no machinery now survives. Roof slates and timbers lie within the interior. The two mill stones are now located near the entrance to the owner's house, named after the mill. The walls, of split slate rubble, stand to almost full height. There is an entrance-way, with a (now fallen) wooden lintel, in the east gable and a possible blocked

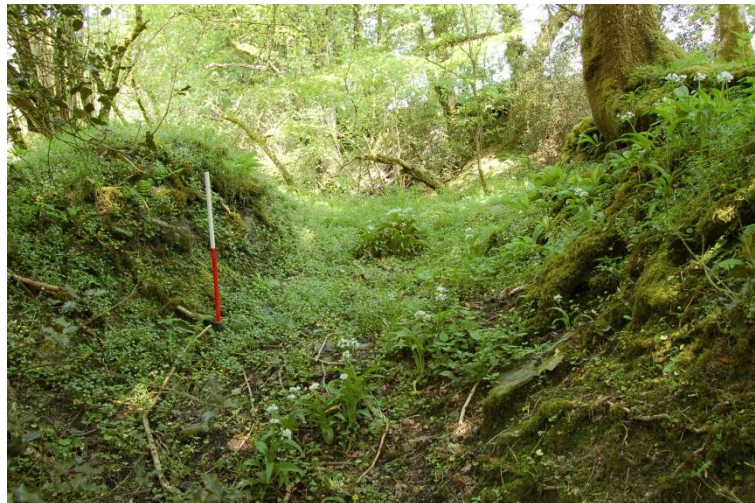
Some further masonry, on a possible levelled platform, was noted to the west of the mill, which appear to be the slight remains of a small, square structure shown on the historical Ordnance Survey maps. Extensive earthworks are also preserved in the vicinity of the mill, although these too were somewhat obscured by vegetation. The mill-race was traced back towards the stream, as far the farm boundary. It runs along

the base of the natural, slope with an earthwork bank created on the western side. Two possible holding ponds were apparent above the mill, both now very silted. A channel appears to lead down from the northernmost pond, past the small, square structure - possibly infrastructure for a sluice? - and on to the northwest corner of the mill (M.Ings, 2012)

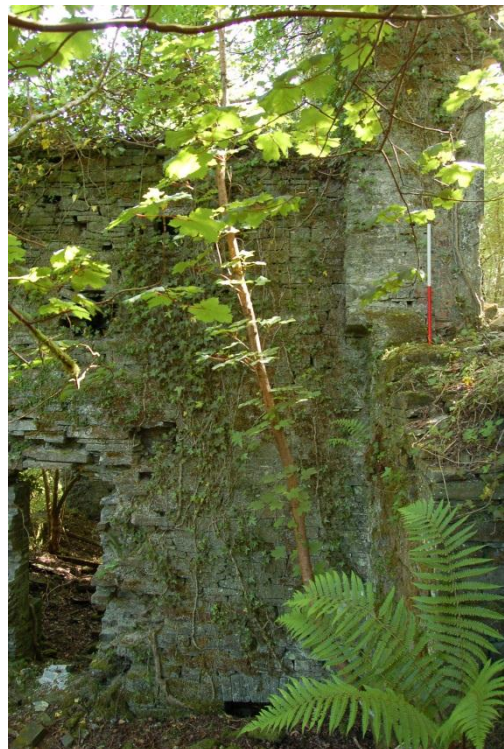
heavily silted and vegetated. It is located below a high, north-south, stone wall which projects out from the northwest corner of the mill, again cut into/revetted the bank, and water from the mill-race would flow over the edge to power an overshot wheel. No machinery survives within the mill. Adjoining the mill to the south is a gable-ended extension, standing slightly narrower and less high than the mill. Three stone, flue-like structures are preserved within this building, which appears to be built on the slope rather than cut into it, creating a two-tiered interior. The RCAHMW record (NPRN 24849) describes this as a drying kiln, of later date. The mill-house stands to the west, at the top of the slope, backing on to the mill at right-angles. It is gable-ended, with a doorway and square window in the north wall and a brick-arched fireplace in the west wall. A separate, square building adjoins the northwest corner of the house and, across the pathway is a well, with water collected in a stone trough. Further outbuildings of unknown function are located to the northeast of the mill, immediately above the river (M.Ings, 2012)

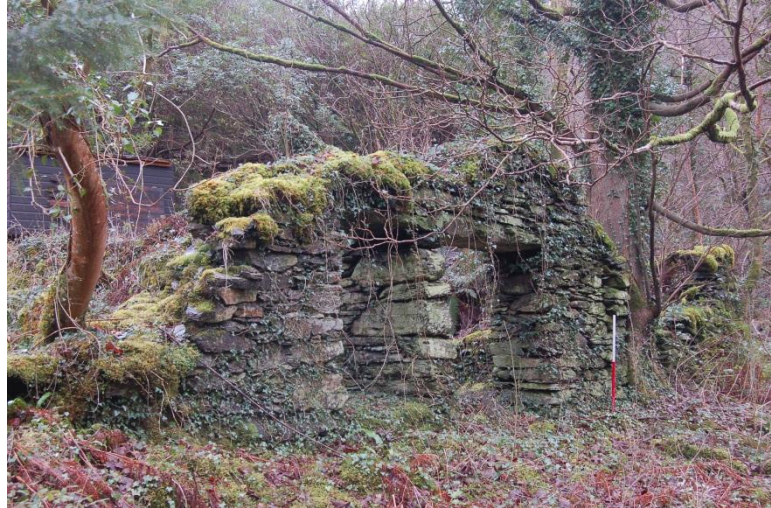
on the private property of a house believed to be converted from millworkers' cottages. The mill is built into a steep bank on the side of the fast-flowing river, which runs very close to its southwest corner. It is now a roofless ruin some 16x6metres and with external walls standing between 1.10-2.0metres high. There appear to be two main cells, as shown on the historic maps, with a doorway to each with stone lintels. Each cell is further

divided east-west. These internal walls stand lower, at some 0.70m maximum. The interior of the building is obscured by tumbled masonry and thick vegetation and no features or preserved machinery could be discerned. The mill's name suggests that it is later than the 18th century corn mill, Melin-y-cwm (PRN 19569), further upriver (M.Ings, 2013)

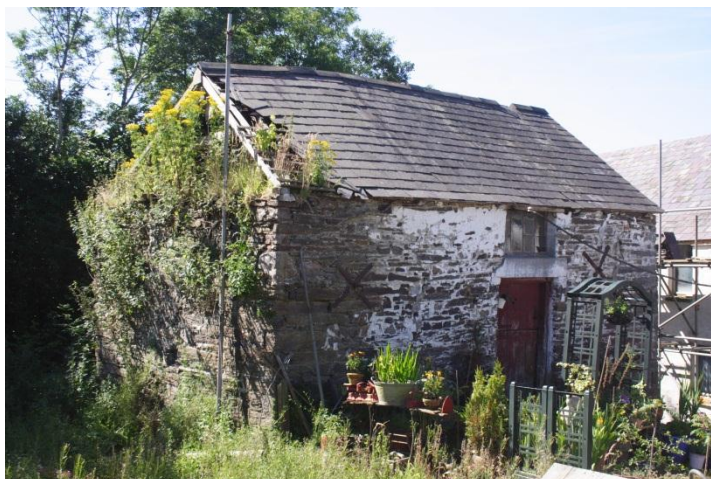
The site was visited as part of the Cadw funded Mills Survey of 2012-13. It is a complex comprising the corn mill, fulling mill (PRN 21369), a corn-drying kiln and farmstead. The two-storey mill is intact, built of local stone rubble with squared quoins

and roofed with slate, although there is some structural damage, largely caused by a collapse of the first floor in the central section of the building. Iron cross ties have been positioned on the external walls to help consolidate the structure. The overshot wheel has now gone and the wheel-pit has been infilled. The internal machinery, thought to date to the mid-late 19th century (RCAHMW, 2002) is largely complete, including two pairs of stones within their wooden casings - French burr stones for grinding flour and Anglesey granite stones for grinding barley. The building was raised during the 19th century to create an attic over the first floor. Two further mill stones are propped up against the corn-drying kiln, located just to the northeast of the mill (M.Ings, 2012)

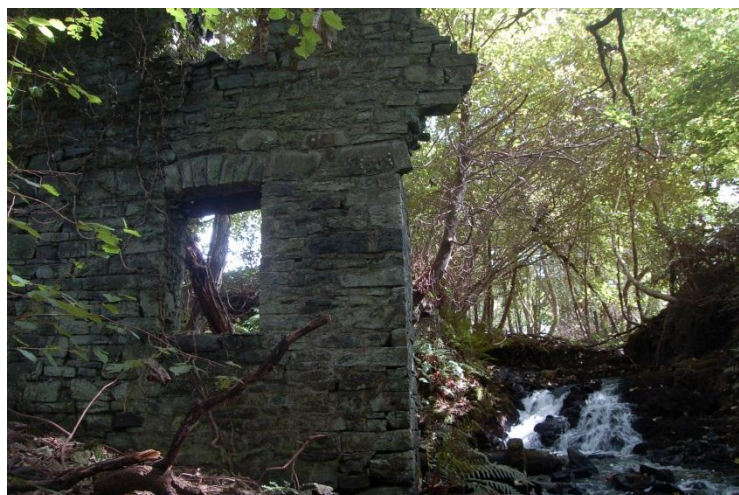
The site was visited during the Cadw funded Mills Survey of 2012-13. The ruins stand beside a fast-flowing stream, just below a waterfall, on a levelled area under a steep bank. Little of the structure survives, with only a section of the west wall, of semi-dressed stone rubble, standing to any height. Here there is a square window and doorway, both with wooden lintels on the ground floor and a partially preserved square window on the first floor. The historic maps indicate that the

mill originally extended over the current stream. Possible masonry is apparent on the far bank, below the waterfall, and it is clear that the first floor of the west wall once extended southward. The wheel would then have been enclosed by the mill building. Fragments of the north side wall were evident but the whole area is strewn with collapsed masonry. The iron axle shaft from the waterwheel lies on the ground, protruding into the stream and a pair of iron-rimmed millstones stand stacked against the west wall. Possible remnant of a metal sluice mechanism remains in situ where the stream passes through the west wall. The mill-pond, created upstream of the mill, now looks dry and partially vegetated but a possible retaining wall on its west side was noted. A row of ruinous buildings located above the mill, to the north, comprise a stable, wagon-shed and a corn-drying kiln (RCAHMW, 2007). These buildings were inaccessible and heavily vegetated at the time of the visit (M.Ings, 2012)

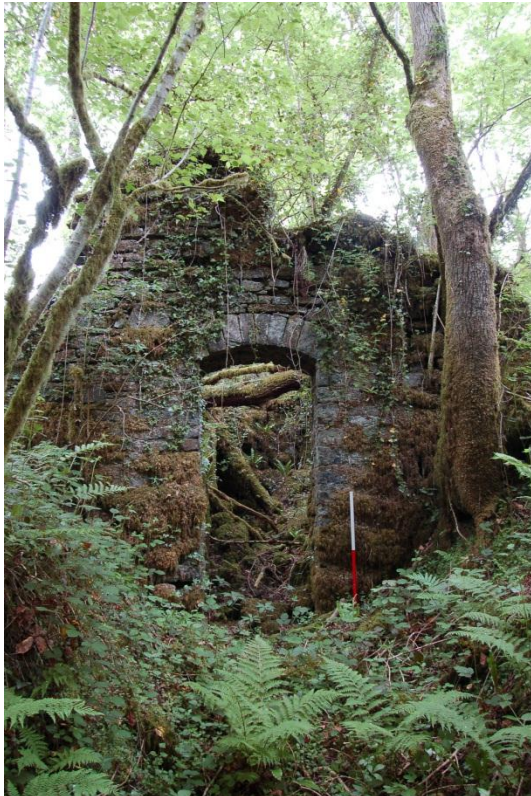
The site was visited during the Cadw funded Mills Survey of 2012-13. The mill is now in an area of thick woodland, within a steep-sided valley flanking the Afon Lash. It is on a levelled platform cut into the bank. The main building, aligned east-west, is divided into

3 cells. Survival of the walls varies, with the southwest, southeast and northeast corners standing almost to full height and much of the south-facing front wall reduced to stone rubble. Tumbled masonry obscures much of the building interior and thick vegetation grows on and up to the remains. The only evident feature of note was the tall, arched doorway near the southeast corner. A hollow way leads from this down to the river. Just to the northwest of the mill is a length of substantial revetment wall, running east-west cutting into the line of the slope. An extensive hollow in the slope above, now very silted and overgrown, possibly represents the site of the former mill-pond. This is fed from the west by a mill-race, the line of which is evident for several metres, running along the base of the slope with an earthwork bank created along its southern side. The second, small building, as shown on modern mapping to the southwest of the mill, is now largely destroyed and covered in undergrowth (M.Ings, 2012)

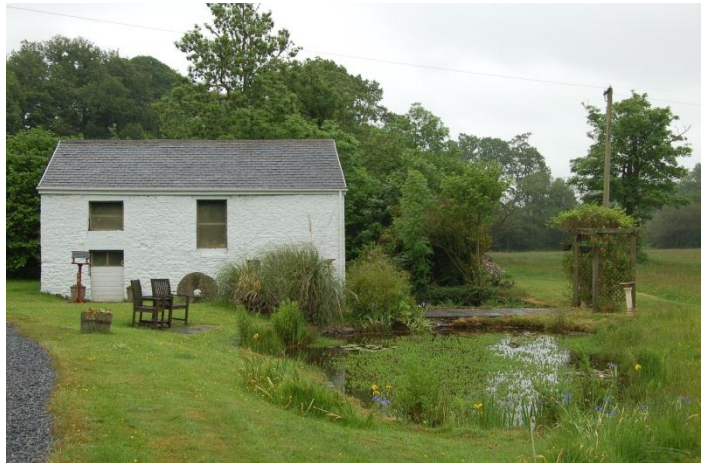
The site was visited during the Cadw funded Mills project of 2012-13. The mill itself, a two-storey, gable-ended stone building with a slate roof, has been restored and converted. The current owners showed me a pre-1902 photograph depicting the mill complete with a wooden waterwheel. The wheel-pit is preserved but the wheel is now gone, and the mill wall has been infilled with bricks where it was once affixed. Four millstones survive, positioned around the garden. The weir on the Afon Gwili, where water is diverted into the mill-race, is still intact and comprises undressed stones and pebbles of varying sizes bonded together. The entrance to the mill-race was also evident with a stone wall some 4-5 courses high. The sluice recorded on the 1906 O.S. map has gone. (M.Ings, 2012)

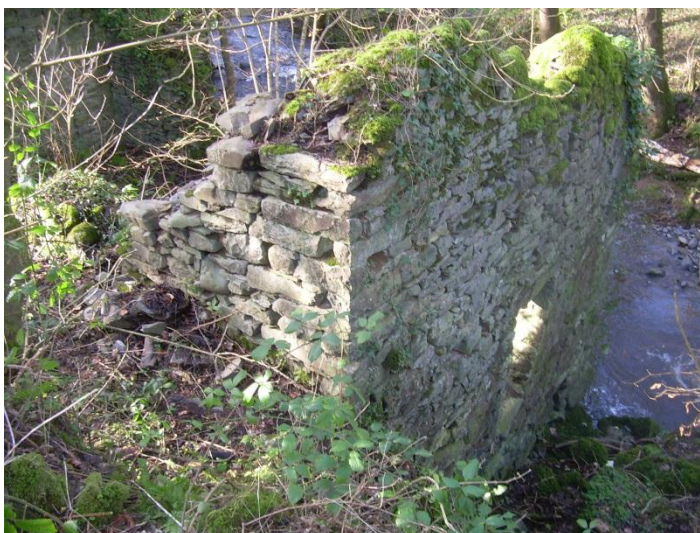
The site was visited as part of the Cadw funded Mills Survey of 2012-13. It is located within woodland on a levelled platform built, of stone rubble with squared quoins, into the bank of the river, revetted by the southeast side wall. The roof has completely gone and the northeast side wall has largely collapsed. The gables stand to almost full height. The entrance is in the southwest-facing gable, now blocked by stone rubble. The

wheel-pit is preserved, adjacent to the northeast-facing gable, and there is a rectilinear axle access through the wall with a stone lintel. The interior of the northeast gable has square niches, presumably to hold the hurst frame. No mill machinery was seen - two smashed mill-stones were recorded in 1988 - but the interior was obscured by stone tumble and thick vegetation. The water-management features are preserved, comprising a weir on the Afon Peris to the east, a heavily silted, vegetated mill-race that runs above and parallel to the river and a mill-pond. This is now silted/infilled and vegetated but its extent is still visible as an earthwork with a revettment wall above the wheel-pit (M.Ings, 2013) Channel, mill ponds visible, mill stones also there.

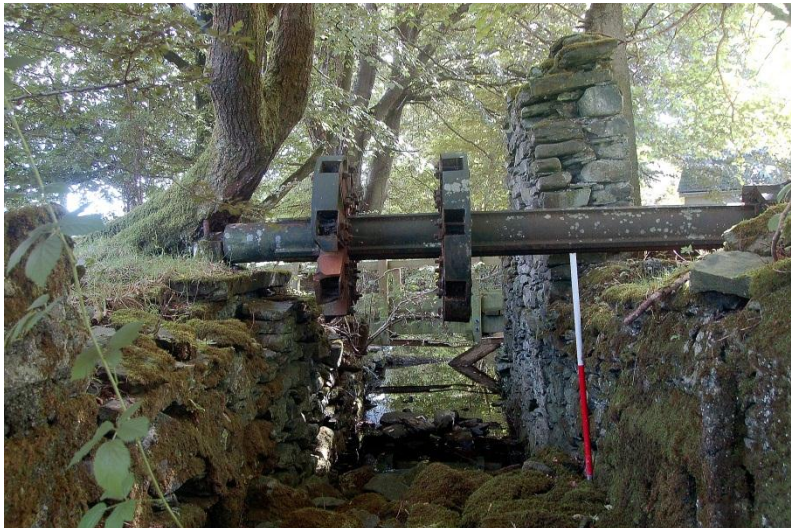
The site was visited as part of the Cadw funded Mills Survey of 2012-13. The mill is now almost totally destroyed. The historic maps indicate that the mill straddles the mill-race but very little of the structure survives. The only standing masonry is the section of the wall above the west edge of the mill-race and wheel-pit, through which the waterwheel axle shaft is inserted. A concrete pillar stands against the inner side of this wall,

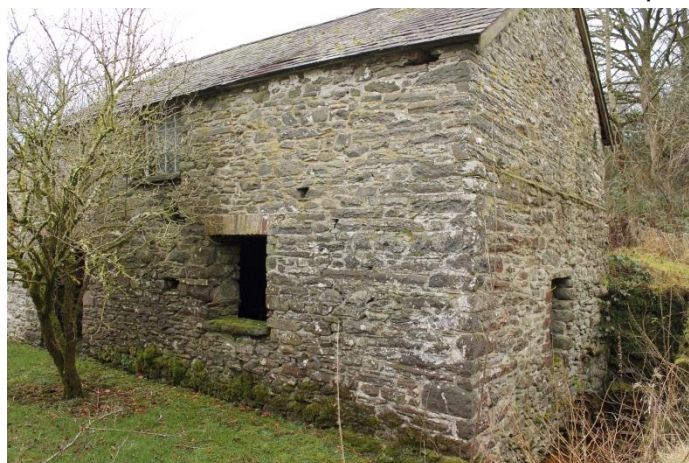
The site was visited as part of the Cadw funded Mills Survey of 2012-13. Unfortunately the current owners were away so a detailed survey of the site was not possible. The gable-ended mill building is of

stone rubble with squared quoins and a slate roof. There is a doorway, groundfloor window and first floor window in the east-facing facade. It is built into a steep bank and the window apertures in the rear wall are into the first floor. A later stone building adjoins the south-facing gable. The wheel-pit is alongside the north-facing gable and the iron frame of a wheel is in situ. A low aperture is presumably where the wheel axle passed through the wall. No internal machinery was evident and the building looks to now be used as a workshop. The holding pond and mill race were not explored. Further information was supplied by the current owner (by email): there was a mill on the site at least as early as 1130, belonging to Strata Florida, but the date of the current building is not known. The overshot waterwheel disappeared a long time ago and the current Pelton wheel was installed relatively recently. There are plans to get the mill working again, with help from the Welsh Mills Society, through dredging the mill-pond and replacing the Pelton wheel (M.Ings, 2013)
