# MEDIEVAL AND EARLY POST- MEDIEVAL FISH TRAPS: A THREAT-RELATED ASSESSMENT 2012

RHIF YR ADRODDIAD / REPORT NO. 2012/59  
RHIF Y PROSIECT / PROJECT RECORD NO. 102815  
DAT 120

# MEDIEVAL AND EARLY POST-MEDIEVAL FISH TRAPS: A THREAT-RELATED ASSESSMENT 2012

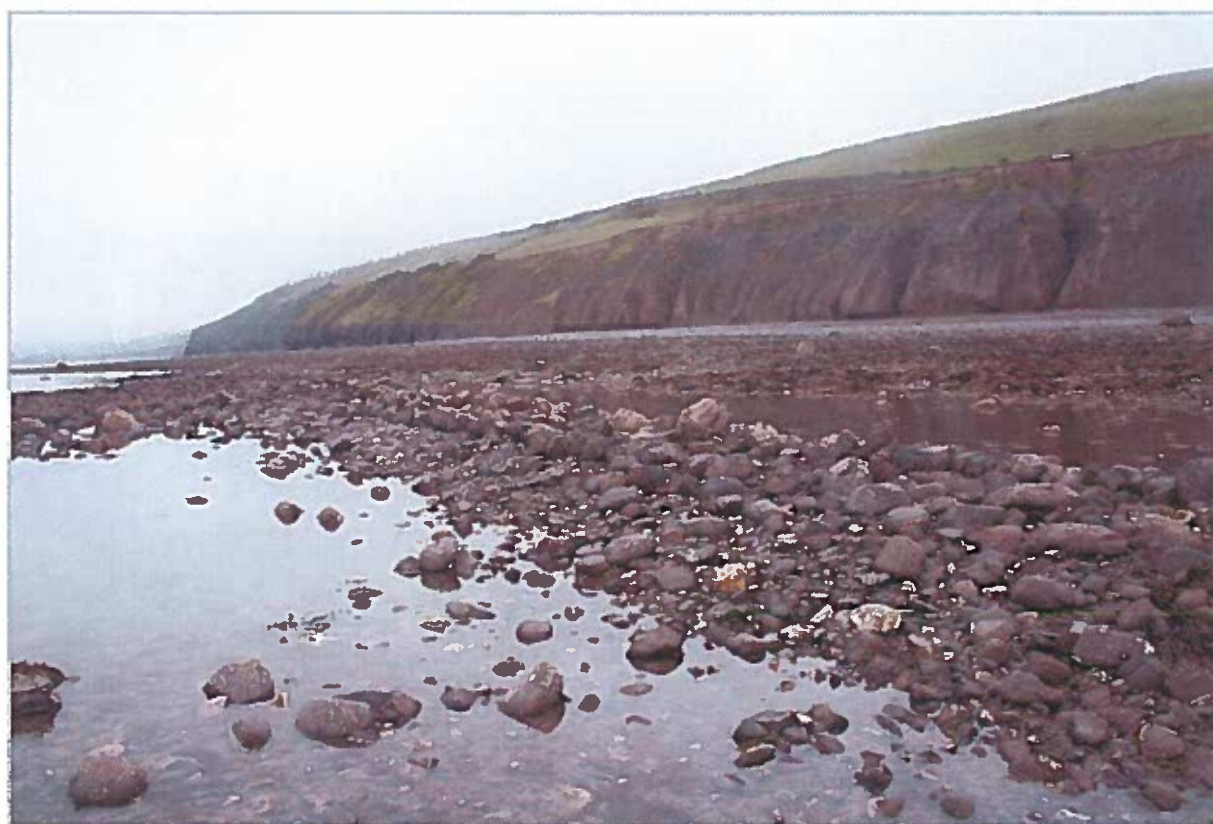
*PRN 32528 A stone built fish trap situated on the stone and shingle foreshore northeast of Aberarth, Ceredigion.*

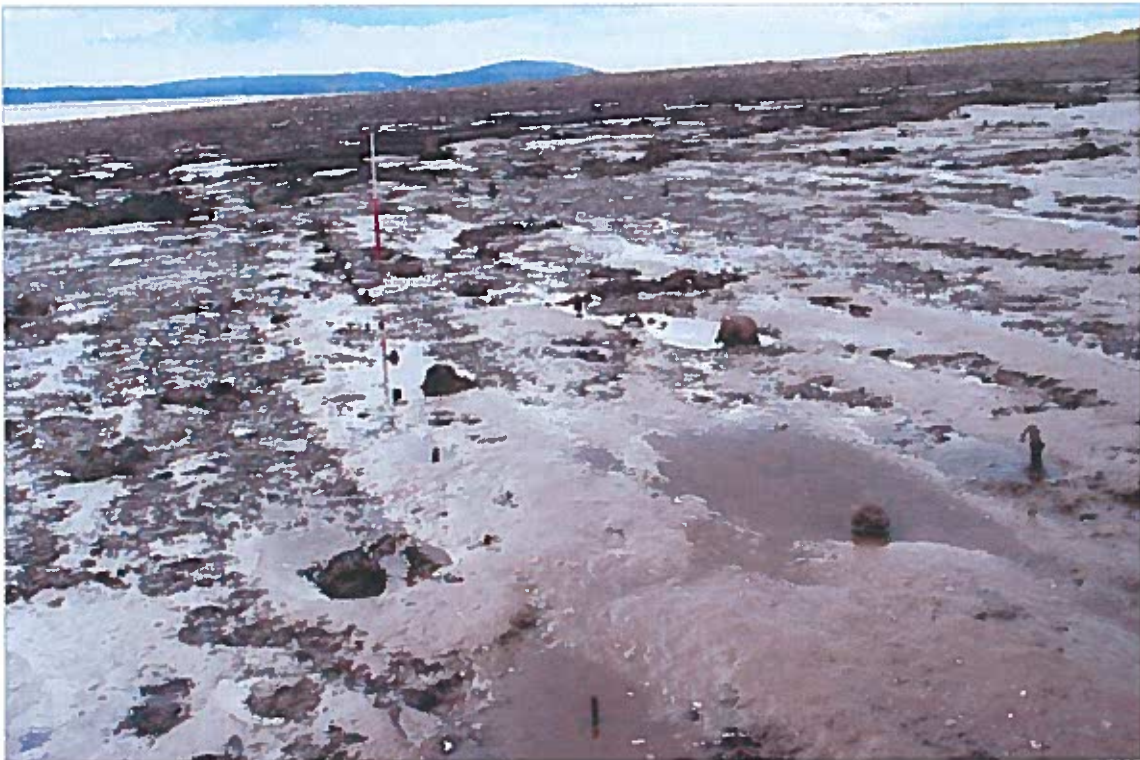
Photo 1 – PRN 31247. The remains of lines of wooden posts that once supported nets found within the intertidal zone at Morfa Bacas.

- The biggest concentration of sites visited during this project was centred on the submerged forest at Morfa Bacas, within the intertidal zone of the Afon Lougher estuary. In 1998 the area was visited as part of the Carmarthen Bay Coastal Survey (Page, N 1998) and over 200 upright stakes were recorded and samples taken from two of the stakes returned radiocarbon dates from the seventeenth and early nineteenth centuries (Page, N 1997). In 2012 far fewer stakes were visible and the stake-lines that had been recorded nearer the main channel of the Lougher were no longer evident. It would appear that the continued northward movement of the channel is steadily eroding the submerged forest and destroying the evidence of fish traps. In places wooden stakes have been replaced by metal bars and tubes, showing a continuity of use until very recent times (Photo 1).

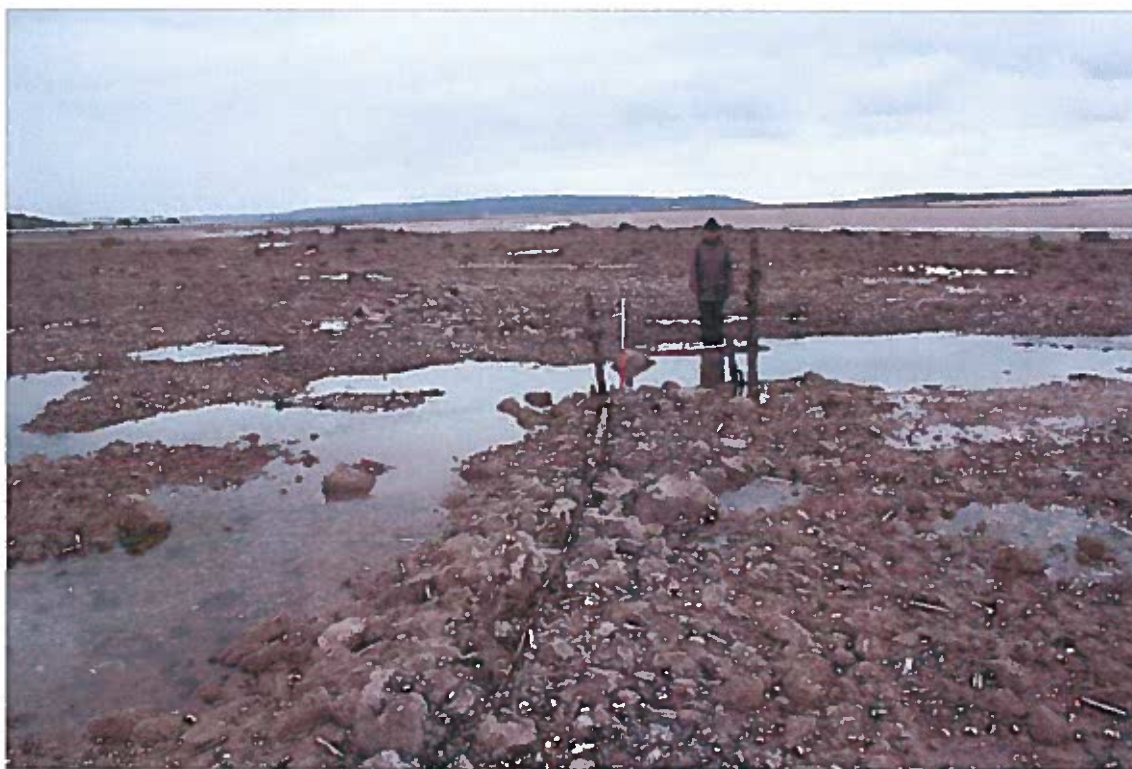
Photo 2 – PRN 30087. The surviving stakes and horizontal timbering of the largest fish weir, Weir A, on Salmon Scar, looking south-east.

The photographs above show the remains of the most substantial of the fish traps on Salmon Point Scar (Weir A as recorded by James & James 2003). This is a complex fish weir that takes advantage of a large hollow within the scar where fish would have been trapped at low tide. Where the scar was highest there was no need to construct any walls but towards the seaward end, approaching the catchment area which drove fish into the trap (Photos 2 & 3) there are low stone banks and timber uprights set in these (Photo 4), with horizontal timbering at ground level. The weir may have medieval origins and was still in use in the 1960s.

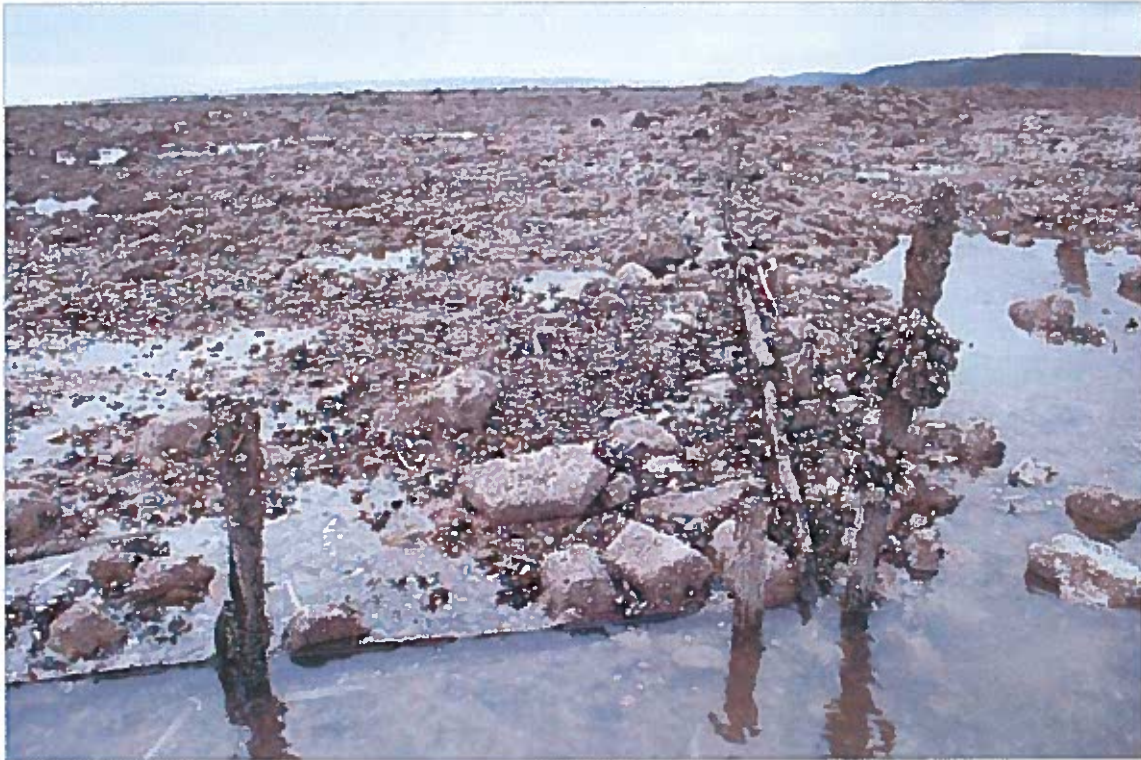
Photo 3 – PRN 30087. The surviving stakes and horizontal timbering of Weir A, looking north-west. The raised bank of the wall can be seen in the background curving around to the right (east).

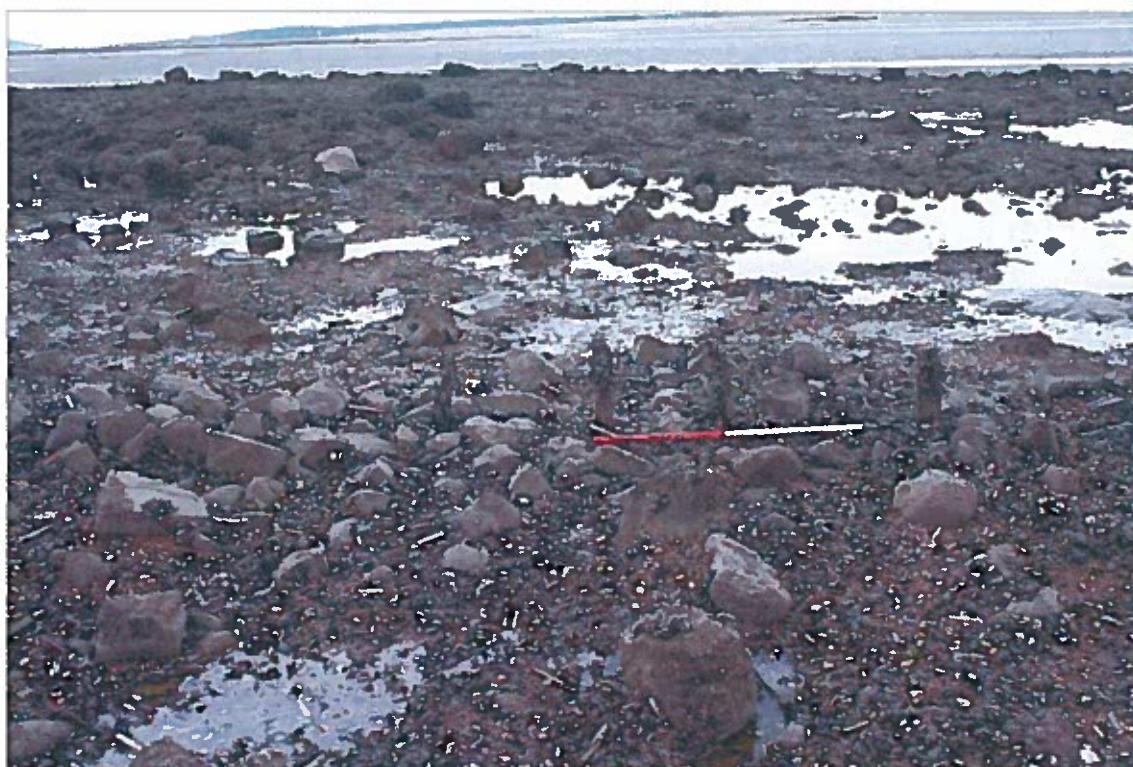
Photo 4 – PRN 30087. Showing the surviving low stone banks and timber uprights of the largest fish trap on Salmon Point Scar.

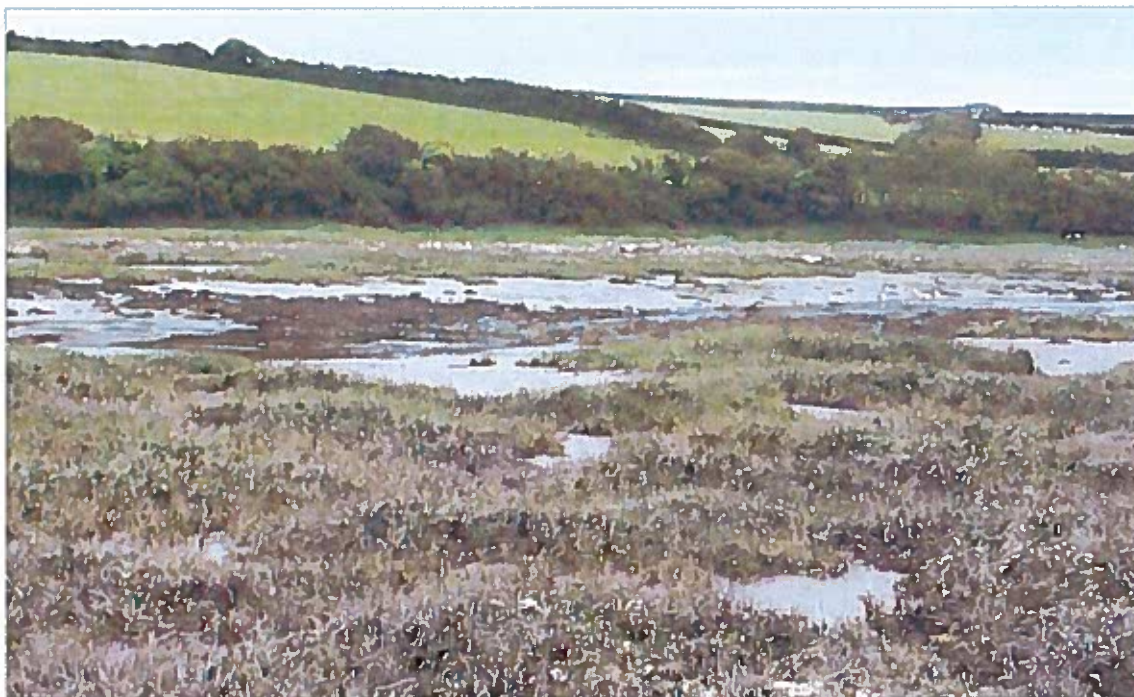
Photo 5 – PRN 34632. The remains of a stone fish weir constructed across Sandyhaven Pill, Pembrokeshire. Looking east.

- The majority of fish weirs situated on rivers survive as arrangements of wooden posts but there are a few examples of stone built structures. A stone-built fish weir across the channel of Sandyhaven Pill is one example visited during this project (Photo 5). All that remains is a low bank of rubble, approximately 50m long (E-W) and 2m wide and 0.3m high. It is not breached at any point by the channel and is probably post-medieval in date. It is depicted on the Ordnance Survey maps of 1875, 1908 and 1953.

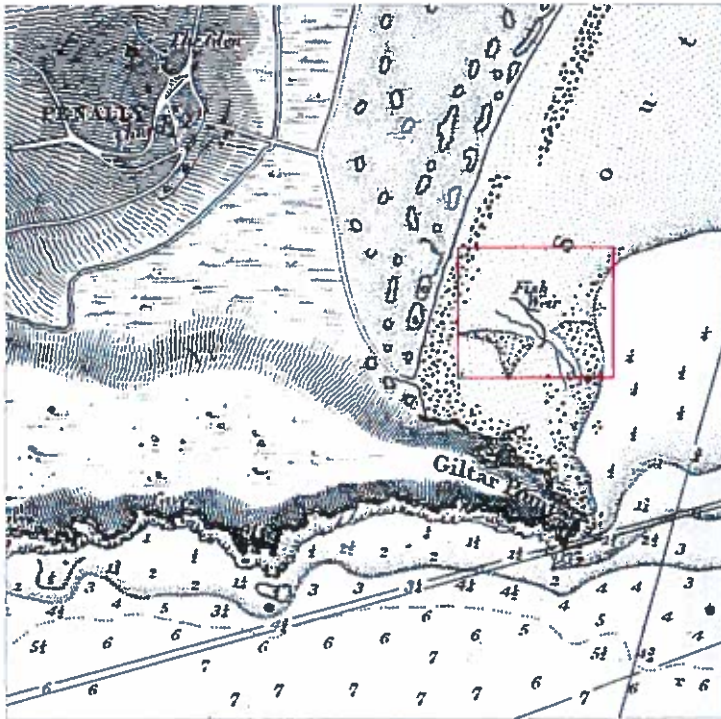
Figure 2 An extract from Captain Aldridge's Chart of Tenby and Caldey Roads 1856, showing a *Fish Weir* at the far southern end of Penally Beach near Tenby (PRN 30040).

- The problem of the constant movement of beaches is highlighted by the example of a fish trap located at the far southern end of Penally Beach near Tenby (PRN 30040). Labelled as a 'Fish Weir' on Captain Aldridge's Chart of Tenby and Caldey Roads 1856 (Figure 2) it was first recorded on the ground in 1995 (Gale 1995) at low water spring tide. It was visible as a V-shaped structure with the apex of the V pointing seaward, constructed from stone boulders and beach pebbles within which were lines of wooden stakes. It was noted during the periods of recording how much the appearance of the beach changed between tides, with material and sand rearranged, accumulated or dispersed.

Subsequent site visits have found no trace of any structure, although this part of the beach is markedly stonier and boulder strewn.

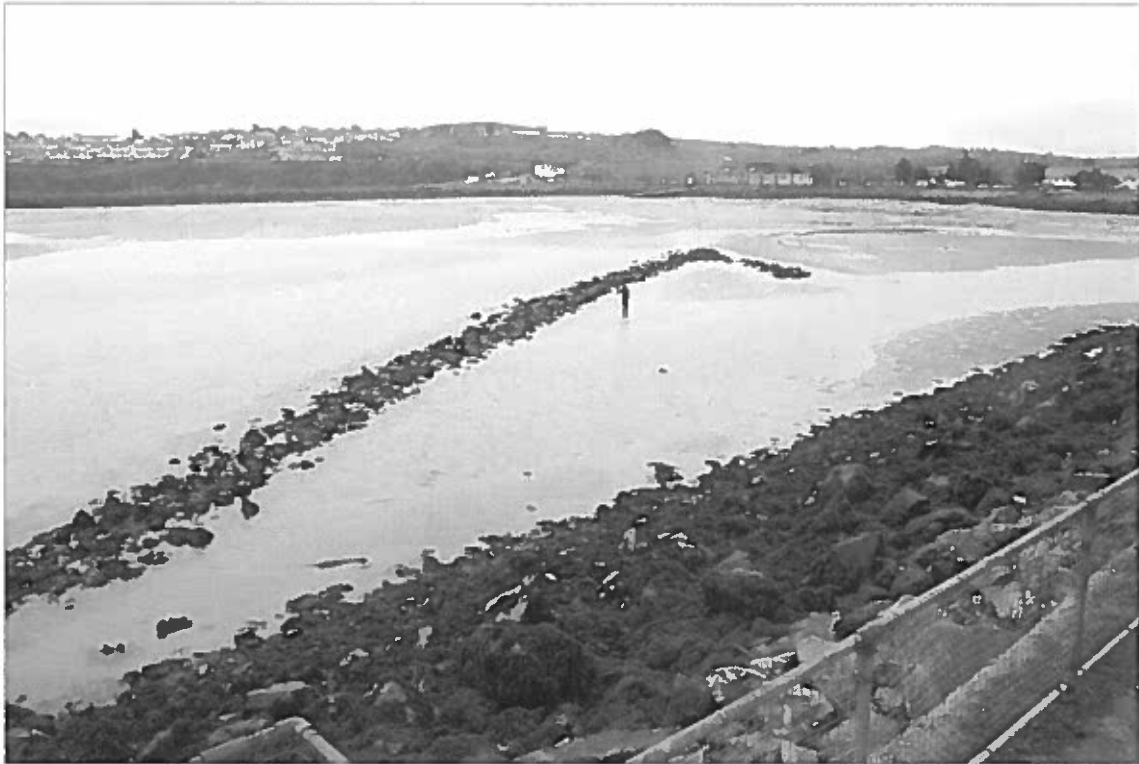
Photo 8 – PRN 32127 The remaining half of the V-shaped fish trap at Goodwick as it appears today at low tide.

What remains of the fish trap now extends for approximately 120 metres into Fishguard Harbour from the harbour side and then turns to the north for approximately 37m (Photo 8). The wall is constructed from large stone boulders and measures approximately 5.0m wide, and still retains water at low tide. The sluice or gate was presumably at the apex of the V and has been destroyed by the construction of the railway in the nineteenth century.

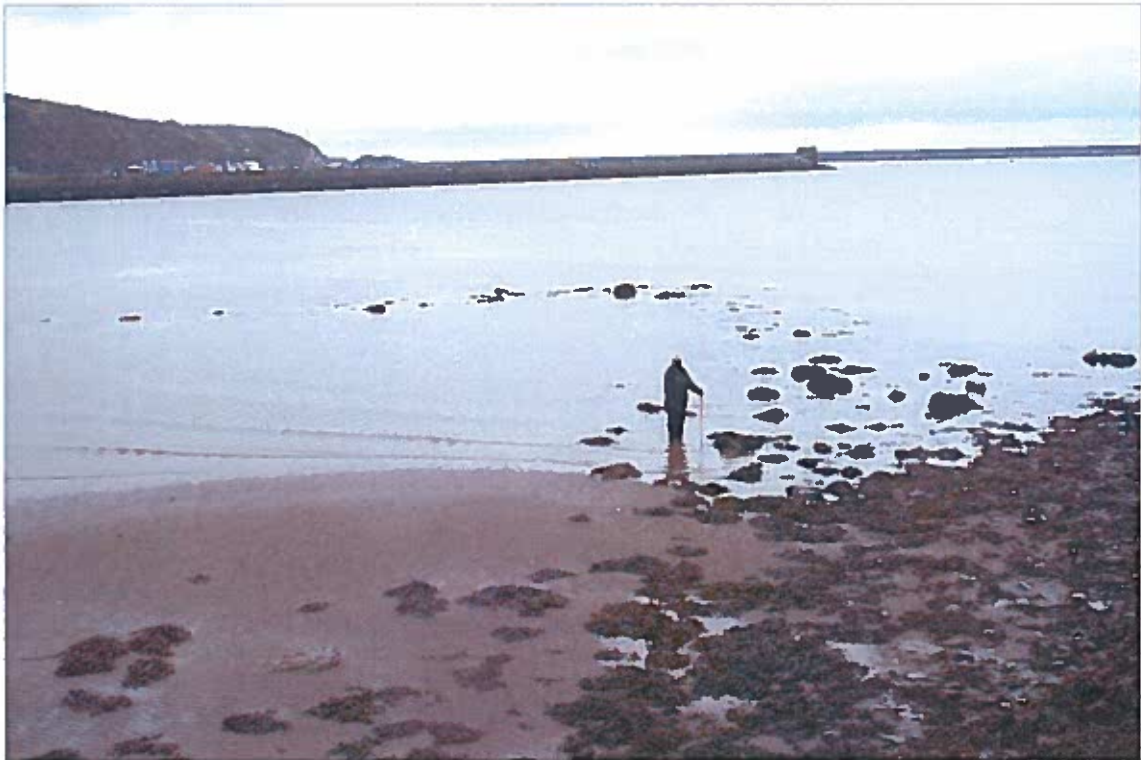
Photo 9 – PRN 103601 The small crescent shaped fish trap located on the south side of Goodwick beach, still partially submerged even at very low tides.

- In contrast on the other side of Goodwick beach there is another smaller, crescent shaped fish trap (PRN 103601), not depicted on any historic map or chart (Photo 9). Built from stone boulders it is approximately 80m in length and 5m wide. The apex of the crescent points seaward and the south-east end adjoins coastal rocks. However, unlike neighbouring PRN 32127 it is further down the beach and sits below the low water mark and is only partially exposed at the lowest tides of 0.5m and under. Present sea-levels would make it very difficult to use and make repairs and this might indicate a construction date back in the early medieval period or earlier. In 2012 it was not possible to record a sluice or gate because it was never fully exposed and remained submerged at its apex even at a very low tide.

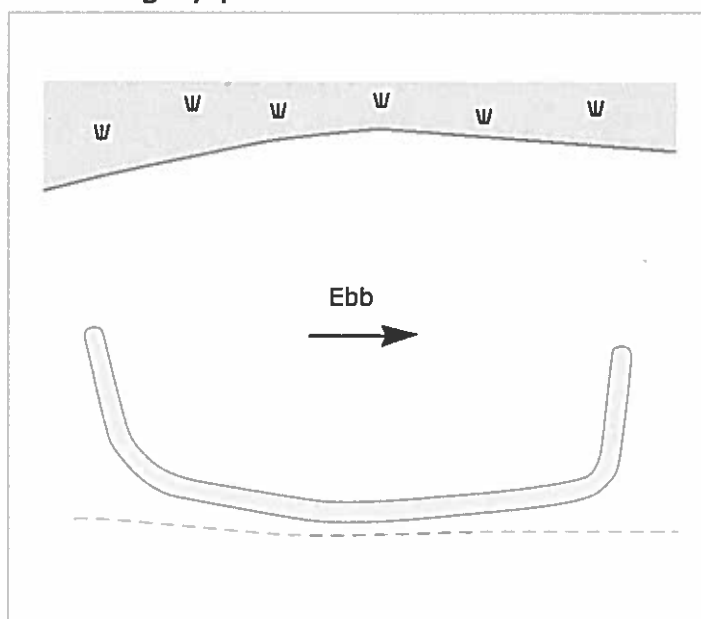
Figure 7 An elongated crescent shaped fish trap; examples of which are found along the coasts of Pembrokeshire and Ceredigion. This was not a form identified by Bannerman and Jones (1999) in their study of fish traps around the coasts of Anglesey and Gwynedd.

- Larger more elongated examples can appear more as a long boulder wall running approximately parallel to the shore whose ends then curve landward (Figure 7). Sluice gates are placed along the long wall that runs roughly parallel to the low water mark.

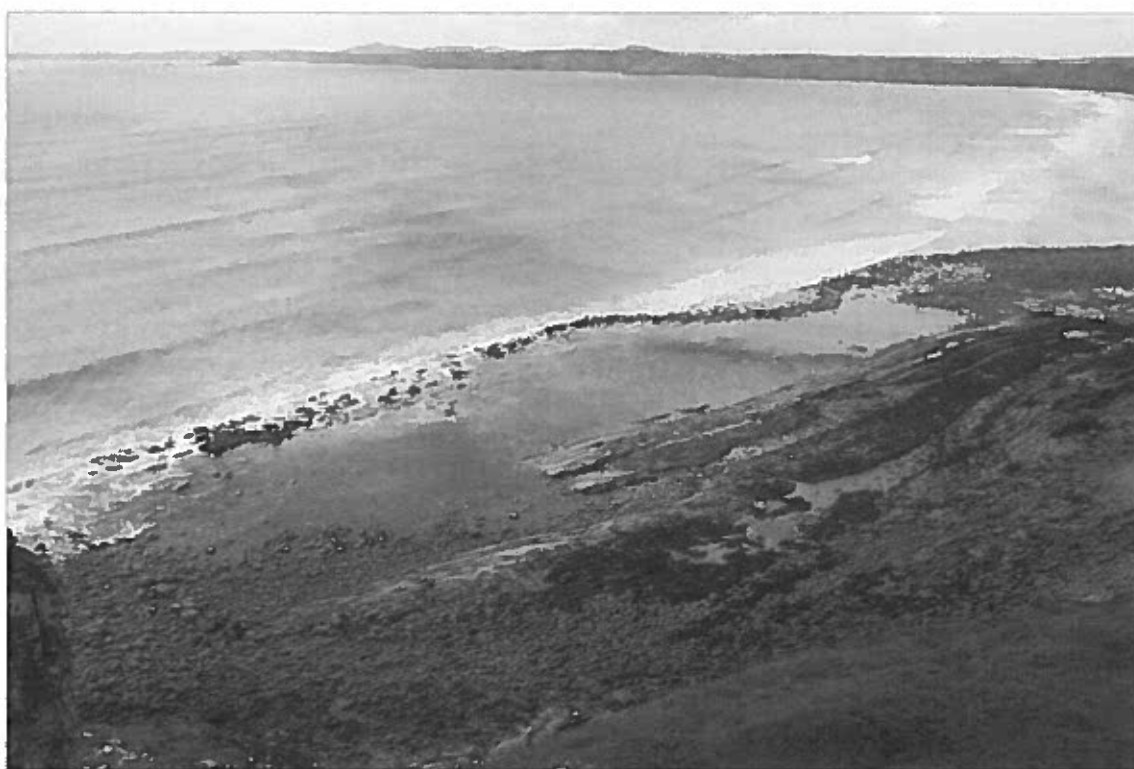
Photo 10 – PRN 103607 The large stone built fish trap at the very southern end of Newgale beach, Pembrokeshire.

The photograph below shows such a style of fish trap. This large stone-built fish trap is situated at the very southern end of Newgale beach, Pembrokeshire in an area of rocks below Black Cliff

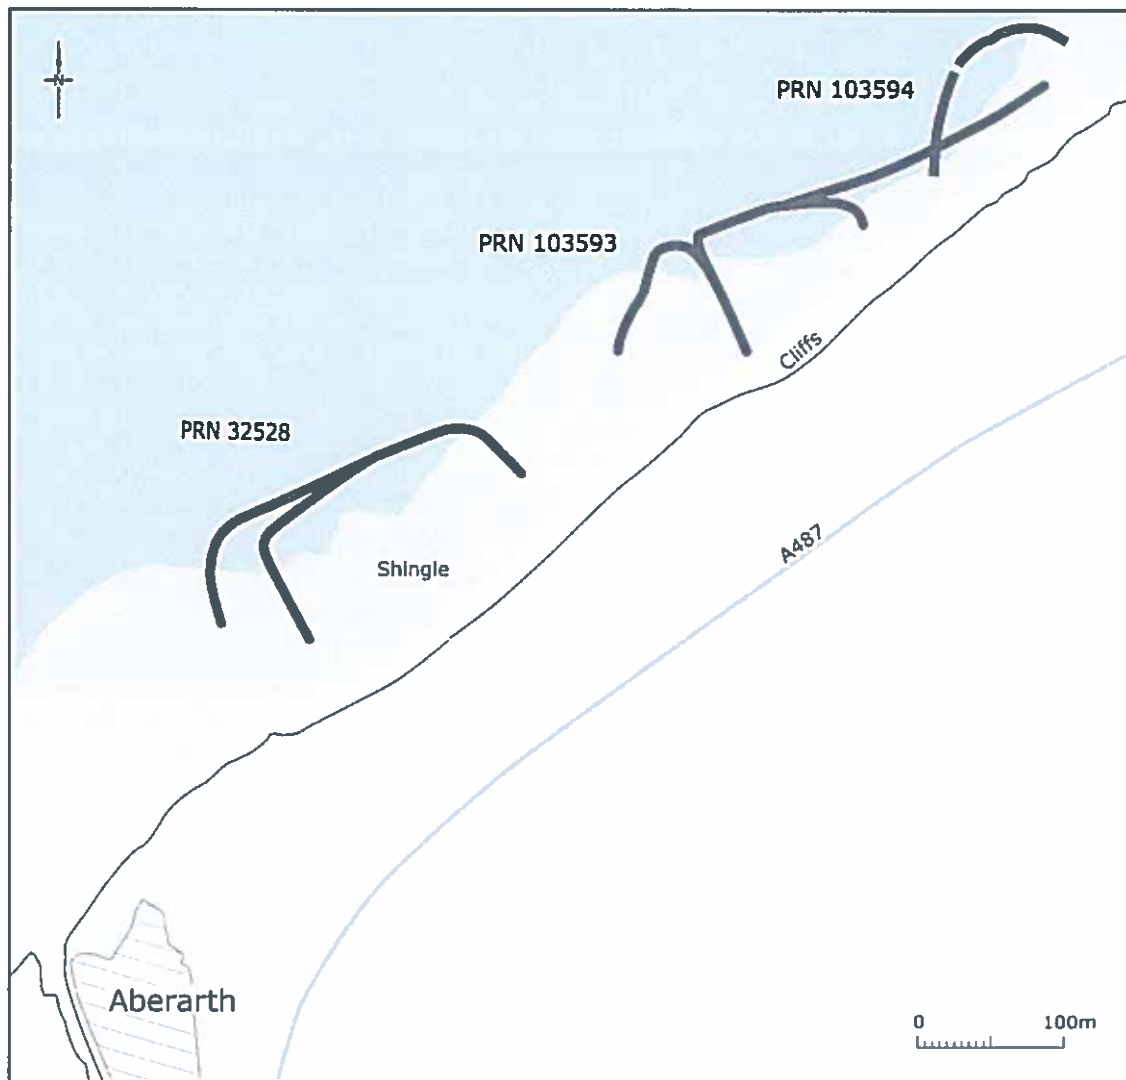
Figure 8 A plan of the group of stone fish traps that lie on the shingle foreshore to the northeast of Aberarth, Ceredigion.

- PRN 32528 consists of two arms of elongated crescent shape (Figure 8), which probably represent different phasing of the same trap. One elongated crescent shape is visible on the first edition Ordnance Survey 6" mapping of 1890. The long seaward side of both phases of the trap measure over 100m each and the curving arms of the trap run up the beach for up to 60m. The first arm of the fish trap is constructed from large stone boulders and measures c.4.0m wide. The landward sides of the banks are neatly faced and built up with boulders (some very large) on the seaward side to form a wide sloping bank. The second arm is neatly faced on both sides and measures c.2.5m until it joins the first arm and then becomes a rougher stone bank faced on the landward side only.

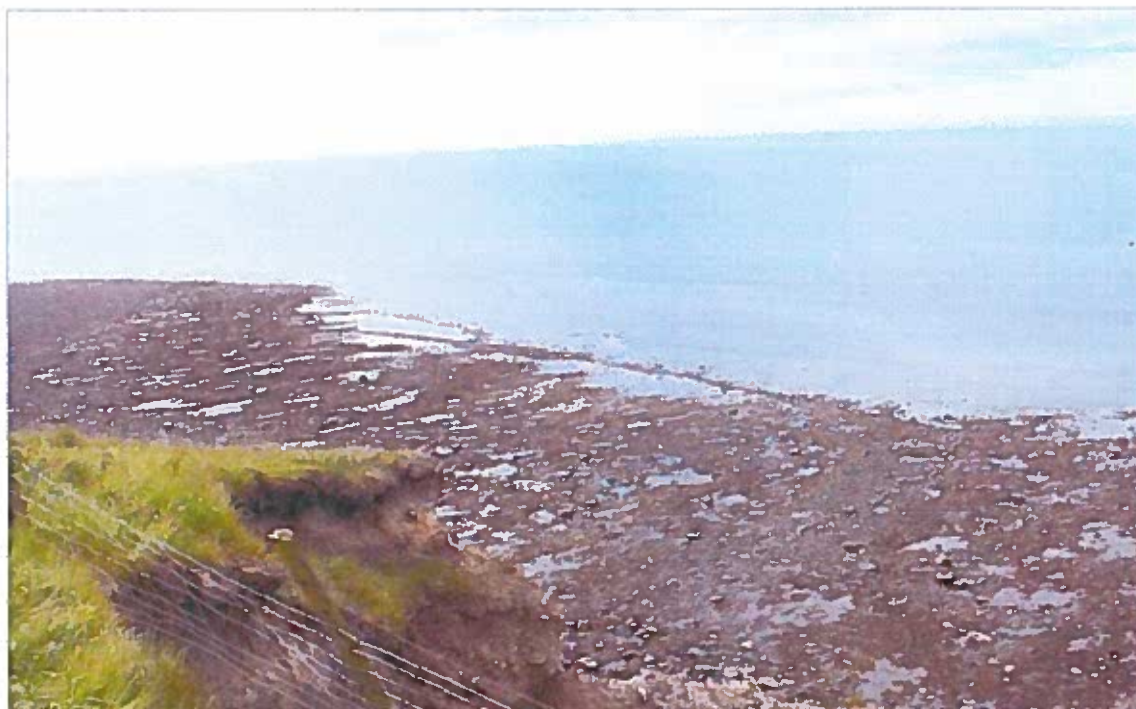
**Photo 11 – PRN 32528 The multi-phased stone built fish trap situated on the stone and shingle foreshore north-east of the mouth of Aberarth.**

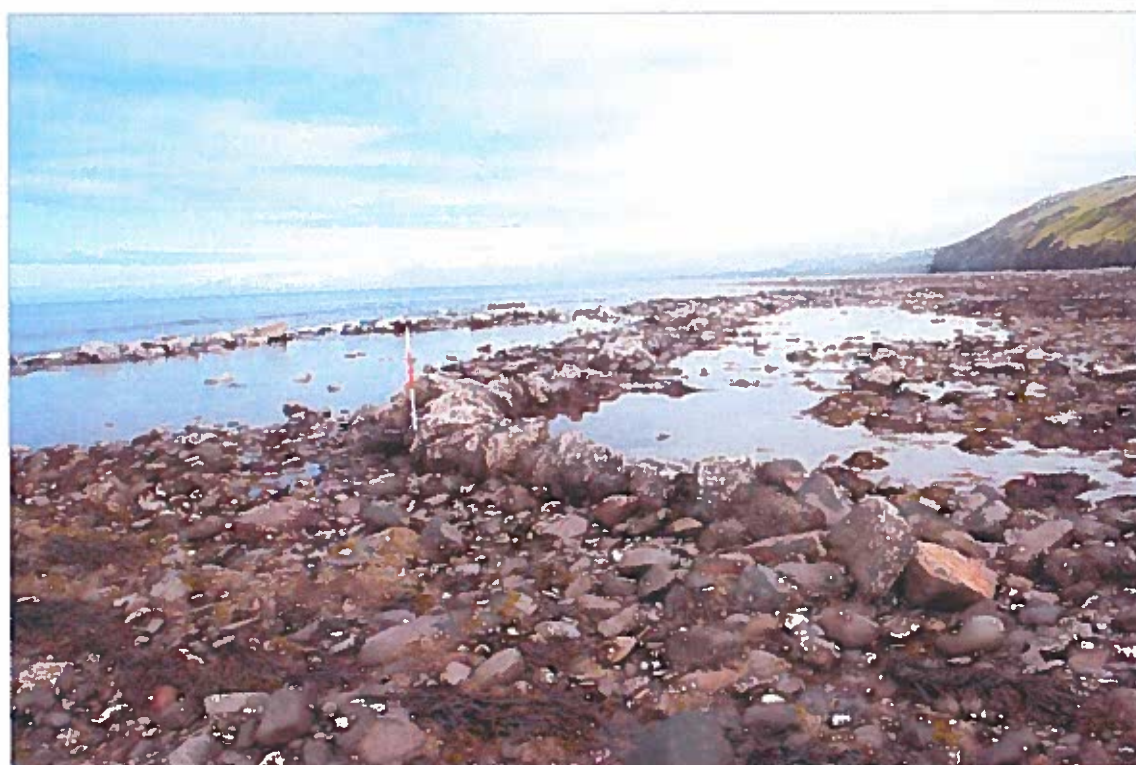
**Photo 12 – PRN 32528 Detail of the well preserved stone walls, still retaining water at low tide.**

The traps retain water at low tide. Well-constructed sluice gates exist along the seaward long sides of the traps, with faced stones on their internal edges. Small circular traps were identified within the larger trap area.

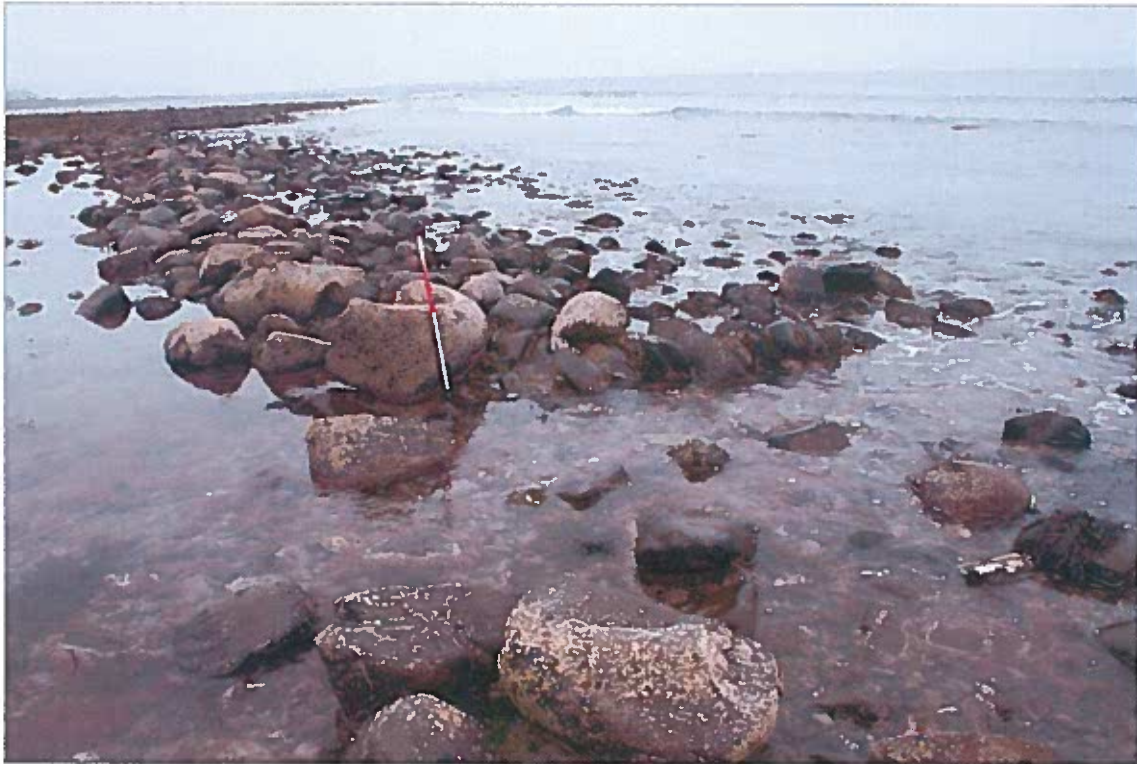
Photo 13 - PRN 32528 Detail of one of the sluice gates within one of the seaward walls.

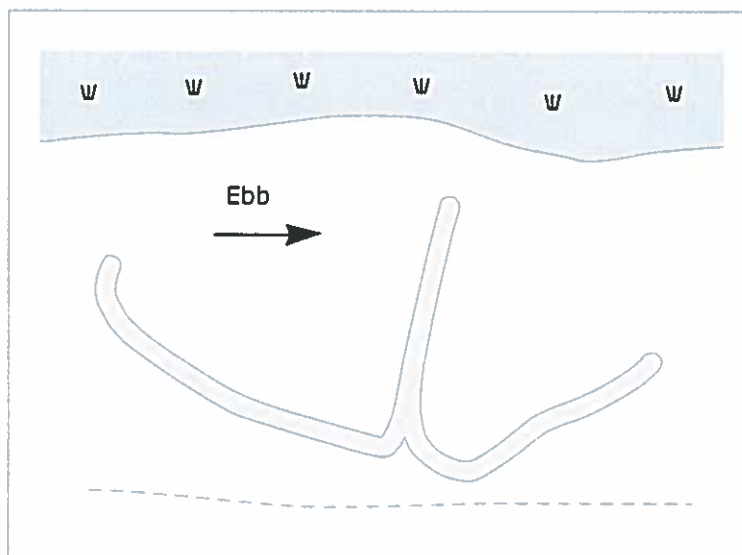
Figure 9 An M shaped fish trap; examples of which are found along the coast of Ceredigion. This was not a form identified by Bannerman and Jones (1999), although it has similarities with the double V shaped form they recorded.

- PRN 103593 is a large splayed M-shaped fish trap (Figure 9). The scheduled fish traps that lie to the west of Aberarth (PRNs are somewhat similar in form).

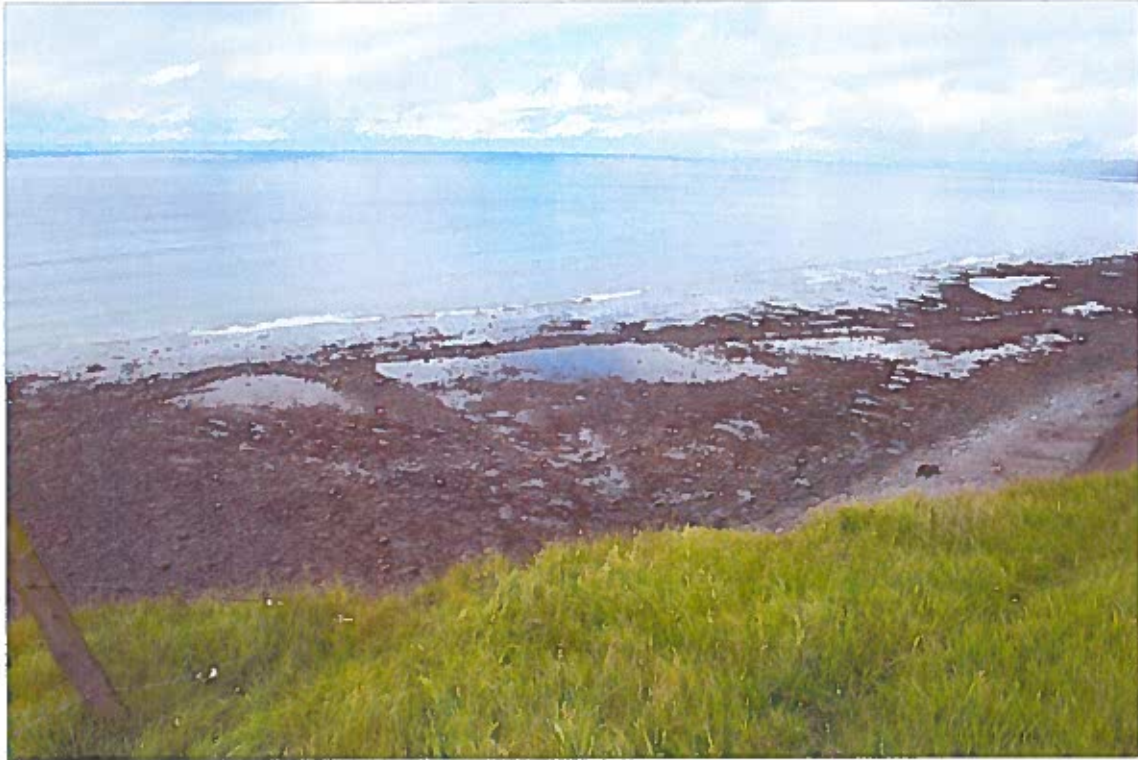
Photo 14 - PRN 103593 Shot taken from cliffs showing the wide M-shaped fish trap. Its eastern arm connects to the crescent shaped fish trap PRN 103594 that can be seen to the right of the photo, pointing out to sea.

at an angle towards the shore for roughly 120m, while the eastern arm runs in an easterly direction for approximately 220m, more parallel to the shore. It is this eastern arm that connects to the curving crescent shaped fish trap PRN 103594 further to the north-east (Photo 14).

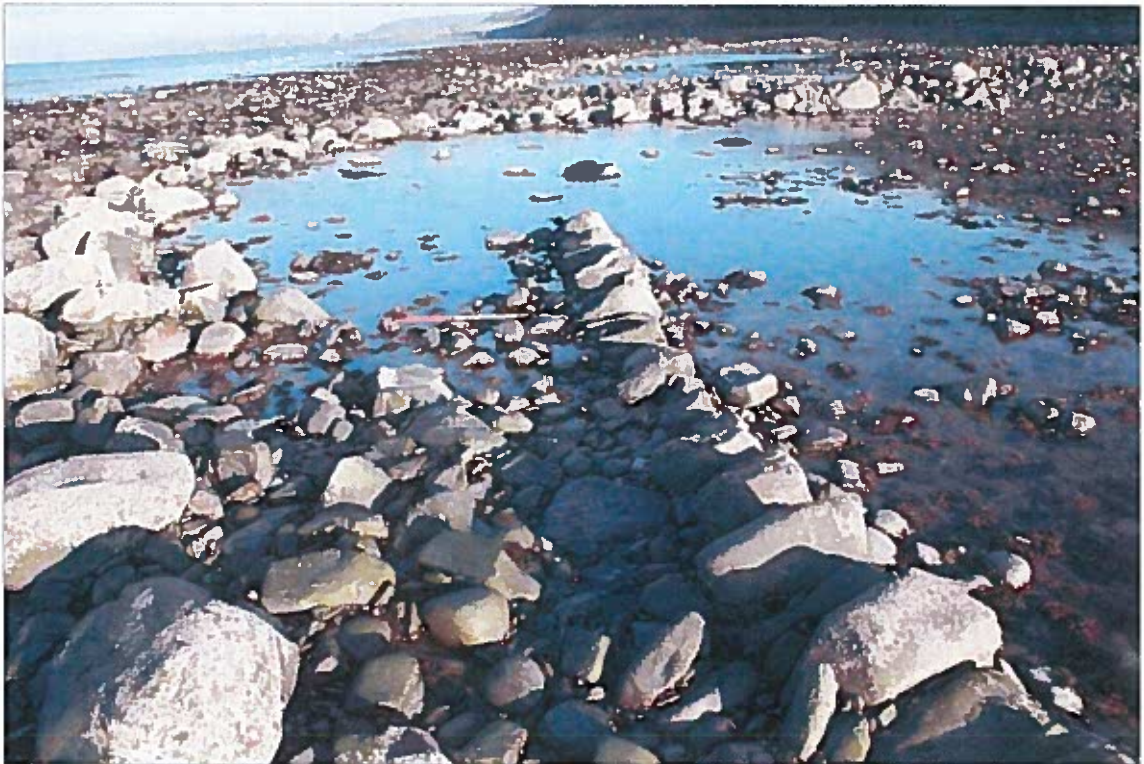
Photo 15 - PRN 103593 Detailed shot showing how the fish trap has been altered over time with additional lengths of wall.

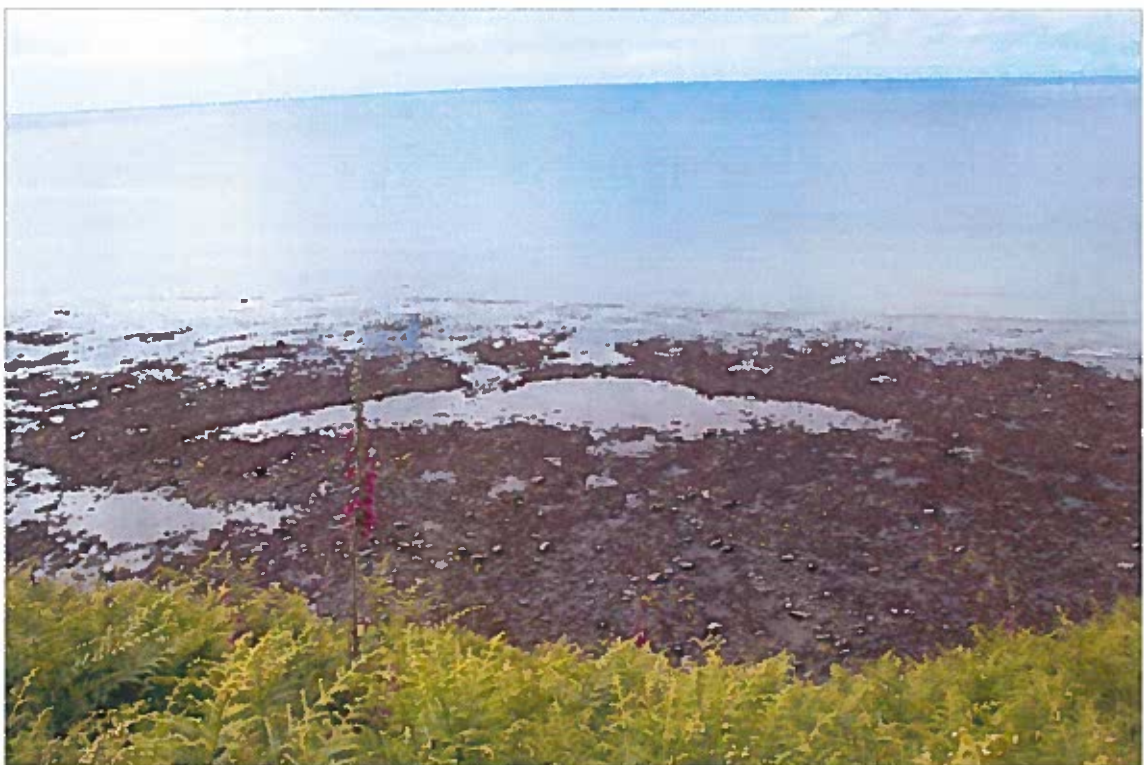
Photo 16 - PRN 103594 A crescent shaped fish trap. Just to the west of the apex of the curve is a large sluice measuring several metres wide. This sluice then empties into what appears to be a manmade pool dug out of the ground.
