# **WATER MAIN RENEWAL SCHEME, ADJACENT TO ST NICHOLAS AND TEILO CHURCHYARD, PENALLY, PEMBROKESHIRE: ARCHAEOLOGICAL WATCHING BRIEF**

RHIF YR ADRODDIAD / REPORT NO. 2012/71  
RHIF Y PROSIECT / PROJECT RECORD NO. 102821

## WATER MAIN RENEWAL SCHEME, ADJACENT TO ST NICHOLAS AND TEILO CHURCHYARD, PENALLY, PEMBROKESHIRE: ARCHAEOLOGICAL WATCHING BRIEF

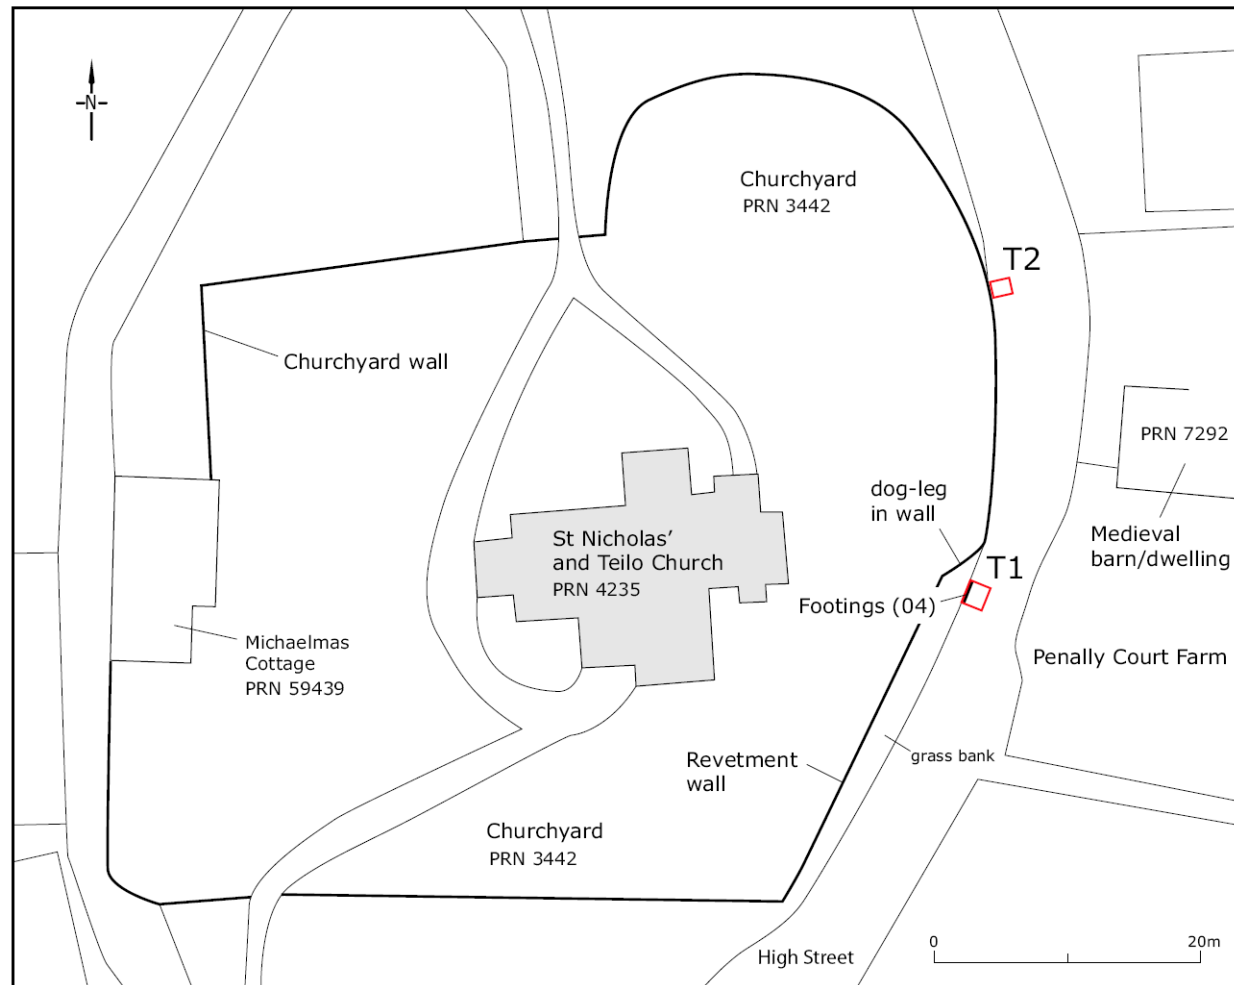
**Figure 2:** Location of trenches T1 and T2

- 3.1.4 The route of the water main relevant to the watching brief, ran in a north-south direction between two small trenches (T1 and T2, Figure 2) 21m apart, on the main street of Penally adjacent to the churchyard wall. The road is approximately 12mOD above sea level. Both trenches were opened with a tracked excavator using a toothed bucket.

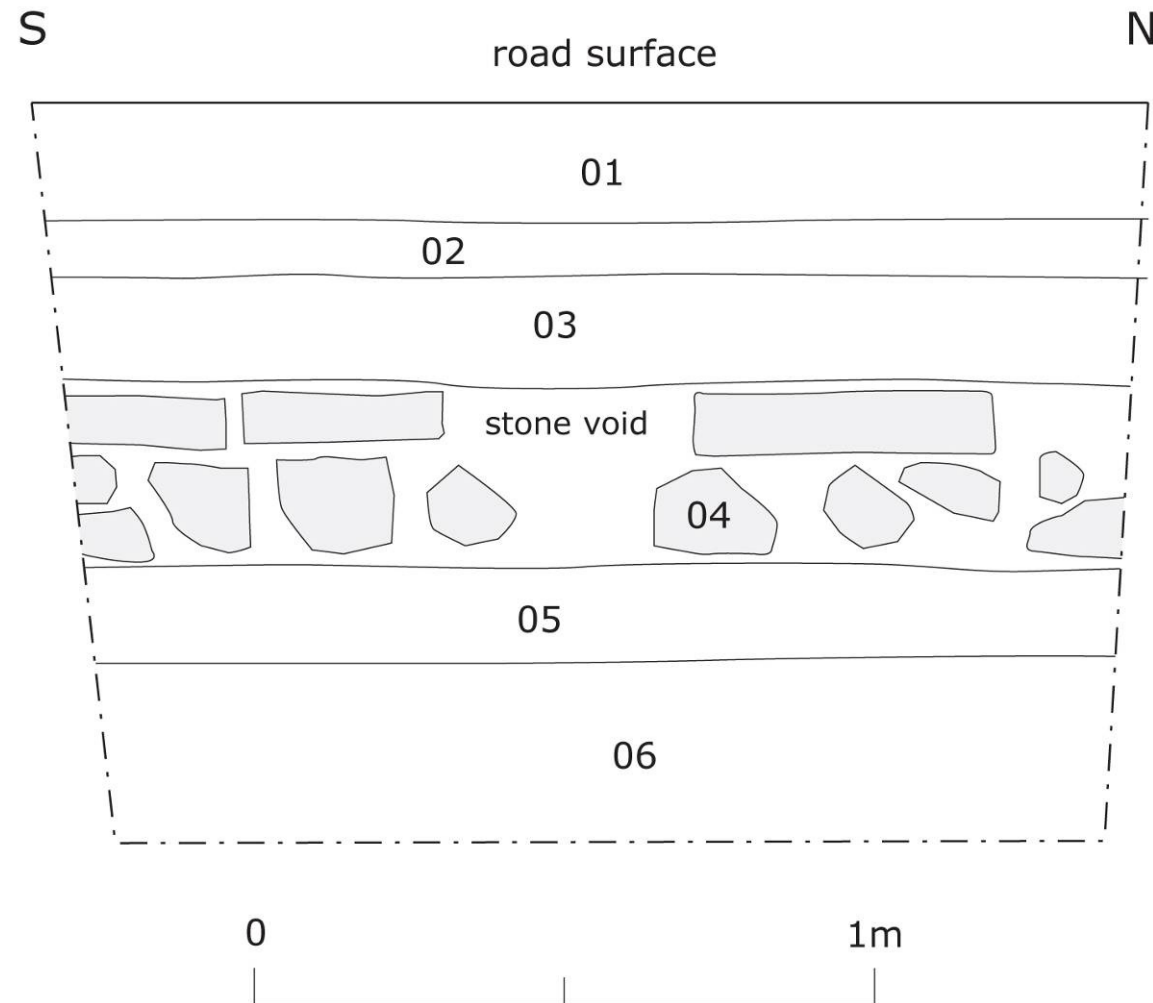
**Figure 3:** East facing section of T1

- 4.1.3 The east facing section (Photos 2 & 3; Figure 3) - adjacent to the grass bank - revealed a series of layers. The upper layer was Layer (01), a very dark brown silty clay approximately 0.20m thick; (02), a 0.08m thick layer of aggregate/chippings; and (03), very compact, pink-yellow, sandy silty clay, containing lenses of small stone, approximately 0.17m thick. This layer revealed the only artefact; a sherd of 'willow pattern' pottery.

- 4.1.4 Below (03) was a linear alignment of stones (04). This consisted of a bottom 'rubble' course of irregular shaped stones averaging 0.12m in length overlain with a course of flatter dressed stone averaging 0.10m thick and between 0.2m and 0.45m long. No mortar was detected. The footings (04) rested on a deposit of pink-brown, silty-clay containing 50% small stones (05), which in turn stood on a layer of yellow-brown, silty-clay containing 50% small stones (06). The last two layers probably represent changes in the natural.

- 5.2 In Trench 1, on the east facing side and continuing beyond the trench section, a linear alignment of stones (04) was recorded. This consisted of two courses of stone. The lower of the two courses was of rubble construction and stood on natural silty-clay deposits. This arrangement supported a course of flatter, block-like, 'worked' stone, the whole suggesting a possible foundation course or footings for a former wall.

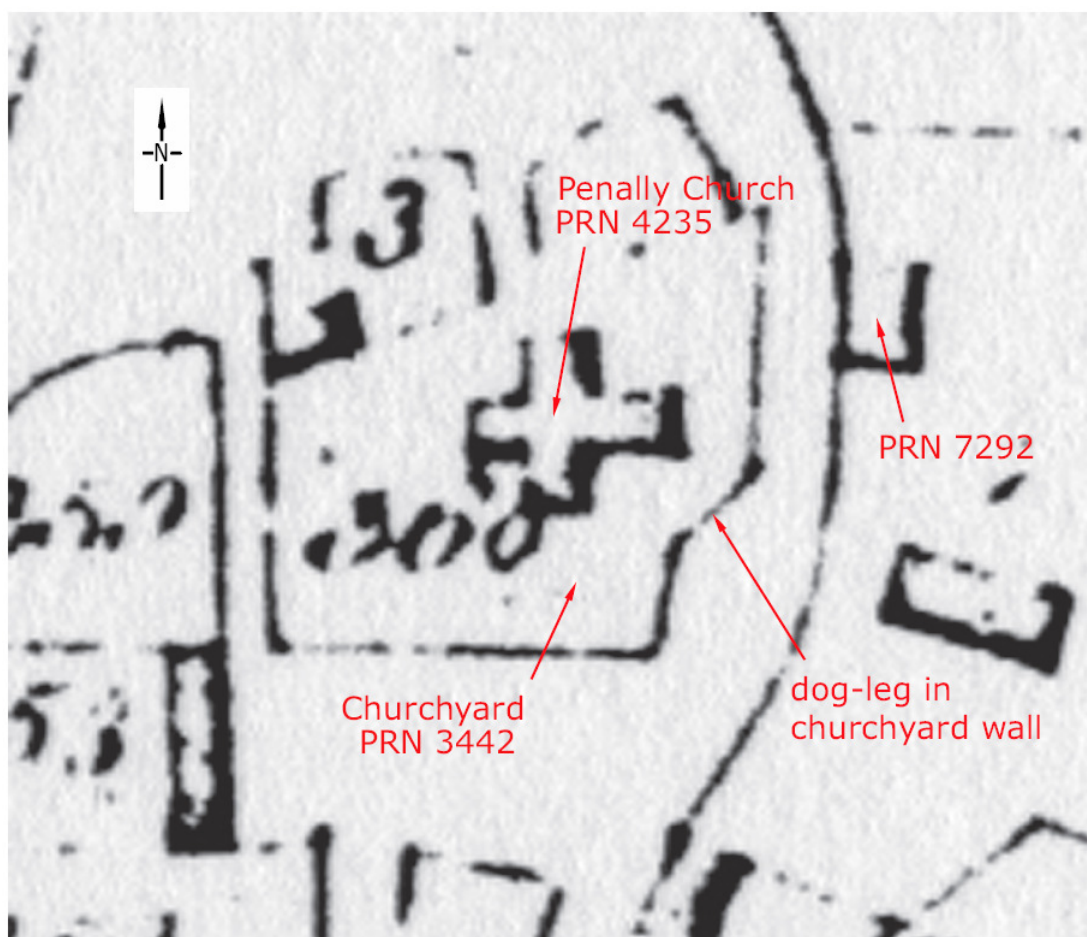
**Figure 4:** Extract of Tithe map of Penally of 1842 showing dog-leg in wall

- 5.3 It is impossible to ascertain from the length of footings exposed the purpose or function of this wall and also whether it has any associations with any surrounding upstanding masonry. One possibility is that the churchyard wall has been moved back from the road due to a former collapse or road widening. This theory could also account for the dog-leg that is still visible in the churchyard wall at this point (Figure 2). The footings align with the standing wall alignment before the dog-leg (Photo 4). This realignment occurred before 1842, as the tithe map for the parish of Penally, printed in that year, clearly shows the dog-leg (Figure 4).

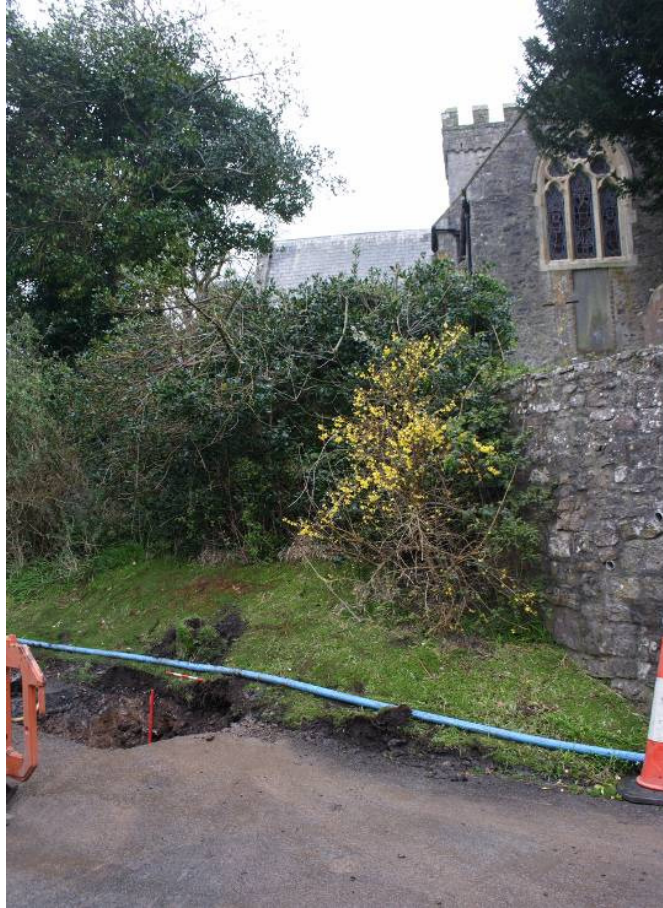
**Photo 1:** View west across street. Trench 1 in the foreground; dog-leg in churchyard wall can be seen beside grass bank; Penally Church in background.

- 4.1.1 Trench 1 measured approximately 1.8m by 1.5m and 1.2m deep. It was sited on the road 2.5m away from the churchyard wall, just south of a dog-leg in the wall-line, approximately 21m south of trench 2. A grass bank lies between the wall and the trench.

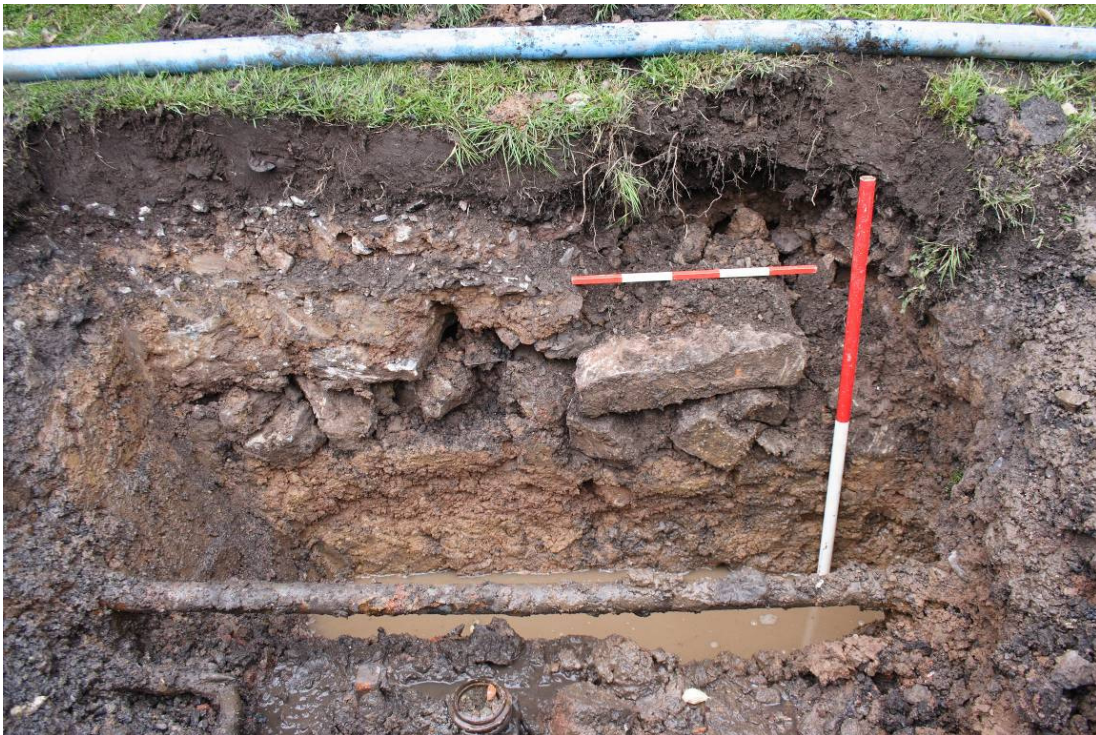
**Photo 2:** East facing section of Trench 1 showing wall footings (04).  
1m and 0.5m scale.

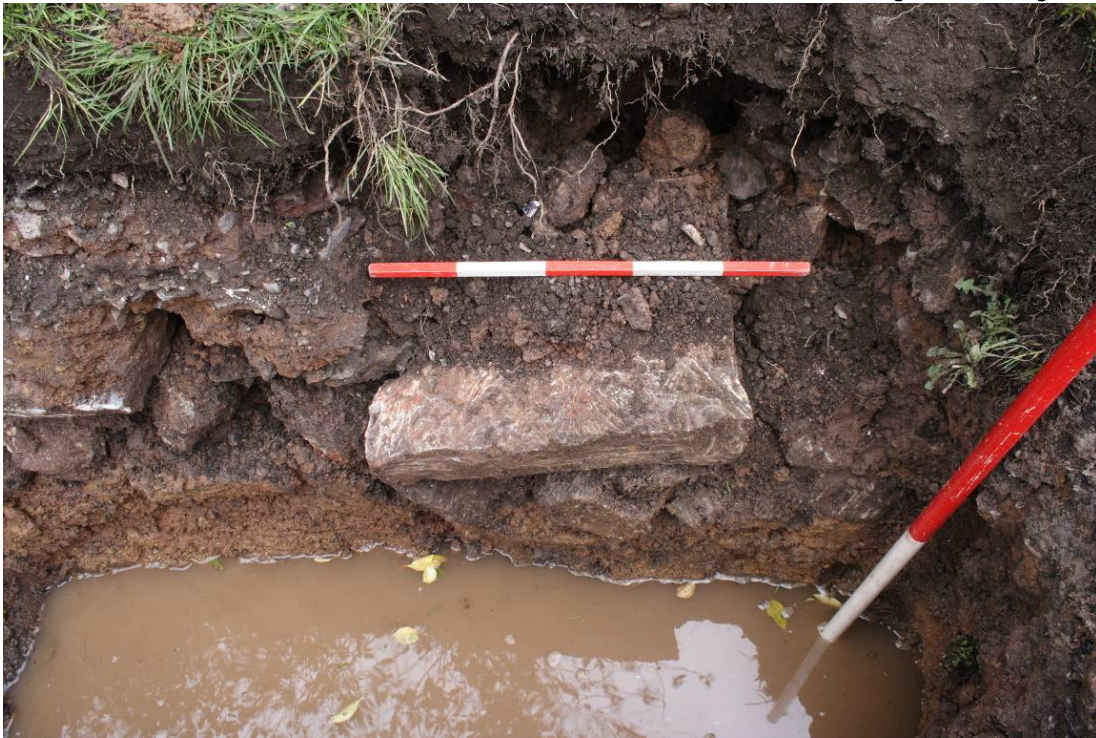
**Photo 3:** Close-up of flat stone in upper course of (04) within Trench 1. 1m and 0.5m scale.

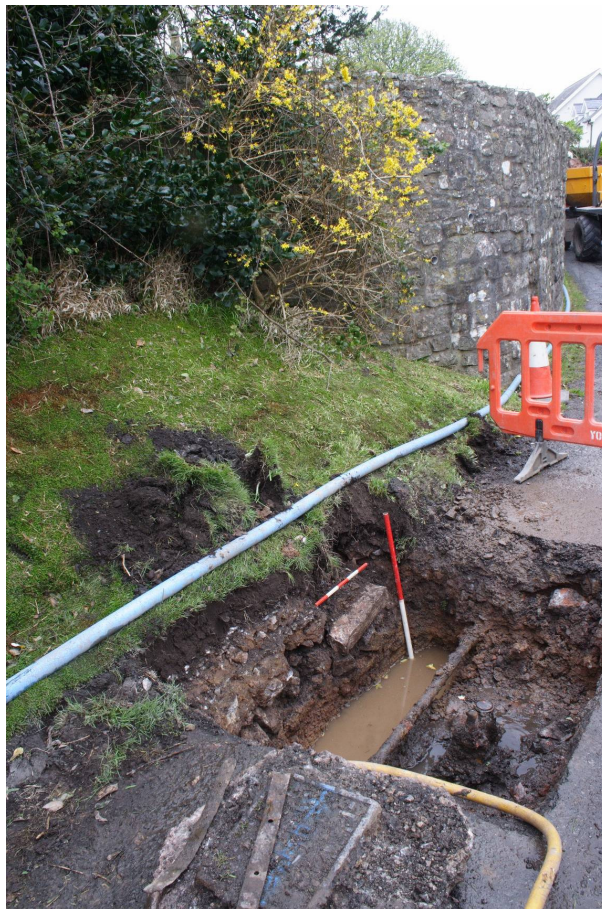
**Photo 4:** View north of Trench 1 showing wall footings (04) and its possible alignment to the churchyard wall before dog-leg. 1m and 0.5m scales.

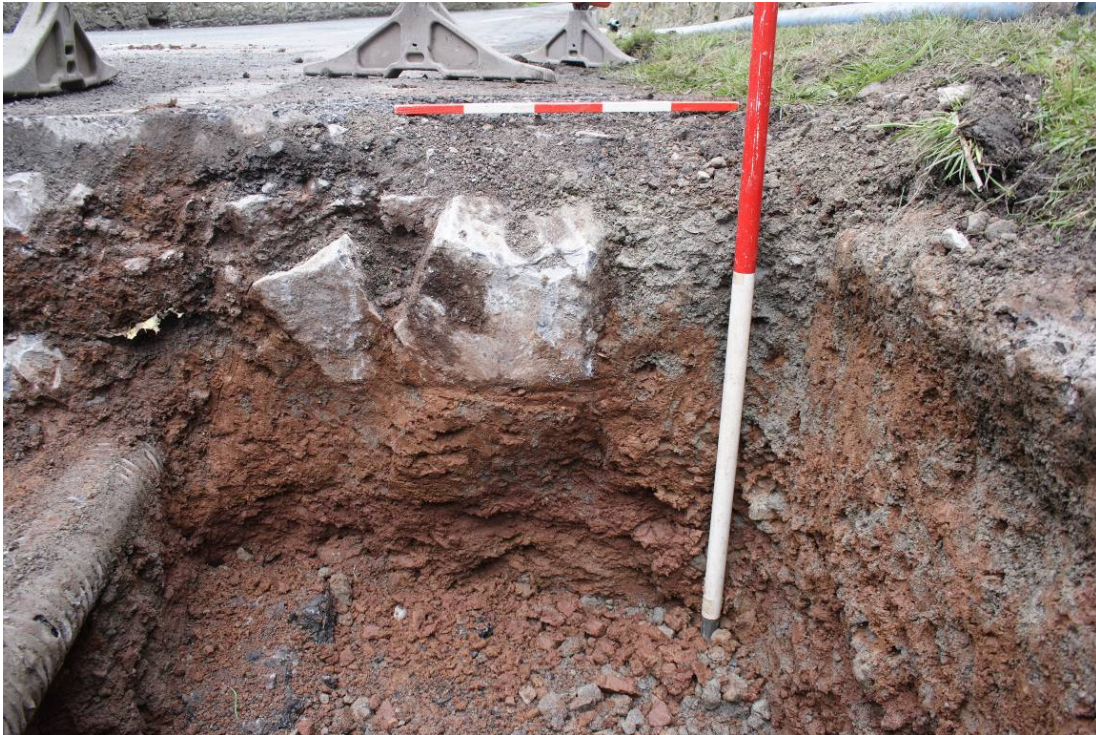
**Photo 5:** View south showing stones in north facing section of Trench 2 set into the silty-clay natural. 1m and 0.5m scales.

- 4.2.1 Trench 2 measured approximately 1.35m by 1.1m and sloped from 0.75m to 1m deep. It was sited 0.65m away from the churchyard wall and a few metres south from where the wall begins to curve west.
- 4.2.2 The south, east and west facing sections revealed typical road sections consisting of natural silty-clay overlain with a layer of aggregate averaging 0.40m thick, capped with a layer of tarmac approximately 0.08m thick.
- 4.2.3 The north facing section (Photo 5) revealed two sub-angular stones measuring 0.23m x 0.15m and 0.28 x 0.22m, partly set into the natural silty-clay. The top of the larger stone lay just below the base of the tarmac. This feature seems to end on the west side of the stones, whilst on the east side a trench cut for a service pipe might have truncated this feature. No dating evidence was recovered from the feature.

- 5.5 The north facing section of Trench 2 revealed two stones set halfway into the underlying silty-clay natural, their upper halves protruding into the aggregate which constitutes the road make-up. As so little remains of this feature, interpretation is questionable. It could be kerbing for a former road, track or path; alternatively it could be the remnants of a metalled floor or road; or simply the remains of an infilled pothole.
- 5.6 The watching brief has demonstrated that the small excavations needed for the water main renewal have actually caused a minimal impact to the archaeological remains that had survived disturbance from the original water main.

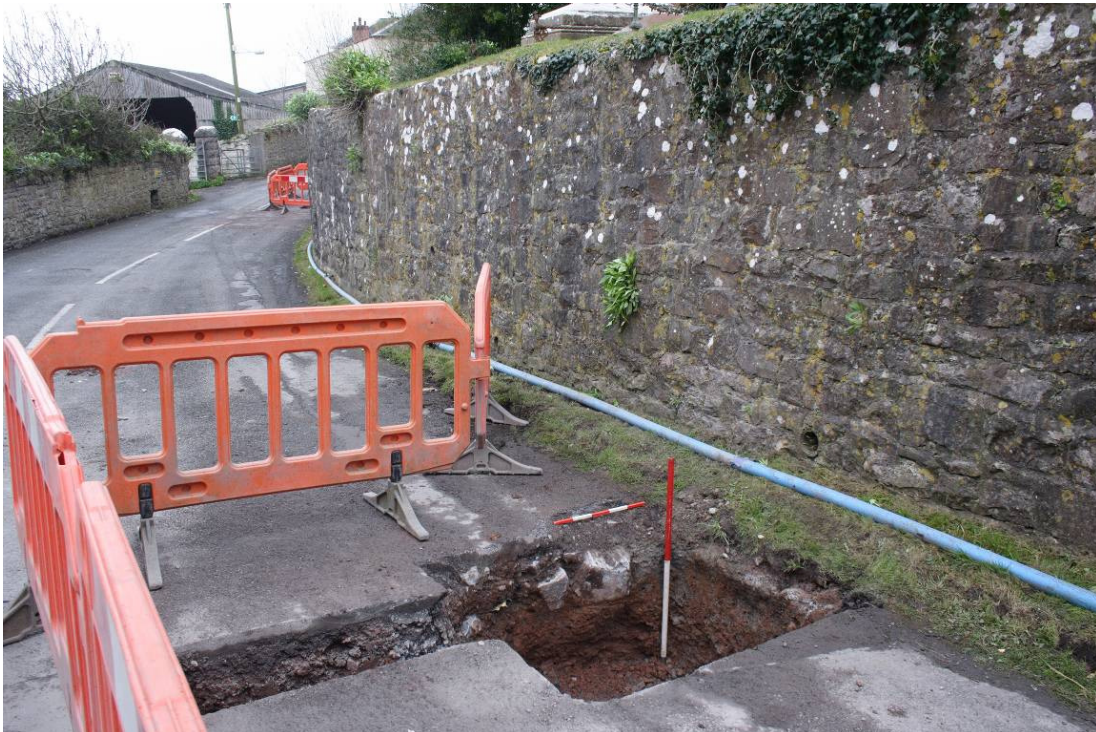
**Photo 6:** View south looking at Trench 2 and its proximity to the churchyard wall. Safety barriers surround Trench 1 in the background.
