DWR CYMRU WATER MAIN RENEWAL SCHEME PHASE I AND II, LLANCYNFELYN, CEREDIGION: ARCHAEOLOGICAL WATCHING BRIEF

Prepared by Dyfed Archaeological Trust
For: Dwr Cymru Welsh Water

RHIF YR ADRODDIAD / REPORT NO. 2012/31
RHIF Y DIGWYDDIAD / EVENT RECORD NO. 102868

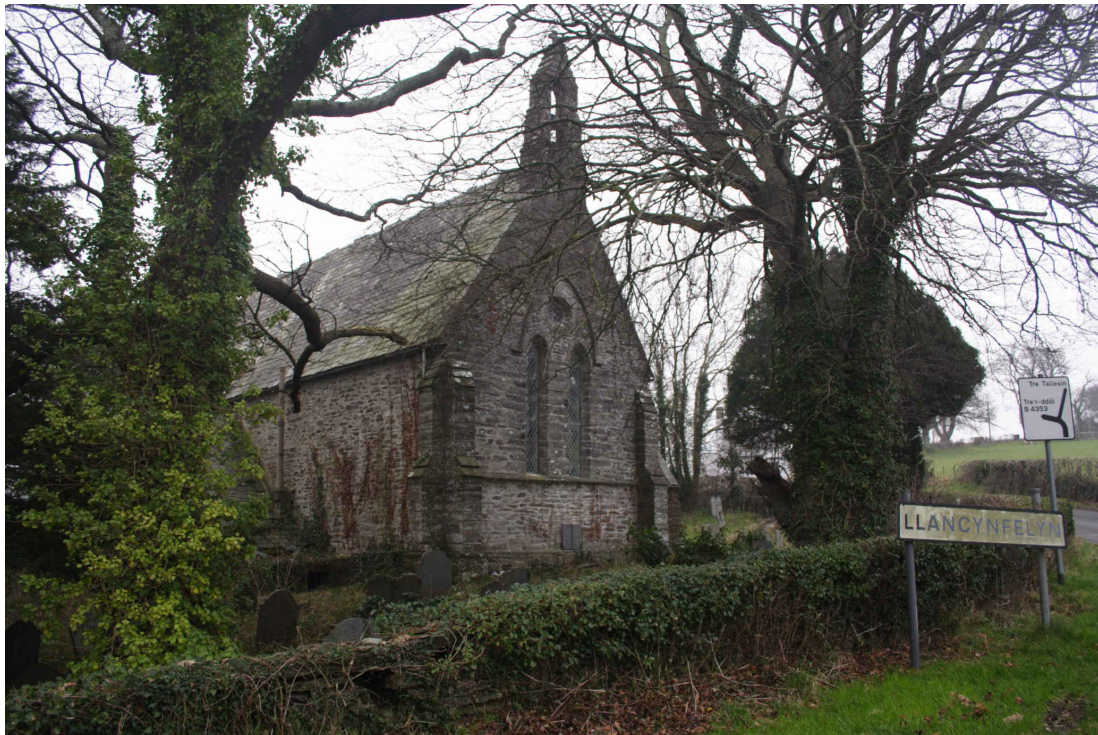
Photo 1: North east facing view Llancynfelyn Church

4.2.5 Following communication with the onsite contractor a further site visit was made on 27th February 2012 to monitor test pitting to locate the water main and test the ground conditions in the vicinity of Llancynfelyn Church (Photo 1).

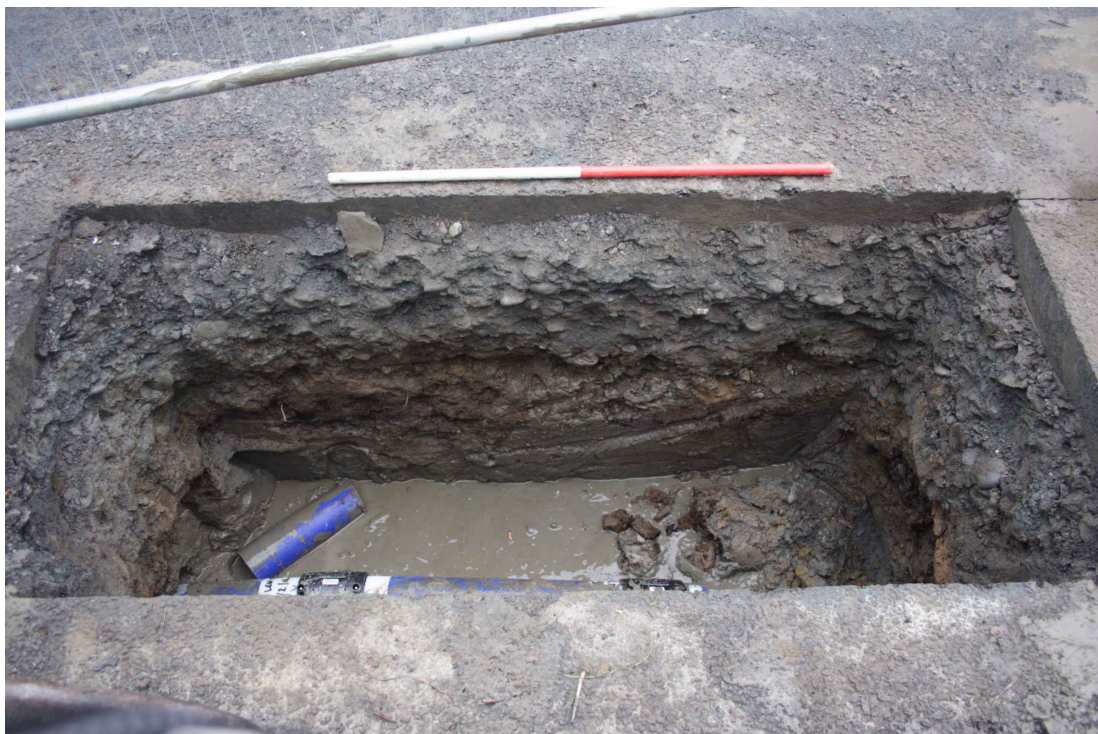
Photo 2: North facing representative section showing road formation layers overlying clays (Area 1)

4.2.3 No peat deposits were revealed in any of the excavated areas, the trenches indicating that the road had been built directly upon natural clays (Photo 2).

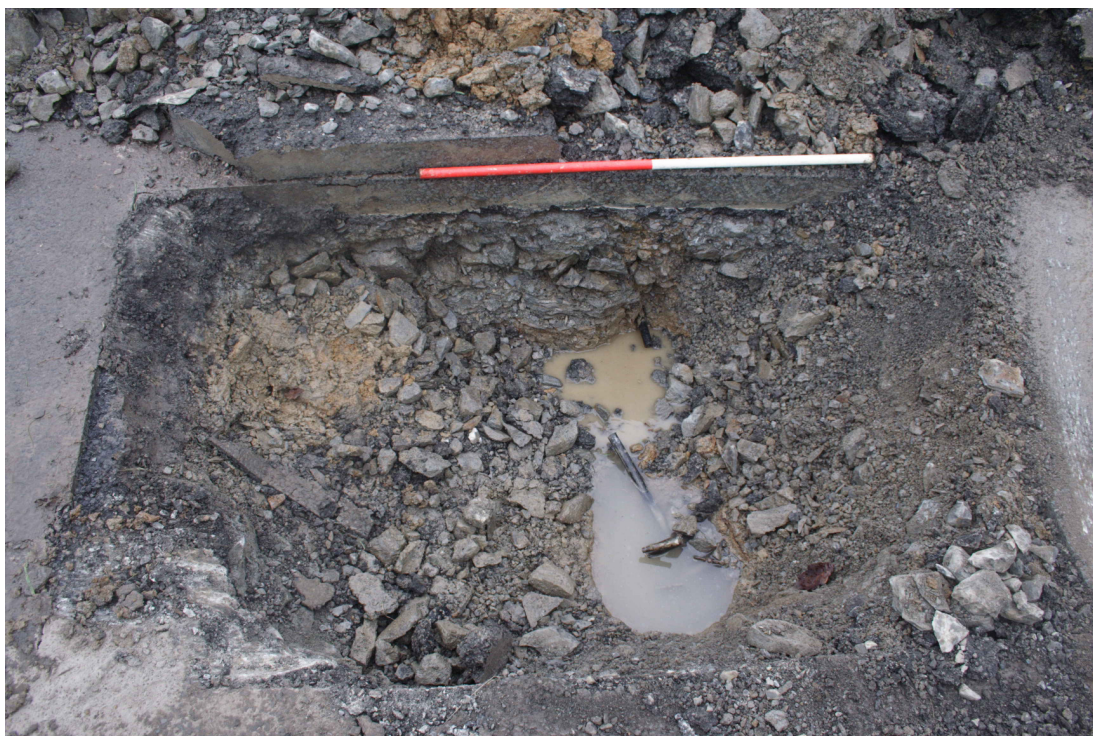
Photo 3: West facing section Test Pit 1 (Area 2)
(NGR SN 6453 9221)

4.2.7 Two of the test pits were located within the roadline and revealed modern road formation layers overlying natural clays and bedrock, which are considered to be of minimal archaeological interest (Photos 3 & 4).

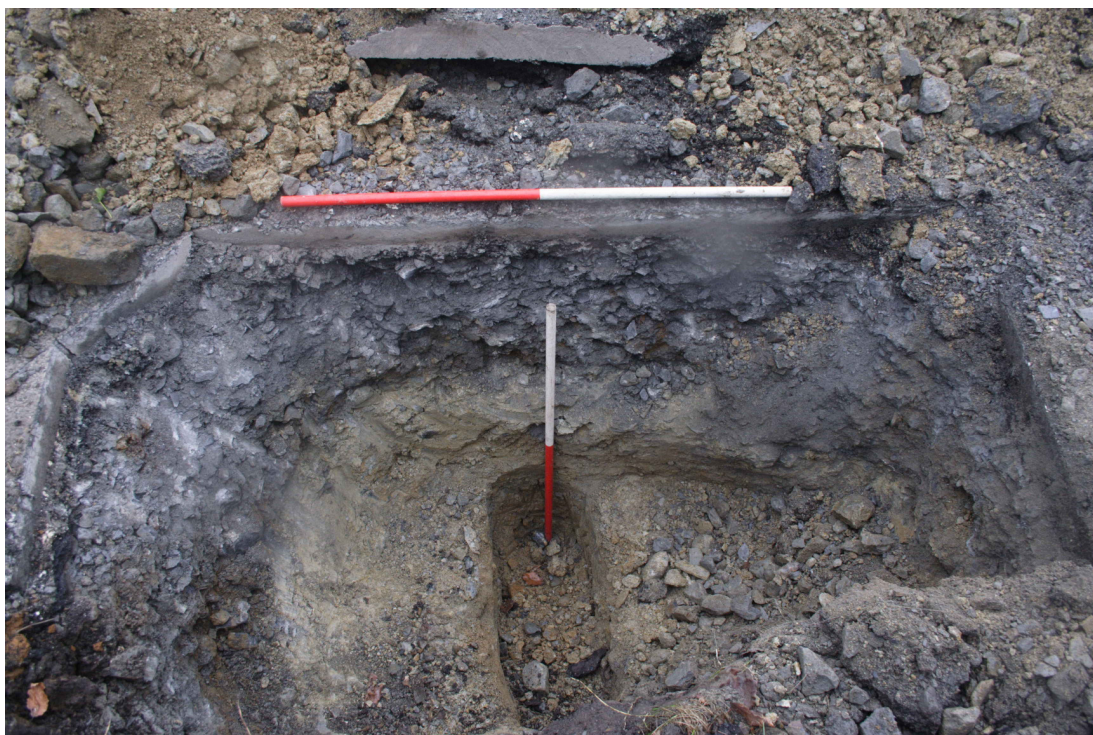
Photo 4: North east facing section Test Pit 2 (Area 2)
(NGR SN 6457 9217)

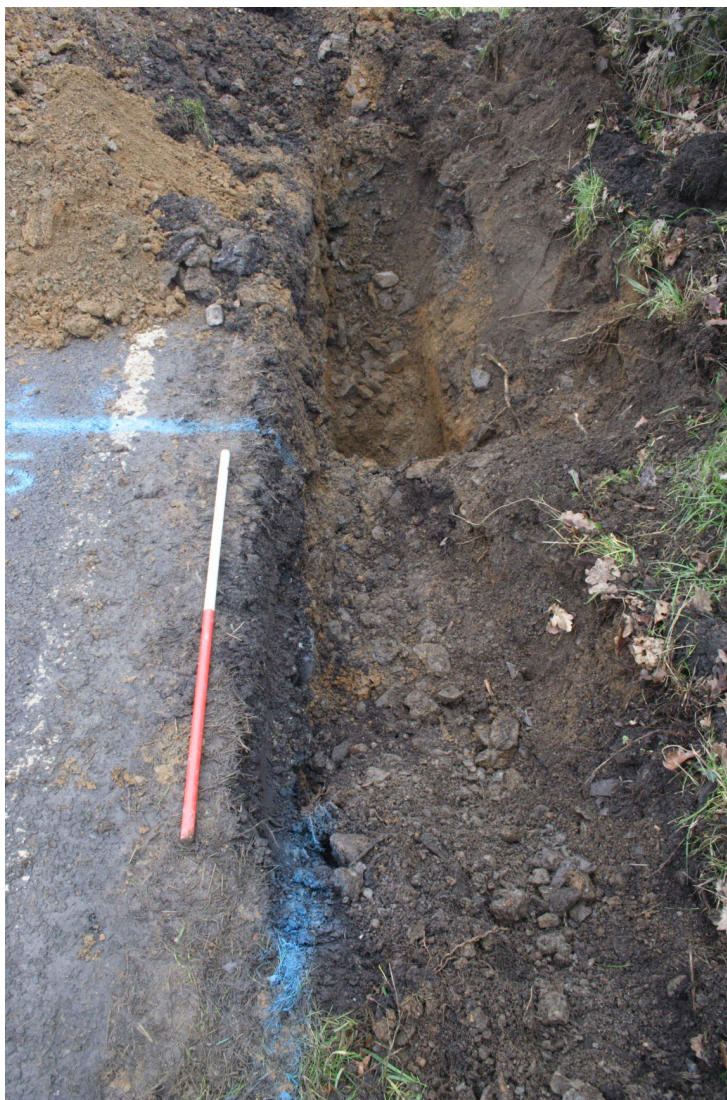
Photo 5: East facing view of Test Pit 3 (Area 2)
(NGR SN 6448 9223)

4.2.8 The third test pit was located on the grass verge adjacent to the road and revealed a 0.3m deep dark brown clay silt topsoil overlying natural clays (Photo 5).
