LAND ADJACENT TO IVY COURT COTTAGES, IVY COURT, LLYS Y FRAN, PEMBROKESHIRE:

ARCHAEOLOGICAL WATCHING BRIEF 2012

Prepared by Dyfed Archaeological Trust
For: M A Rees Construction Ltd

RHIF YR ADRODDIAD / REPORT NO. 2012/34
RHIF Y DIGWYDDIAD / EVENT RECORD NO. 102871

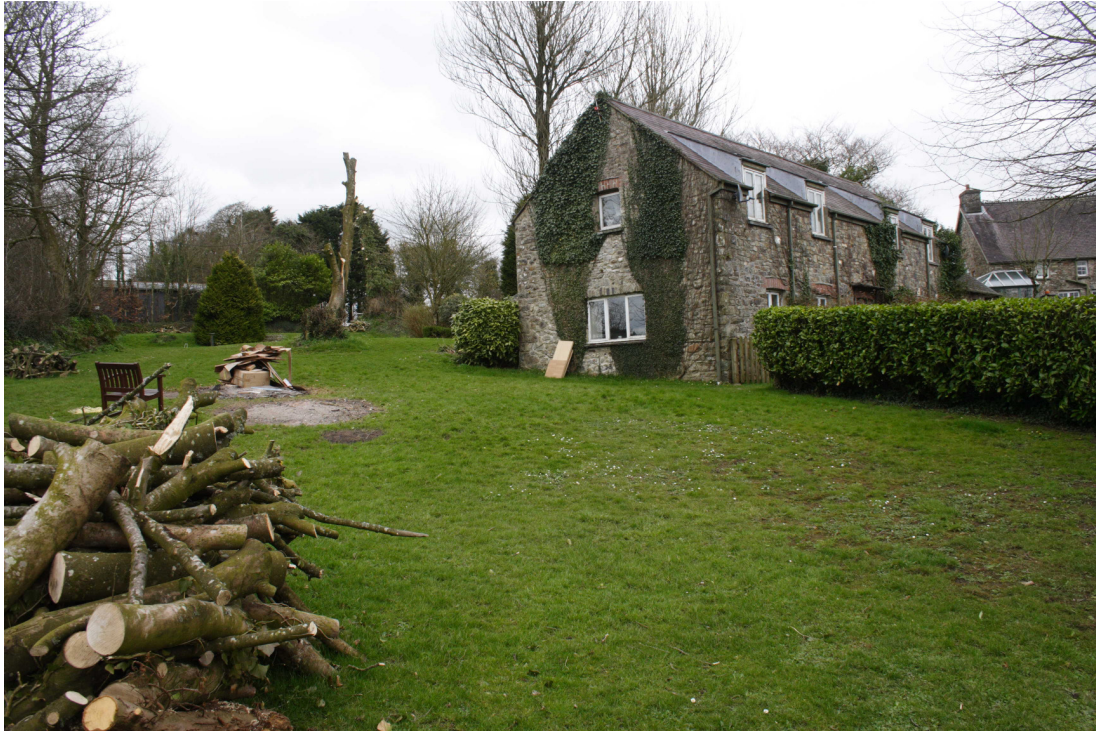
The development area was laid to grass, forming part of the gardens of the Ivy Court complex (Photo 1). There was no indication of the property boundary shown on the first edition Ordnance Survey map being present within the area. It was considered very likely that the garden had been terraced to some degree in the past, as at least two very regular breaks in slope were visible, one along the northern edge of the development area and a second one further to the north. A lowered pathway was also present running along the northern side of Ivy Court Cottages, with a breeze block retaining wall.

Photo 1: View northeast across the proposed development plot, showing western gable end of Ivy Court Cottages

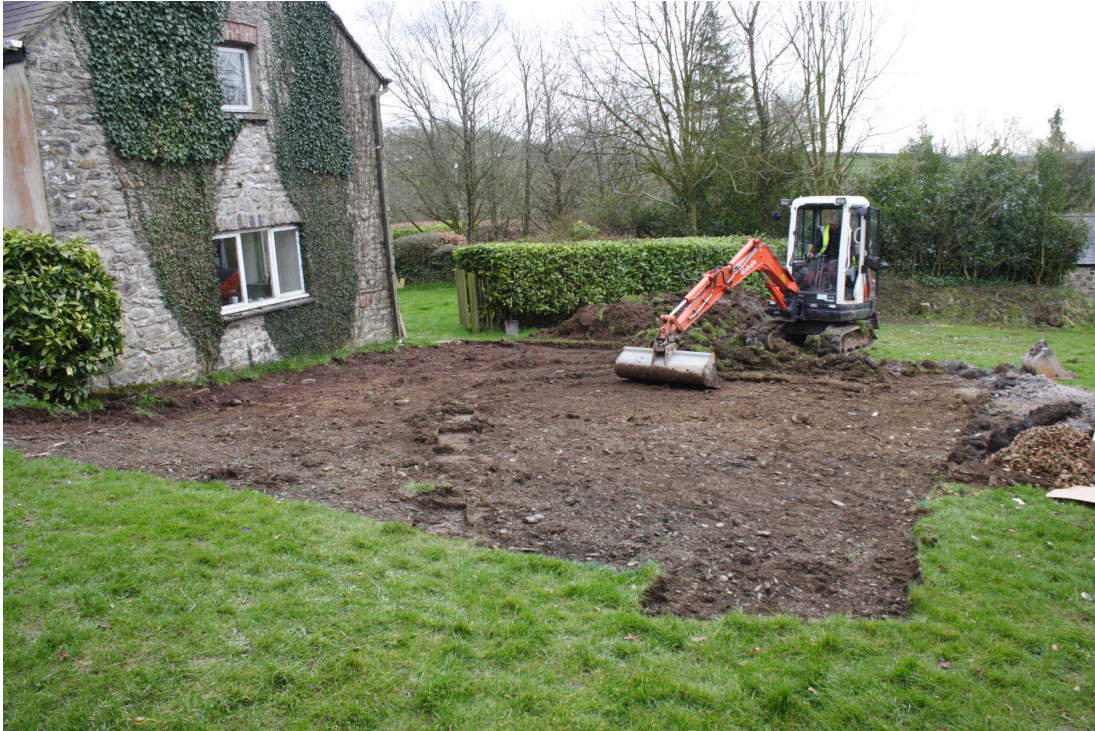
A mini-digger fitted with a flat bladed bucket was used to strip the topsoil of the area on the western side of the cottages covering the footprint of all but the southern part of the L-shaped footprint of the proposed new structure (Photo 2), and it was in this area that a watching brief was carried out (Figure 2). The topsoil comprised merely a thin layer of turf lying on a compact level of redeposited material across the majority of the development area. A line of concrete flag stones was noted in the turf which had become overgrown and hidden (Photo 2).

Photo 2: Topsoil stripping of the site area showing line of impressions of concrete flag stones in the excavated surface

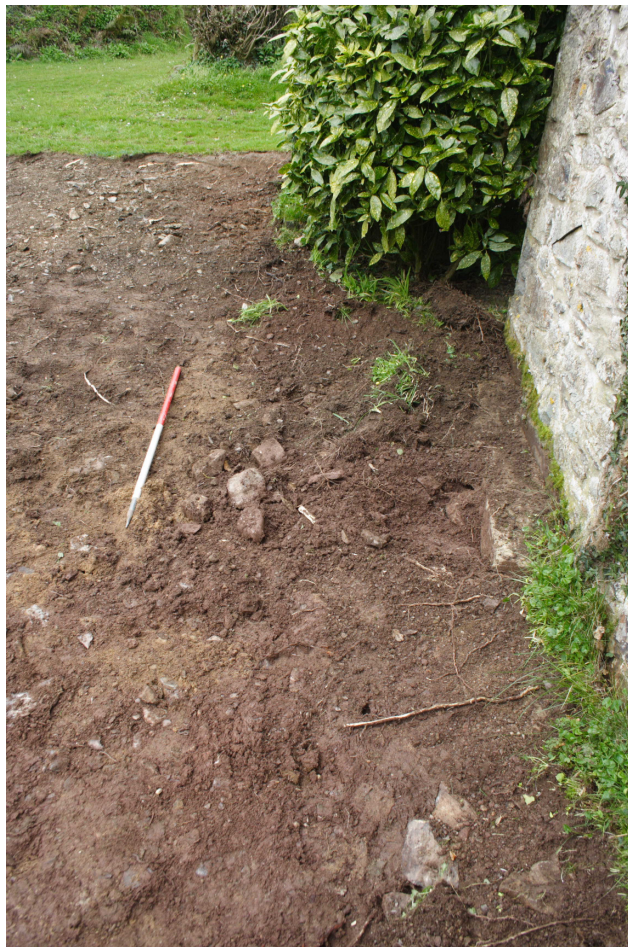
Adjacent to the western end of Ivy Court Cottages the ground was less substantially compacted, and numerous bits of detritus including batteries, bottles and old paint pots were present (Photo 3). A large long stone was noted at the base of the wall footings for the cottages, which following further excavation was shown to be the very base of the wall foundations (Photo 3).

Photo 3: Area of looser backfilled material adjacent to Ivy Court Cottages and large stone in footings

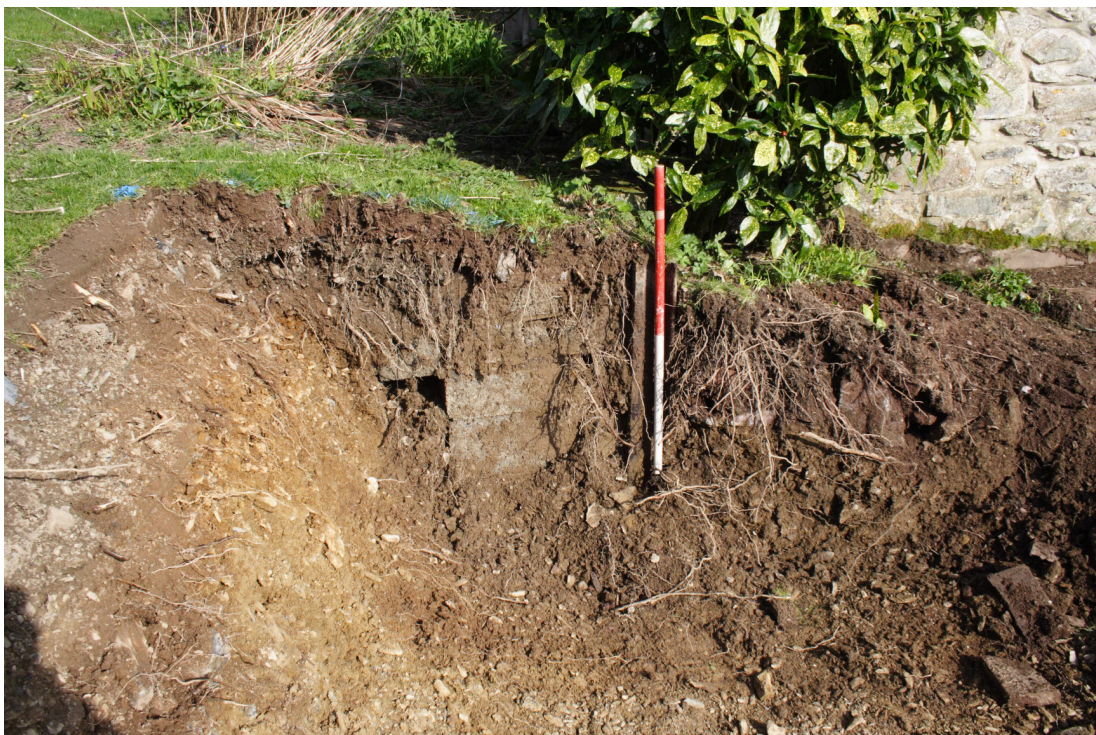
In the northeastern corner the end of the breeze block retaining wall was visible (Photo 4). Adjacent to this wall it could be seen where a steep cut had been terraced into the natural 'rab' bedrock (Photo 4). The redeposited material lying above the bedrock (and below the thin turf layer) was 0.25m thick in the northeast corner of the exposed south facing section. The material backfilled into the terrace adjacent to the breeze block wall contained substantial quantities of modern debris (including very modern building materials).

Photo 4: Northeastern corner showing breeze block retaining wall and terrace in natural 'rab' bedrock

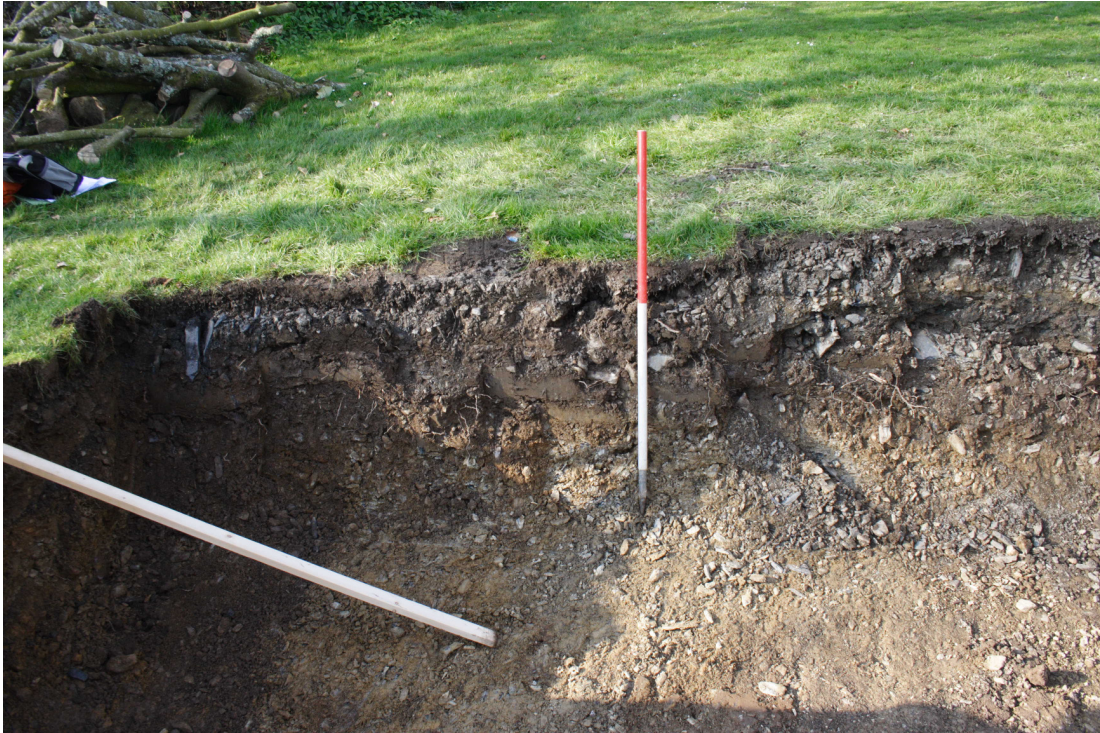
The remainder of the south facing section exposed along the northern edge of the machined area (Photo 5) had varying depths of redeposited material compressed onto the underlying bedrock (0.7m depth in the central part of the section, lowering to 0.4m depth in the northwestern corner). Parts of scaffolding poles and a piece of railway track were recovered from this layer, as well as modern ceramic, glass and plastic. Railway tracks had been used as supports for the breeze block wall as well, so were presumably brought to the site at the same time.

Photo 5: Northwestern part of exposed south facing section of development area

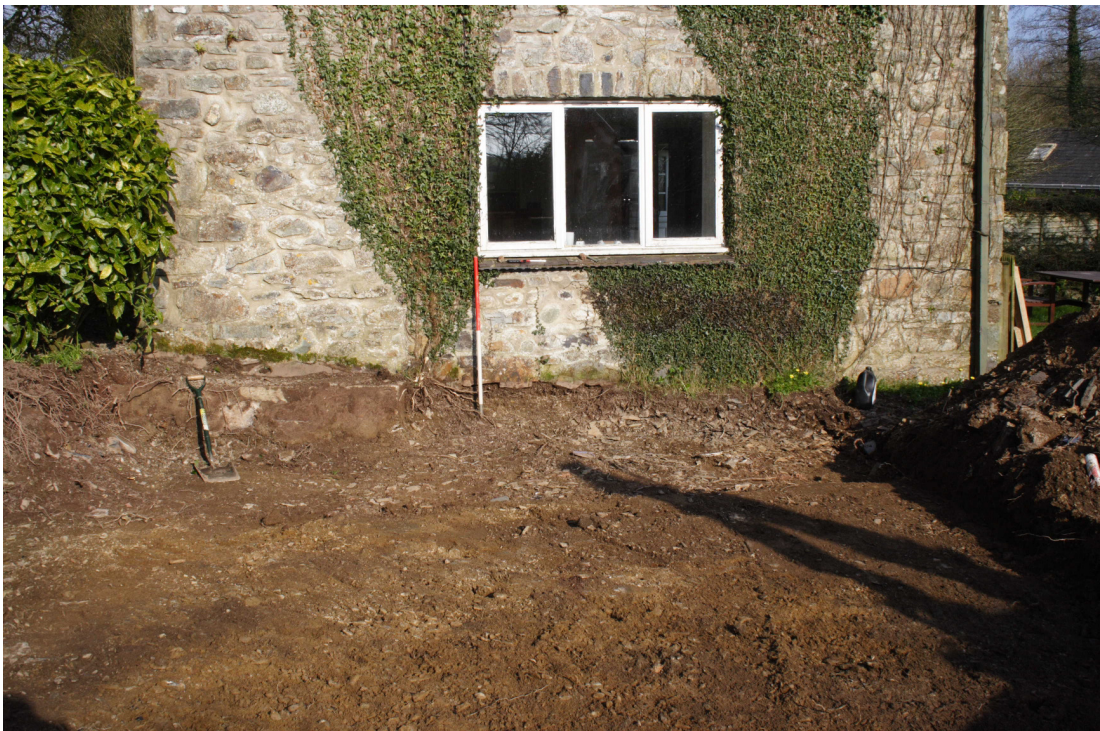
The area adjacent to the cottage had been infilled with soil, stone and building material debris (plastic, cables, paint pots etc). A compact natural 'rab' layer was exposed adjacent to the building onto which the insubstantial footings of the western gable end wall of Ivy Court Cottages had been built (Photo 6).

Photo 6: View towards western gable end wall of Ivy Court Cottages showing insubstantial footings on 'rab' bedrock
