BRICKYARD LANE PHASE II, CARMARTHEN, CARMARTHENSHIRE: ARCHAEOLOGICAL WATCHING BRIEF (SN 4041 1872)

Prepared by Dyfed Archaeological Trust
For: Morgan Sindall plc

RHIF YR ADRODDIAD / REPORT NO. 2012/39
RHIF Y PROSIECT / PROJECT RECORD NO. 102926

BRICKYARD LANE PHASE II, CARMARTHEN, CARMARTHENSHIRE: ARCHAEOLOGICAL WATCHING BRIEF

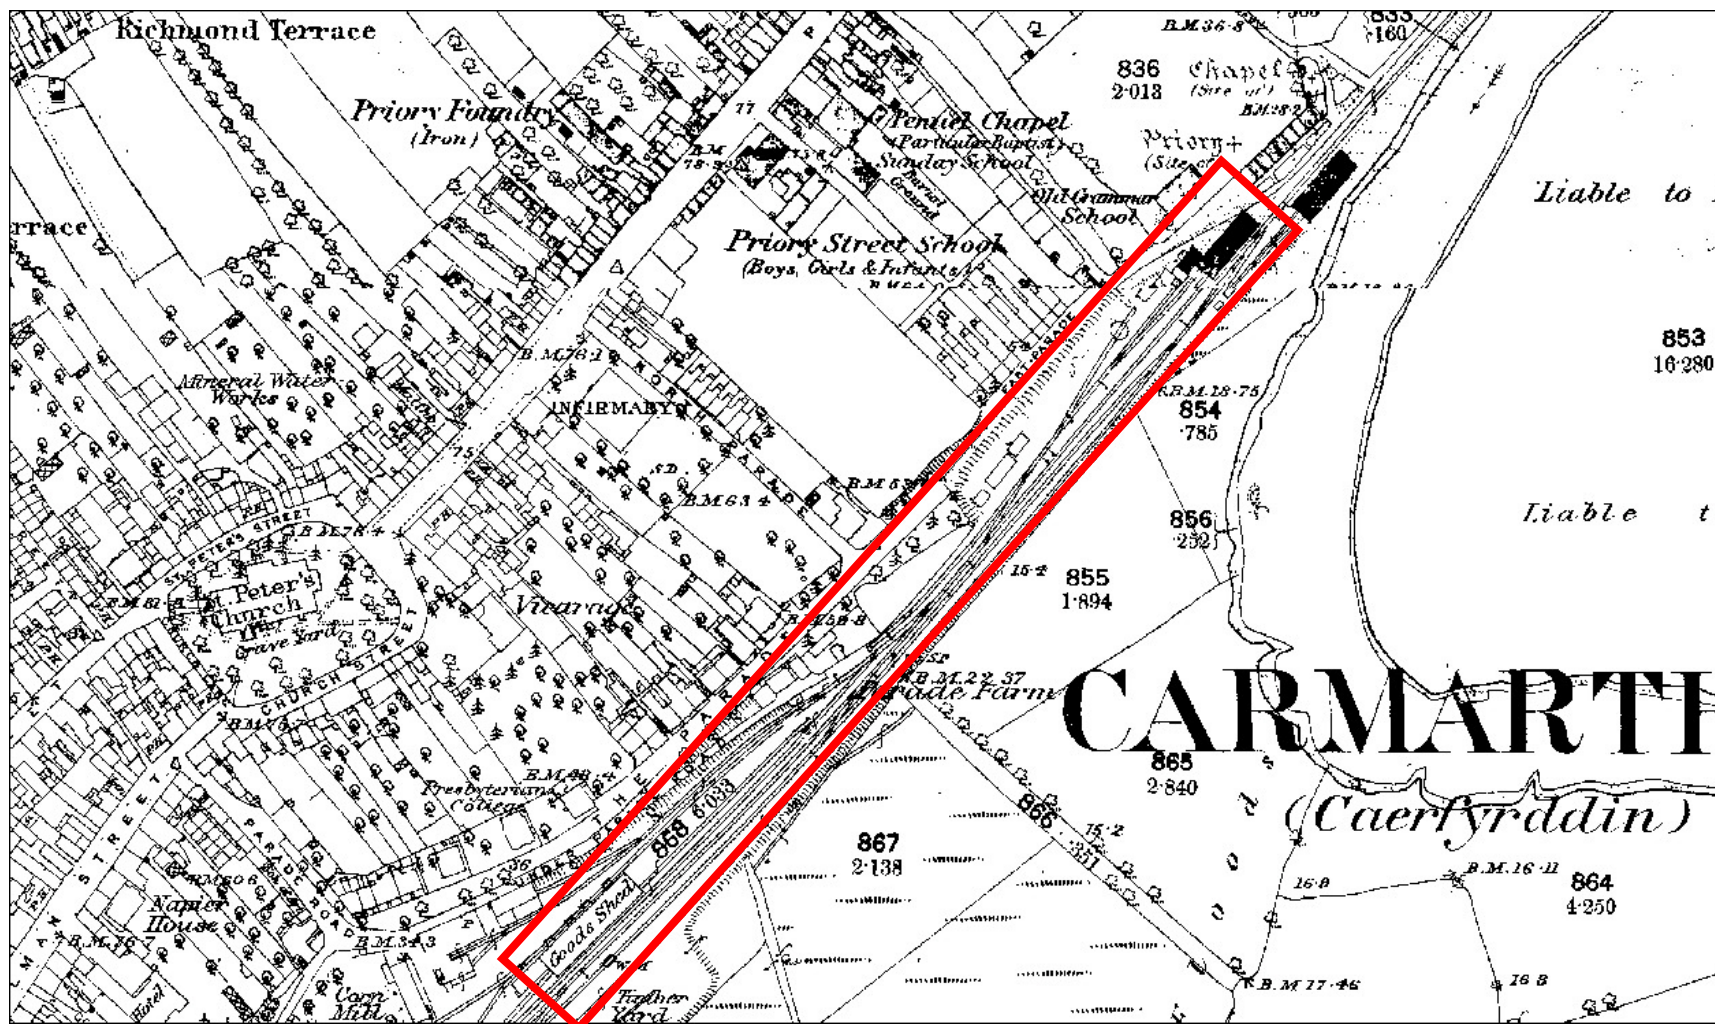
2.2.10 Late 19th and early 20th century 1:2500 scale maps show that the development area was occupied by a network of railway lines and structures associated with the operational needs of the running of the railway and goods yard. The only structure annotated on the maps is a Goods Shed towards the southwest end of the development area. It is however, possible to identify a turntable towards the northeastern end of the area. Two substantial buildings, also located towards the northeastern part of the development area, are annotated as 'Engine Sheds' on the 1888 1:500 scale map of the area. Whilst many of the structures located along the route of the works are unnamed it is considered that they include water tanks, possible coaling stages, signalling maintenance and storage buildings (Figures 2-3 and 9). Much of the area had been cleared by the late 1980s with only the goods shed remaining (Figure 4).

Figure 2: Extract of 1888 1:2500 scale Ordnance Survey Map of the area, with the route of the water main renewal works shown in red

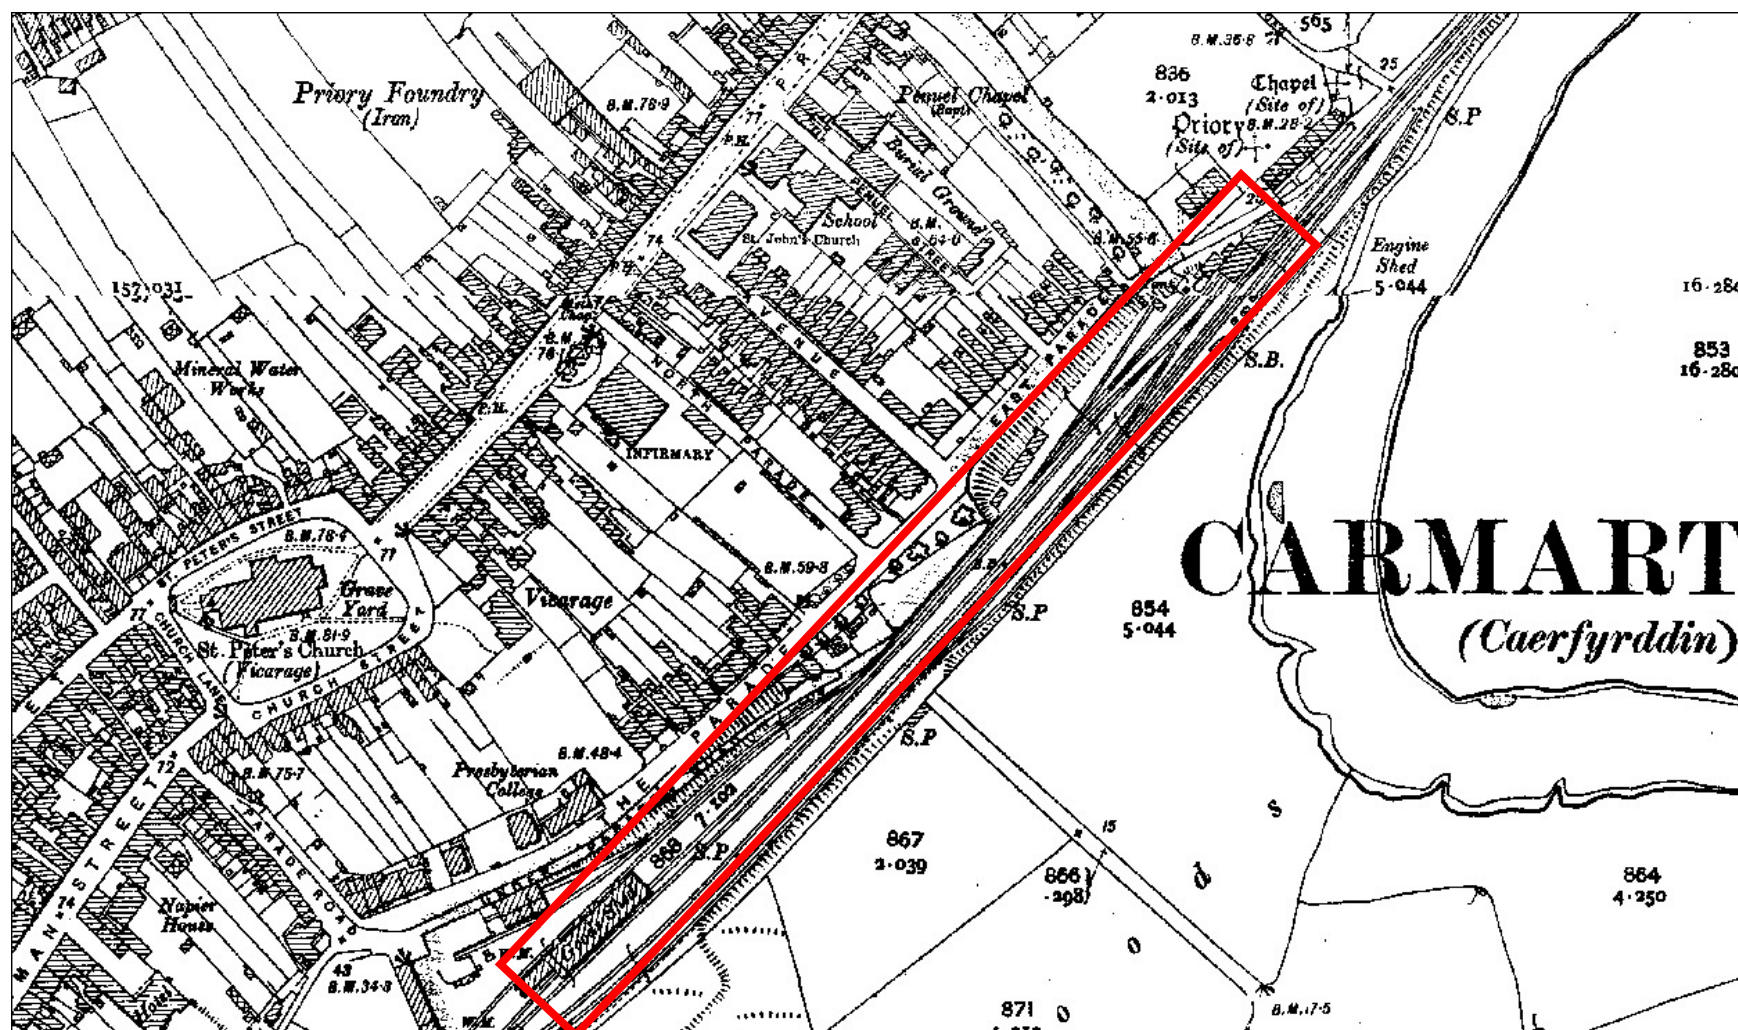
Figure 3: Extract of 1906 1:2500 scale Ordnance Survey Map of the area,
with the route of the water main renewal works shown in red

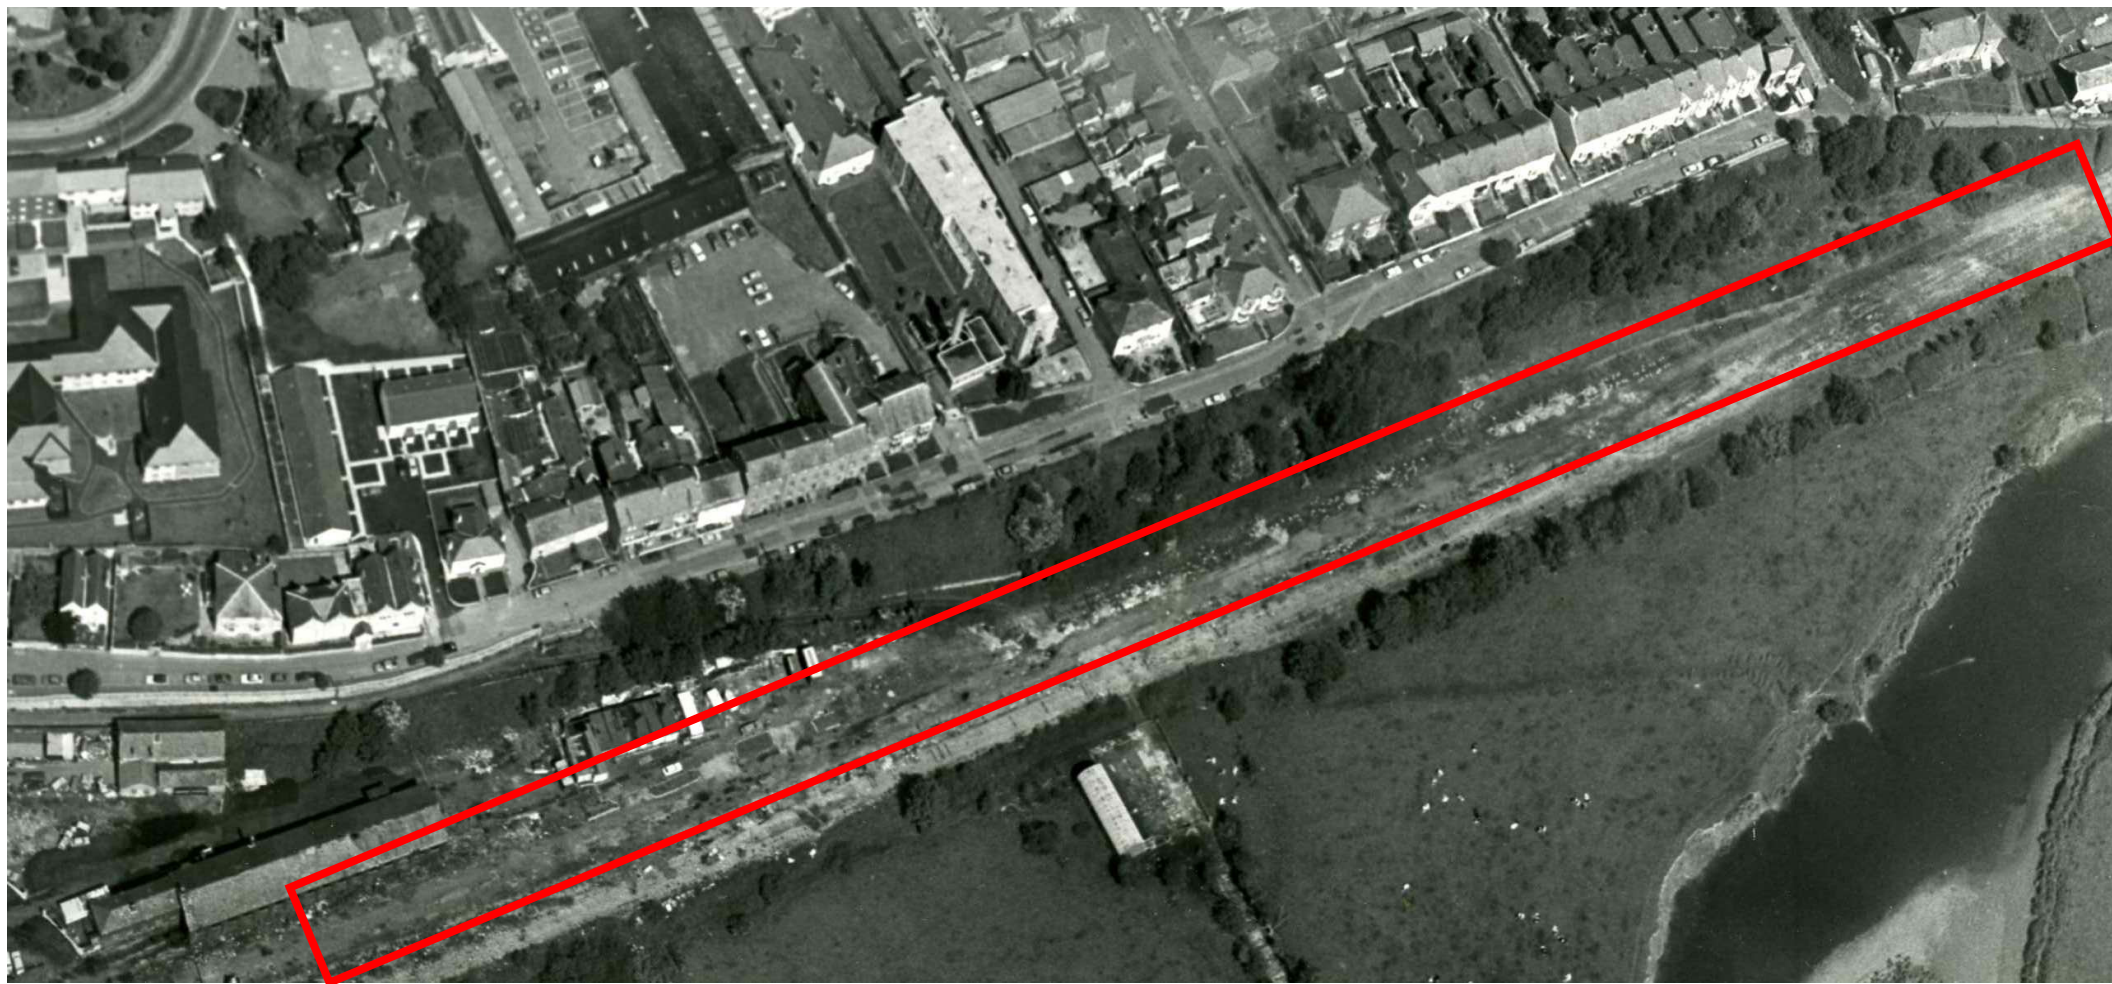
Figure 4: Late 1980s aerial view of development area (DAT collection).

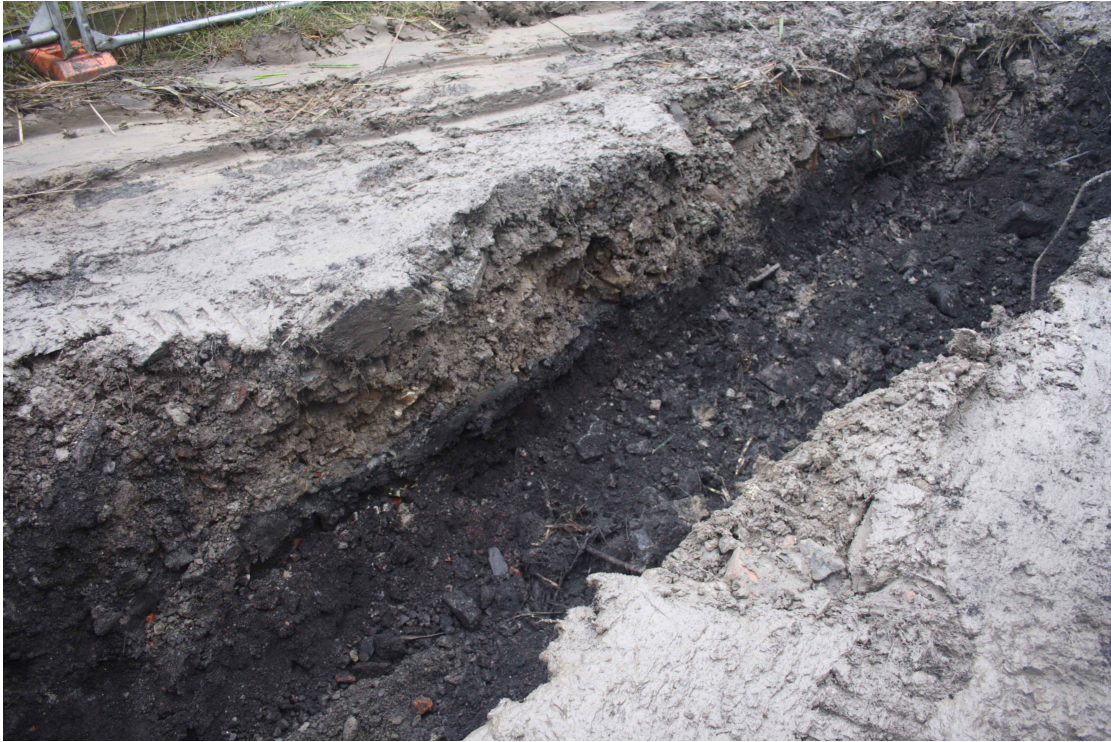
4.2 The trench was excavated through a firm upper layer comprising mid-grey clay silt containing frequent small to medium angular stone (100) with a depth of c.0.55m. This overlay a moderately compacted grey black clay silt containing frequent fragmentary red bricks and large stones (101) (Photo 5). Underlying (101) was a mid-grey brown compacted natural clay, with a visible thickness of 0.4m (102) which formed the base of the trench. This stratigraphic sequence was visible along the entire route of the water main renewal works.

Photo 5: SE facing representative section showing (100) and (101)

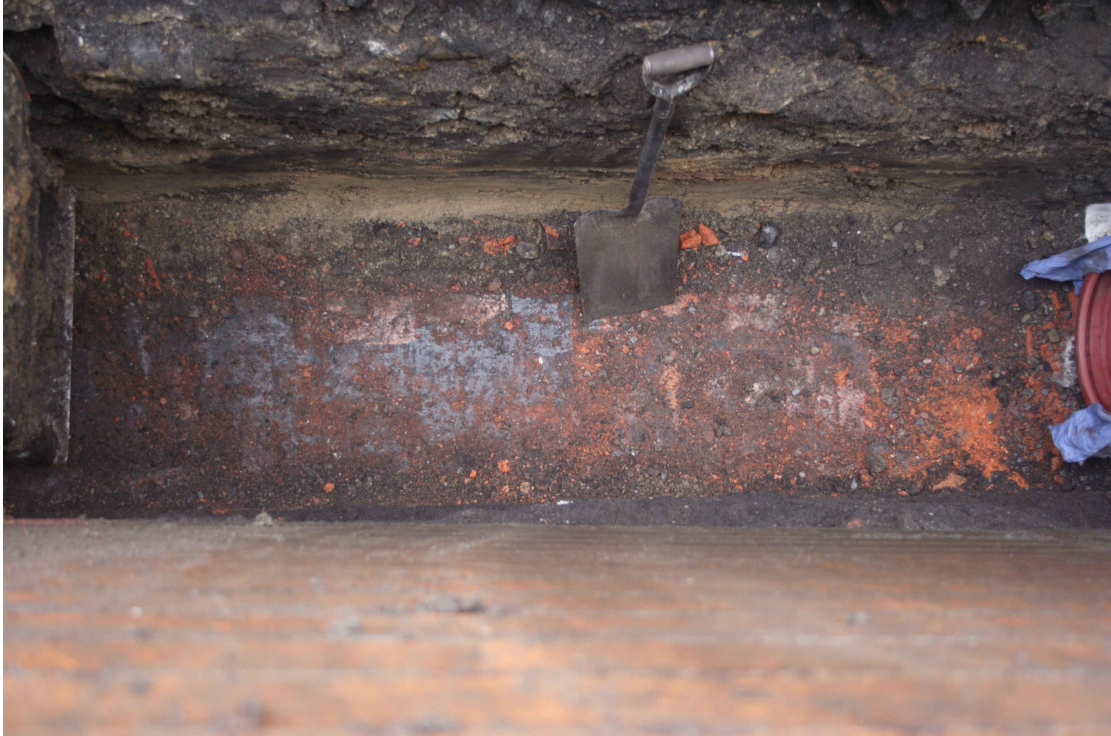
4.3 The archaeological remains of two structures, both associated with the railway line and goods yard, were revealed during the course of the archaeological watching brief. The first structure was a 6m x 0.6m length of northeast – southwest aligned brick wall footing located at NGR SN 4192 2035 (Photo 6-8). Late 19th century mapping indicates that a c.30m x c.9m engine shed stood at this location from at least 1888 (Figure 4). During the course of the excavation work a number of red bricks marked LNWR were recovered indicating that the shed was constructed by the railway company. The LNWR operated its own brickworks, with a capacity to produce 6 million bricks per annum, which was located at the Crewe Railway works (Devine & Clark 2002, 10-11). Additional research has revealed that the LNWR engine shed replaced an earlier structure constructed by the Central Wales & Carmarthen Junction Railway during the 1870s which was destroyed by a gale. No evidence for this earlier structure was identified within the mains renewal area.

Photo 6: Vertical view of LNWR engine shed wall footing.

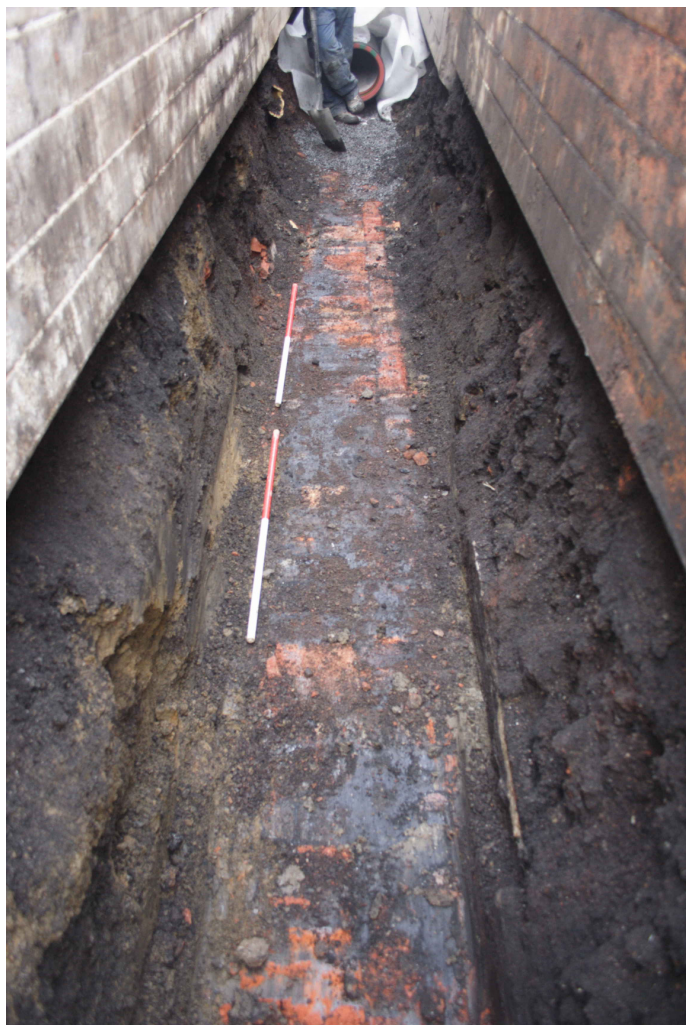
Photo 7: NW facing view of LNWR engine shed wall footing

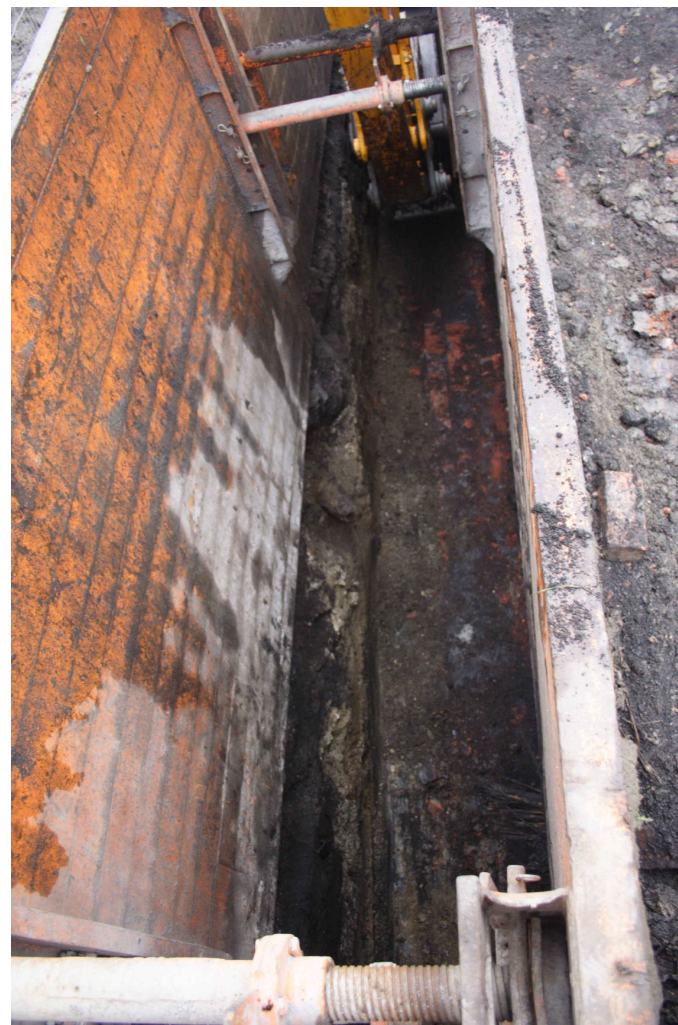
5.2 The brick footings of the northwest wall of the former LNWR engine shed, potentially constructed between 1884 and 1888, were revealed at NGR SN 4192 2035 and further remains of this structure lie beneath the ground at this location. Late 19th and early 20th century maps show that further structures relating to the railway also lie within this area and it is likely that evidence for these may also survive below ground.

Photo 8: Overall view of LNWR engine shed wall footing

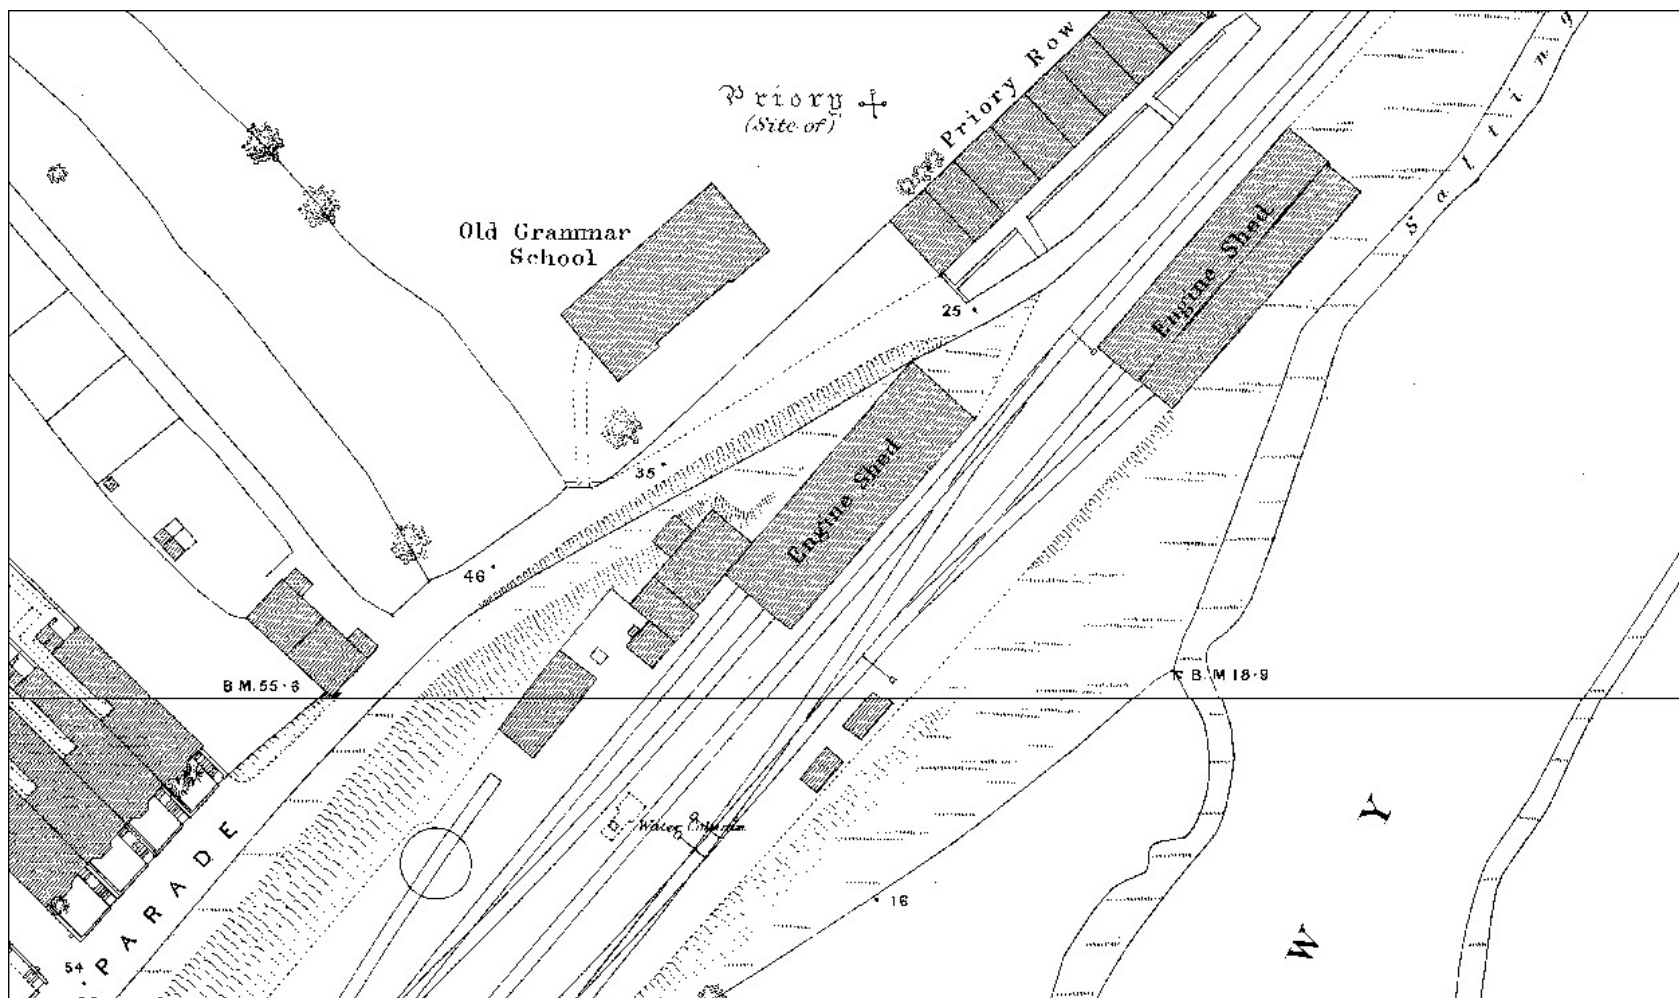
4.4 The replacement shed was constructed to a standard 'north light' design of Francis William Webb, Chief Mechanical Engineer of the LNWR and was unusual in that it was of timber construction (Pennington, pers comm⁴). Early 20th century photographs show that the engine shed was of seven bays with mono pitched roofs with a dividing wall running along the middle of the structure (Photos 9 and 11). The engine shed closed on July 4th 1937 and by 1948 no trace of the structure survived (*ibid*). It is considered that the wall revealed within the excavation area forms part of the footing of the northwest side of the former engine shed and was probably constructed sometime between 1884, the time when the LNWR gained ownership and running rights of the full route between Carmarthen and Craven Arms, and the publication of the 1888 Ordnance Survey Map.

Figure 5: LNWR engine shed as shown on 1888 1:500 OS map

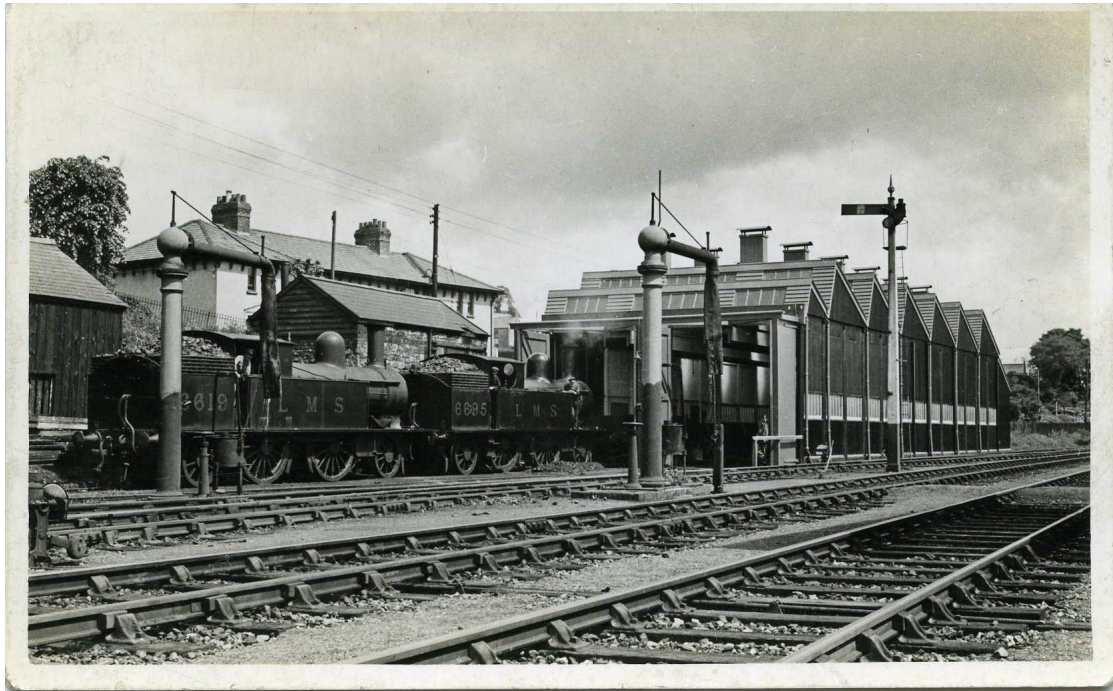
Photo 9: Former LNWR Webb design 'north light' shed Carmarthen, 1936

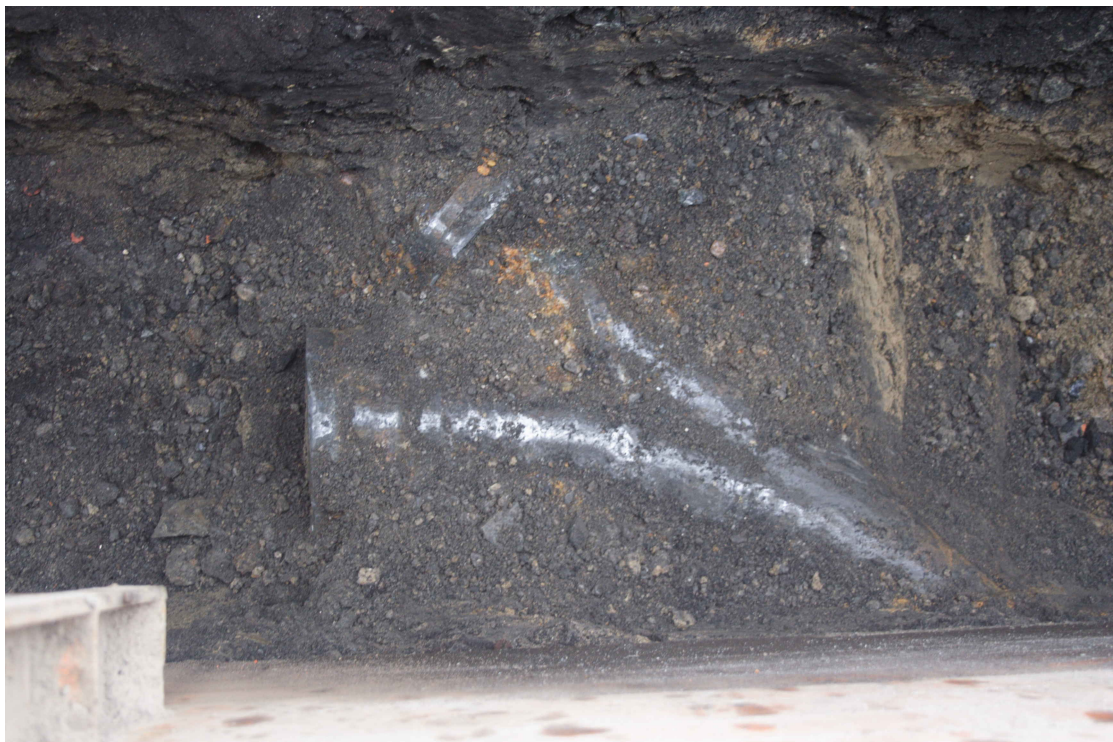
4.5 The second structure revealed was a 'Y-shaped' northwest – southeast aligned length of cast iron piping that continued beneath the northwestern side of the trench (c. NGR SN 4191 2035; Photo 11). This length of piping is considered to have formed part of the water supply system used to replenish the water tanks of locomotives. The 1888 OS map shows water columns c. 17m to the southwest of this location at NGR SN 4189 2032, with a further structure at NGR SN 4190 2035. These are shown to be a raised water tank and possible pump house on an early 20th century image of the area (Photo 12). By the publication of the 1906 Ordnance Survey map, reworking of the track layout had been undertaken and a signal box had been constructed at c. NGR SN 4191 2031 indicating that the water tank was demolished by this time. The map shows a structure marked as 'Tank' at NGR SN4188 2033 and an early 20th century photograph of the area shows the structure along with the 'new' signal box and water column shown on the 1888 Ordnance Survey Map. This redevelopment of the area is visible on an early 20th century photograph (Photo 12). It is likely that the water used to

supply the tank was pumped directly out of the nearby River Towy. A photograph of the LNWR engine shed taken in 1936 shows two water columns positioned outside the entrance to the building (Photo 9). Given the northwest – southeast alignment of the piping it is possible that it dates to the early part of the 20th century.

Photo 10: Cast iron water supply pipe.

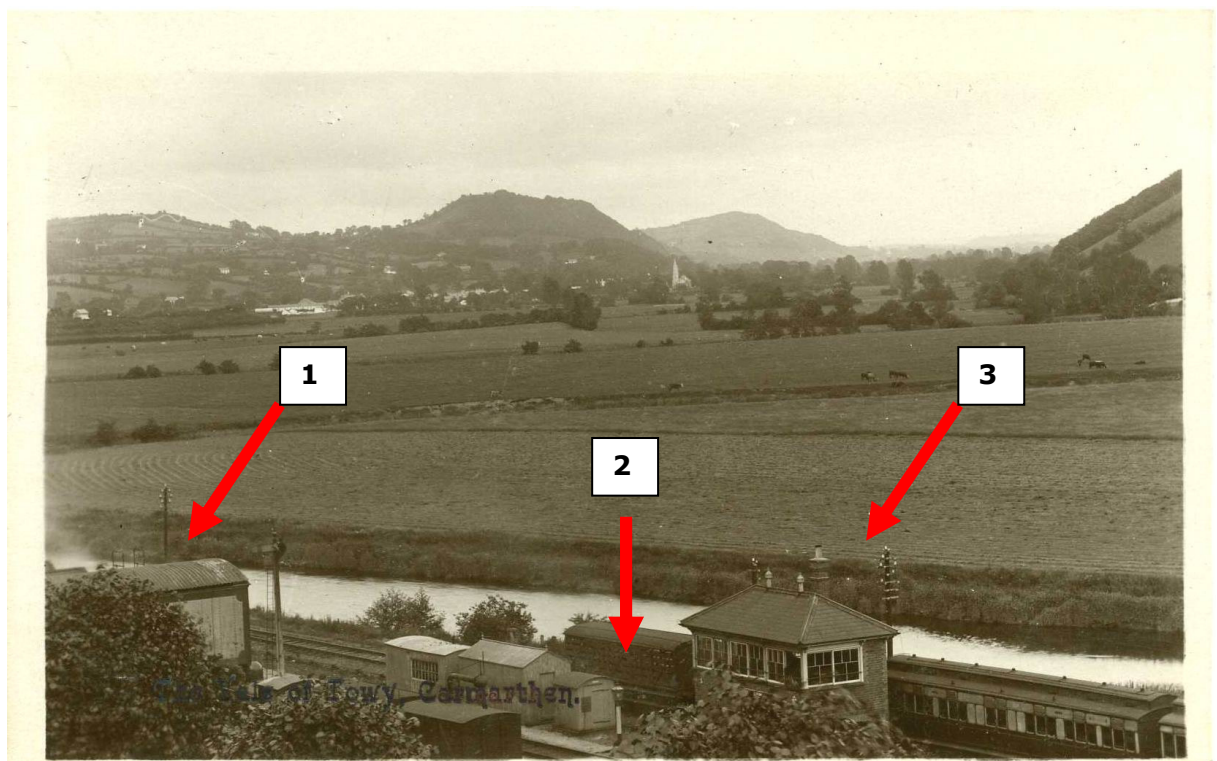
Photo 12: Early 20th century photograph showing later water tank (1), water column (2) and 'new' signal box (3).
