**LAND AT CWRT CASTELL TEIFI, LLANDYSUL,
CEREDIGION (SN41801 40674)
ARCHAEOLOGICAL WATCHING BRIEF**

Prepared by Dyfed Archaeological Trust
For: Mr J D Davies

RHIF YR ADRODDIAD / REPORT NO. 2012/41
RHIF Y PROSIECT / PROJECT RECORD NO.102927

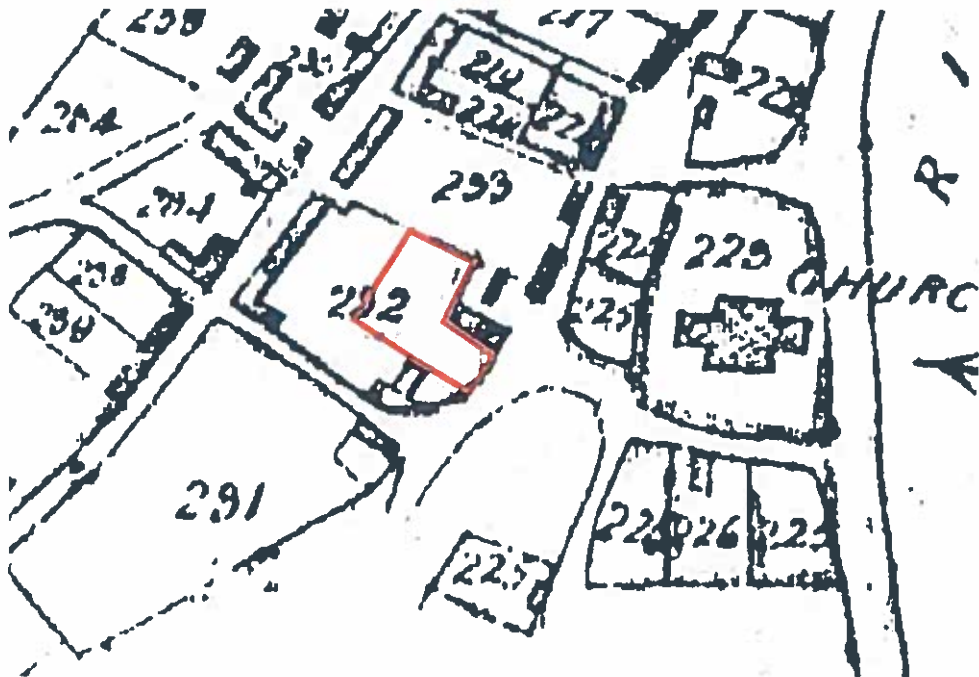
Figure 3: Extract from the Llandysul Parish Tithe map c. 1844

2.2.6 The 1841 Tithe map of Llandysul shows that the site area was undeveloped (Figure 3). By the 1889 Ordnance Survey map (Figure 4) a number of structures had been erected within the site boundary, including a large building in the southern part, a smaller structure to the southwest and a row of buildings fronting Porth Terrace. The 1905 Ordnance Survey map (Figure 5) shows the same layout as that for 1889.

- 5.1 The majority of the development area has been back garden or yard plots for the entirety of the mapped history of the site (Figures 3, 4 and 5). The most recent structures on the south side of the plot were a shed and an agricultural building. No evidence of the former building on the Porth Terrace street frontage represented on historic mapping (Figures 3, 4 and 5) appears to have survived within the development area.

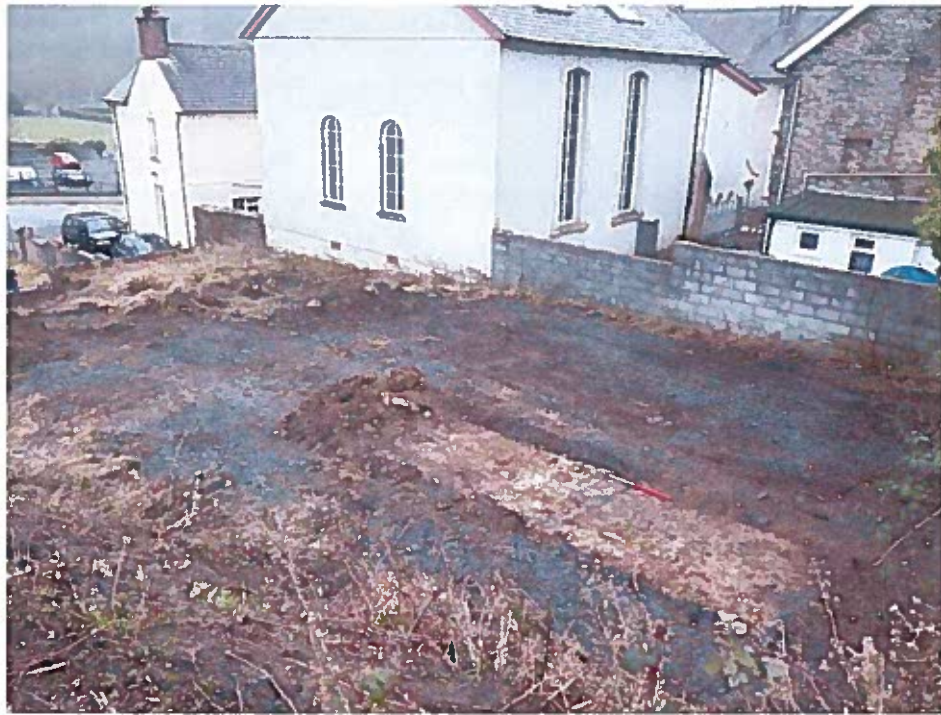
4.1 Test excavation 1 (Photo 1)

- 4.1.1 This test excavation was approximately 5m long and 1.6m wide and 0.05m deep. It lay in the southwestern part of the development site. The entire area to the south of the access ramp running across the site appears to have been reduced in height to create a level area behind the Lon Wesley street front properties.
- 4.1.2 Directly below a 0.05m thick layer of stone chippings, the top of a natural yellow clay silt containing shale and gravel fragments was revealed.
- 4.1.3 No features or deposits of archaeological significance were present.

Photo 1: Trench 1 looking southeast from the top of the ramp

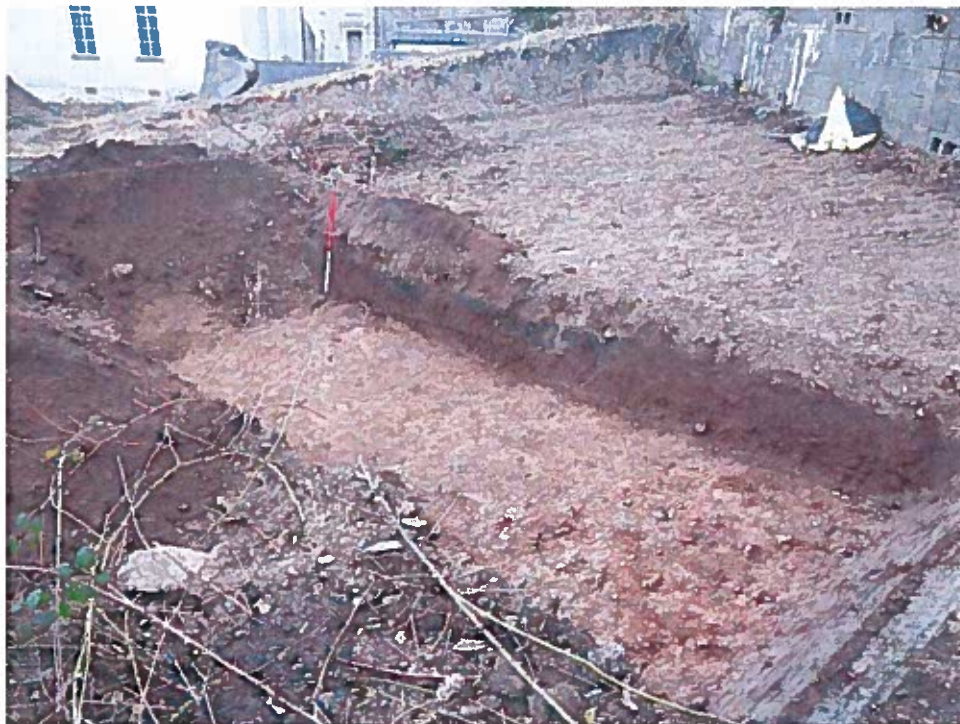
4.2 Test excavation 2 (Photo 2)

- 4.2.1 This test excavation was approximately 5m long and 1.6m wide and 0.7m deep. It was located in the northwestern part of the development site.
- 4.2.2 A c.0.2m thick deposit of crushed shale had been deposited on top of the former ground surface. This sealed a 0.5m thick homogenous topsoil deposit containing occasional charcoal and 19/20th century pottery fragments. No cut features cut into the natural geology or buried deposits were present below the topsoil.
- 4.2.3 This part of the development site appears to have been undeveloped garden or allotment land.

Photo 2: Trench 2 looking south

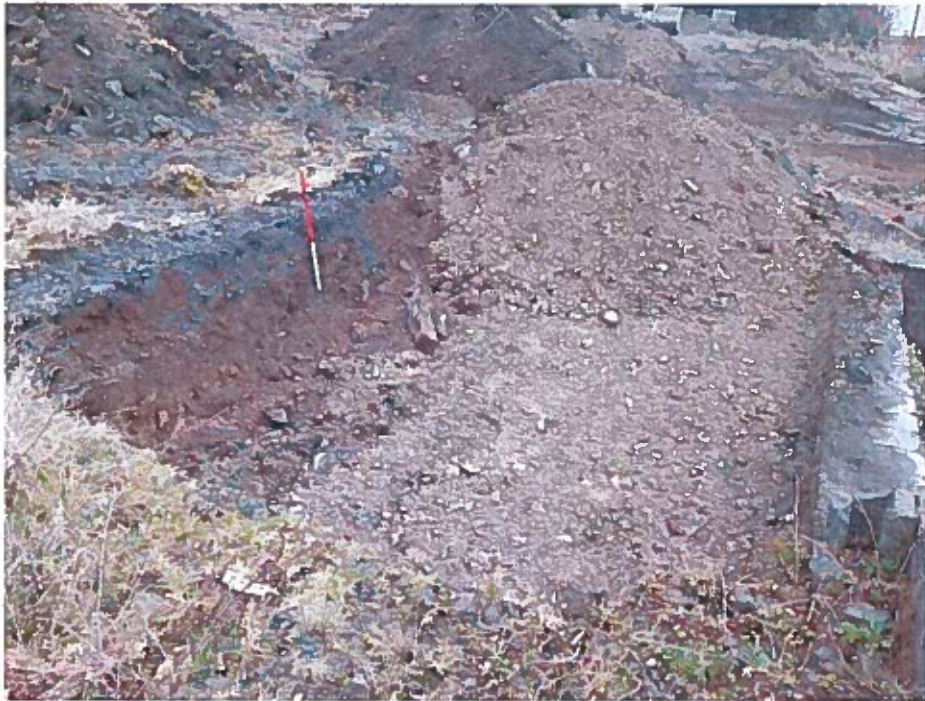
4.3 Test excavation 3 (Photo 3)

- 4.3.1 This test excavation was approximately 4m long and 3m wide. It was located in the southeastern part of the development site south of the pre-existing access ramp.
- 4.3.2 The majority of this area was backfilled with a crushed shale deposit behind a breezeblock parking bay wall. Along the western edge, topsoil similar to that revealed in Trench 2 was present.

Photo 3: Trench 3 looking north

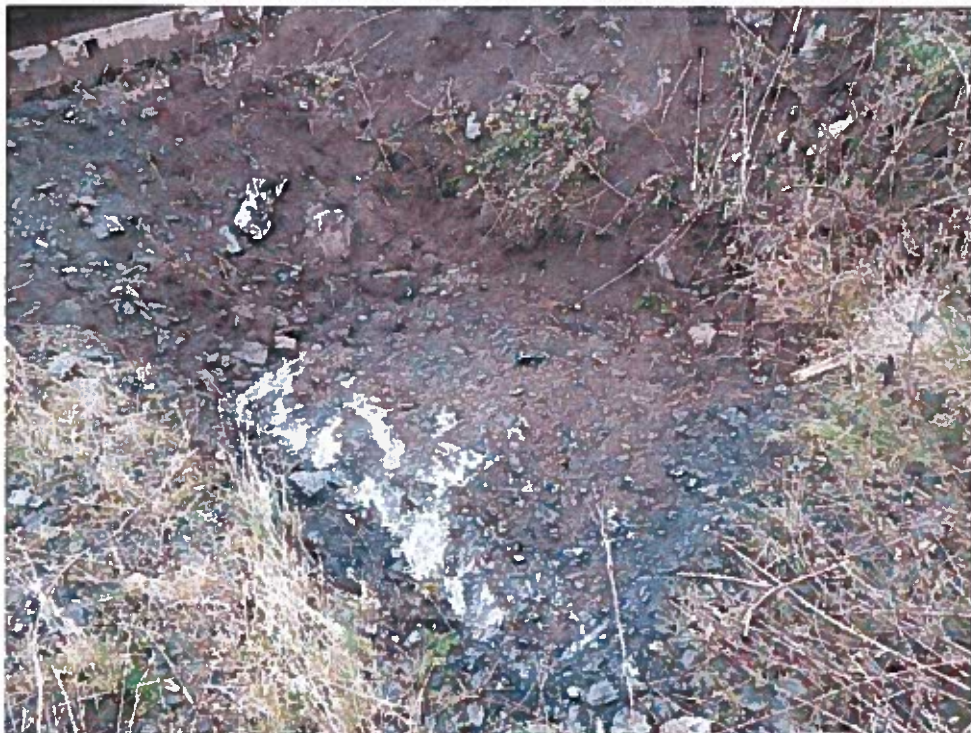
4.4 Test excavation 4 (Photo 4)

- 4.4. A small area approximately 1.6m by 1.6m was opened up in the street level terraced area. This was located on the eastern side of the development site.
- 4.4.1 The excavation revealed solid shale bedrock immediately beneath the turf cover. It appears that this area has been completely terraced into the shale bedrock and that any structural remains relating to former buildings on the plot that are depicted on historic mapping of the site have been previously removed (Figures 3,4 and 5).

Photo 4: Trench 4 looking west

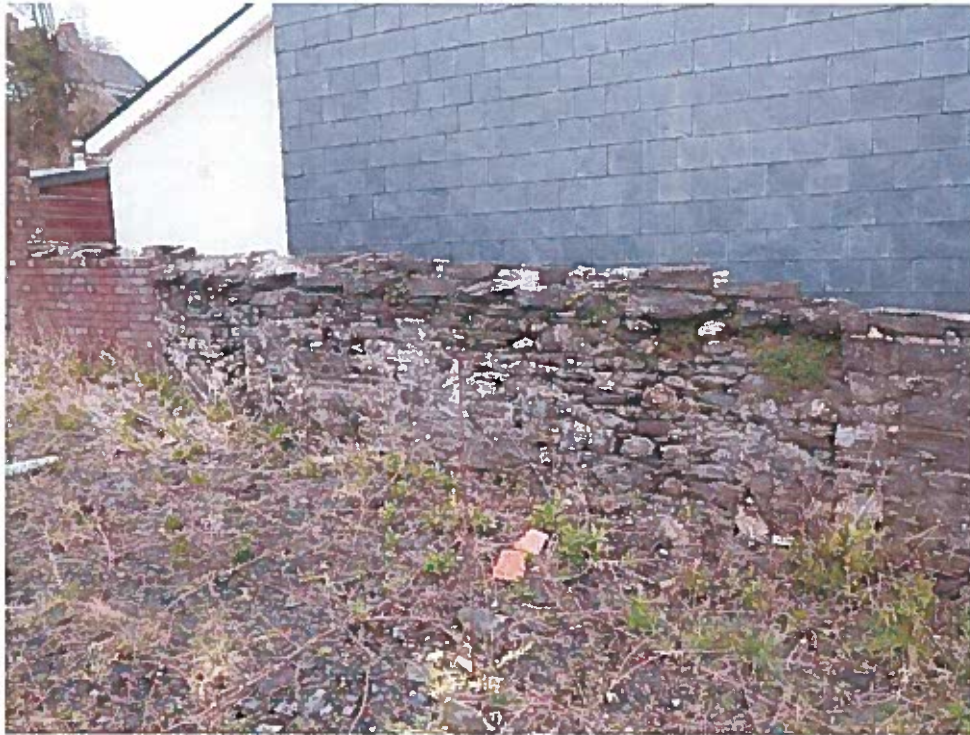
- 5.6 The existing wall between the north edge of the development site and the neighbouring house is clearly the result of several phases of construction and repair (Photo 5). Examination of the stonework of this wall did not suggest it was a remnant of a former building. A trial trench in the vicinity came down directly on to natural shale bedrock.

Photo 5: Part of the property boundary wall looking north
