LAND ADJACENT TO BRIG-Y-COED, PENRHIW-LLAN, LLANDYSUL, CEREDIGION ARCHAEOLOGICAL WATCHING BRIEF

APRIL 2012

Prepared by: Dyfed Archaeological
Trust Ltd.
For: Trevor Hopkins Associates

RHIF YR ADRODDIAD / REPORT NO. 2012/43
RHIF Y PROSIECT / PROJECT RECORD NO.102929

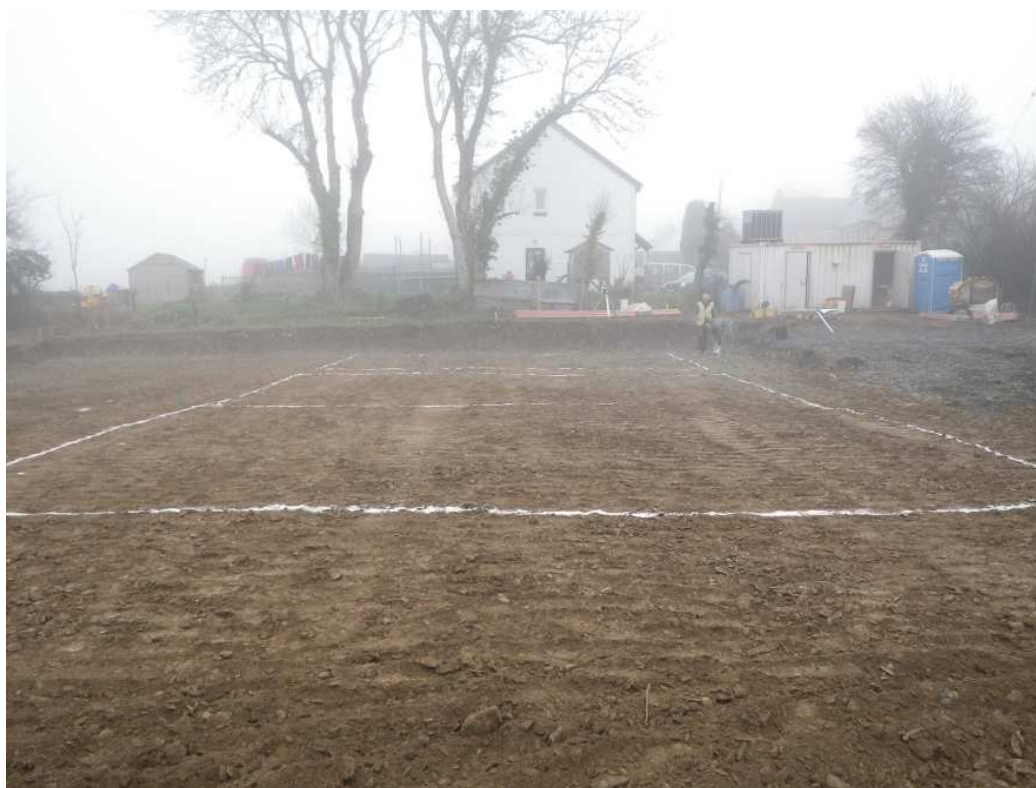
Photo 1: Topsoil stripped area looking east

- 4.1 On arrival the ground preparation had already commenced. The entire footprint area of the three dwellings had been stripped of topsoil (Photos 1 and 2).

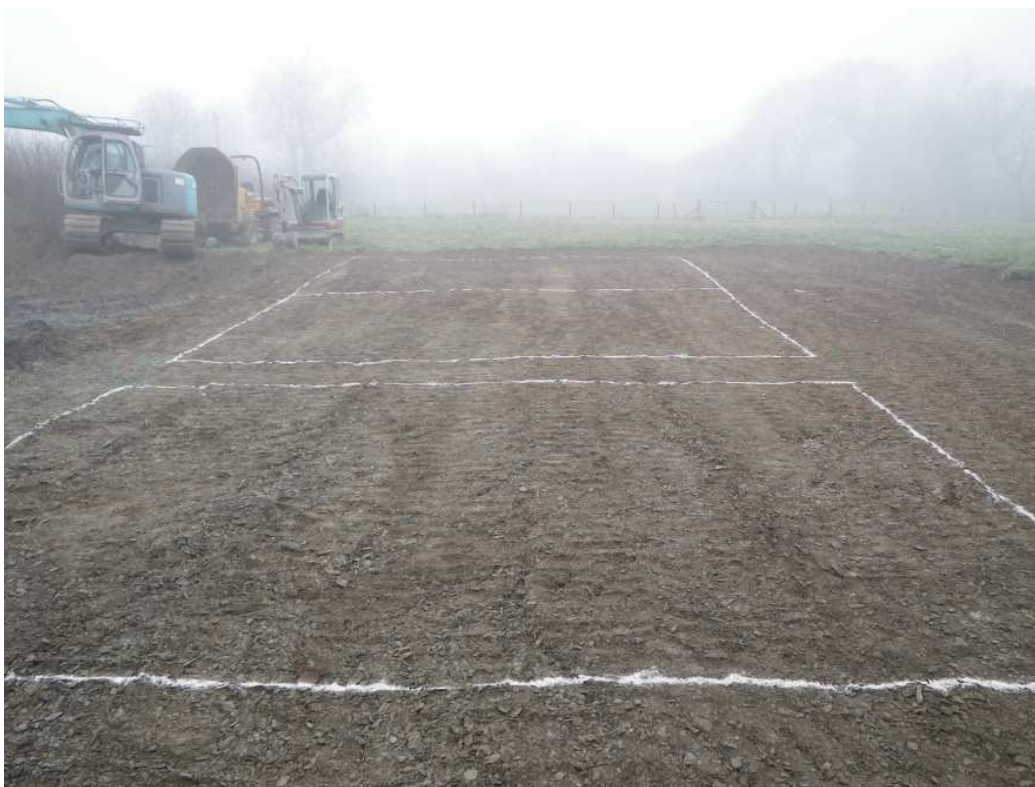
Photo 2: Building plots 3, 4 and 5 looking west following topsoil strip

- 4.2 Approximately the eastern two thirds of the plot had been machine excavated into the underlying mid grey shale bedrock ('rab'). In the final third, light brown clay silts overlying the bedrock remained in situ.

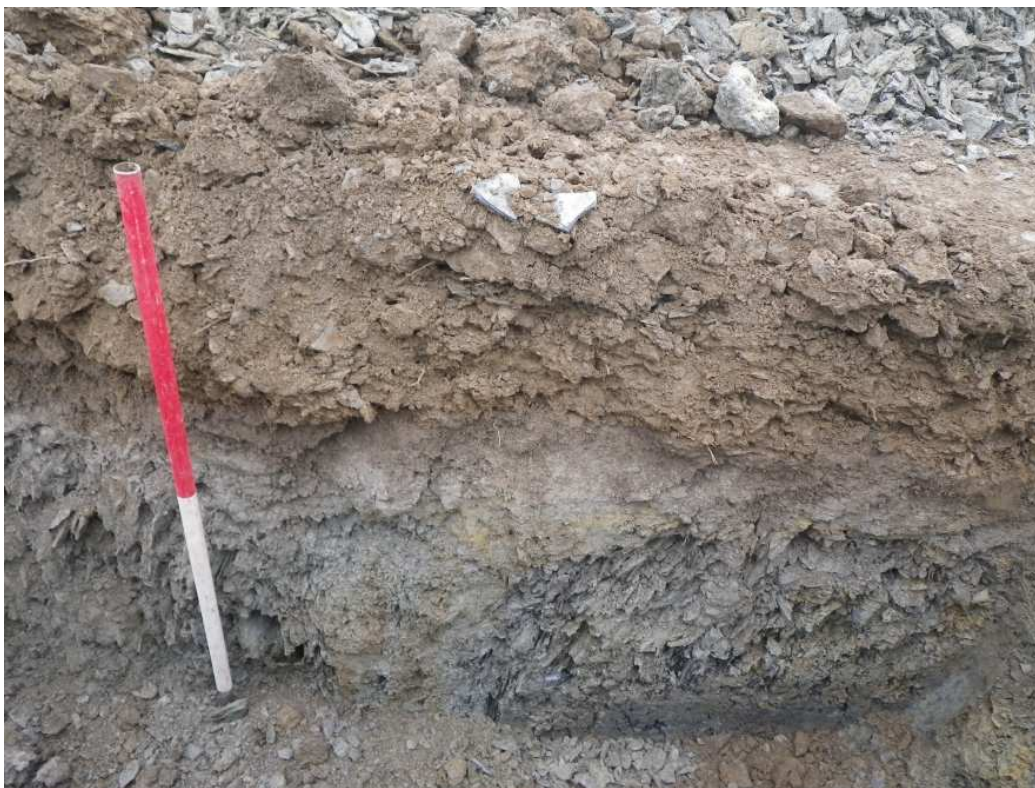
Photo 3: Representative portion of foundation trench profile

- 4.3 Within the area of surviving sub-soil the excavation of the westernmost foundation trench was observed (Photos 3 and 4). No archaeological features were present.

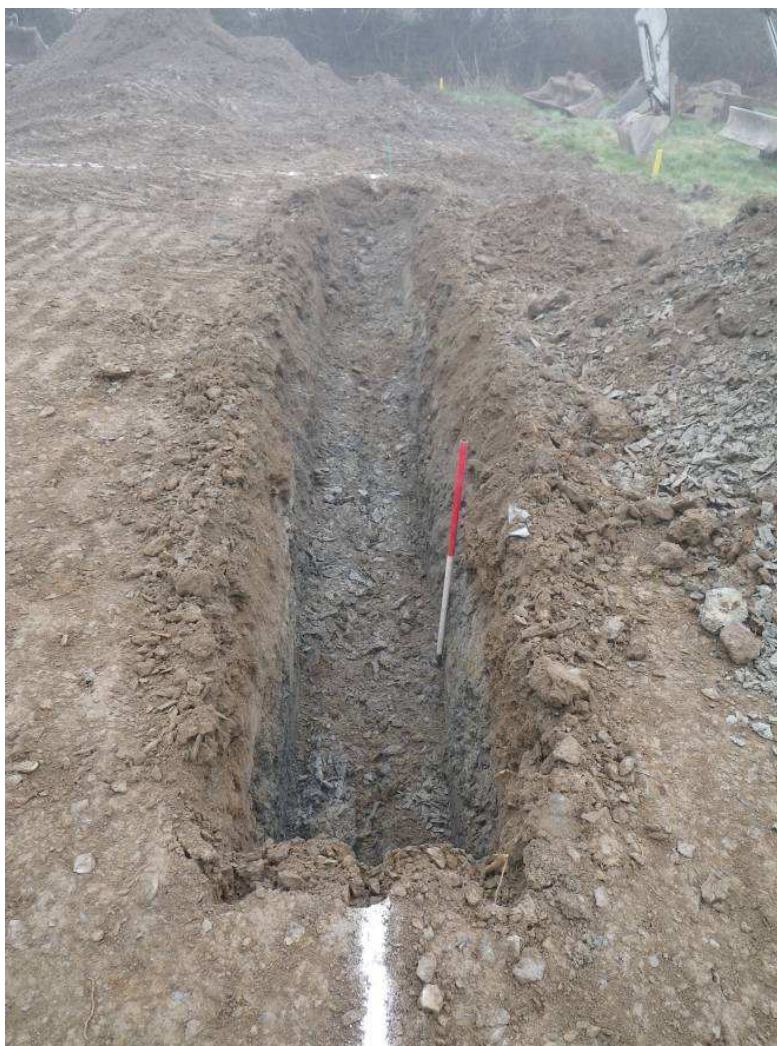
Photo 4: Foundation trench at west end of plot, looking southeast
