CAEGLAS "CEGIN FOCH" BUILDING RECORDING
PENTREBACH, LAMPETER, CEREDIGION
(NGR SN 5461 4734)

A standing building survey

RHIF YR ADRODDIAD / REPORT NO. 2012/45
RHIF Y PROSIECT / PROJECT RECORD NO. 102931

Mai 2012
May 2012

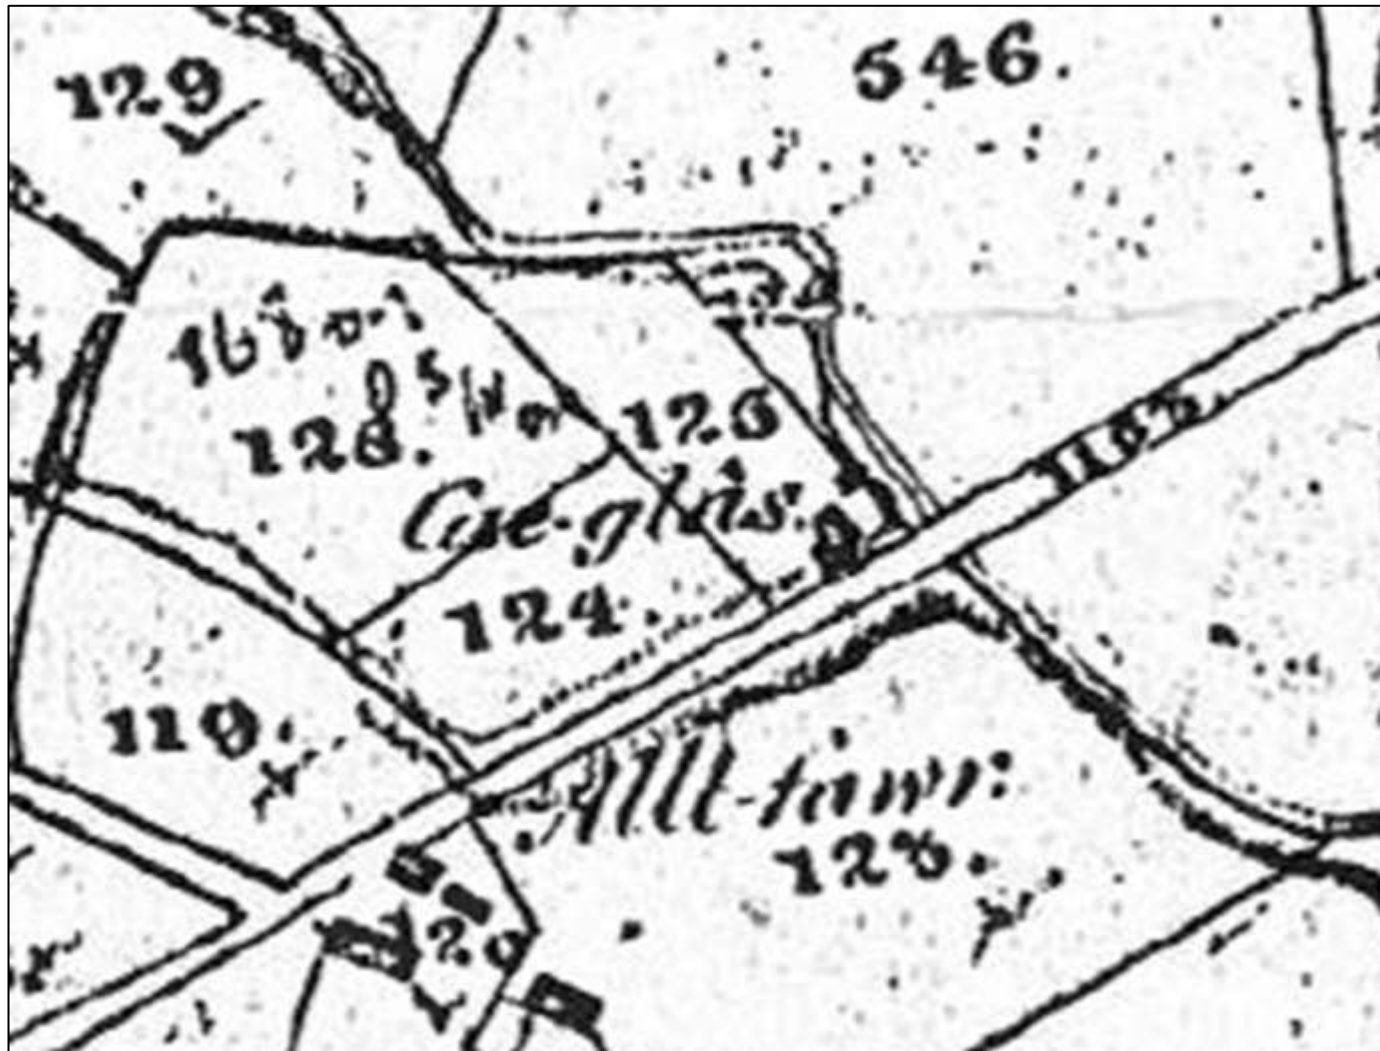
Fig 1. Extract of the 1843 Tithe map showing the farmhouse and additional outbuilding on the holding.

The 1843 tithe map shows the small holding of Caeglas and with a rectangular outbuilding on its property although it is not in the location of the *cegin foch* and is more likely to be another outhouse (Fig 1).

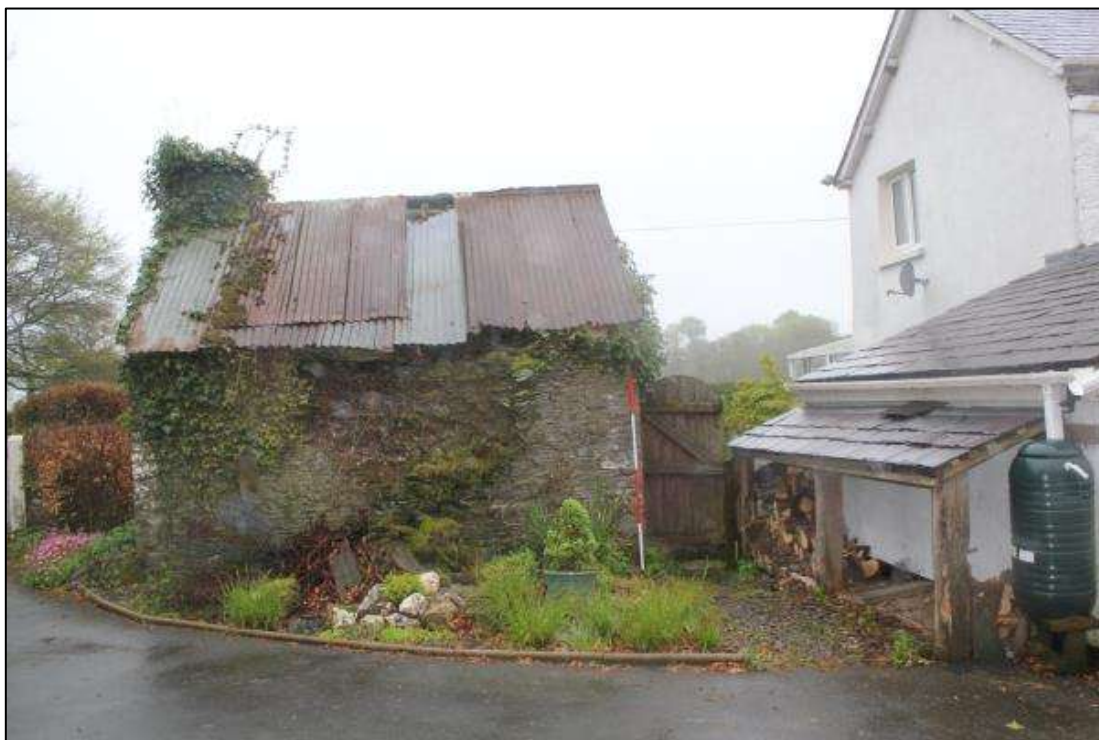
Today, the *cegin foch* survives as a near intact, small rectangular building around 5m in length and 4m in width, with a corrugated zinc roof and stands c. 4.5m in height. It is situated in close proximity to the farm house; about 4m from the eastern elevation of the farmhouse. It is orientated in an east/west alignment and at 90° to the farmhouse. The Dairy, cow shed and pigsty have now been converted to join the farmhouse. A wooden door now joins the south-eastern corner of the former pigsty to the north/western corner of the *cegin foch* (Photo 2).

Photo 2. This photo (taken to show the north facing elevation of the *cegin foch*), shows the building's close proximity to the farm house. The sloping slated roof of the lean-to in the right of the foreground is that of the suspected former pigsty (Photo: M.Bell).

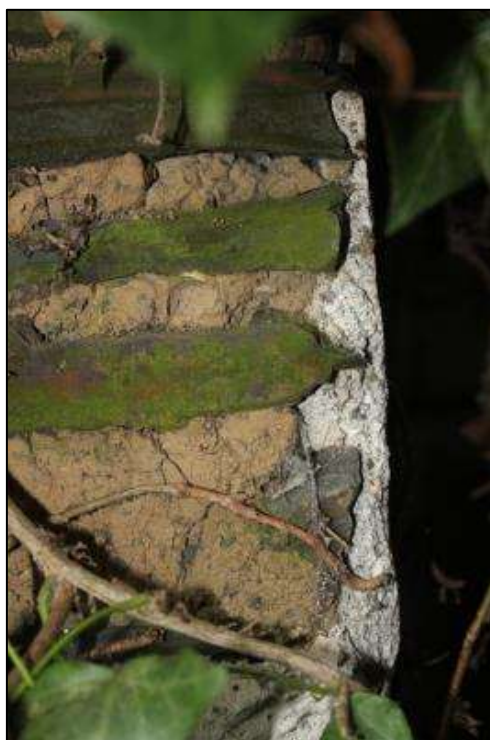
The building is constructed of rubble stone, thought to be the local shale or mudstone and is bonded with a mud/clay mortar (Photo 3). Although highly weathered on the exterior and with little remaining, a lime rendering was used to plaster the building internally and externally. Whilst there is no surviving evidence, it is likely that the building was limewashed during its use.

Photo 3. Viewed in cross-section; this image shows the rubble shale walling, clay/mud bonding and lime plaster or rendering (Photo; M.Bell).

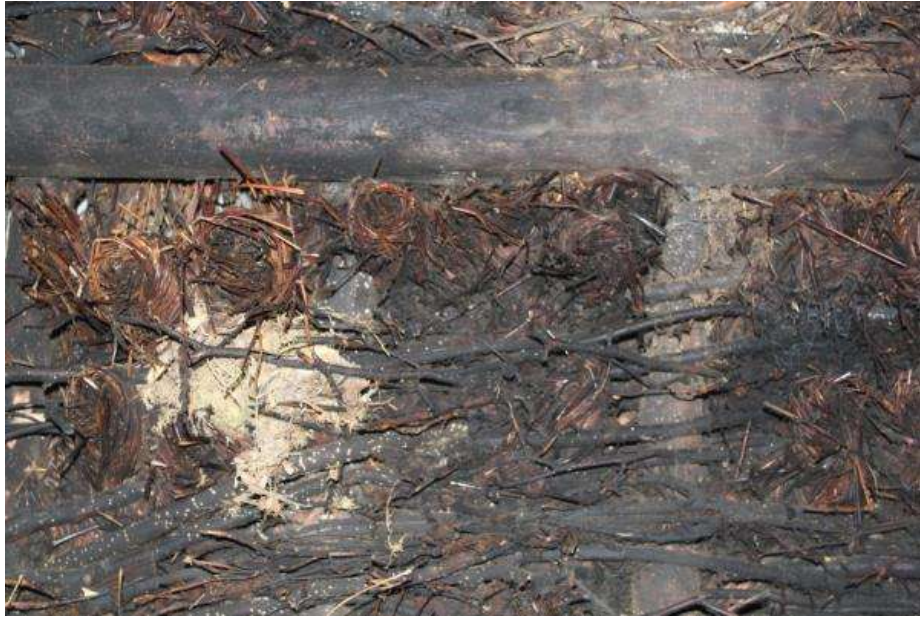
The surviving thatch appears to be of the *thrust thatching* technique whereby handfuls of straw are knotted at one end and a thrust into the underthatch using a forked device (Photo 4). This technique was common for the region and into mid Wales. There is very little surviving evidence of the underthatch layer which would have consisted of gorse, heather, straw or turf, either laid in bundles or left loose and then tied or pegged to the foundation

layer. The foundation layer itself appears to be constructed predominately of wattle woven larch on rough timbers which are laid vertically on the purlins.

Photo 4. Knotted bunches of straw indicate a *thrust thatching* technique. The wattle woven larch foundation layer provides a convenient home for a swallow's nest! (Photo: M.Bell).

If conservation work is to be undertaken then further work is required to determine the content of the thatch; a sample of the surviving thatch should be taken in order to identify the species profile represented.

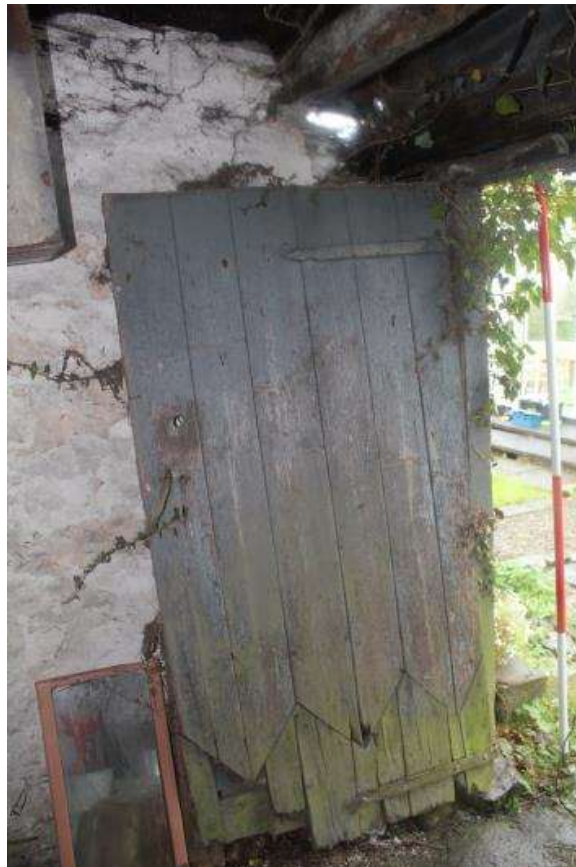
The door to the building is on the gable end; itself the west facing elevation. The wooden door is of single-plank construction with splicing repair work at the bottom of the door with hook and band hinges. There does not appear to be any evidence of a door latch of any kind, instead a well-worn, a finger sized hole serves as a handle (Photo 5).

Photo 5. The single plank wooden door. Note the splicing repair work at the bottom of the door and the small hole handle substitute towards to top left of the door. (Photo: M. Bell).

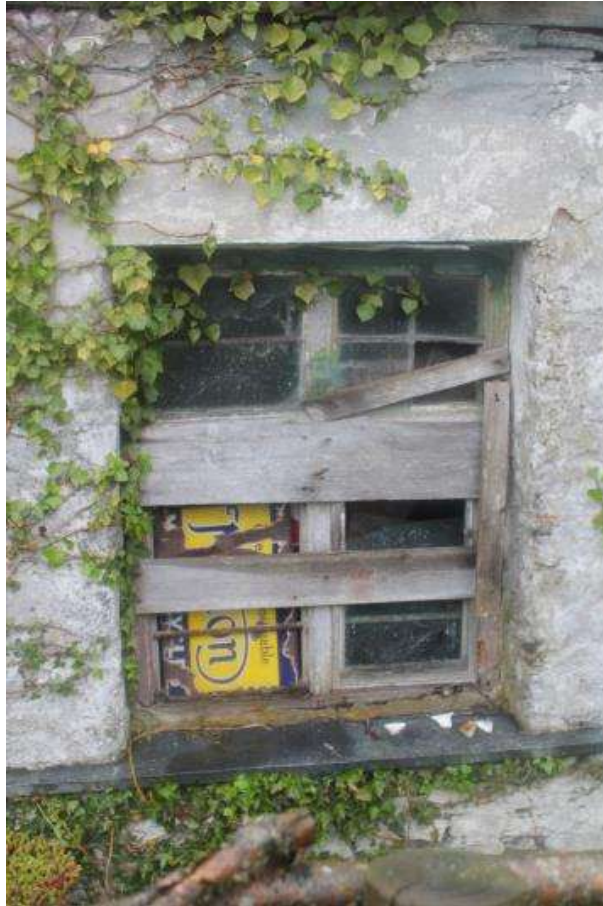
A single window on the southern elevation illuminates the building. This window is well constructed with lead canes in the glass panes and is thought to be made of oak. During the building survey, it was suggested that the window may be 18th century in origin and is likely to have been taken from elsewhere, possibly demoted from the farmhouse itself (Photo 6).

Photo 6. Beneath the modern reinforcements, the original window frame, panes and lead comes are still visible. (Photo: M. Bell).

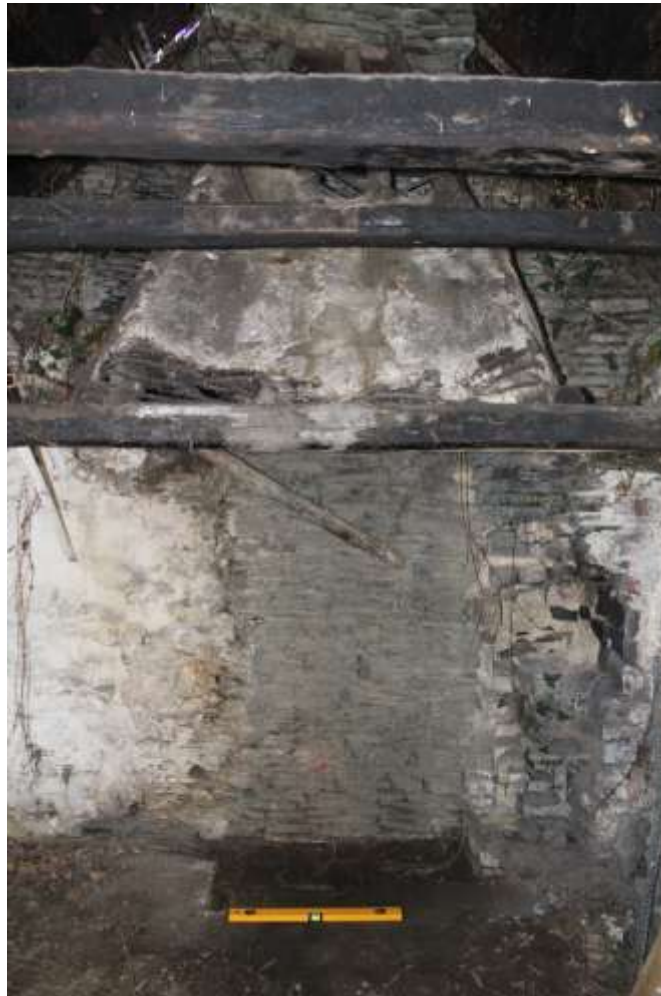
Inside the building a brick lined hearth still survives beneath the wicker firehood (Photo 7). These bricks are frogged with the names "TRIMSARN METALIC" and "JCE" (Photo 8). Superficial research into these bricks suggests that "TRIMSARN METALIC" bricks originate from brick works near Kidwelly in Carmarthenshire. No further information has been retrieved for the origin of the "JCE" bricks (source : <http://www.penmorfa.com/bricks>).

Photo 7. The brick lined hearth visible beneath the larch wattle chimney-hood resting on the cross beam. Note the daub on the exterior of the hood. (Photo: M Bell).

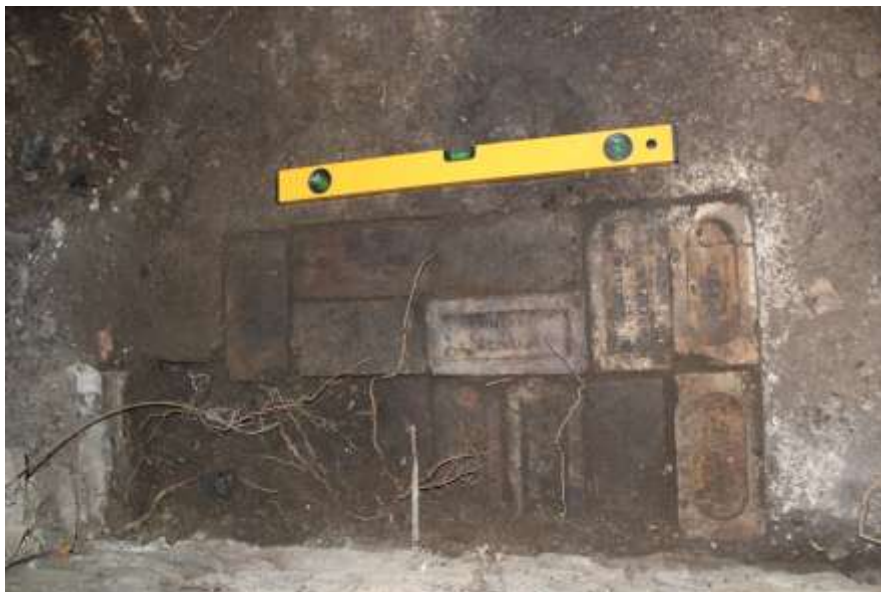
Photo 8. The frogged fire bricks in the hearth. (Photo: M Bell).

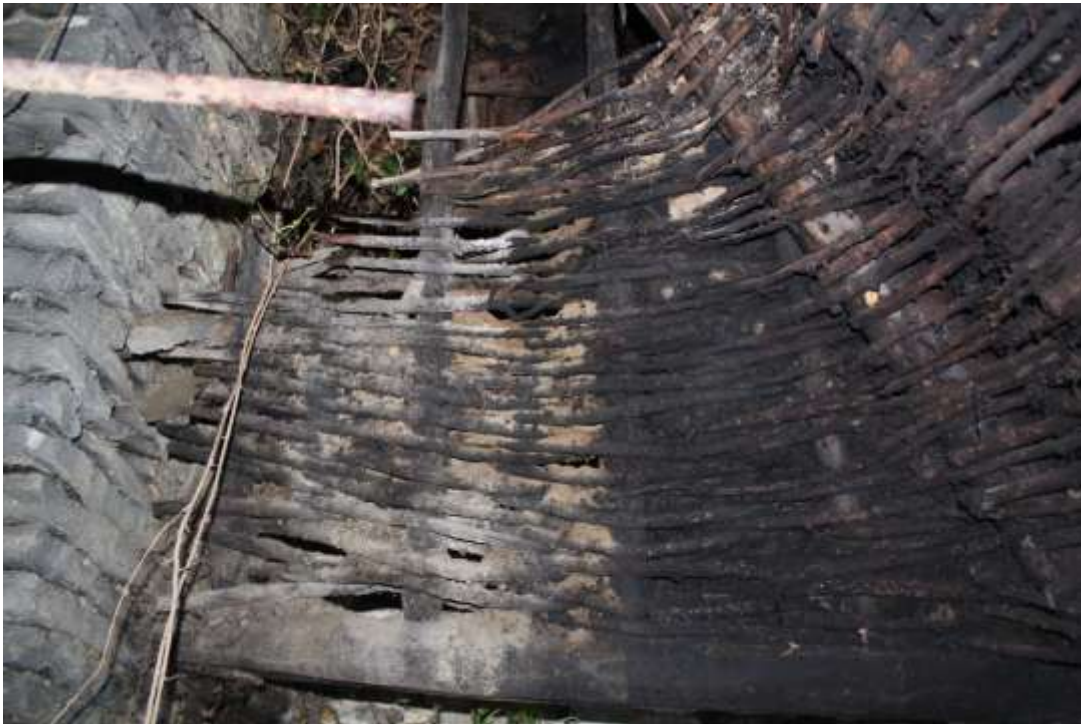
The impressive wicker chimney-hood appears to be constructed of larch wattle and the outside of the hood is covered in daub. There does not appear to be any evidence for daub on the inside of the hood and the wattle is blackened with soot (Photo 9). This firehood rests on a cross-beam (also known as a *mantell smidde*) which runs across the width of the building. Such wattle and daub chimney-hoods would have been common place in such rural buildings across Carmarthenshire and Ceredigion during the 18th and 19th centuries.

Photo 9. Interior shot of the wattle chimney-hood showing the soot blackened larch wattle. Note the absence of daub on the interior of the hood (Photo: M Bell).

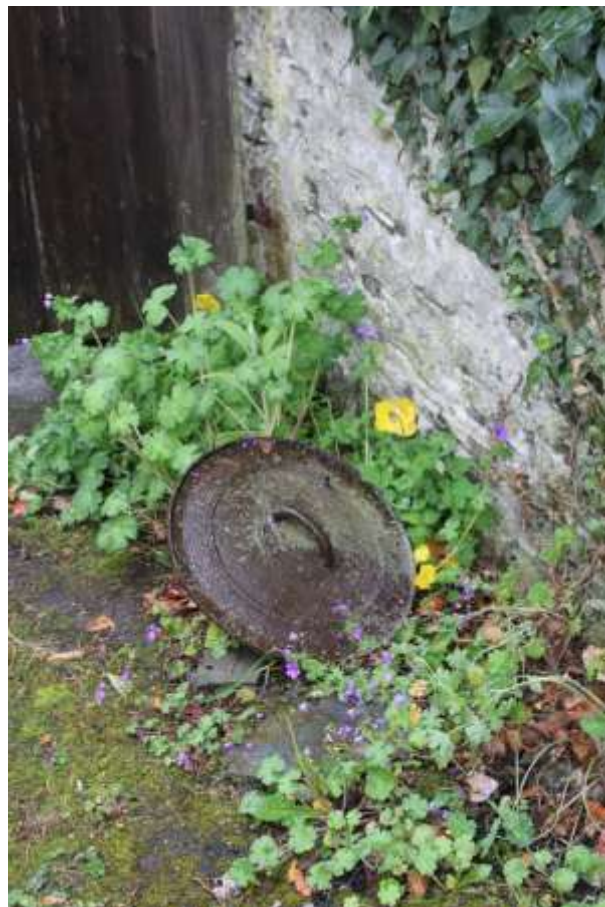
Photo 10. The cast iron cooking pot lid found in the rockery in front of the building (Photo: M Bell).

The *cegin foch* is situated within the garden of the main farmhouse. Just in front of this building is a rockery garden with a small pond feature. At the end of the survey, a cast iron cooking pot lid was discovered amongst this rockery (Photo 10). On further enquiry to the Flexman's it was revealed that this pond feature was in fact a large cooking pot which had been reinstated in the garden (Photo 11). It is very likely that this cooking pot might have originated from the *cegin foch*.

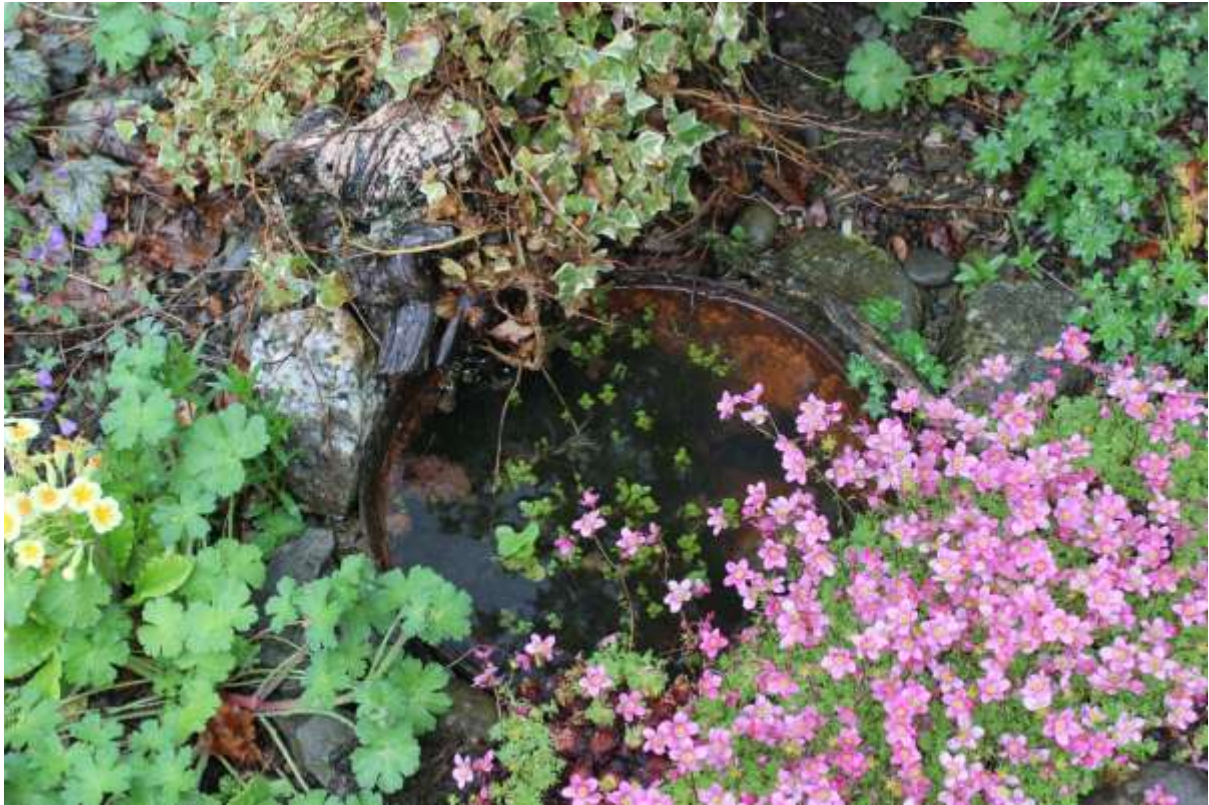
Photo 11. The cooking pot reinstated in the rockery as a pond feature (Photo: M Bell).
