131 PRIORY STREET, CARMARTHEN: ARCHAEOLOGICAL WATCHING BRIEF 2012

Prepared by Dyfed Archaeological Trust
For: Harold Metcalfe Partnership

RHIF YR ADRODDIAD / REPORT NO. 2012/51
RHIF Y PROSIECT / PROJECT RECORD NO. 103456

131 PRIORY STREET, CARMARTHEN: ARCHAEOLOGICAL WATCHING BRIEF

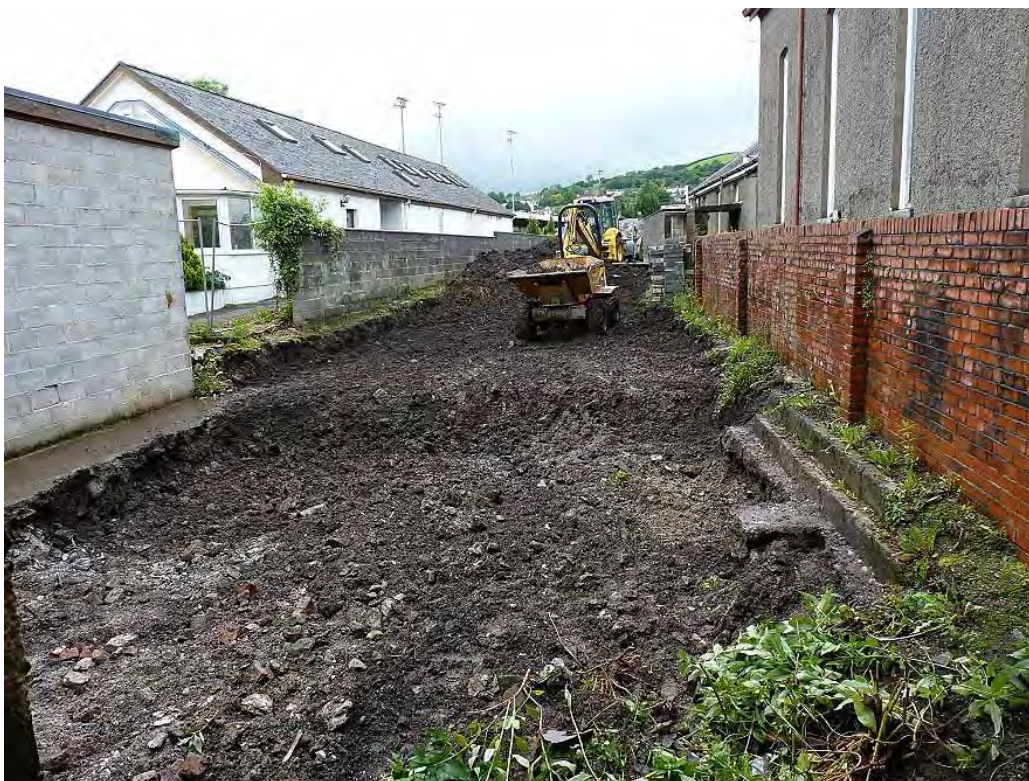
Photo 1: General shot looking northwest during excavation of the foundation raft to the rear of the existing street-front property.

4.2 The foundations excavated immediately behind the existing street-front property lowered the ground level by c.1m (1.3m below the planned final floor level), over an area 6m wide and extending 12m back from the rear of the existing building (Photos 1 - 7). At this point the south-western edge was brought in 1m to 1.7m and the foundations continued at the same level for a further 5m before being stepped up by c.0.3m (to 0.8m below ground levels) and continuing another c.9m back. This completed the area excavated for the concrete foundation raft for the proposed building lying immediately behind the existing street-front property (Photo 8).

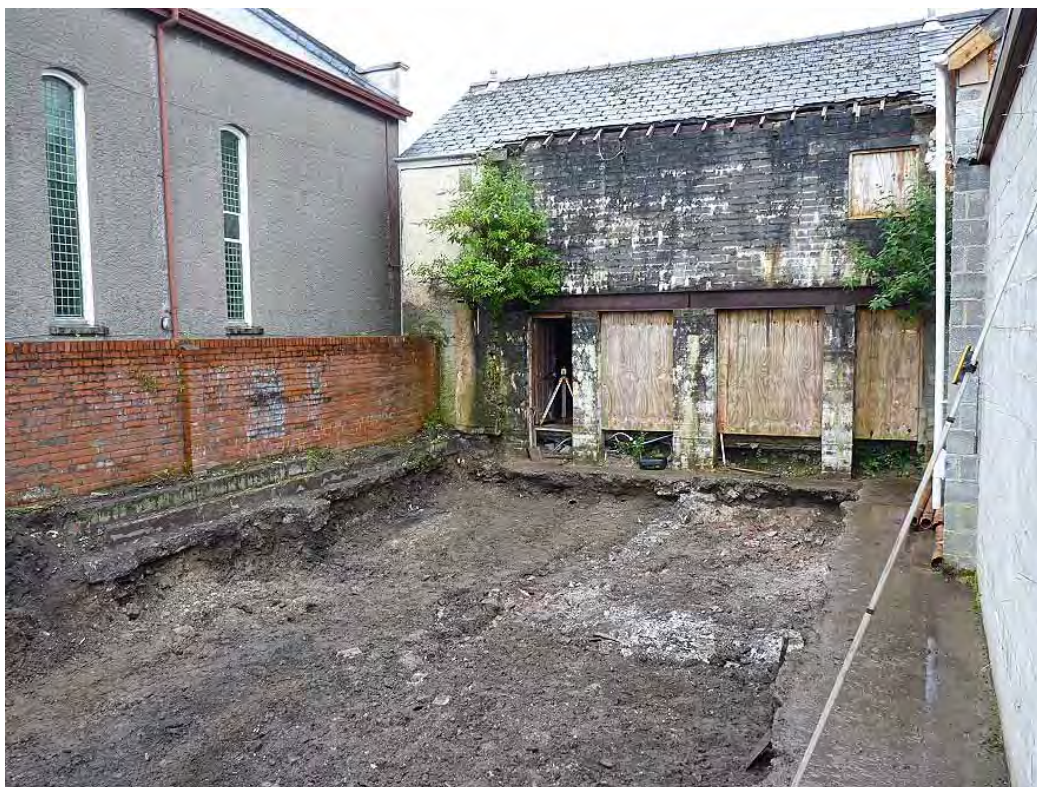
Photo 2: Excavated area to the rear of the street-front property. Cellar remains are visible in the top right.

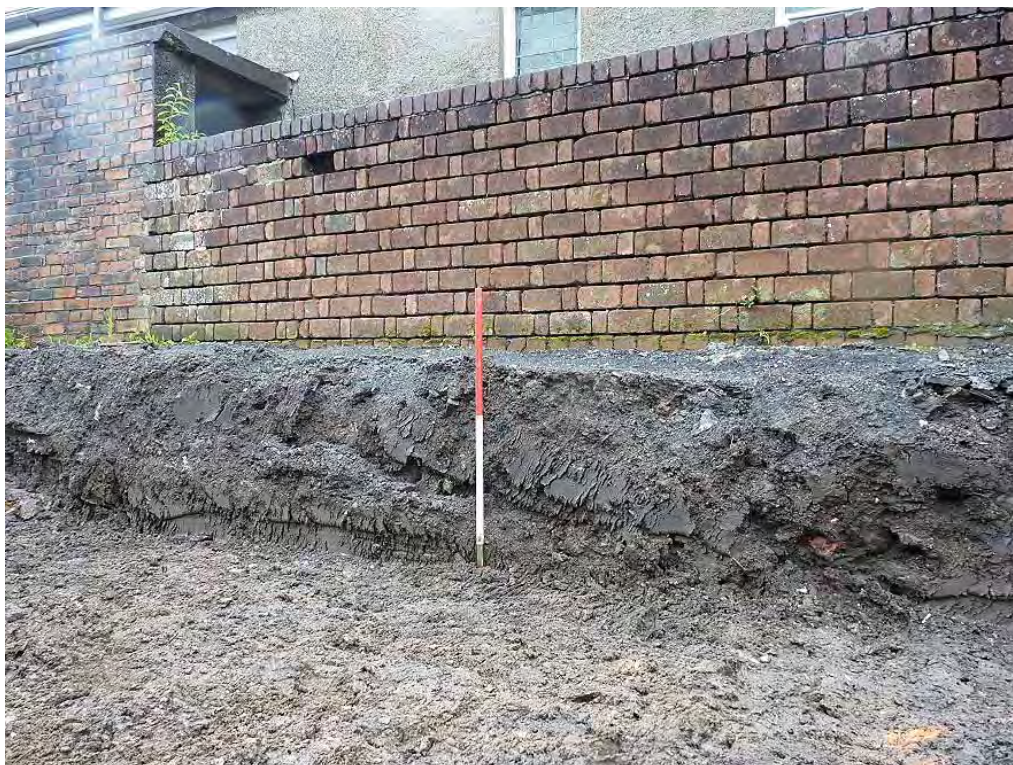
Photo 3: Typical section through excavated deposits to the rear of the street frontage. 1m scale.

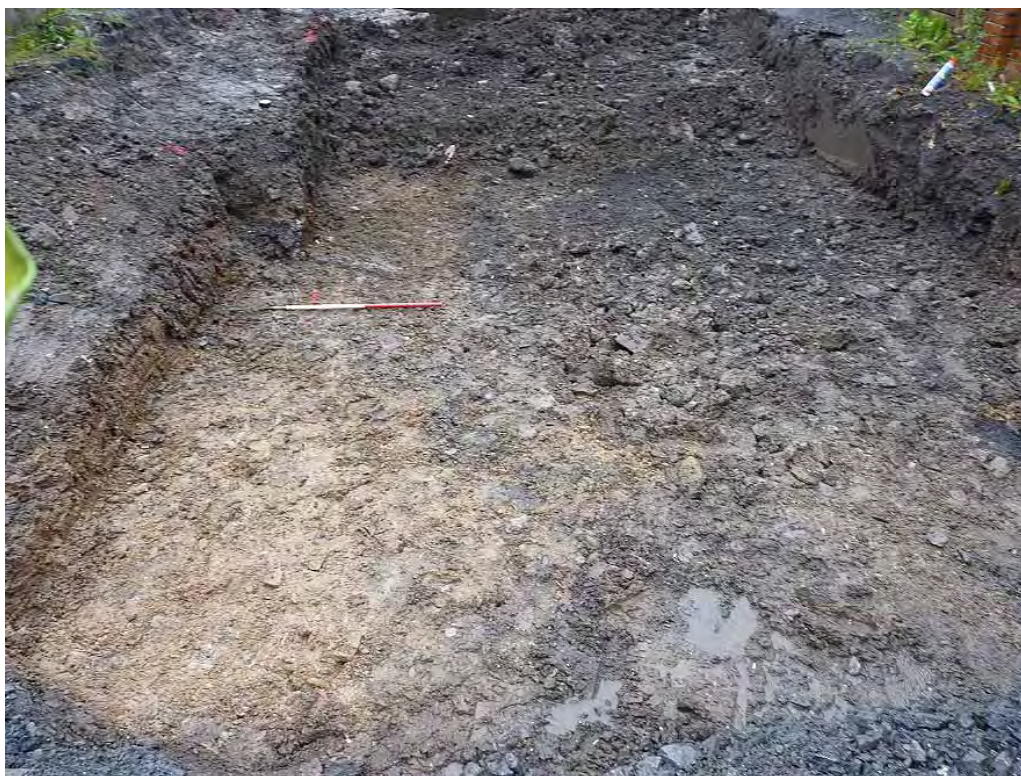
Photo 4: View, looking northwest, of the lighter sandy-clay archaeological deposit on the left. This appears to be a continuation of deposit 107/119 revealed and recorded during the archaeological evaluation (Poucher 2012). 1m scale

4.3 The initial foundation design had a step up at 12m from the rear of the existing property, but due to poor quality soft ground this step was extended a further 5m back. As a consequence a patchy area of light yellow-brown sandy-clay was revealed within this extended area, at most 2.5m long and extending 1m into the area excavated (Photos 4 & 5). This deposit contained some fragments of mortar and Roman-period ceramic building material. This would appear to represent a continuation of deposit 107/119 as identified within Trench 1 of the archaeological evaluation (Poucher 2012). This had been interpreted as a layer of Roman demolition material. Upon its appearance the ground levels were not reduced any further. The north-eastern edge of this deposit was cut by Trench 1 of the evaluation itself. To the northeast of this was a series of later post-medieval dark grey-brown silty-clays.

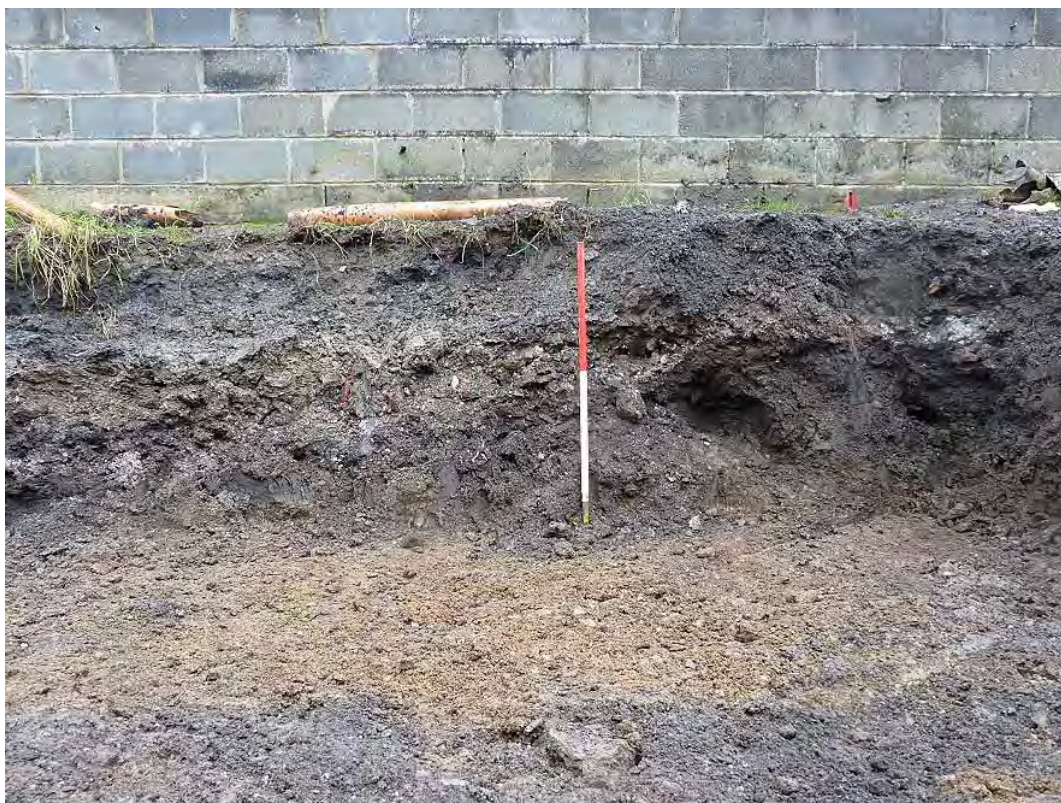
Photo 5: North-east facing section showing deposits overlying lighter archaeological layers 107/119. 1m scale.

4.5 At the north-western end of these initial foundation excavations the presumed Roman deposit (107/119) was overlaid by a mid brown silty-clay (first recorded 14.5m north of the rear of the existing property). This deposit became apparent spread across the full width of the excavated area immediately to the north of the Evaluation Trench 1. This deposit contained some Roman pottery fragments and ceramic building material and may therefore correspond to deposit 201 identified within Evaluation Trench 2, a possible Roman period soil layer. This was cut by two modern or late post-medieval service ditches. Again, once this deposit was revealed ground-levels were not reduced further.

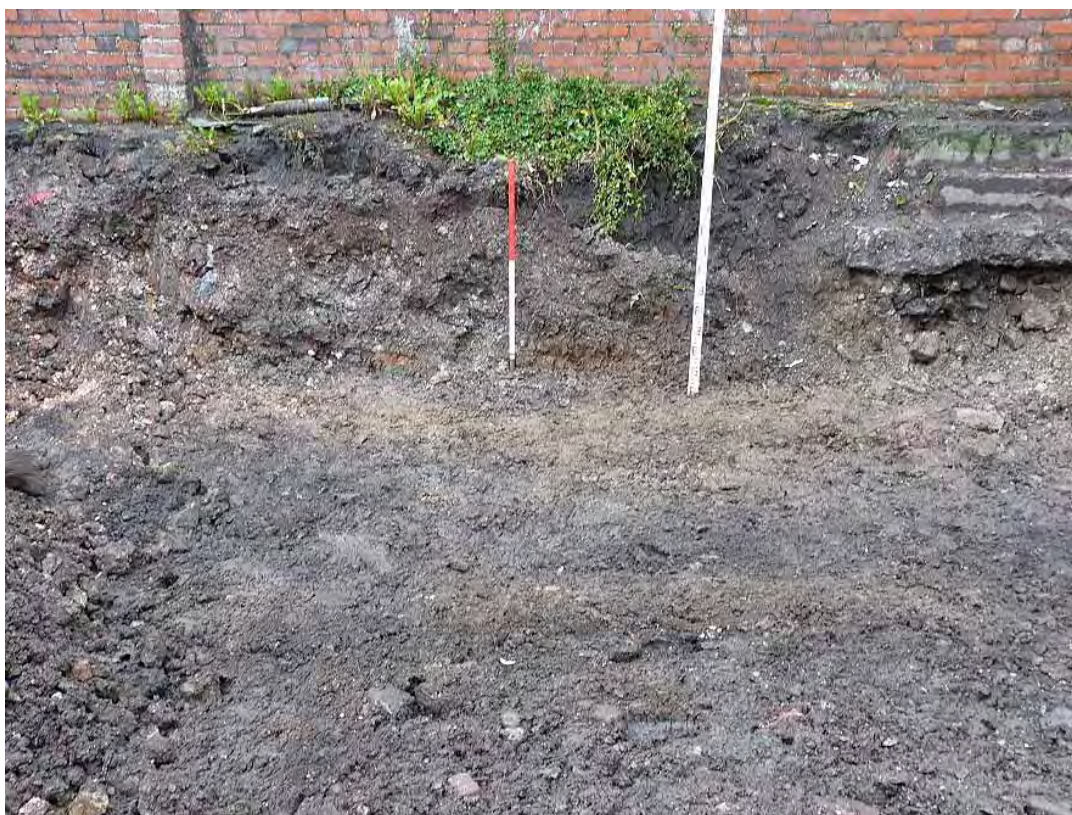
Photo 6: South-west facing section showing the lighter yellow-brown archaeological deposit at the base revealed for a 2.5m long stretch along the north-eastern side of the excavated foundations. 1m scale.

4.4 Against the north-eastern edge of the excavated area (8m out from the rear of the existing property), a curving deposit 2.5m long and at most 1.9m wide, of light yellow-brown sandy-silty clay was revealed (Photo 6). This contained occasional fragments of what appeared to be Roman-period ceramic building material. At its easternmost extent were the fragmentary remains of what appeared to be stones set in a lime-mortar, of indeterminate date, but possibly archaeological. This deposit was heavily truncated by later post-medieval deposits.

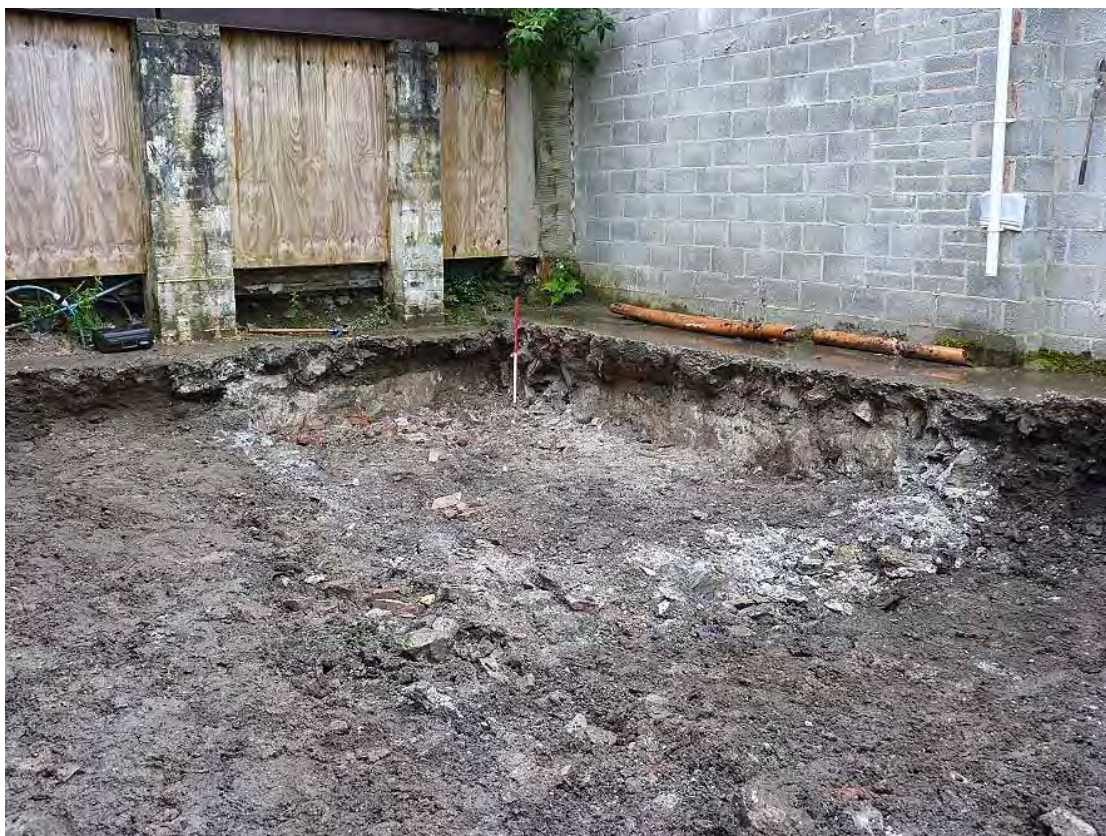
Photo 7: South facing shot of the cellar remains. 1m scale.

4.6 The remaining deposits revealed were a mix of late post-medieval and modern soil and demolition layers, along with some sewage and service trenches. Fragments of presumed 19th century walls were revealed which were associated with the existing property. This included the remains of a cellar to the rear of the 131 Priory Street (Photos 2 and 7). It measured 6m by 4m, defined by a stone wall 0.5m wide, with the occasional brick, set in a lime mortar, and in-filled with brick and demolition rubble. On the north-eastern side the remains of another stone-built wall, set in a lime mortar with coal inclusions, was recorded extending from the existing property. This wall was 0.8m wide, c.8m long aligned SE – NW, parallel with the existing boundaries. This presumably represents part of the rear outbuildings visible on late 19th century map sources (Figure 3).

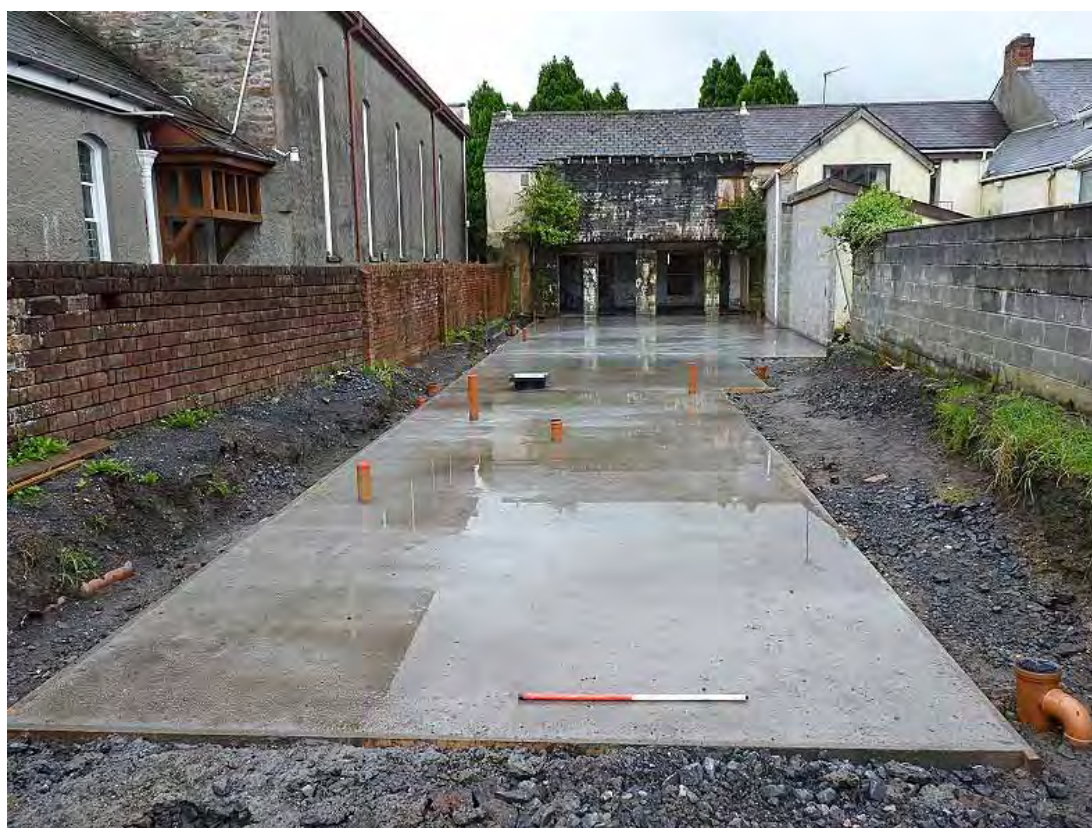
Photo 8: Southeast facing shot of the completed foundation raft to the rear of the street frontage. 1m scale.

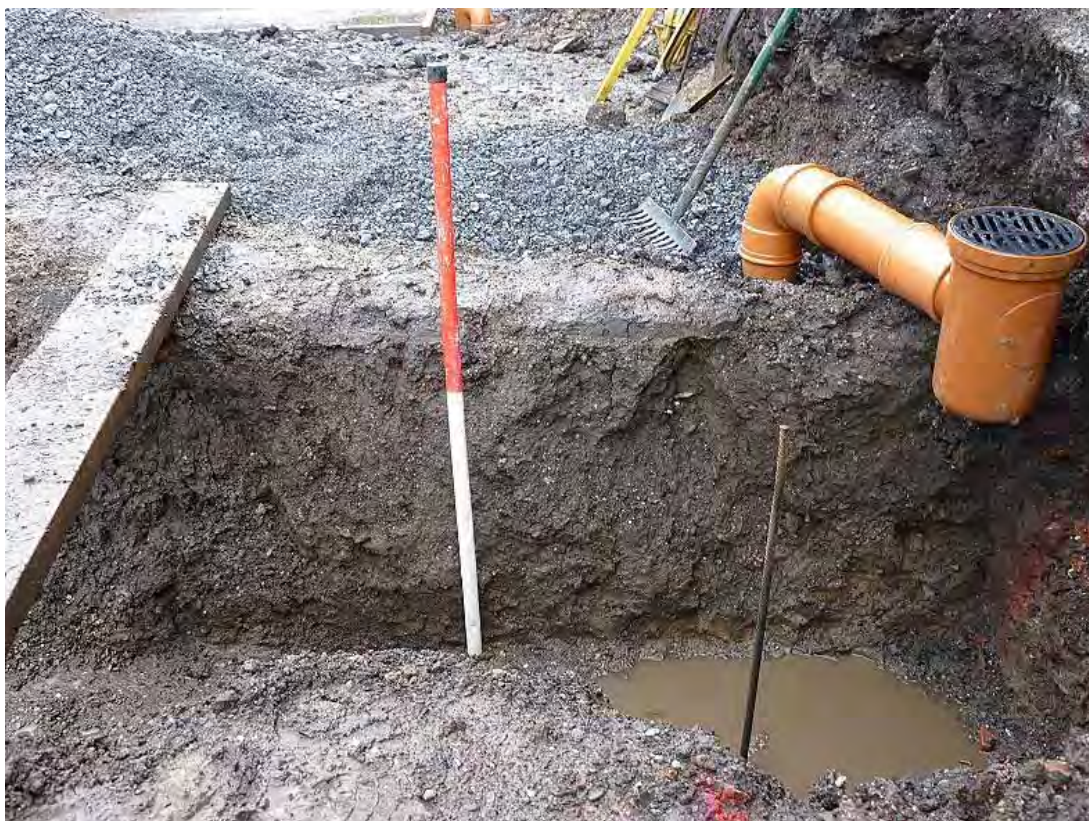
Photo 9: South-east facing shot of a typical section revealed by the foundation trenches for the rear classrooms, at the south-eastern end. 1m scale.

4.8 From the south-eastern corner of these classroom foundations, at the base of the excavation, was a deposit of light yellow-brown sandy-clay. This deposit was at most 0.8m wide and c.5m long. No finds or dateable material was recovered from this deposit. Overlying this deposit, and revealed throughout the rest of the foundation trenches, was a deposit of mid to dark grey-brown clayey-silt, that appeared to represent deep garden soils (Photos 9 – 11). A range of pottery was recovered from this deposit, largely post-medieval in date, with some late 19th or early 20th century fragments, but also including some possible medieval fragments. This deposit was occasionally cut by modern disused services.

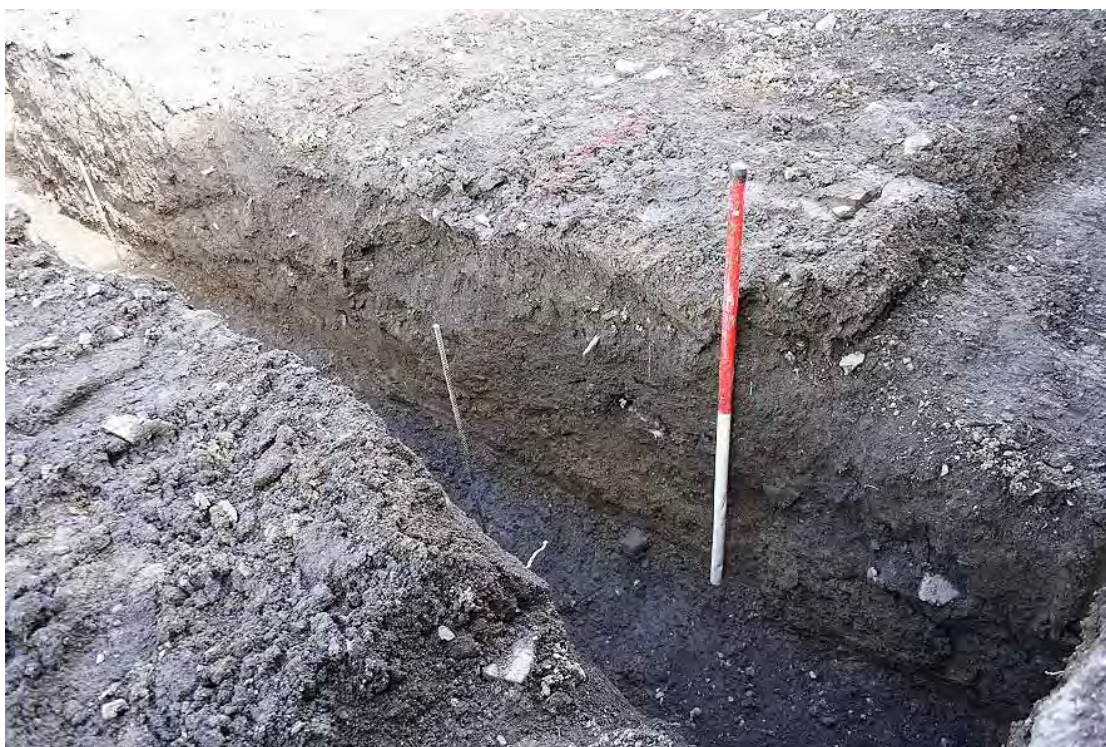
Photo 10: East facing shot of a typical section revealed by the foundation trenches mid way along. 1m scale.

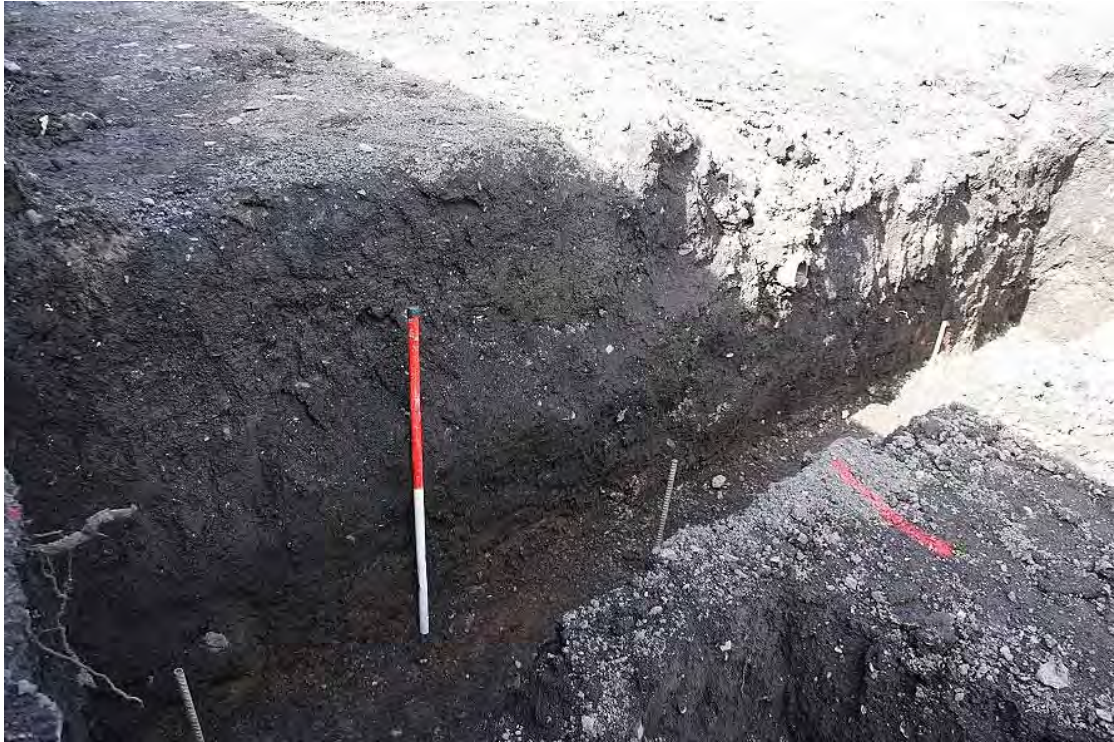
Photo 11: North facing shot of the deepest section revealed at the north-western end of the foundation trenches for the rear classrooms. 1m scale.
