TWENTIETH CENTURY MILITARY SITES: AIRFIELDS – DISPERSED SITES AND DEFENCES

Final Report – RECOMMENDATIONS

A THREAT-RELATED ASSESSMENT 2013-2014
DAT 115A

RHIF YR ADRODDIAD / REPORT NO. 2014/21
RHIF Y PROSIECT / PROJECT RECORD NO. 103632

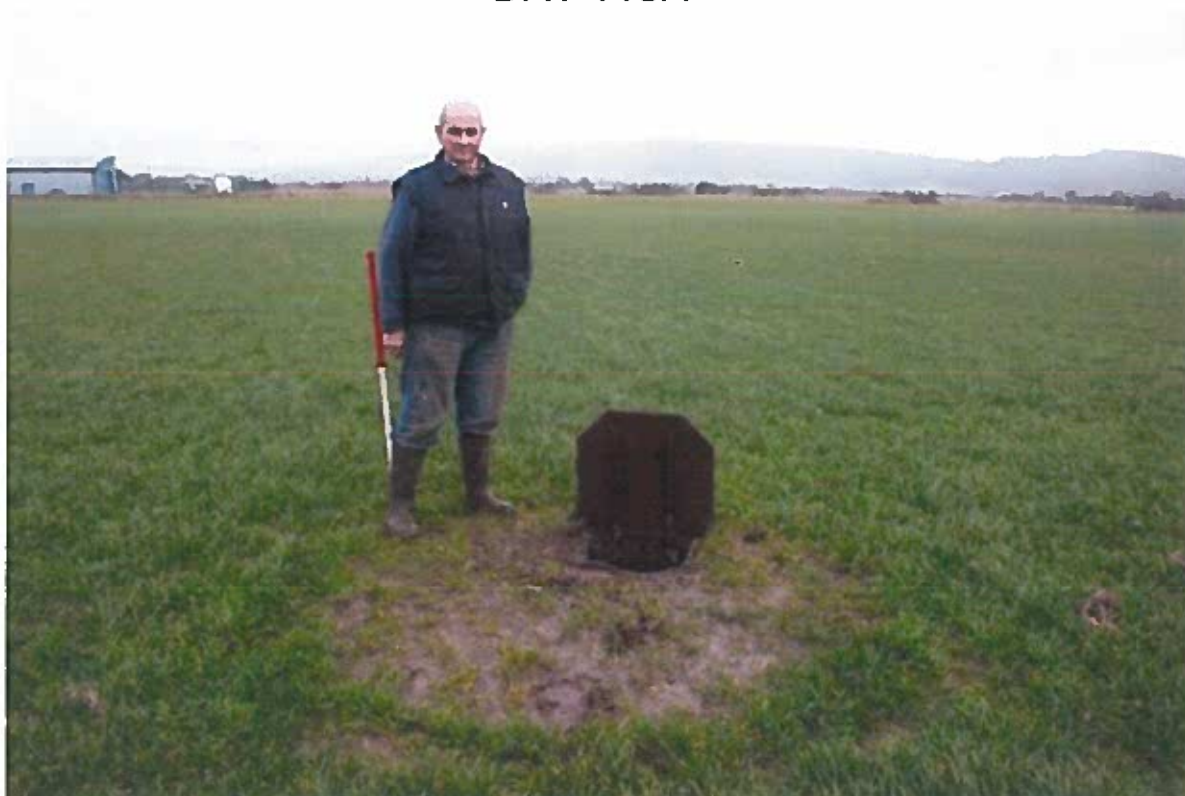
A retractable pillbox, Pickett Hamilton fort, at Pembrey Airfield

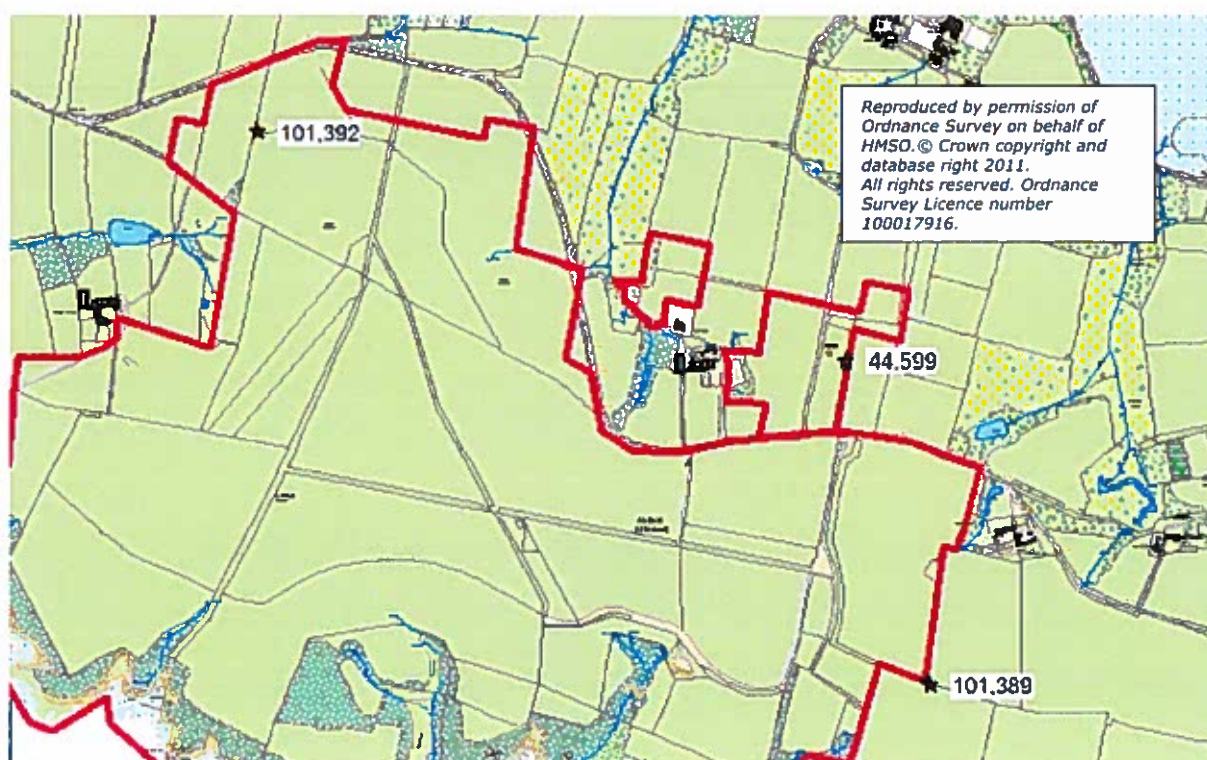
Figure 1: Map of RAF Angle with sites identified for scheduling.

The gun post at Angle is already listed partially in relation to its use during the Second World War; 'Listed as survival of an C18 windmill with additional significance in relation to wartime bunker and airfield.' It is suggested that along with the pillboxes to the east (PRN 101389) and northwest (PRN 101392) of the airfield, the Battle Headquarters (PRN 44599) should be protected via statutory means as a group of related structures of great significance to the airfield in the event of attempted invasion or attack. In addition the pillbox to the east (PRN 101389) is significant in being modified from the standard design in order to fit into an existing hedgeline. It is recommended that each of these sites are scheduled.

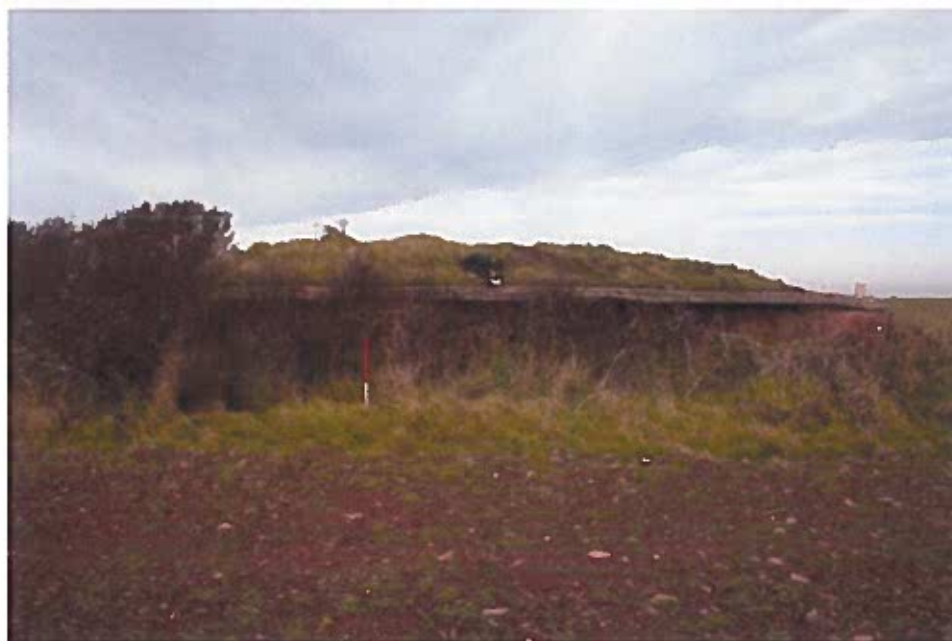
Pillbox, located within hedge to the east of Angle airfield. Similar to pillbox located to the NW of the airfield except the roof is modified to carry the turf over the embrasures and continue the hedge line. Described by RJC Thomas as, "Semi-sunken, irregular hexagonal plan, integral 'D' shaped Anti-Aircraft Light Machine Gun pit against N wall, fair-faced brick, flat turf covered concrete roof on corrugated steel sheeting. Roof maintains line of hedge to the east. Wide splay embrasures fitted with Turnbull mountings." (Duplicate PRN 44601). A Pyper 2012.

Figure 2: Modified pillbox to continue hedgeline to east of RAF Angle

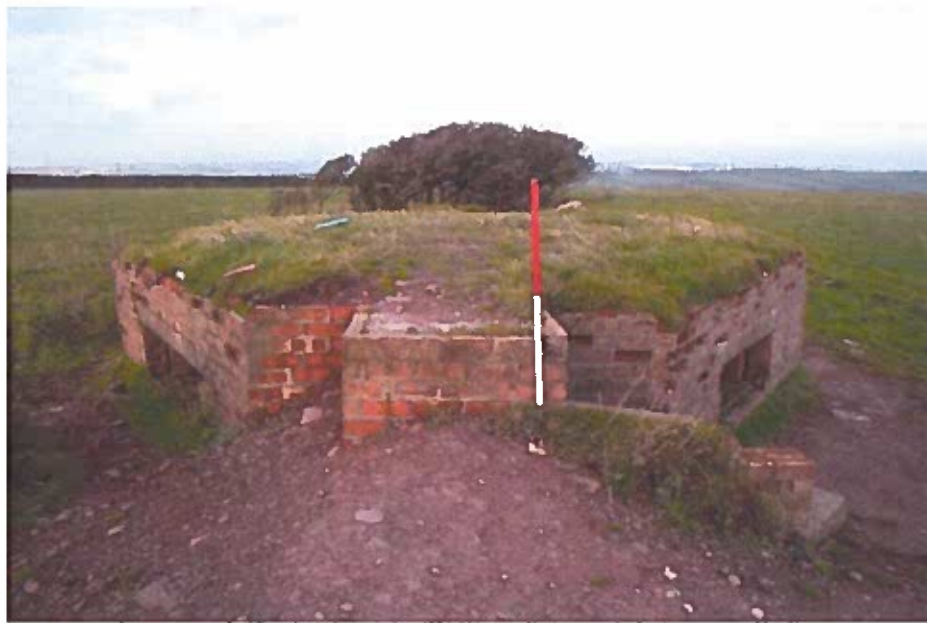
Similar in construction to PRN 101389 at the eastern side of the airfield. Visited Nov 2011, A. Pyper.

Figure 3: Pillbox to the northwest of Angle airfield

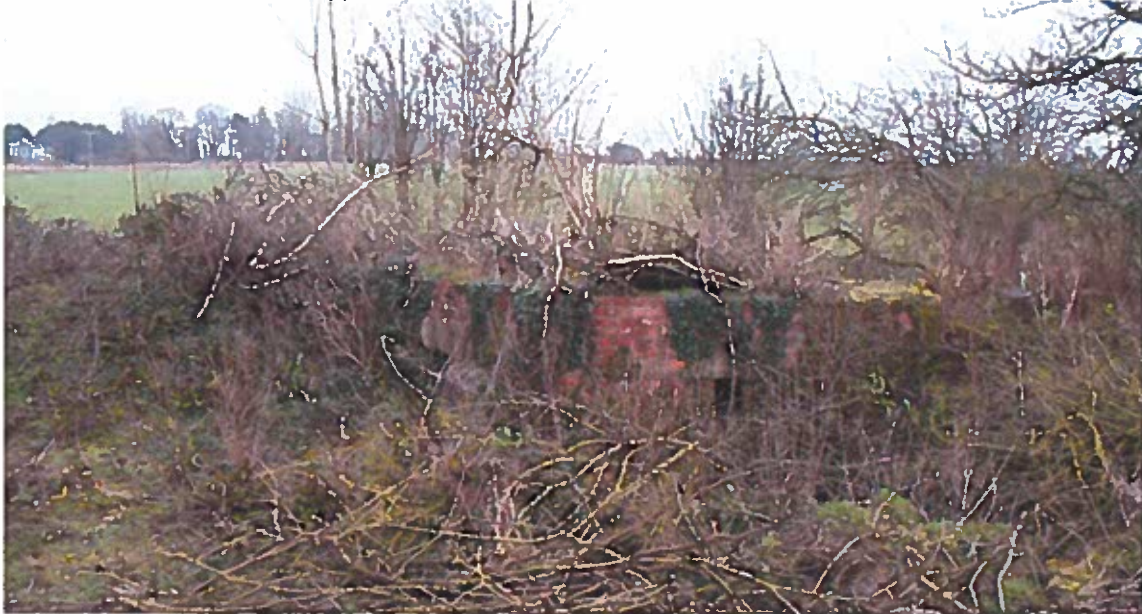
Brick built semi-sunken pillbox, irregular hexagonal with D shaped anti-aircraft light machine gun emplacement to the north. Wide embrasure to the southeast, narrow loops to the northeast, northwest and southwest. South side has dumped material against it so embrasure not visible. A Pyper Jan 2014.

Figure 5: Pillbox to west of airfield

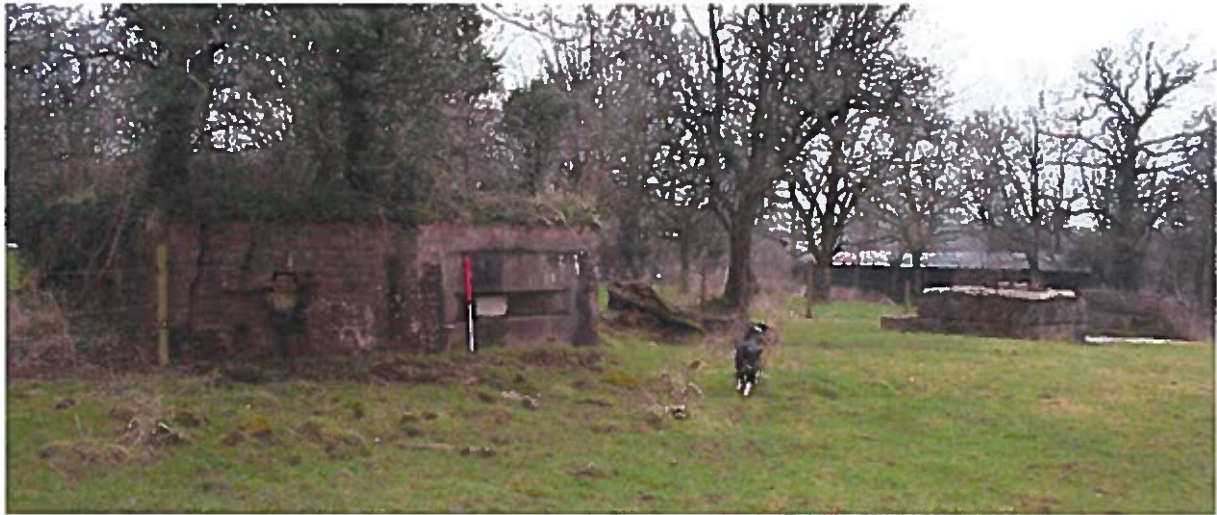
airfield this structure is sunken into the ground with a flight of steps at the west end surrounded by railings, to the east is a square concrete observation cupola which projects up out of the ground beside which is a metal hatch which is the emergency exit via ladder. In between the two structures is the concrete pad which forms the roof of the sunken complex of rooms which lie underground. To the east of the structure within the hedge line is a pillbox (PRN 26158) which also forms part of the ring of defences around the airfield. A Pyper 2014.

Figure 6: In the foreground a pillbox (PRN 26158) to the rear the cupola of the Battle headquarters

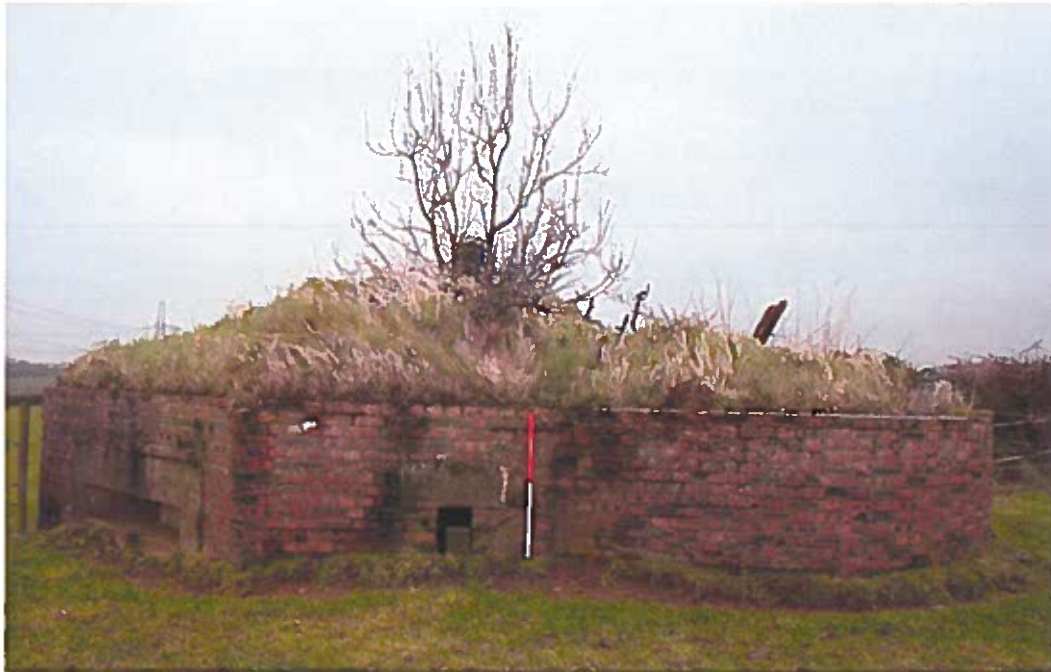
Brick built pillbox to the northeast of battle headquarters (PRN 26157) Based on Type 24 (irregular hexagonal) with D-shaped anti-aircraft light machine gun brick built pit to the south. Wide gun embrasures on the northwest, northeast, east and southeast faces and a narrow embrasure to the west. Part of a ring of defences around RAF Carew Cheriton airfield. Turf covered and built into the junction of three hedgelines. A Pyper Jan 2014

Figure 7: Pillbox to the east of the battle headquarters facing onto airfield

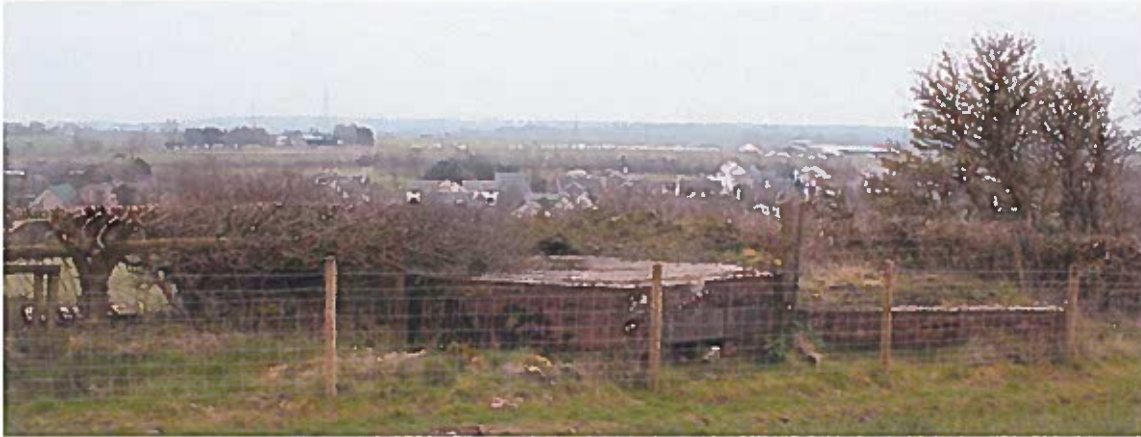
Pillbox located in a hedgeline overlooking the airfield at Carew, built with brick and concrete flat earth and turf covered roof. Partially sunken and very overgrown with brambles. Appears to be slightly altered from standard form and irregular in shape but largely hexagonal. RJC Thomas's description identifies it with two wide splay embrasures with Turnbull mountings and two narrow embrasures. To the west, and within the hedgeline is brick walled rectangular annexe. To the east, though not attached is a concrete gun post PRN 26161. A Pyper 2014

Figure 8: Pillbox overlooking airfield beyond

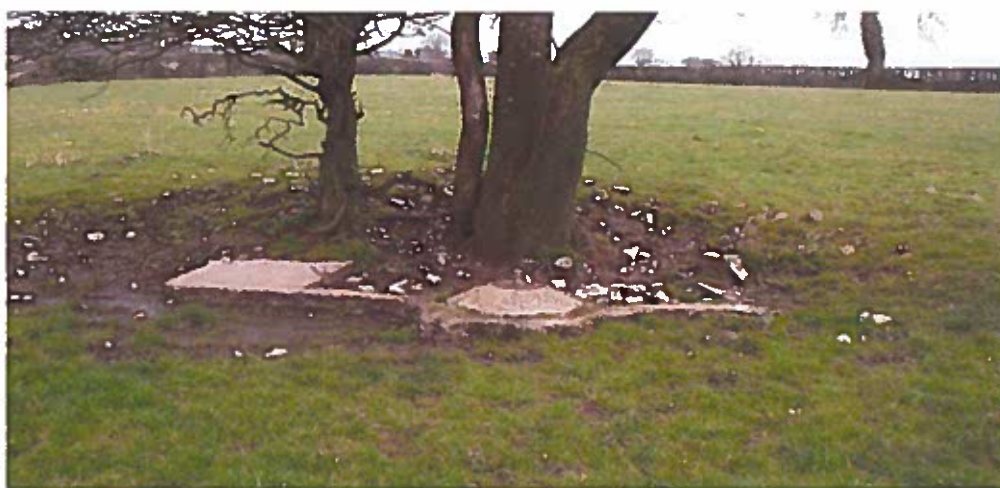
A spigot mortar gun emplacement, positioned in good vantage point overlooking the bridge across the river bridge at Milton which formed the old road. The concrete setting is visible below a hawthorn tree, with the steel pin standing proud of a concrete circular setting, to either side are concrete encased magazines. Now infilled, only the top of the cylindrical column is visible with the spigot and the tops of the concrete magazines. A Pyper 2014.

Figure 9: Spigot Mortar overlooking Milton Bridge

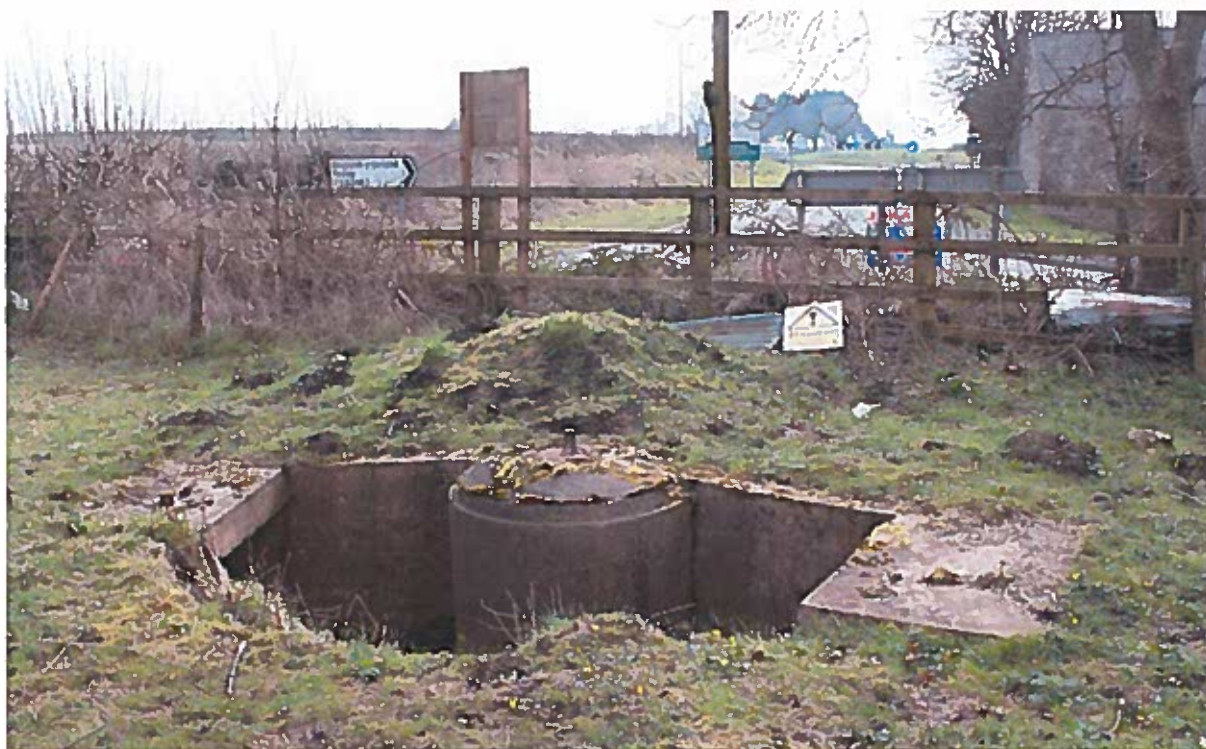
A spigot mortar gun emplacement, positioned in to the north of the T junction on the east side of Sageston village. A concrete structure set into the ground and below ground level. The centre of the structure is a concrete cylinder with a steel spigot set in the top. To either side are concrete encased magazines. The sides of the pit are lined with corrugated iron (maybe recently replaced when the interior was dug out a short while ago). A Pyper 2014.

Figure 10: Spigot Mortar overlooking Sageston road junction

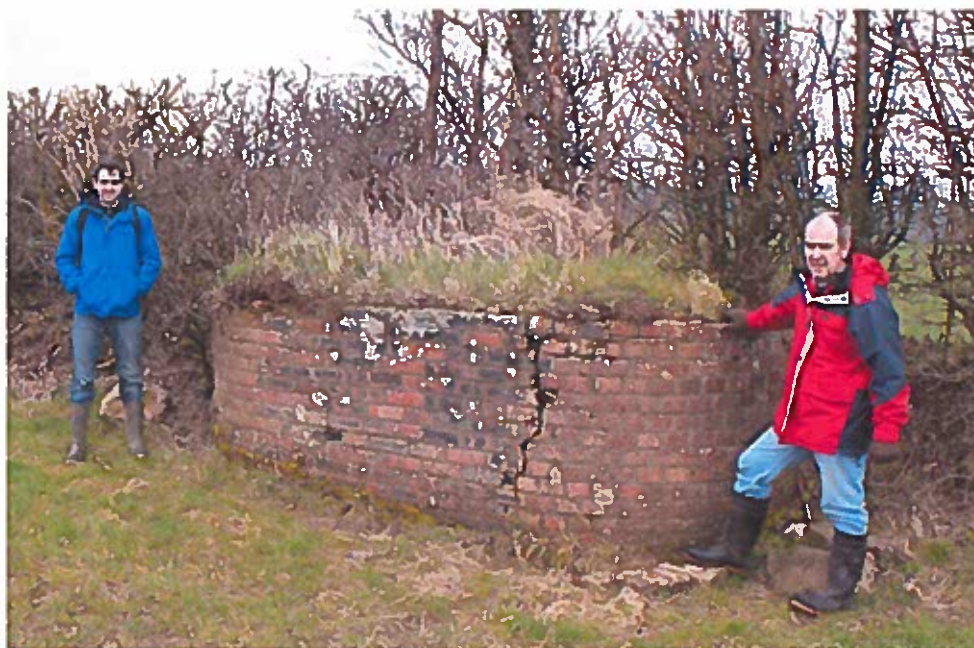
A light anti-aircraft gun emplacement, or motley stalk gun emplacement set into the hedgeline running north between defences at PRN 26160 and PRN 105917. Consists of two precast concrete 'sewer pipes' set vertically side by side. The exposed edge on the west side has a brick built facade with wrapping around the curved ends. Earth has been backfilled between the pipes and brick facing with turf now covering. A Pyper 2014.

Figure 11: Motley stalk gun emplacement in the hedgeline to the north of RAF Carew Cheriton.

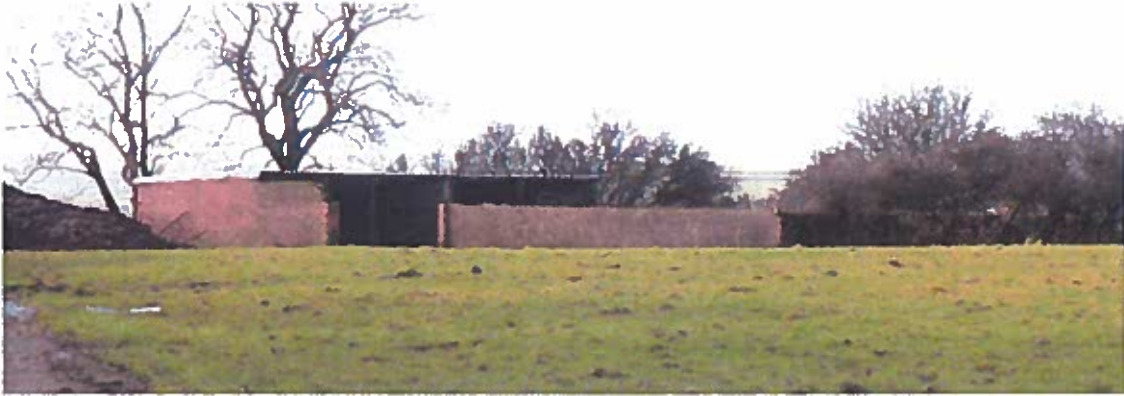
A brick built enclosure which formed the Main Beacon for RAF Haverfordwest, part of a landing system to guide airplanes into Haverfordwest airfield and are associated with the Inner and Outer Beacons. Consists of a brick walled enclosure c 1.5m high with a concrete floor within. Converted for agricultural use when visited in 2013 with the southwest wall enclosed and roofed for stock. A Pyper 2013

Figure 13: Main beacon at RAF Haverfordwest

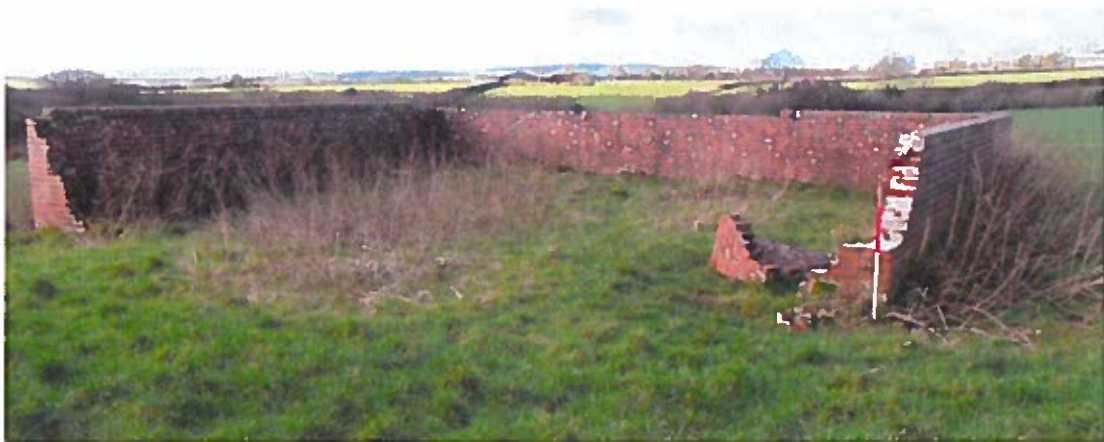
Outer navigational beacon for RAF Haverfordwest. Consists of a square brick walled enclosure measuring c 9m with walls 1.5m high. When visited in 2013, the east wall has been demolished but otherwise the walls are intact. A Pyper 2013.

Figure 14: Outer navigational beacon for RAF Haverfordwest

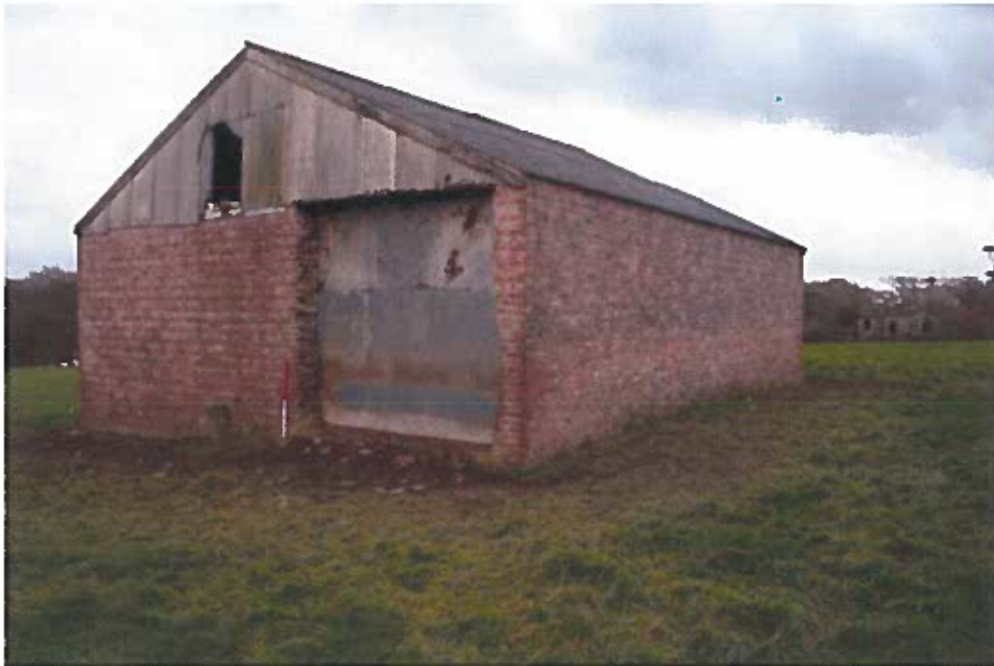
Rectangular red brick structure with a later pitched roof, pedestrian access in south wall and later double doorway inserted into north wall. Associated with the picket post (PRN 102487) to the south, these structures form the Inner Beacon, part of a landing system to guide airplanes into Haverfordwest airfield and associated with the Main and Outer Beacon. Visited Nov 2011, A. Pyper 2012.

Figure 15: Inner beacon for the airfield at RAF Haverfordwest

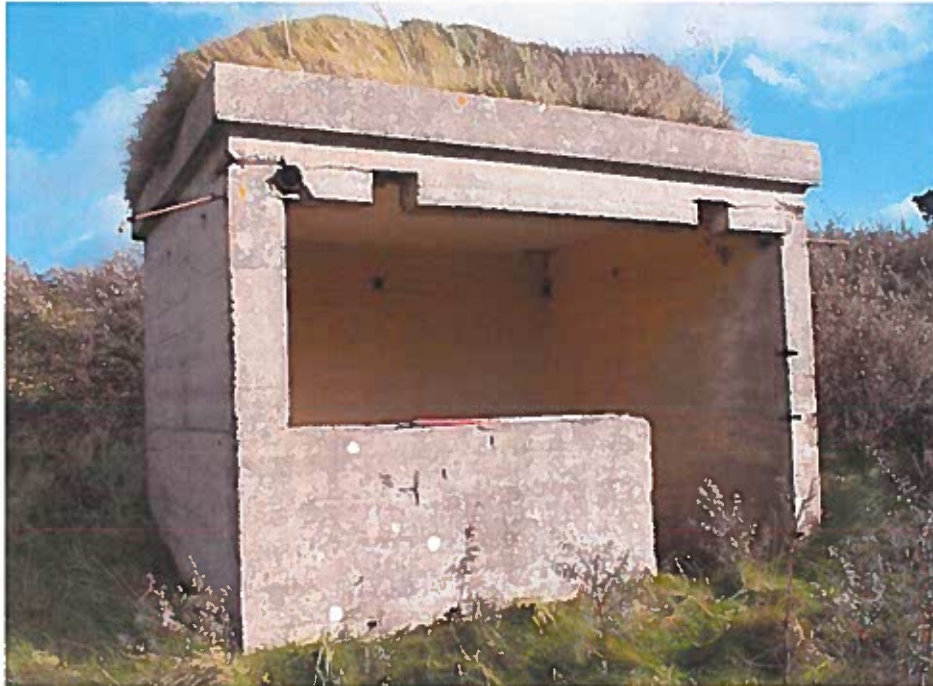
A gun emplacement built of reinforced concrete with turf on the flat roof. Identical in form to PRN 31414. Rectangular in plan 3.05 x 2.4 m with openings facing southwest. One wide rectangular opening in southwest wall with doorway to side. Internally the walls are painted cream and a small concrete pad on the northeastern corner may form the base of stove. Other fixings and fixtures are traceable in the paintwork of the interior. Forms part of series of gun emplacements built to defend Cefn Sidan beach from invasion or attack during the Second World War. A Pyper 2014

Figure 17: Gun emplacement overlooking Cefn Sidan beach

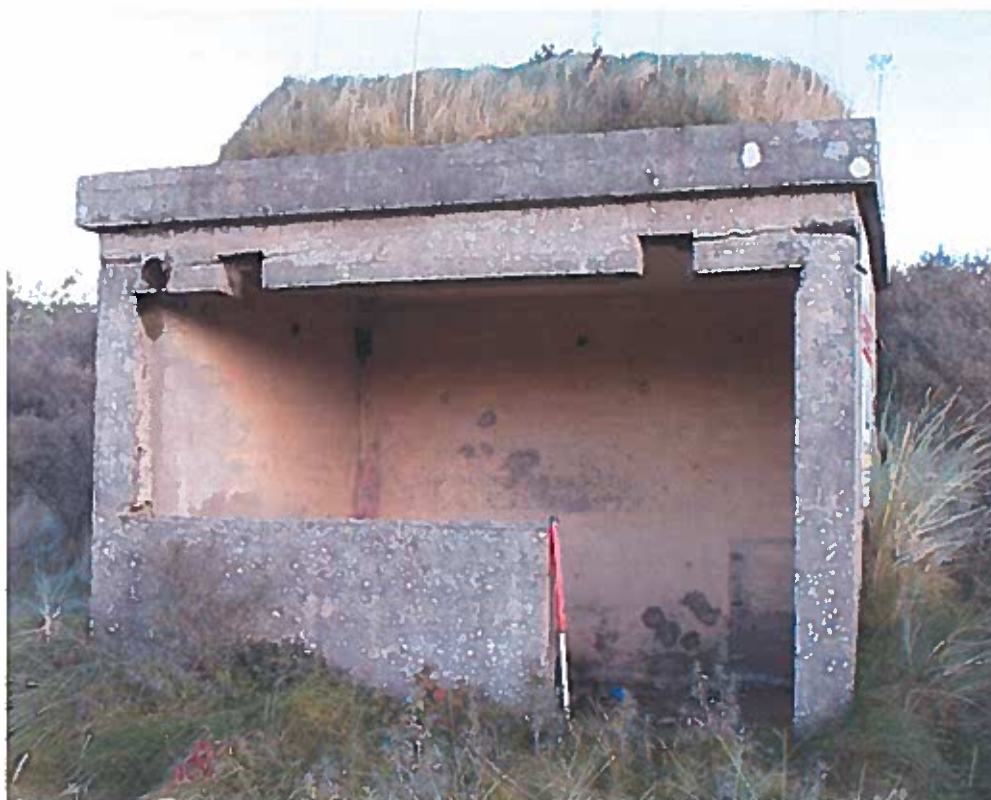
A gun emplacement built of reinforced concrete with turf on the flat roof. Rectangular in plan 3.05 x 2.4 m with openings facing southwest. One wide rectangular opening in southwest wall with doorway to side. Internally the walls are painted cream and a small concrete pad on the northeastern corner may form the base of stove. Other fixings and fixtures are traceable in the paintwork of the interior. Forms part of series of gun emplacements built to defend Cefn Sidan beach from invasion or attack during the Second World War. A Pyper 2014

Figure 18: Gun emplacement, one of three overlooking Cefn Sidan

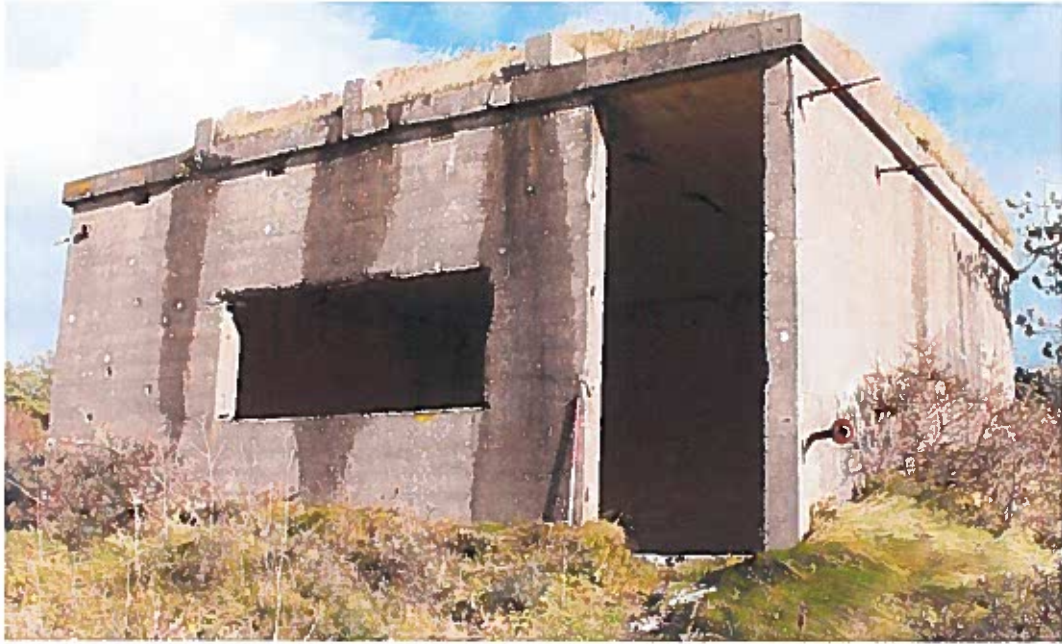
A gun emplacement built of reinforced concrete with turf on the flat roof. Rectangular in plan 6.4 x 7.3m with openings facing southwest. One wide rectangular opening in southwest wall with doorway to side. Internally the walls are painted cream and a small concrete pad on the northwestern wall may form the base of stove. Other fixings and fixtures are traceable in the paintwork of the interior. Forms part of series of gun emplacements built to defend Cefn Sidan beach from invasion or attack during the Second World War. A Pyper 2014

Figure 19: Gun emplacement overlooking Cefn Sidan beach

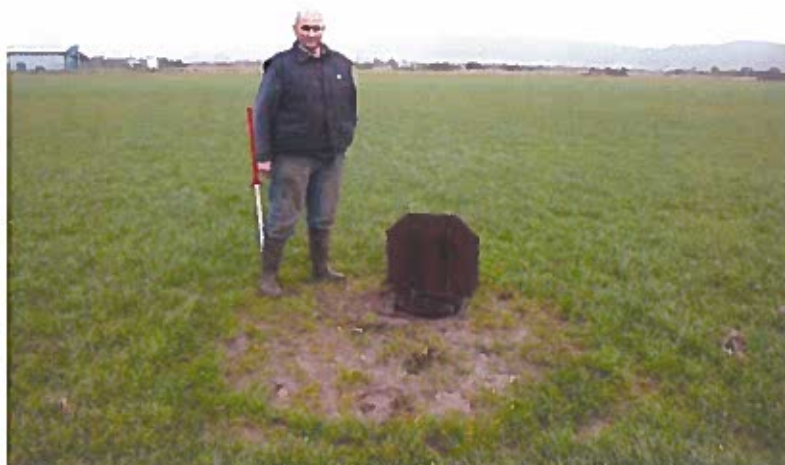
Concrete pad survives within reseeded field, and metal trap door is hinged. Interior is full of water, however allegedly it contains its internal mechanism and hydraulics. A Pyper 2012.

Figure 20: Pickett Hamilton fort to the east of the airfield

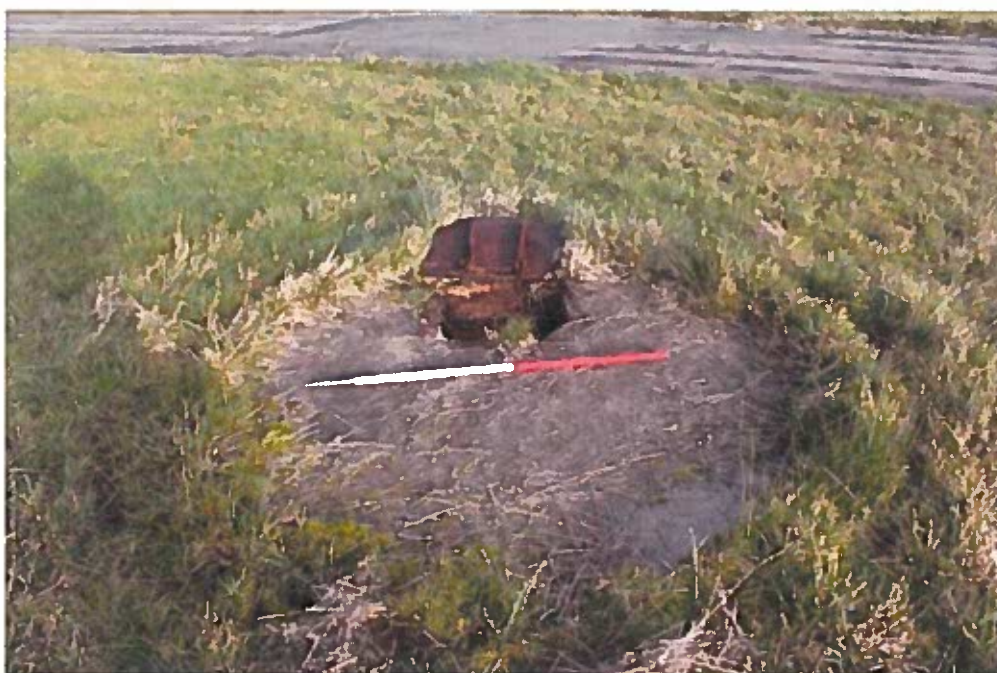
Apparently intact, this Pickett Hamilton is one of two surviving examples which have been recorded at Pembrey airfield. This type of pillbox appears to be very rare in Wales. A Pyper 2012.

Figure 21: Pickett Hamilton fort at the north side of the airfield

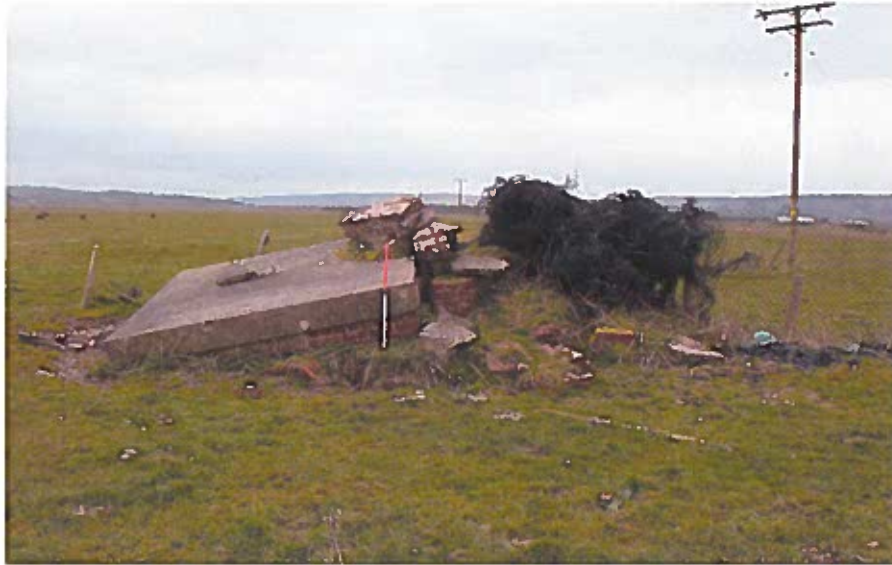
CONDITION DESCRIPTION / Although demolished (blown up?) at some point all the parts of the pillbox appear to survive where they fell, so it is possible to define the gun embrasures. A Pyper 2013.

Figure 22: Demolished pillbox at the southwest end of the sea wall.

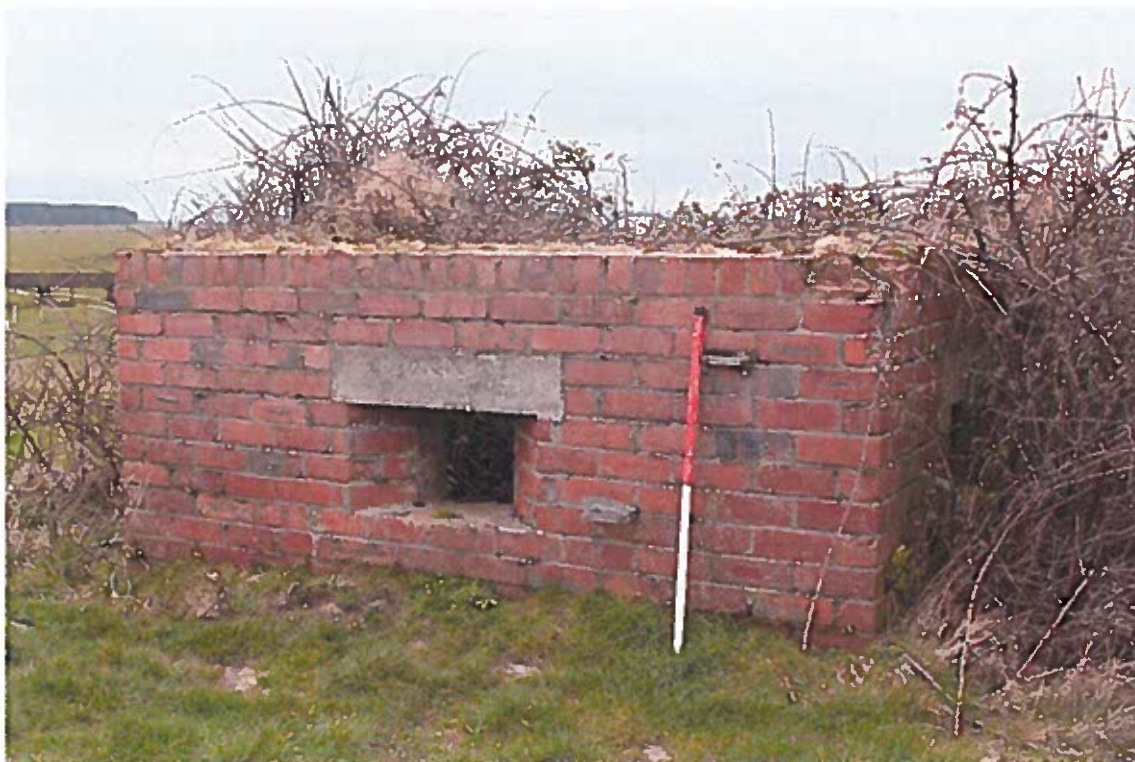
A brick and concrete pillbox located on the northwest side of the Bank-y-Lord sea wall, facing west protecting the airfield to the southeast. Type 23 in design (rectangular subdivided into one open, roofless section the other covered). Narrow gun embrasures with metal pivot mountings in the sill. Forms part of a defensive line of pillboxes which run along Banc-y-Lord. A Pyper 2014

Figure 23: Pillbox on the sea wall at Pembrey, note metal access treads in brickwork

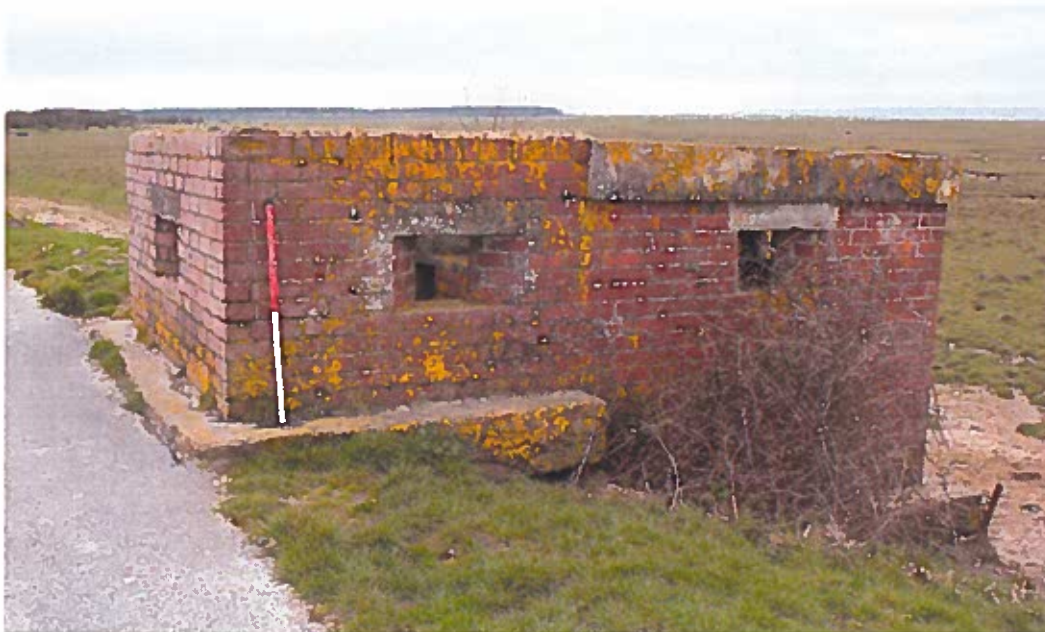
A brick and concrete pillbox located on the northwest side of the Banc-y-Lord sea wall, facing west protecting the airfield to the southeast. Type 23 in design (rectangular subdivided into one open, roofless section the other covered). Narrow gun embrasures with metal pivot mountings in the sill. Forms part of a defensive line of pillboxes which run along Banc-y-Lord. A Pyper 2014

Figure 24: Pillbox built into the sea wall

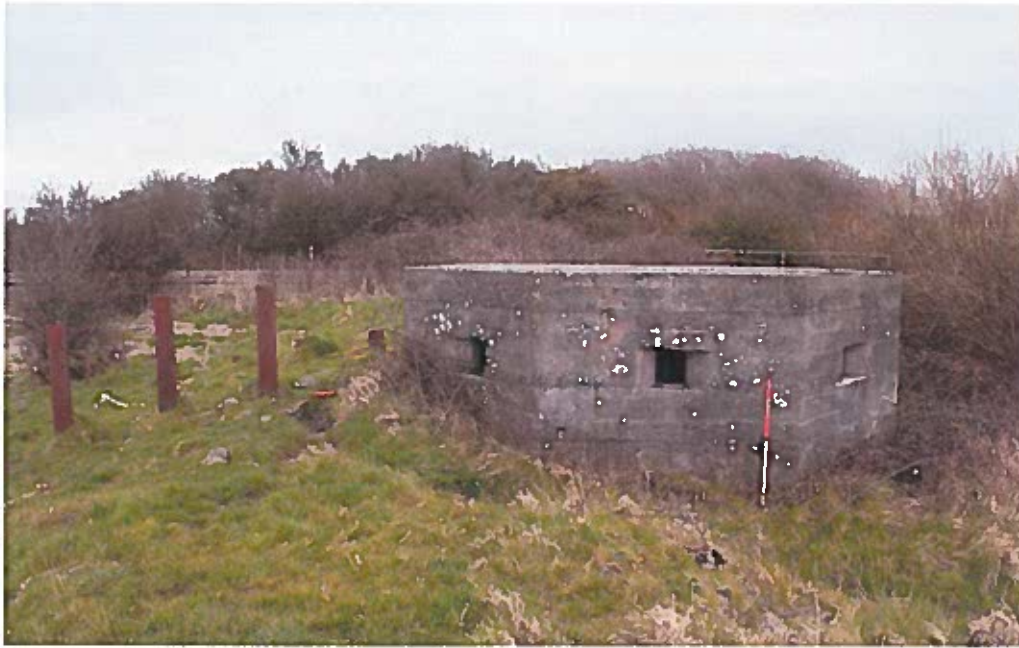
A pillbox built of shuttered concrete to the south of the railway and to the north of Banc-y-Lord. A strong point positioned on the stop line which consists of anti-tank blocks to the south and two parallel lines of vertically set railway rails to the north. The pill box is facing west with the entrance in the east wall. Type 24 (rectangular with canted corners to the west), and with narrow gun embrasures. A Pyper 2014.

Figure 25: Pillbox with anti tank rails to the side forming part of the stopline

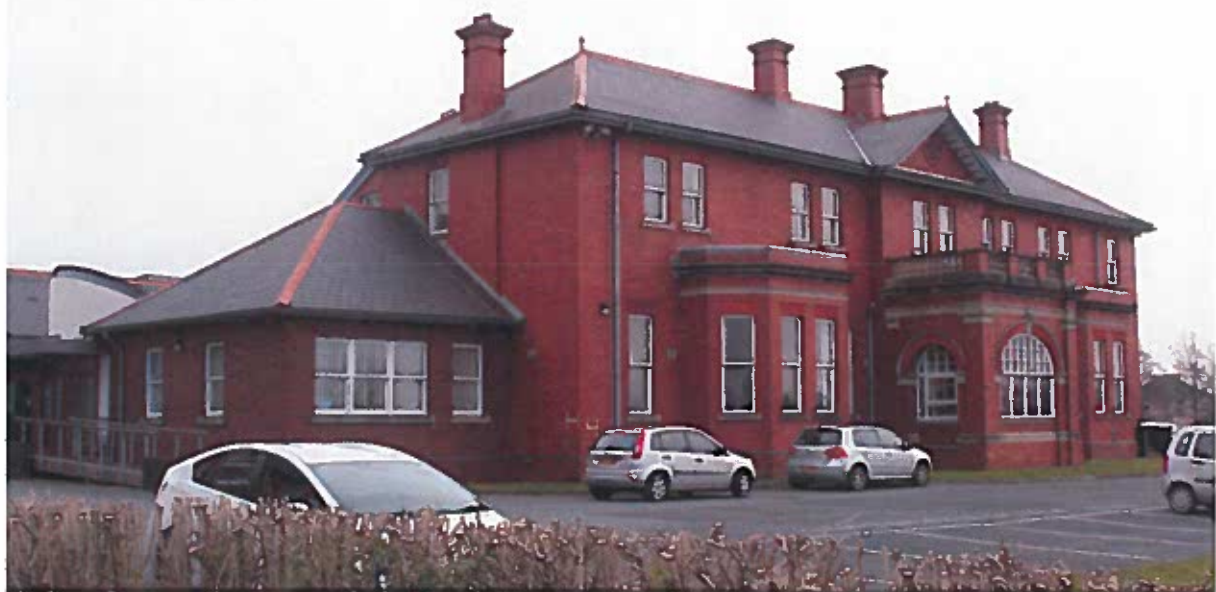
Figure 27: Llanion officers mess

Council offices, formerly Headquarters and Officer's Mess of Llanion Barracks. During Pembroke Docks RAF days (c1930-59) the buildings were designated as Administrative Offices. Red brick pedimented building dated 1904. A Pyper based on RJC Thomas description March 2013

1903-72, Headquarters Building/Officers Mess, now council offices. A large, two storey, brick built, 'L' plan, hipped slate roof, with brick pedimented projections. 7 bay main elevations, 1st floor windows arranged 1-2-2-2-2-2-1. Ground floor brick porch with stone balustrade, two brick canted bay windows. Return range fenestration arranged 1-2-2-2-1-2-1. Central pediment dated 1904, Mosaic in hall dated 1905. RJC.Thomas, 12.03.93.

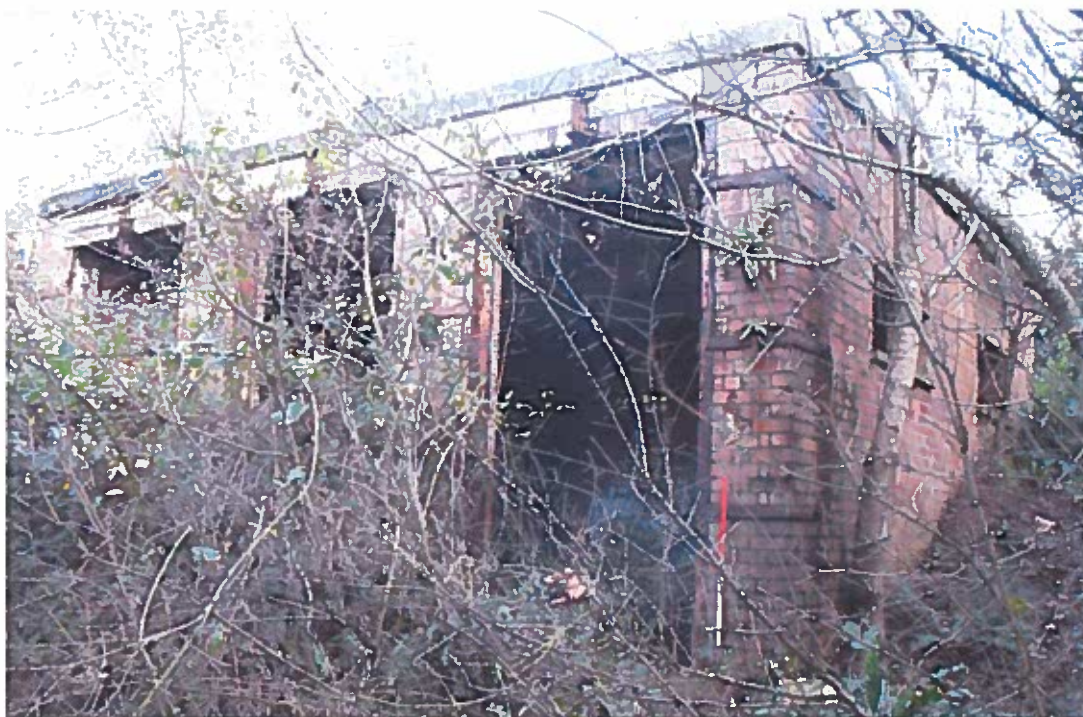
Flying Boat Base built around 1934, Bomb Store/Dump, now derelict. Single storey, permanent brick, square plan, flat concrete roof. Three bay main elevation with three pairs of double steel doors. Narrow standard steel windows in side and rear elevations. Set back into on earth revetment. Fragments of steel bomb handling gantry remains. RJC.Thomas, 14.12.93. One of two stores protected by blast wall PRN 28458. Brick built, flat roof. Originally 3 steel doors to each building at front, now removed. KM 1997

Figure 28: Bomb stores at Pembroke Dock

Further recommendations include the consideration of the Bomb stores at Pembroke Dock for scheduling. These are a well preserved complex of features which relate to a specific and significant part of Pembroke Dock's history.

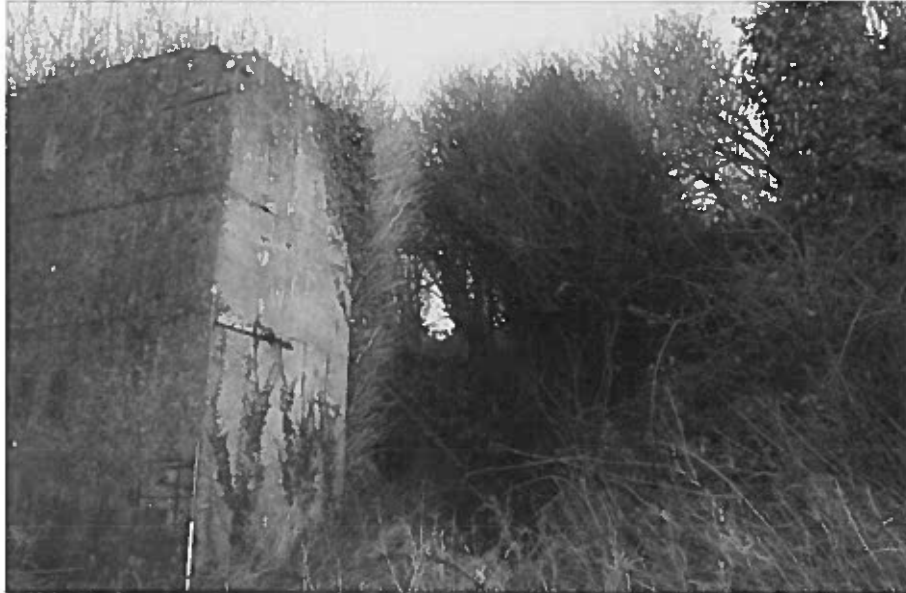
Figure 29: Blast wall in front of Bomb stores at Pembroke Dock

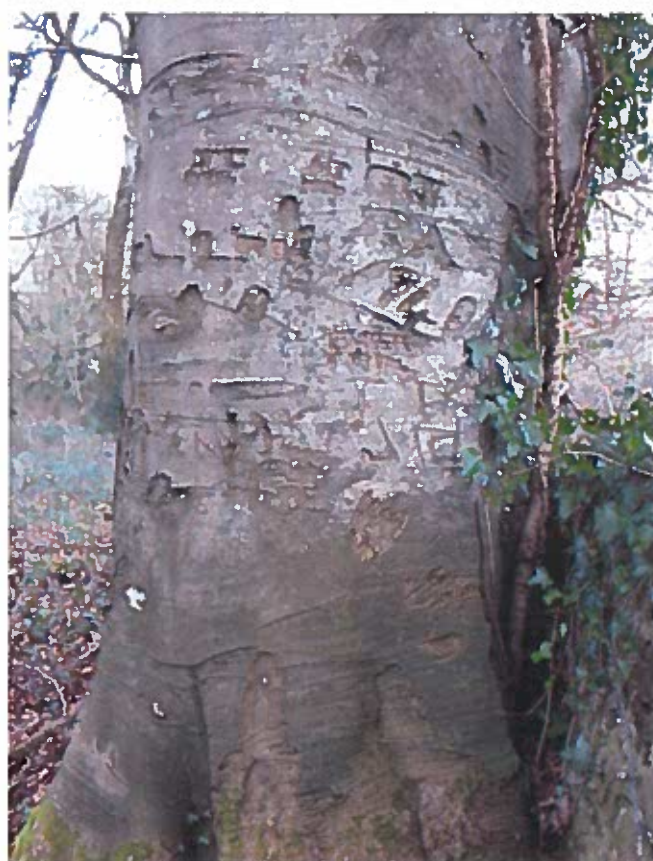
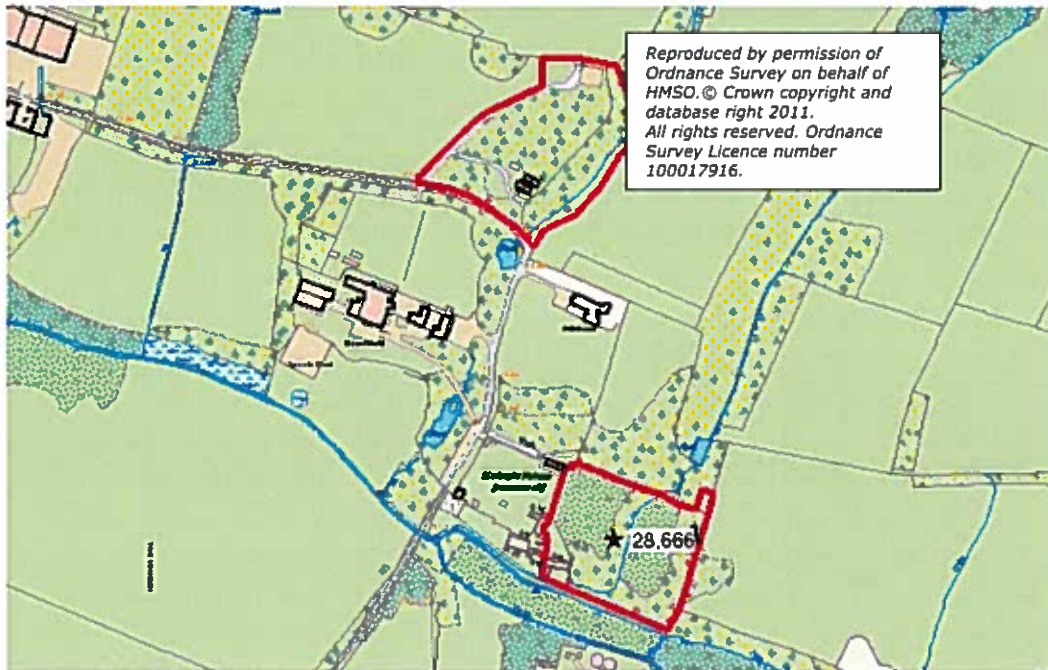
Dispersed site associated with RAF Pembroke Dock, 1939-45, now demolished. Defined on 1944 Air Ministry plan (Dwg No. 2710.44) Formerly consisted of twelve barrack huts (4 timber, 8 nissen), two timber latrines, and one stone ablutions block, dispersed in field to the east of Lamphey Palace ruins. When visited in Jan 2013 only concrete bases were visible in wooded enclosure, many self seeded trees and much undergrowth obscuring hut bases. Some larger beech trees on the boundary to the east inscribed with graffiti, which appears to date to 1940's. Description based on R Thomas's record and updated following site visit 2013, A Pyper.

Figure 30: An example of one of the beech trees at Lamphey Bishops palace.

Figure 31: The dispersed site at Lamphey includes a number of graffitied beech trees

Remote to the Pembroke Dock are the dispersed quarters at Lamphey Bishops palace. While the structures associated with the accommodation of personnel have largely been levelled, a fascinating aspect of the social history of the site is carved into the bark of the beech trees which are established on the site. Here are the inscriptions of large numbers of personnel, some RAF and some American servicemen stationed here prior to embarkation for Europe. It is recommended that a detailed survey is carried out of these inscriptions in order to record the names and dates of individuals. It is worth remembering that these trees have a limited life span and that beech in particular are prone to falling. It would be opportune to make a record while the trees are still intact.
