TWENTIETH CENTURY MILITARY SITES: AIRFIELDS – DISPERSED SITES AND DEFENCES

Final Report – RECOMMENDATIONS

A THREAT-RELATED ASSESSMENT 2013-2014
DAT 115A

RHIF YR ADRODDIAD / REPORT NO. 2014/21
RHIF Y PROSIECT / PROJECT RECORD NO. 103632

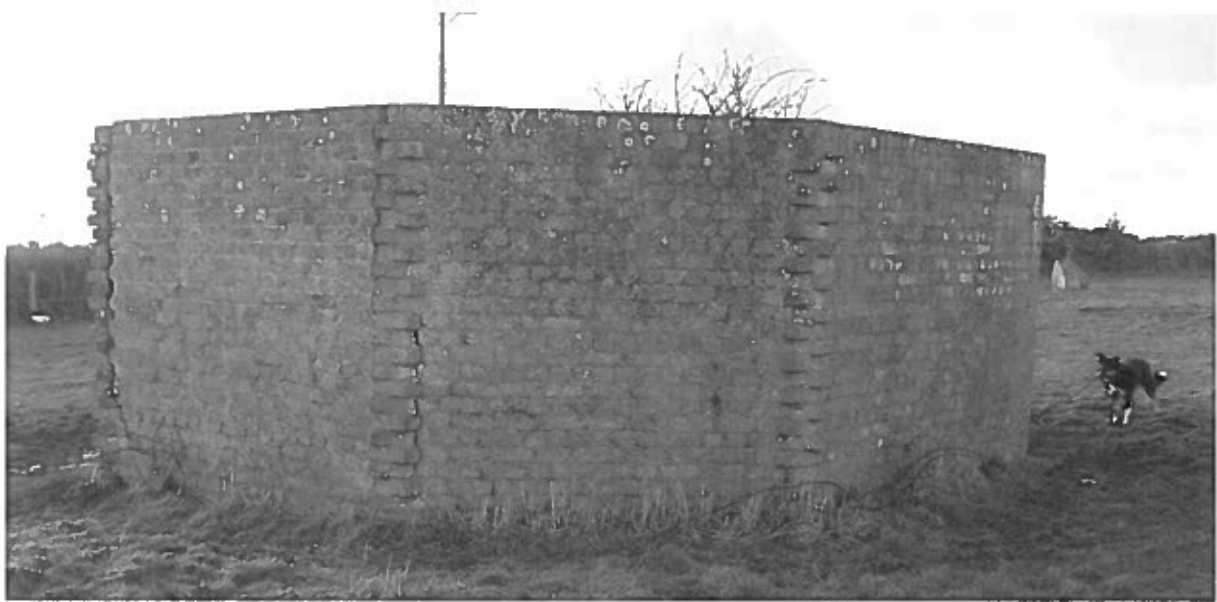
Octagonal brick built structure 2.36m high, 5.5m across, entrance with blast wall in the north side. Built during the Second World War, the brick wall encloses the base of a HD/DF tower (High Frequency Direction Finding) for assisting aircraft to navigate their way back to the St Davids Airfield. Alice Pyper, December 2013.

Figure 33: The octagonal wall enclosing a HF/DF tower

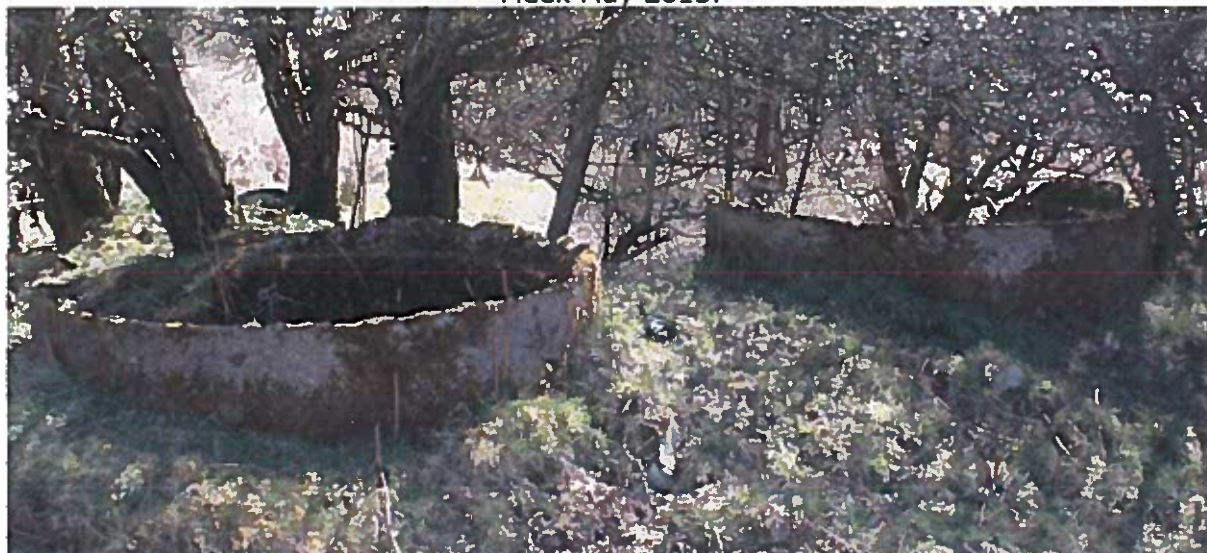
Two circular concrete rings placed side by side at the junction of two field banks. Also referred to as Motley Stalk gun emplacements, they are gun pits for Light Anti-Aircraft guns. Built within the field bank. Approx. 1.60m deep and 0.9m across. The bottom is silted up. Located in thick blackthorn hedge. Both rings have broken down sides. L.

Figure 35: Motley Stalk gun emplacements located within the hedgebanks

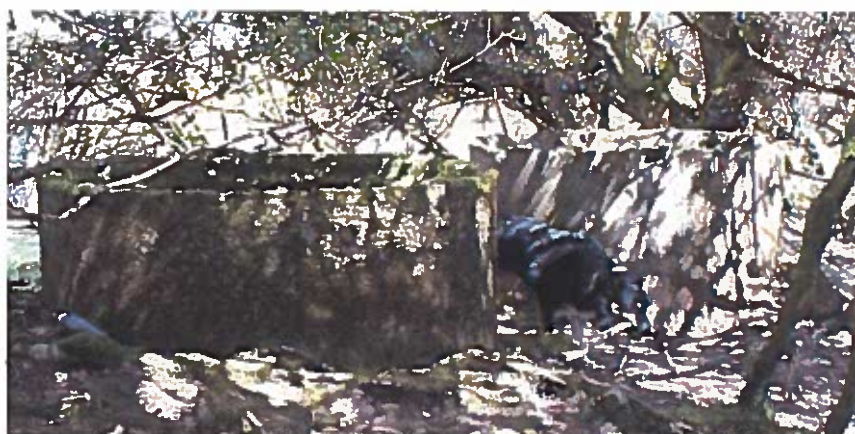
Two complete, circular, concrete rings. Situated on the hedgebank. Also referred to as Motley Stalk gun emplacements, they are gun pits for Light Anti-Aircraft guns. Both rings are intact but filled with water. L. Meek May 2013.

Figure 36: Remains of one of four Motley Stalk gun emplacements

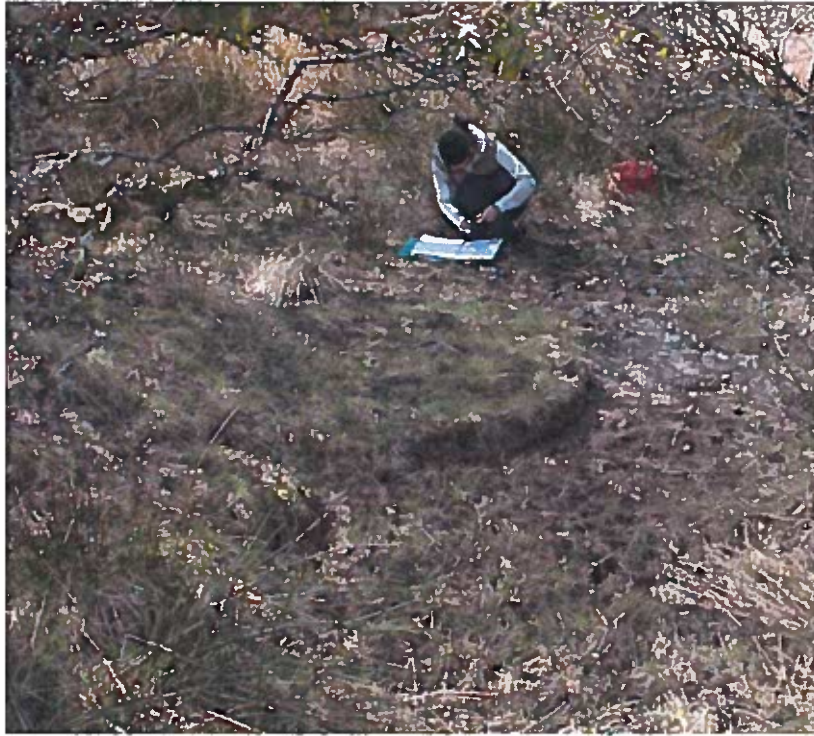
Situated within the hedgerow bank are the remains of two concrete rings (the bases). Also referred to as Motley Stalk gun emplacements, they are gun pits for Light Anti-Aircraft guns. Surrounded by scrub overgrowth. Only the circular concrete ring bases are situated within the hedgerow. Very little remains of the two rings. Their height is barely higher than ground level. L. Meek May 2013.

Figure 37: Fragmentary remains of a Motley stalk gun emplacement

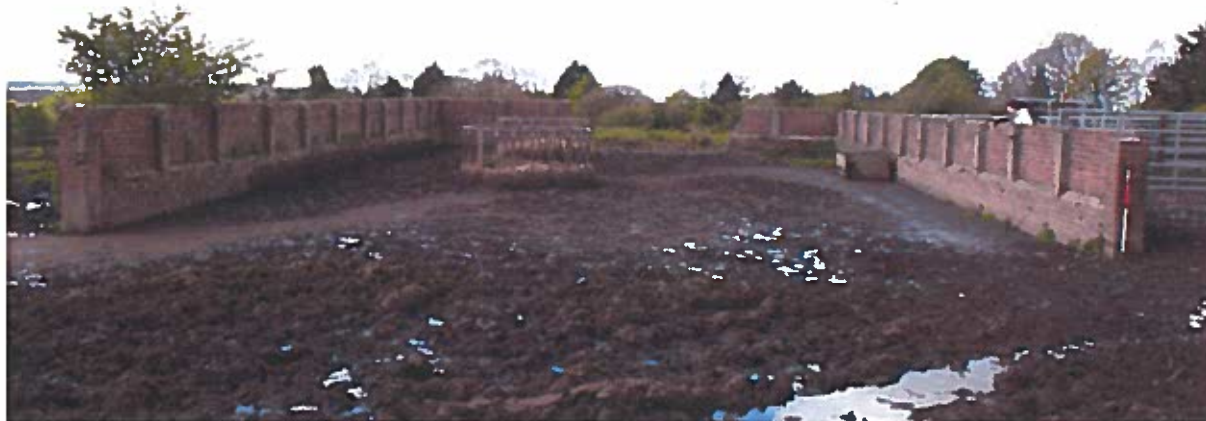
Main Beacon, a red brick, rectangular, concrete structure, now used for cattle. Height=150cm. North East end is open. South West end has a large entry; one pier has been demolished. The Main Beacon forms part of the Standard Beam Approach blind landing system to assist aircraft landing at night or in poor visibility. It forms part of three beacons lined up on the main runway (Inner Beacon PRN 102576, Outer Beacon PRN105897). L. Meek May 2013.

Figure 38: The Main beacon Standard Beam Approach landing system.

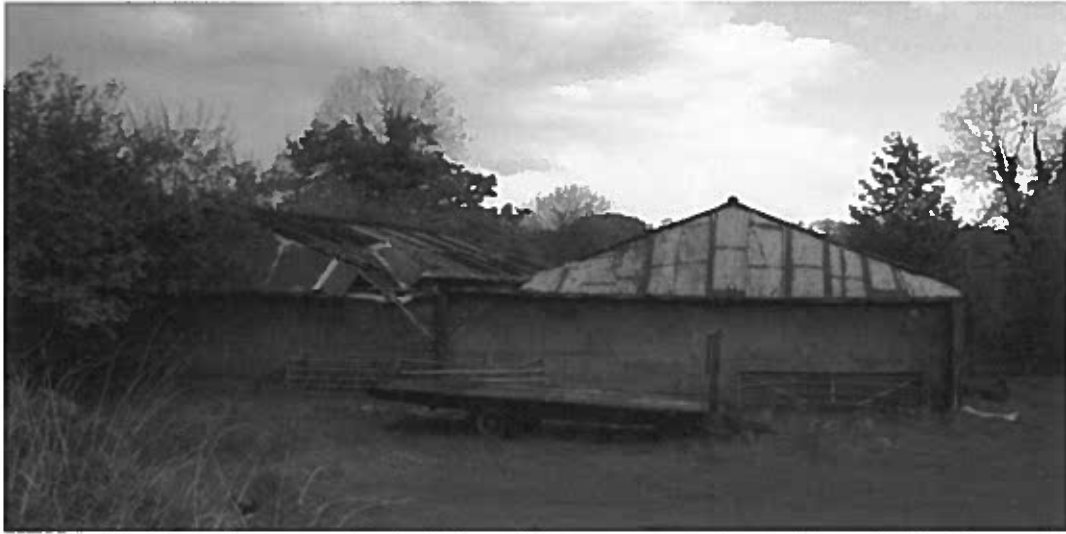
Inner Marker Plinth consisting of a concrete floor. Around 40 years ago the structure was adapted as a store for gliders, it is now used for farming activity. Part of a Standard Beam Approach blind landing system, to assist aircraft landing at night or in poor visibility. It lines up with two other beacons (Main beacon PRN 102573 and Outer beacon PRN 105897) and the main SW - NE runway. L. Meek May 2013.

Figure 39: Only the concrete plinth from the beacon survives with a shed built over it

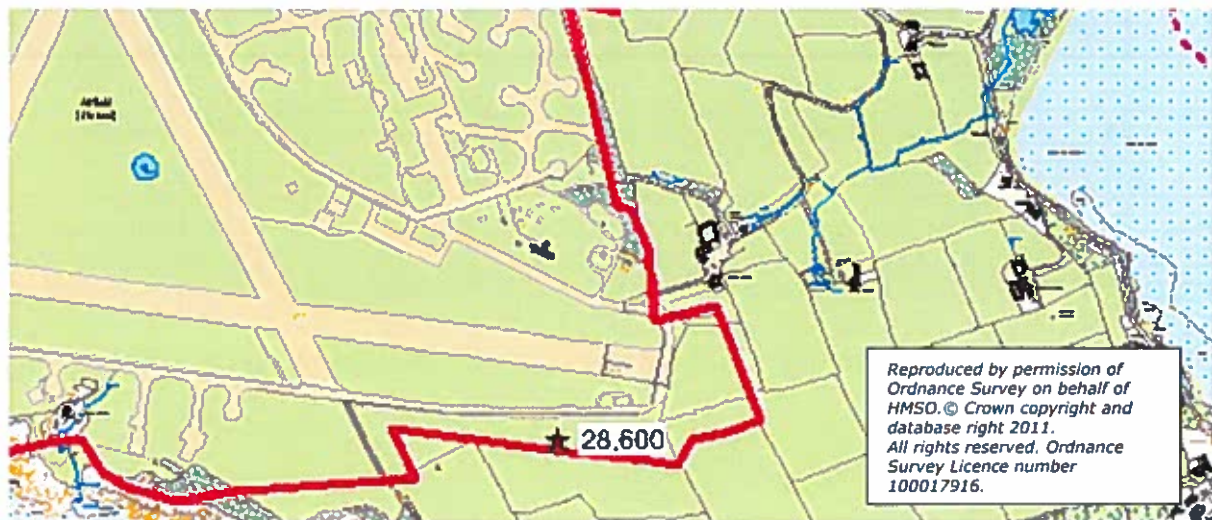
Figure 40: Map showing the location of the battle headquarters

Dale airfield has already been recognised as being worthy of statutory protection and the footprint of the airfield has been scheduled. Currently the boundary of the scheduled area excludes the battle headquarters, PRN 28600. It is recommended that this element is incorporated into the scheduling to recognise it as an integral part of the airfield complex.
