MAINS GAS SUPPLY INSTALLATION AT ST. MARY'S CHURCH, CARDIGAN, CEREDIGION: ARCHAEOLOGICAL WATCHING BRIEF

RHIF YR ADRODDIAD / REPORT NO. 2012/72
RHIF Y DIGWILLIAD / EVENT RECORD NO. 103633

Tachwedd 2012
November 2012

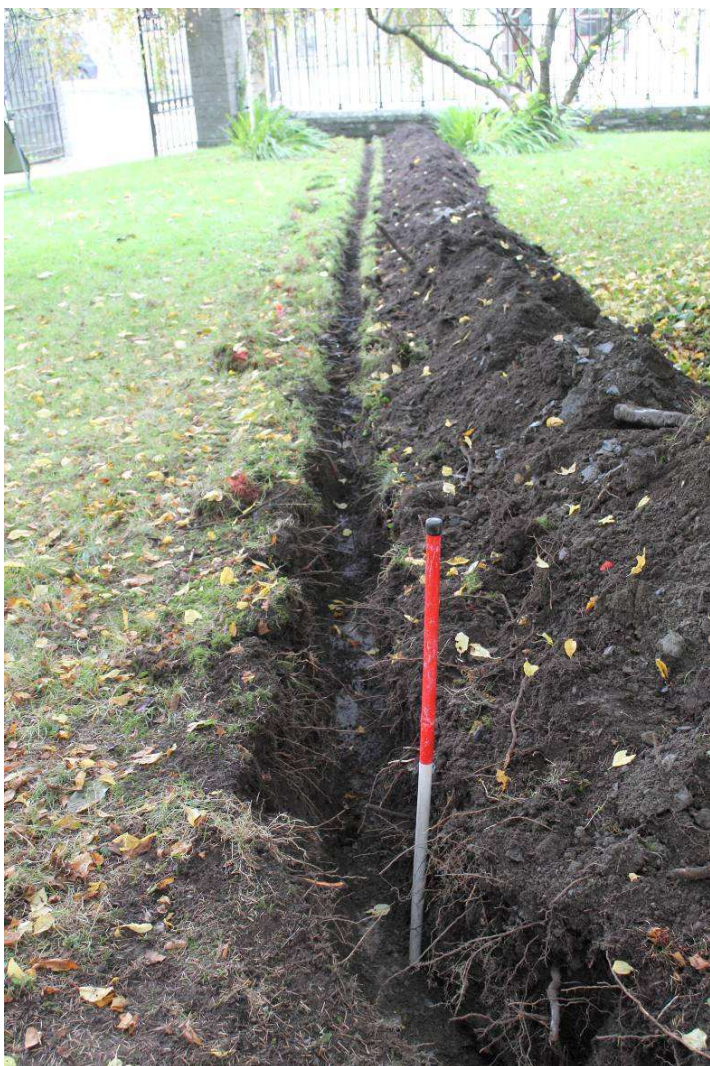
Photo 1: North end of trench looking north

3.2 The uppermost deposit (Layer 1) consisted of a loose dark grey-brown humic clay silt approximately 0.20m thick. Within this deposit were occasional apparently natural irregular slate fragments of varying shape and size.

3.3 Beneath Layer 1 was a 0.2m thick deposit of pale grey-brown clay silt (Layer 2) with widespread mortar fragments and small to medium (up to 0.10m) slate fragments. Within this layer (and extending into Layer 1), were occasional larger dressed slates measuring up to approximately 0.30m x 0.40m x 0.02m. Two of these appeared to be intentionally placed vertically. These slabs may once have propped up gravestones that have since been removed. There was no evidence of associated grave cuts, and it seems likely that many of the gravestones had been moved from their original locations, before they were removed completely (several gravestones are now leant up against walls on the perimeter of the graveyard). A few fragments of 19th/20th century ceramics were noted in this deposit.

3.4 Beneath Layer 2 was an approximately 0.05m thick deposit of variably sized flat lying slate fragments within a mixed yellow-brown clayey silt matrix (Layer 3). This layer contained mortar fragments and occasional charcoal fragments along with 19th/20th century ceramics, glass and clay tobacco pipe stem fragments.

3.5 Where the excavated trench went through Layer 3, a clean mid yellow silty-clay containing slate fragments was revealed (Layer 4). It was uncertain whether this was the top of a natural deposit, or an intentionally deposited make-up layer.

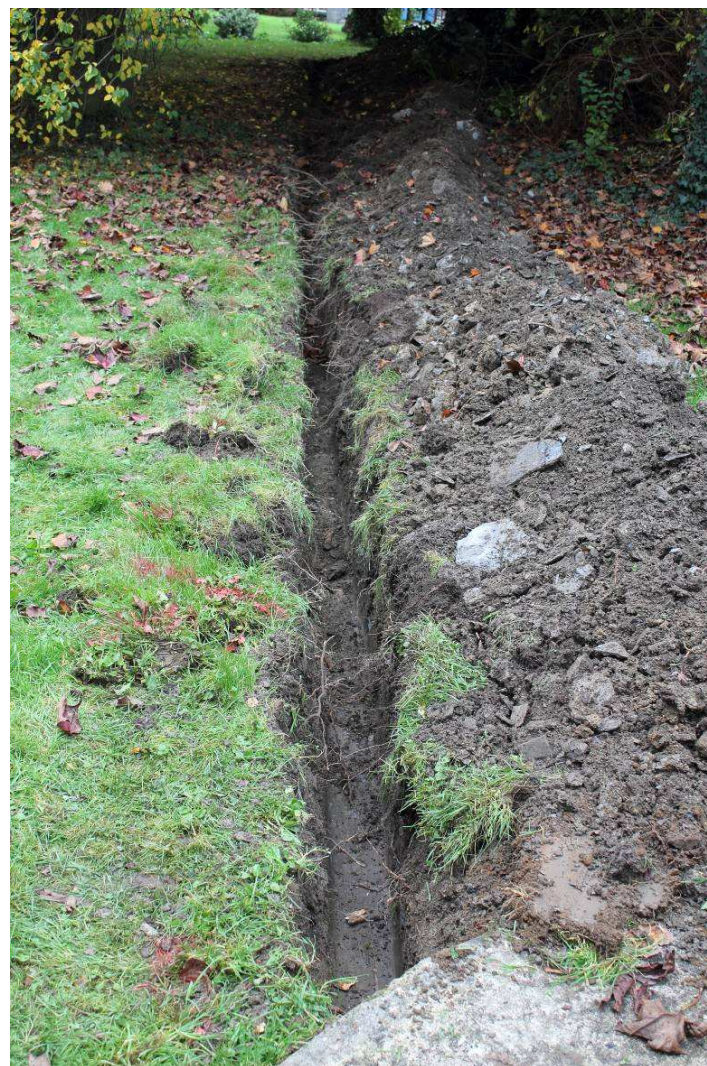
Photo 2: Trench to west of paved area, looking northwest

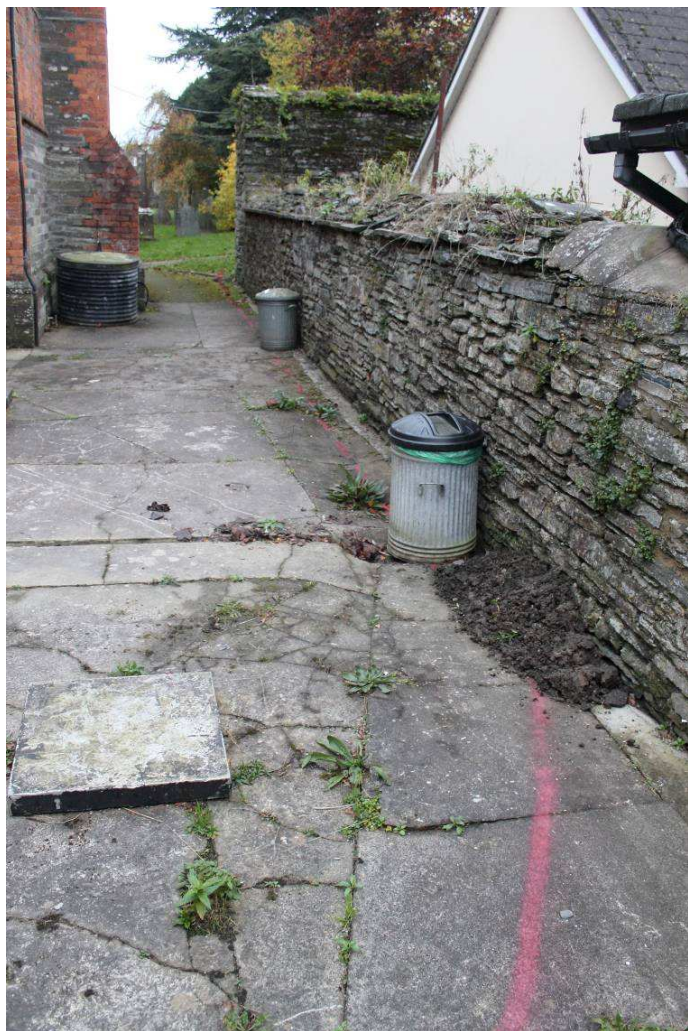
Photo 3: Line of trench (not excavated) in paved area (marked by red line)

3.1.4 The excavation through tarmac concrete and paved surfaces at the east end of the pipe trench were not monitored, since small excavations to locate live services, coupled with the results of the rest of the watching brief strongly suggested that no significant features or deposits would be revealed.

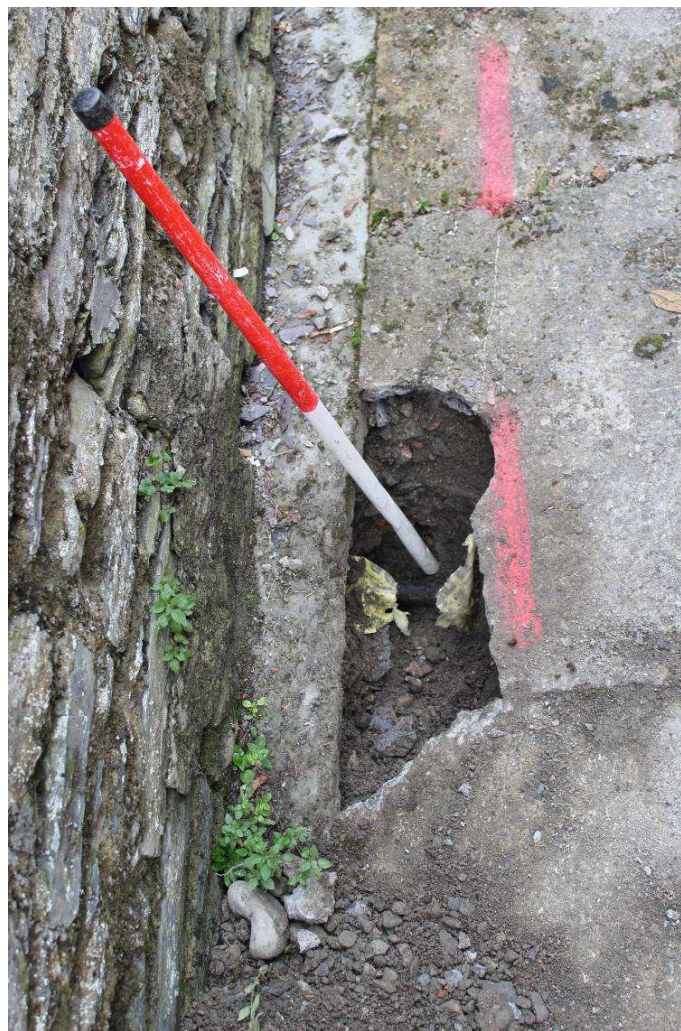
Photo 4: Small excavation to locate services

3.6 Beneath the paved areas surrounding the church, two small excavations to locate live services indicated there was no topsoil (equivalent to Layer 1). Below the slabs was a 0.30m thick deposit of mid grey mixed clay silt, gravel and mortar (Layer 5). This is presumed to be a make-up layer similar to Layer 2, but which has been subject to much more disturbance.
