CASTELL HEINIF, PEMBROKESHIRE FOOTPATH RE-ROUTING 2012: WATCHING BRIEF

Prepared by Dyfed Archaeological Trust
For Cadw and PCNPA

RHIF YR ADRODDIAD / REPORT NO. 2013/3
RHIF Y PROSIECT / PROJECT RECORD NO. 105346
Cadw Project No. DAT 123

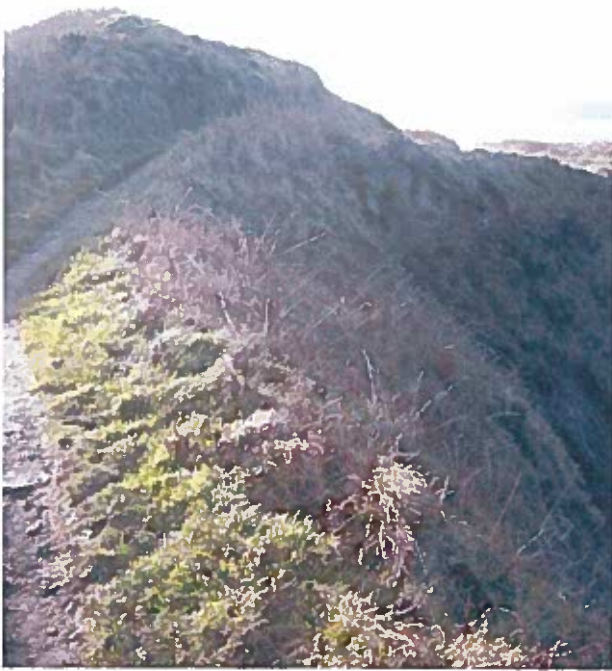
Photo 1: Castell Heinif. Pinch point of former coast path between inner bank of fort and cliff erosion. View SW

The Pembrokeshire Coast Path National Trail passed to the north of the inner bank of Castell Heinif. Continuing erosion on the adjacent slope was creating a pinch point that disconcerted walkers, as the path here was forced very close to the cliff edge. As continuing erosion was likely to exacerbate the problem the only alternative was to create a new route for the path. Cutting back the end of the fort's bank again was not considered a viable option as this would be just a short term fix.

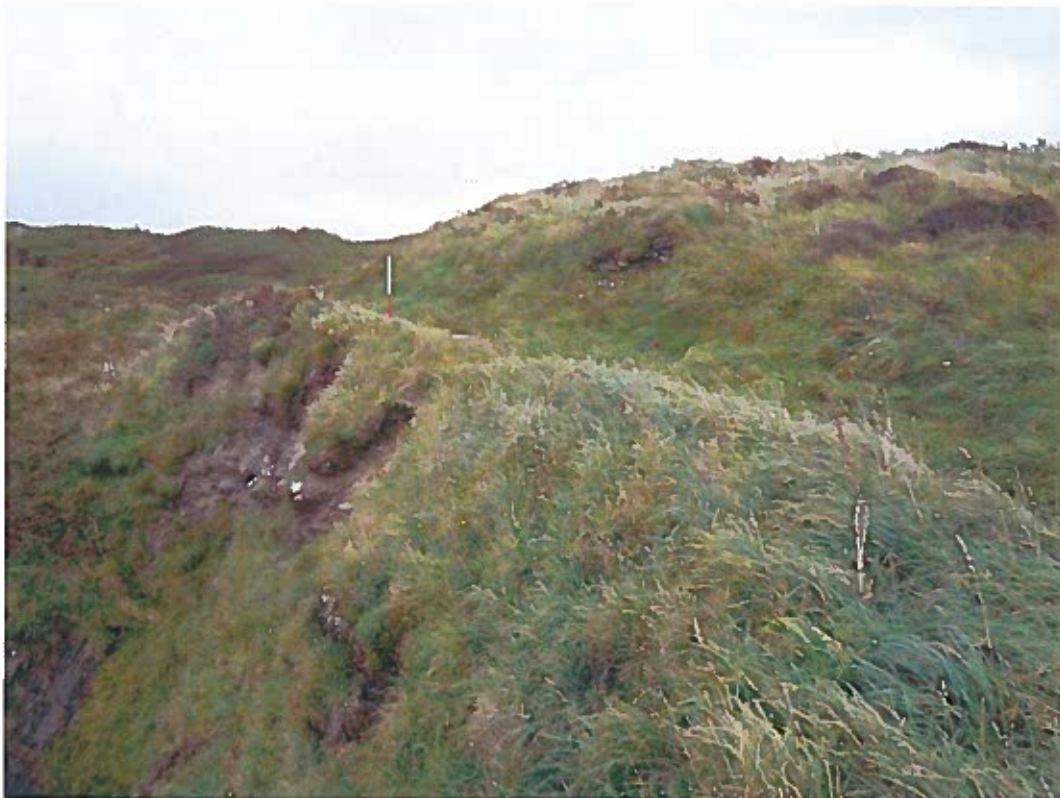
Photo 2: Castell Heinif. Pinch point of former coast path between inner bank of fort and cliff erosion. Scale 1m. View E

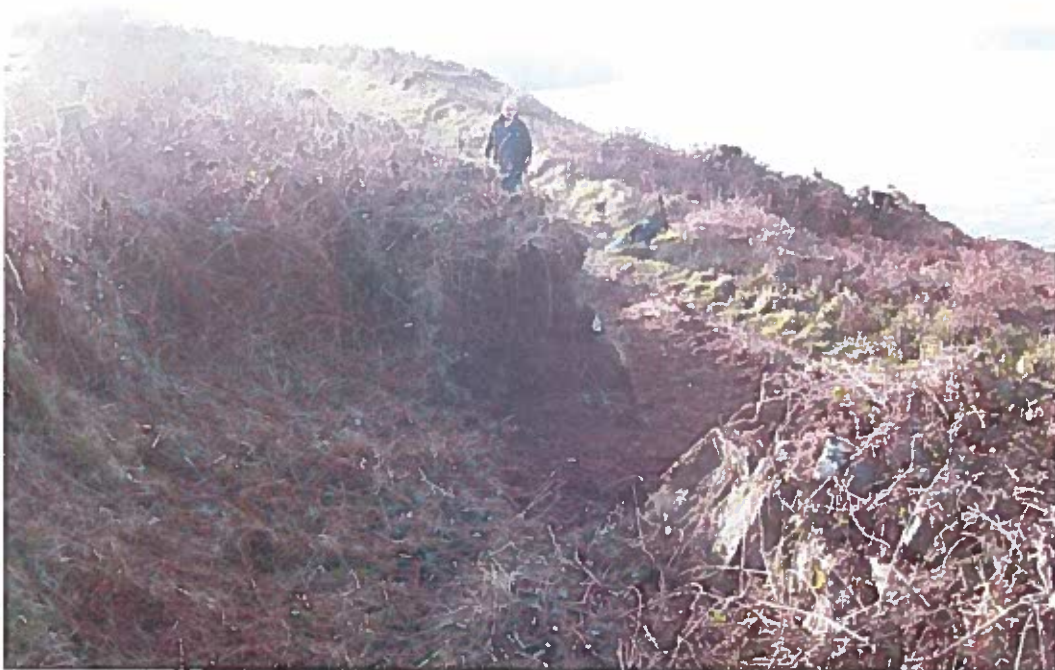
Photo 3: Castell Heinif. New route through hedge bank to the south of fort. View S

The hedge bank at the southern end of the defences was cut through to allow the new path into the inner ditch (Photo 3). At the northern end the base of a former hedge-bank was very slightly reduced to remove a trip hazard (Photo 4). Postholes were dug in non-sensitive areas for direction signs at either end of the re-routing. The sign to the south (Photo 5) was outside of the fort defences and the northern sign (Photo 6) was located on modern infill on the inner ditch from when the original coast path was constructed. The old path has been left as was.

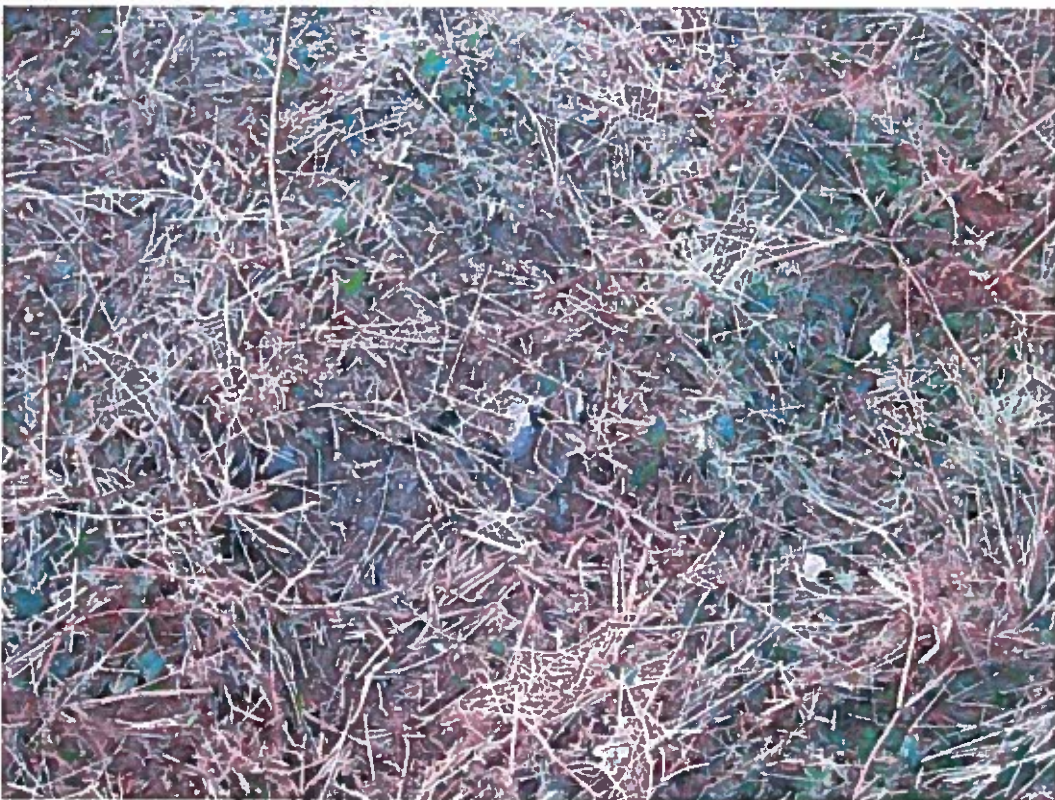
Photo 4: Castell Heinif. Remains of hedge bank in northern end of inner ditch. View S

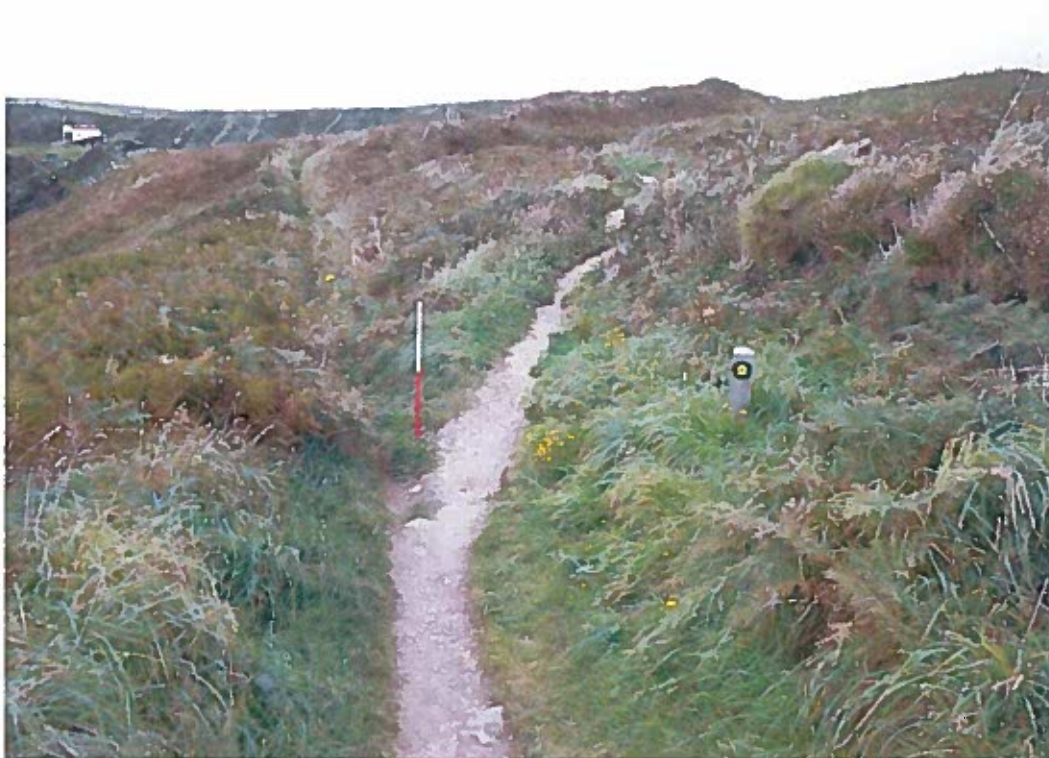
Photo 5: New path and sign, old path to left 17/09/2012. Scale 1m.
View N

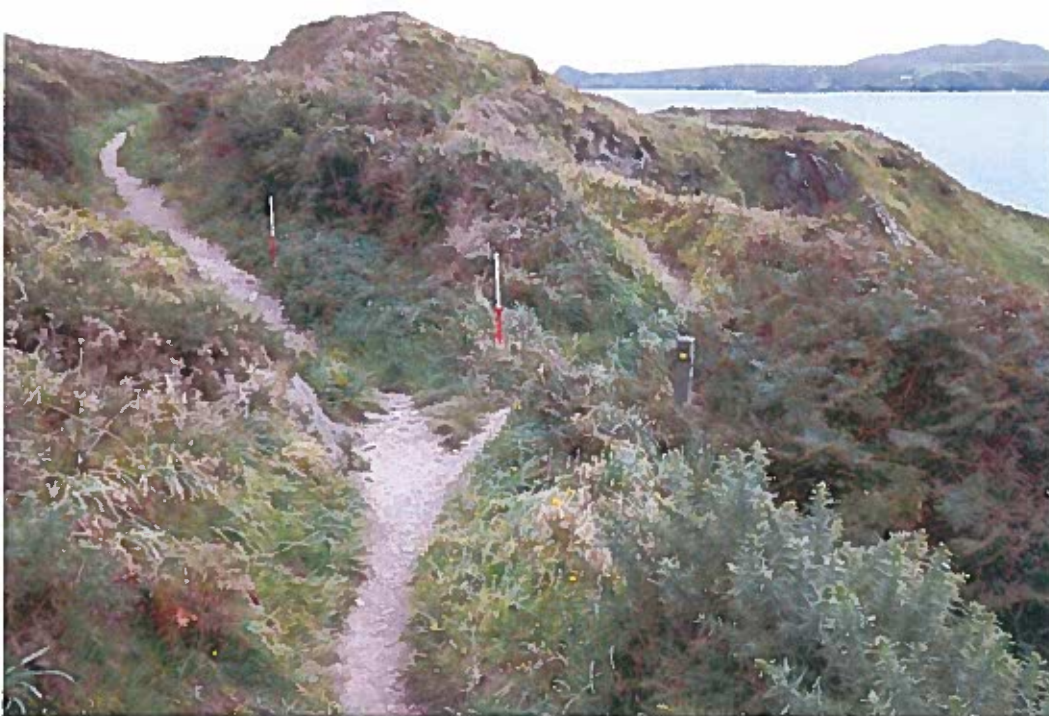
Photo 6: New path and sign 17/09/2012. The slight remains of the hedge bank (Photo 4) is adjacent to the left scale. Scales 1m. View SW
