**CAER WEN, PONTFAEN, DWR CYMRU
WATER MAIN RENEWAL SCHEME,
PEMBROKESHIRE:
ARCHAEOLOGICAL WATCHING BRIEF
(NGR SN 52340 56220)**

RHIF YR ADRODDIAD / REPORT NO. 2013/16
RHIF YR DIGWYLLIAD / EVENT PROJECT NO. 105421

CAER WEN, PONTFAEN, DWR CYMRU WATER MAIN RENEWAL SCHEME, PEMBROKESHIRE: ARCHAEOLOGICAL WATCHING BRIEF

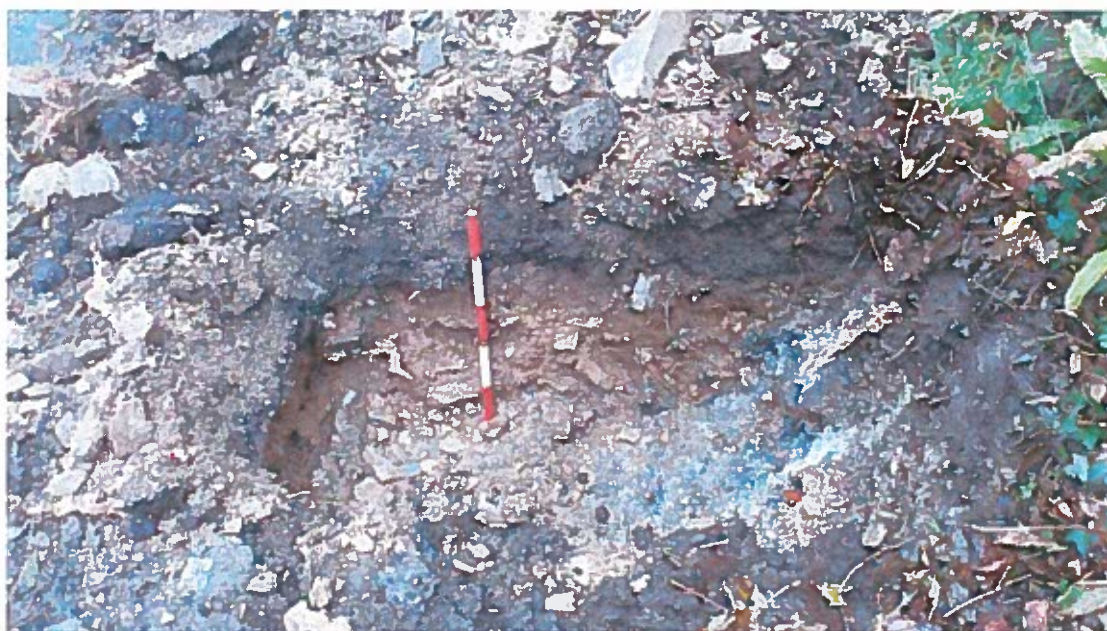
4.1.3 The present road/tarmac surface accounted for the main uppermost deposit found within Pit 1 and had a maximum depth of 0.20m, layer (1000). Underlying the road surface a layer of light brown degrading shale bedrock was encountered, layer (1001). This deposit gradually gave way to a harder grey shale bedrock (1002) which continued to the base of the excavation at 0.55m below ground level.

4.1.4 During the excavation of Pit 1 only modern road make up deposits and natural bedrocks were encountered (photo 3). No deposits or features of archaeological significance were encountered.

Photo 3: View of north east facing section of investigation Pit 1.

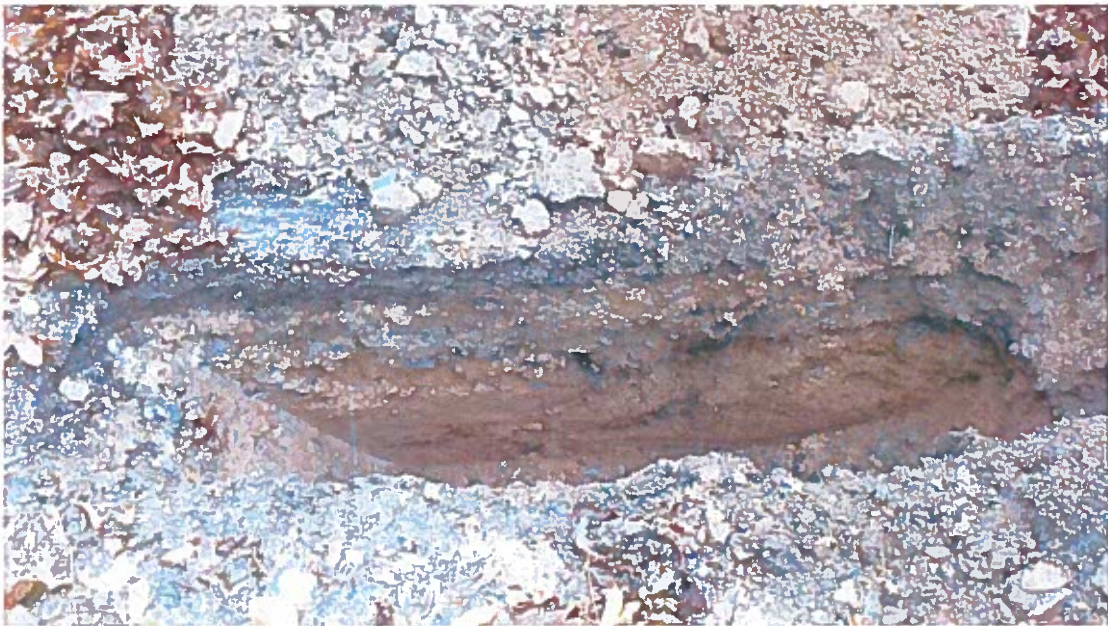
4.1.6 During the excavation of the second pit the upper layers were found to compose of only modern road deposits (layer 2000) of a maximum 0.20m depth. The natural soil horizon was first viewed at 0.20m below the top of the modern road surface and consisted of light brown shale bedrock, layer (2001).

4.1.7 A modern service was revealed near the base of the pit. A vertical straight edged cut was visible within the pit section which related to the modern service.

4.1.8 Only natural soil horizons below modern road make-up were revealed within Pit 2. A single modern service and associated cut were also revealed (photos 4-5). No deposits or features of archaeological significance were encountered.

Photo 4: View of northwest facing section of Pit 2 section

Photo 5: View of northwest facing section of Pit 2 section with red lines denoting edges of modern service.

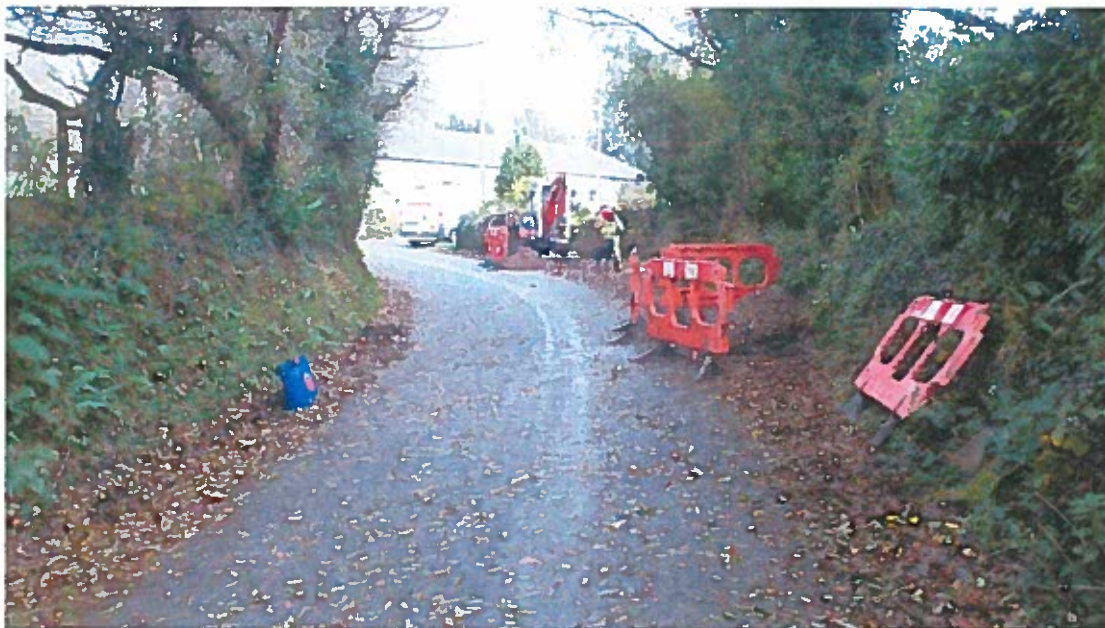
5.2 The two investigation pits have demonstrated that the road which is located to the southeast of St Brynach's Church has been terraced into the hillside. This may have removed any earlier archaeological remains that may have been present.

5.3 This terracing of the roadline could also clearly be seen in the general topography of the area. On the southern/southeastern edge of the road, a near vertical edge rose up to the level of the adjacent field exceeding depths of 1.8m in places. On the western/northwestern side of the road there was a further 1m rise to the ground surface beyond the road. This indicates that the original ground slope would have actually been well above the existing level of the road, but had been terraced when the road was formed. The date of this terracing is uncertain, but the evidence from the test pits would suggest that modern resurfacing of the road has further reduced the ground level. The extent of the terracing would have destroyed any archaeological remains that may have formerly been present within the roadline.

Photo 6: View along roadline towards Pontfaen House showing difference in ground level on either side of road, viewing west

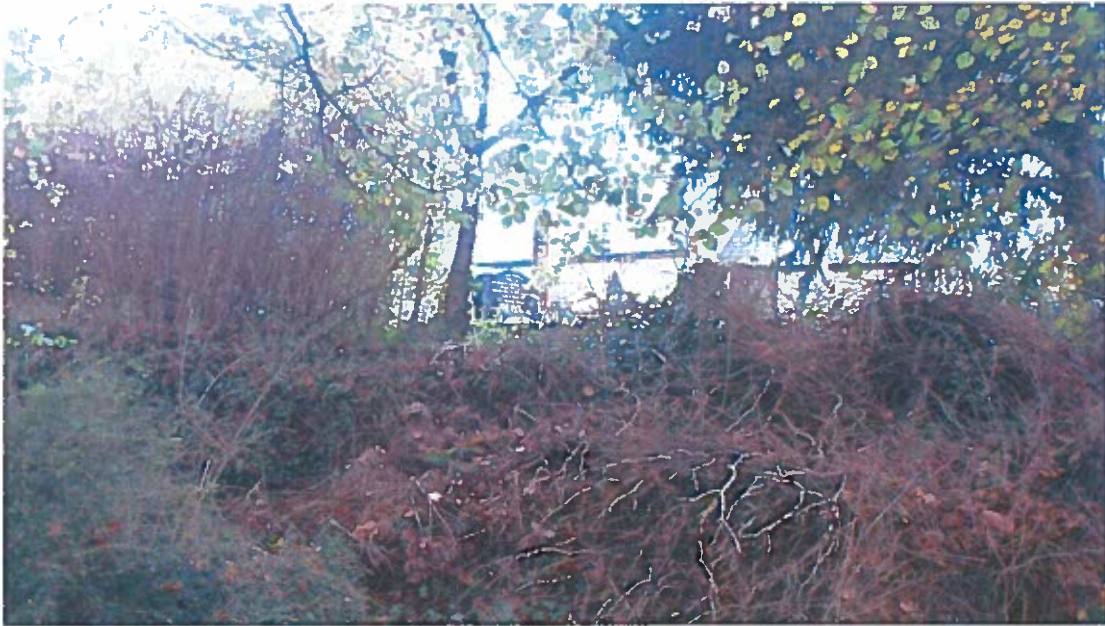
5.4 Observation of the southern boundary of St Brynach's churchyard indicated it was surrounded by an earth bank (Photo 6). On the southern side of this bank, towards the water main renewal area, there was a natural drop in the ground level, indicating that the churchyard had been constructed on a high point of land. The natural topography of the area between the churchyard and the roadline dropped into a small valley heading in a northeasterly direction. It is considered most unlikely that the churchyard would have extended southwards and that any associated settlement would have been in this area. The land to the west of the church, including the area of Pontfaen House, seems far more level and a much more likely candidate for associated archaeological activity to be located.

Photo 7: View of southern boundary of church on top of natural rise in the ground, viewing north

5.6 Due to the presence of bedrock in the investigation trenches, directional drilling of the water main would not be possible, and open-cut trenches would be needed. As the watching brief demonstrated that as the area of archaeological interest had been significantly terraced, there was considered no further need for any monitoring works during the water main renewal.
