# Historic Environment Feature Management Report:

## Two ruined cottages at Esgryn Farm

Customer Reference Number: AA0032174

UIDS: 313,385 AND 313,386

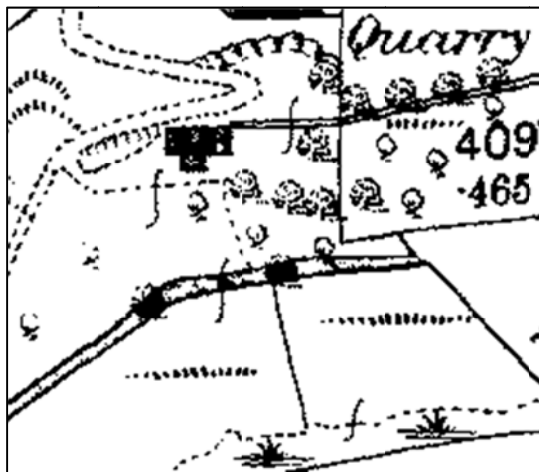
UID 313,386

**PRN 103014** **Name** Cottage SW of Esgryn Farm  
**Period** post medieval **Site Type** Farmstead  
**NGR** NGR 9634 7750

An unnamed minor farmstead recorded on the Ordnance Survey 1st edition mapping (Pembs Sheet 09.16, 1889). Present condition unknown. The buildings are still marked in outline on the recent Ordnance survey.

Recent aerial photographs (Ordnance Survey Next Perspectives 2009) identify the site as being within woodland.

The main management issue for both these sites is the control of tree and scrub vegetation which has the potential to damage buried archaeological remains through the disruptive activity of root development, and built structural remains by the prising apart of masonry bonds.

- Remove mature trees which are at risk of wind throw and could threaten the structure through uprooting (root plate damage) or falling limbs.
- Remove any young trees growing out of the top of the structure by cutting by hand. Do not pull-up by the roots as this is potentially destabilising to masonry bonds. Cut any scrub back by hand in order to retain the visibility of the structure. Spot treat to prevent regrowth.
- Maintain a canopy of mature trees over the kilns. This will prevent light entering the ground, inhibiting scrubby vegetation growth.
- Spot treat stumps with appropriate product to prevent re-growth.

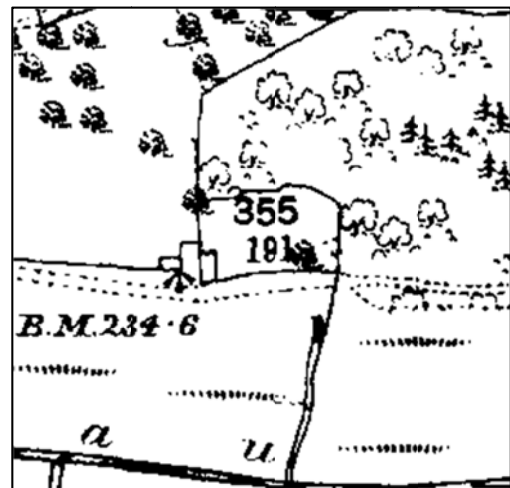
UID 313,385

**PRN 103015** **Name** Cottage NE of Esgryn Farm  
**Period** Post Medieval **Site Type** Cottage  
**NGR** NGR SM 9634 8999

A former cottage site, un-named, recorded on the Ordnance Survey 1st edition mapping (Pembs, Sheet 09.08, 1889). The site now lies within woodland. Present condition unknown.

Recent aerial photographs (Ordnance Survey Next Perspectives 2009) identify the site as being within woodland.

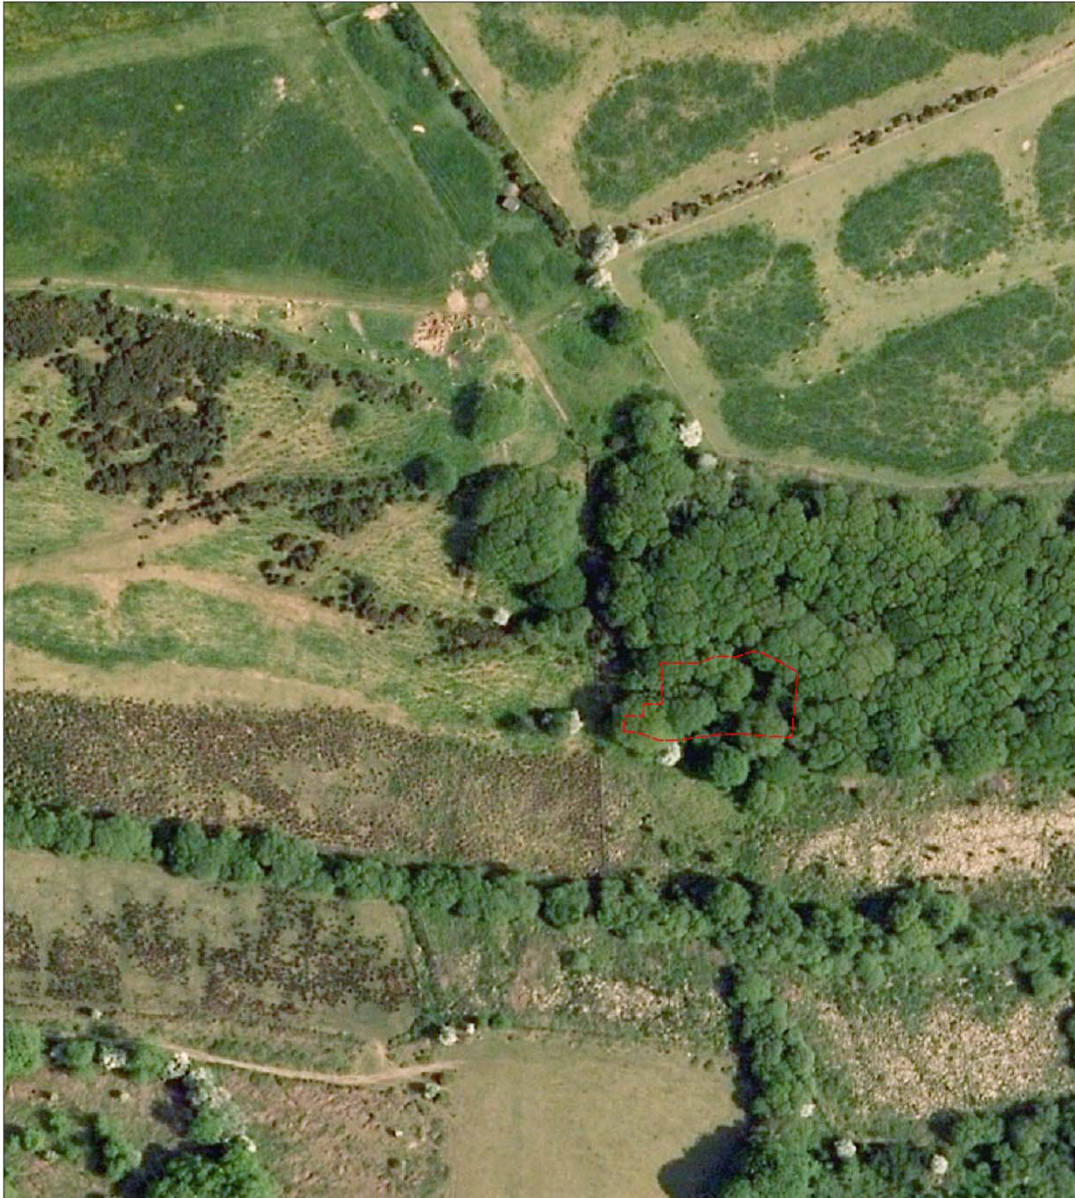
UID 313,386

Aerial photograph

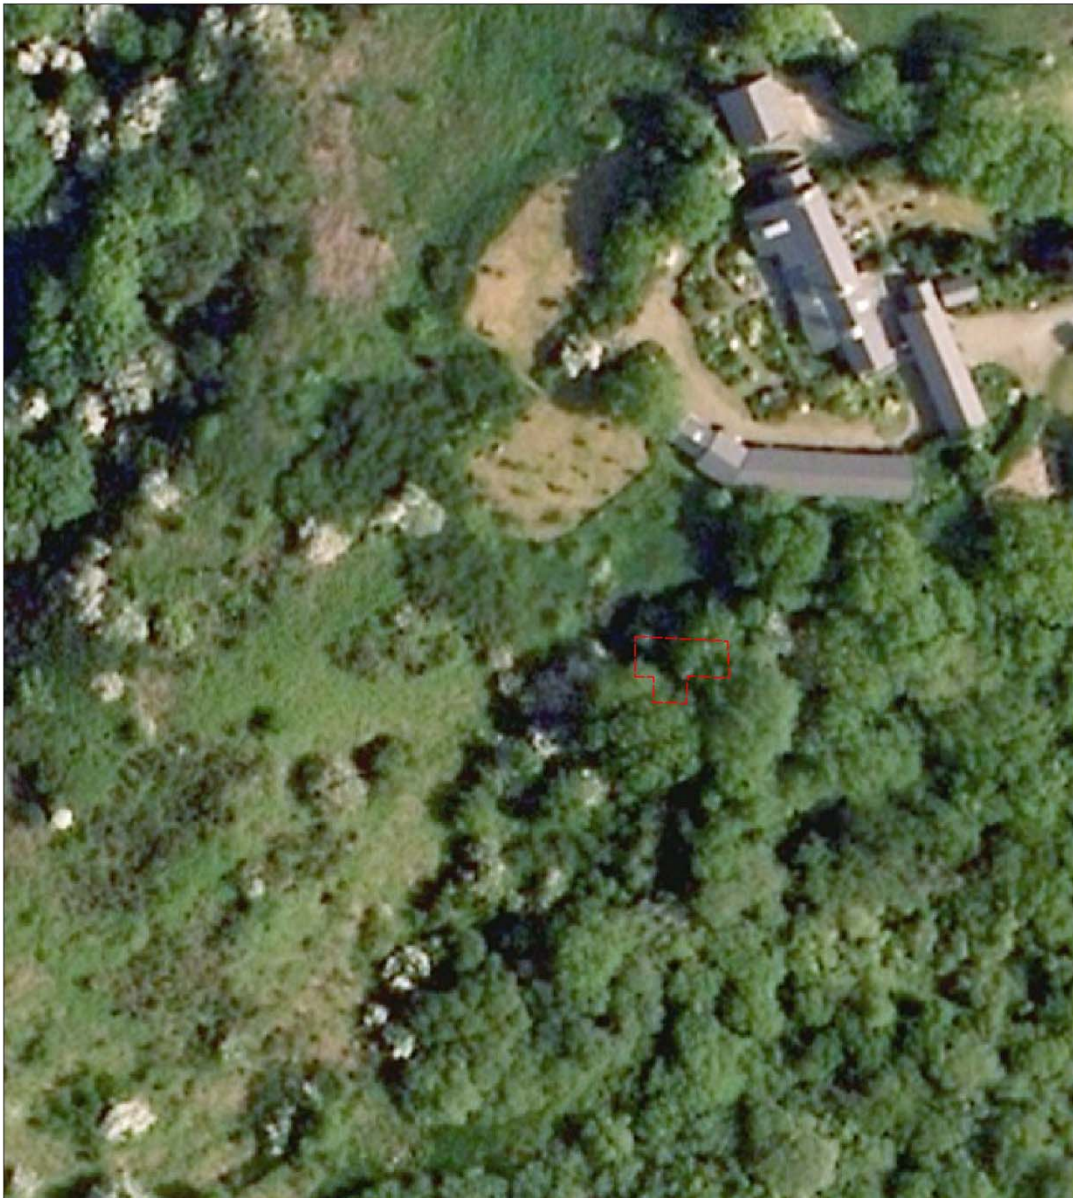
UID 313,385

Aerial photograph
