Historic Environment Feature Management Report:

Lime kiln At Bowett Farm

UID: 300612

This management plan has been produced by Dyfed Archaeological Trust Heritage Management to inform the positive management of the identified Priority Historic Environment Feature. The identified management outcome will meet the objective for the Historic Environment Feature Targeted Layer as part of the Glastir Land Management Scheme.

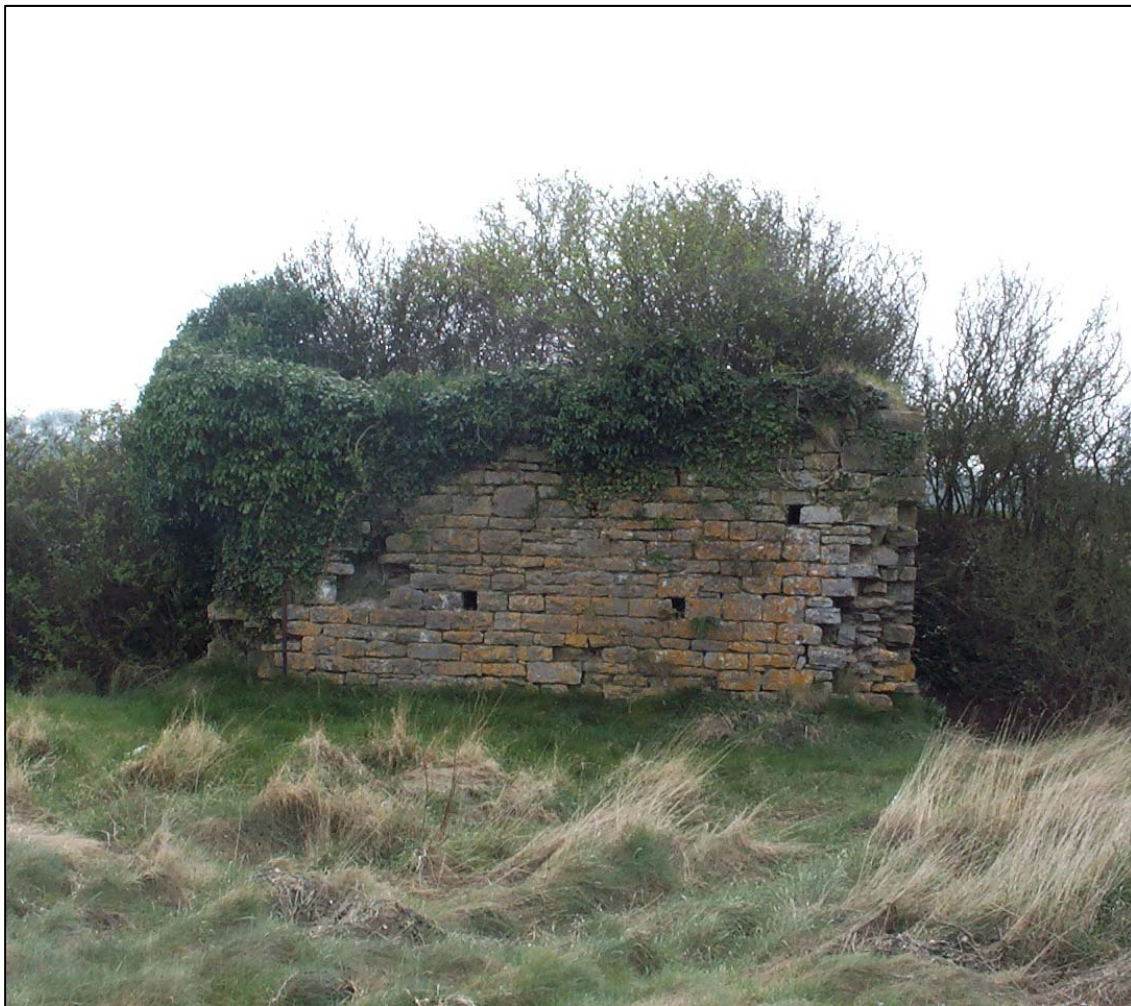
It survives as a square, stone-built structure, with opposing draw holes, access ramp and in-situ brick lining. A field visit in 2002 recorded the structure as near complete but being overgrown with intrusive vegetation and ivy (Pyper).

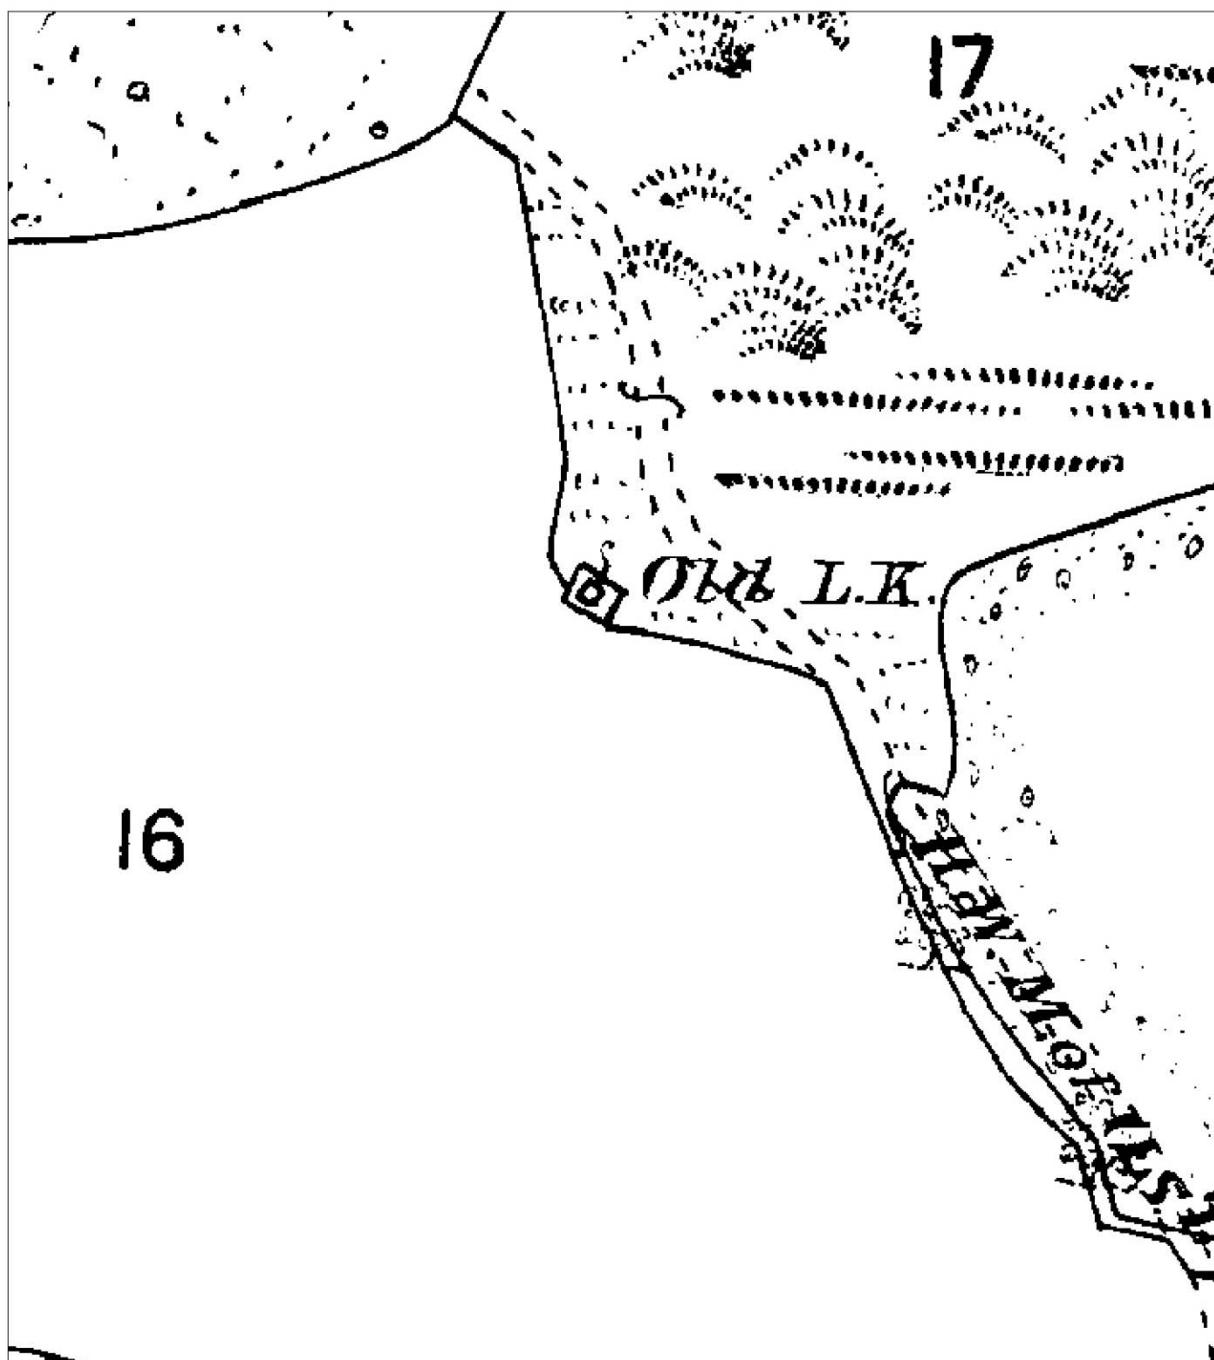
Detail from the 1st edition Ordnance Survey map (1889)

A lime kiln recorded on the 1889 Ordnance Survey map as O K (old kiln) indicating abandonment.

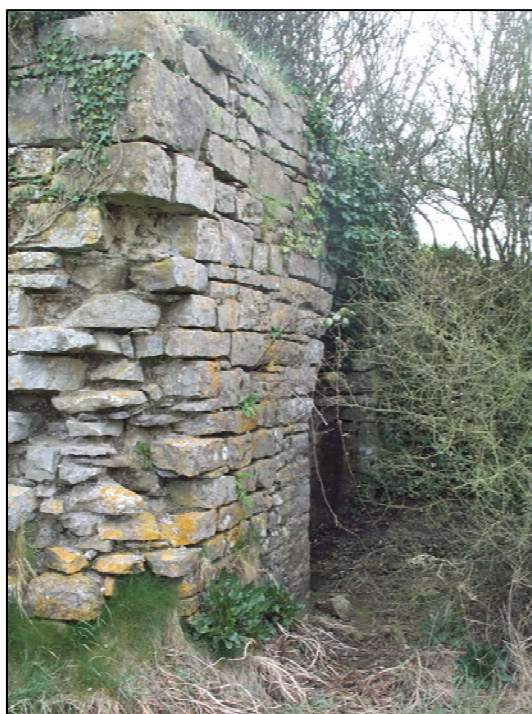
PRN 17903 Damage to corner © DAT 2002

- Cut back any ivy and vegetation in order to retain the visibility of the structure.
- Remove any young trees growing out of the top of the structure by cutting by hand. Do not pull-up by the roots as this is potentially destabilising to masonry bonds. Cut any scrub back by hand. Spot treat to prevent re-growth.
- Carry out a programme of masonry consolidation and re-pointing in order to make the structure safe. Contact Dyfed Archaeological Trust for further advice.

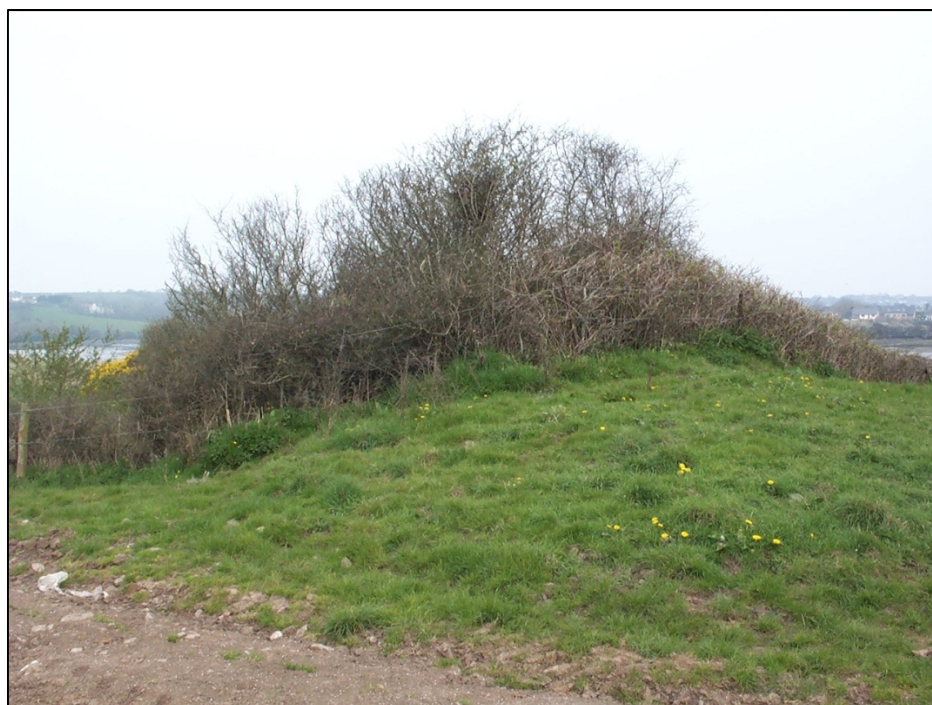
PRN 17903 Charging ramp from SW. © DAT 2002

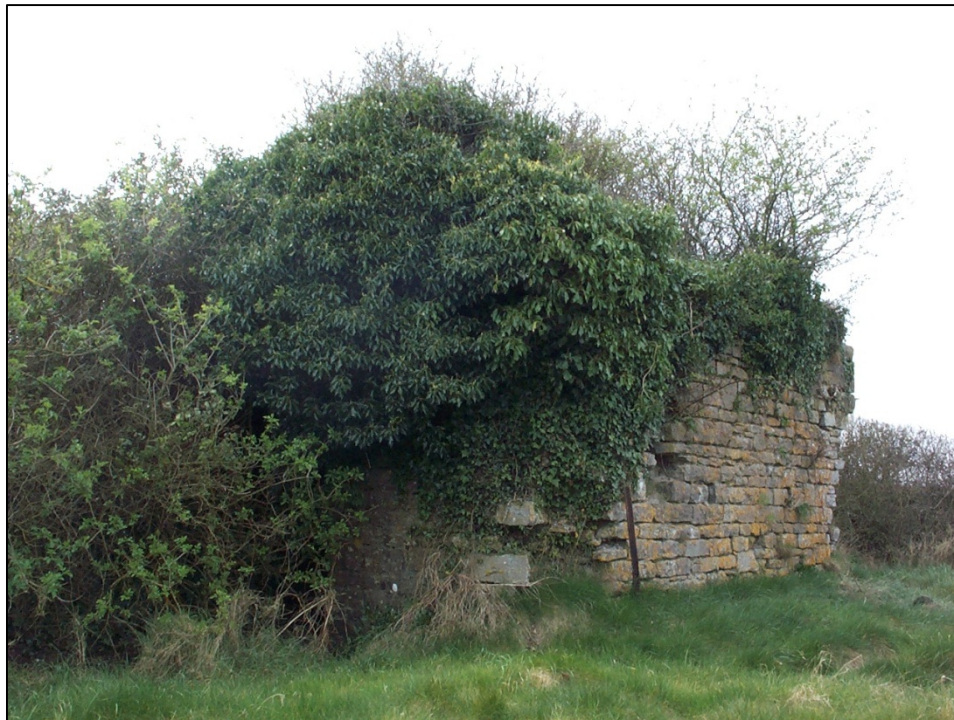
The main management issue for this site is the control of intrusive vegetation which has the potential to damage built structural remains by the prising apart of masonry bonds.

PRN 17903 Ivy over structure from north east © DAT 2002
