Historic Environment Feature Management Report:

Parsons Ruined Farmstead

Customer Reference Number: A0028568

UID: 303,130

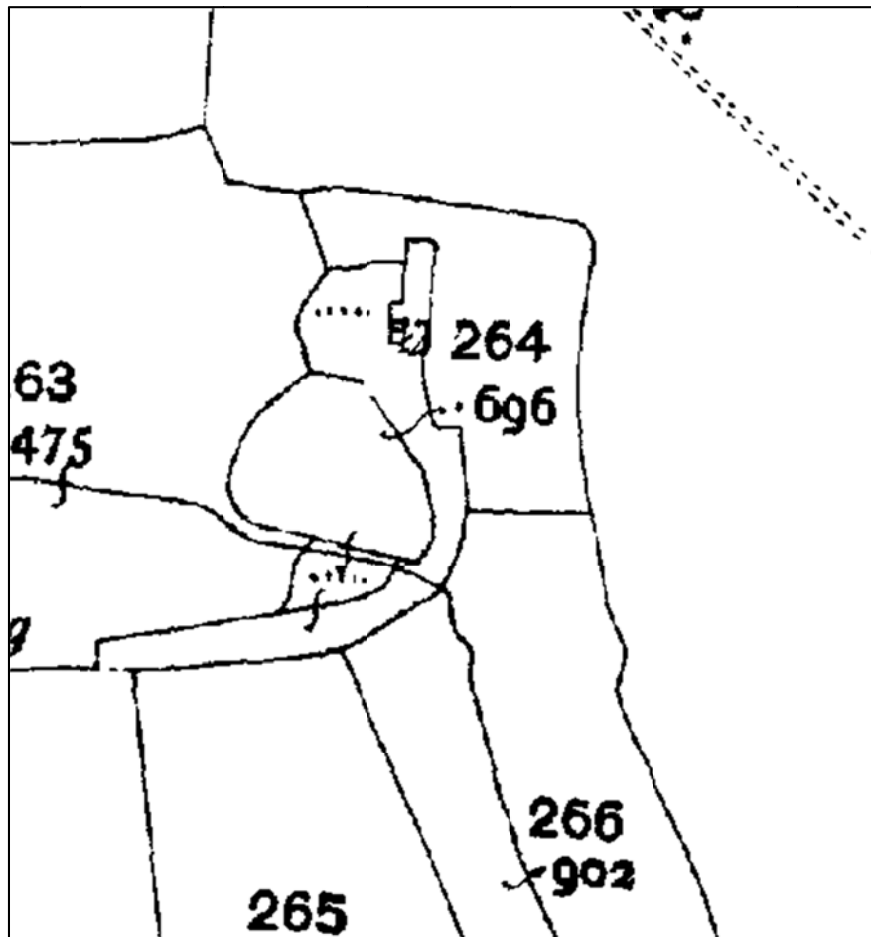
Detail from the Ordnance Survey 2nd¹ edition map (1907) © and database right Crown copyright
and Landmark Information Group Ltd (All rights reserved 08/05/2012)

A minor farmstead known as Parsons marked but unnamed on the Ordnance Survey 1st edition map (1889). At a field visit in 2001 it was described as ruined and overgrown. The outline of the buildings including house, yards and enclosures are still shown on the most recent Ordnance Survey mapping (Mastermap 2011). The present condition is unknown but recent aerial photographs (Ordnance Survey Next Perspectives 2009) show area overgrown with trees and vegetation.

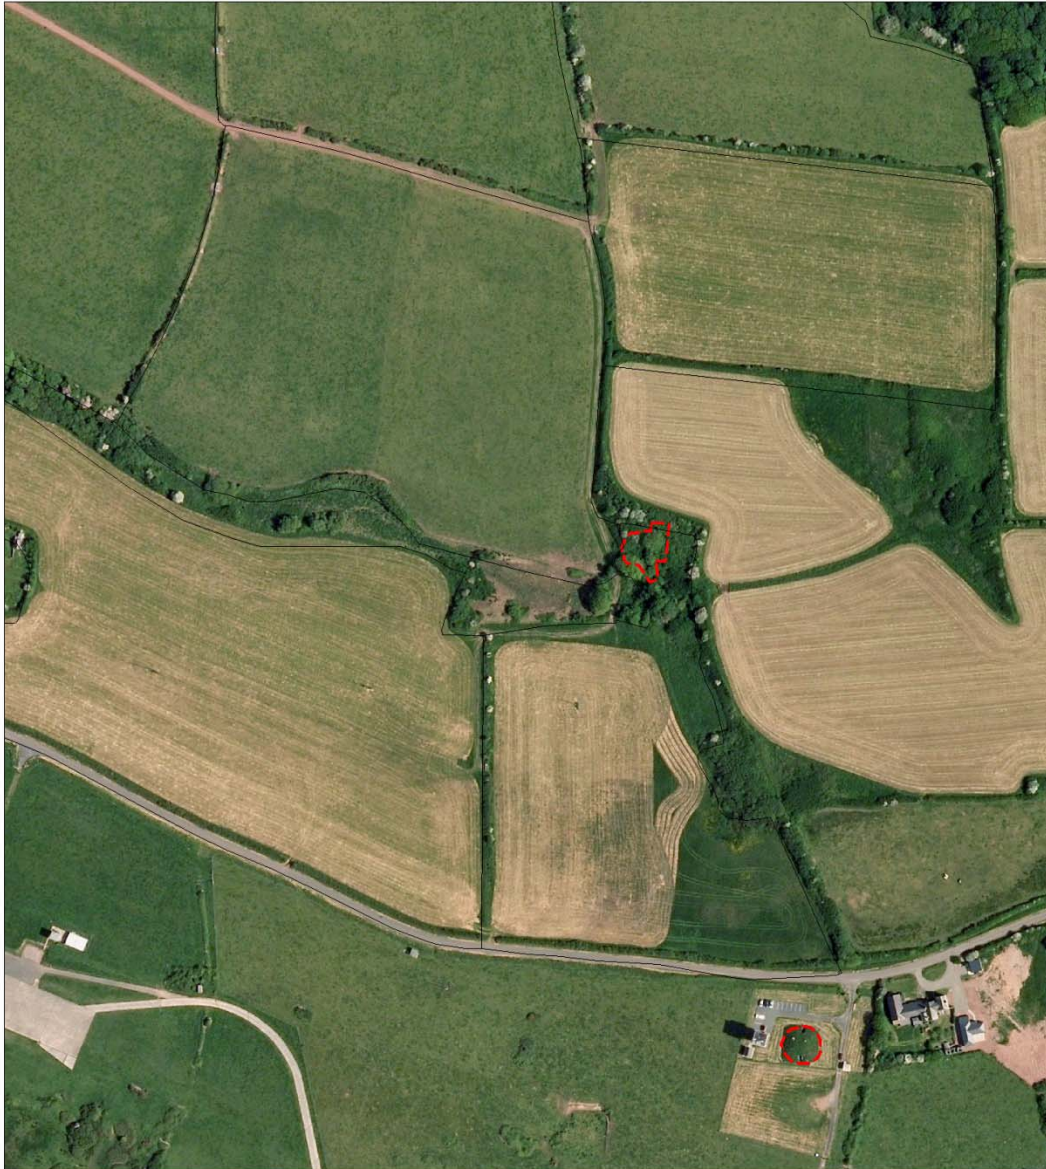
Aerial Photograph

The main management issue for this site is the control of vegetation which has the potential to damage both buried archaeological remains and the built structure through the disruptive activity of root development. Trees can pose a threat through wind throw or falling limbs.

- Remove mature trees which are at risk of wind throw and could threaten upstanding remains of the cottage and cottage enclosure through uprooting (root plate damage) or falling limbs.
- Remove any young trees or vegetation growing out of the wall tops but cutting by hand. Do not pull-up by the roots as this is potentially destabilising to masonry bonds.
- Cut any scrub back by hand in order to retain the visibility of the building ruins.
- Maintain a canopy of mature trees over the site. This will prevent light entering the ground, inhibiting scrubby vegetation growth.
