Historic Environment Feature Management Report:

Bryn Maen Mawr Ruined Farmstead

Customer Reference Number: A0025576

UID: 309802

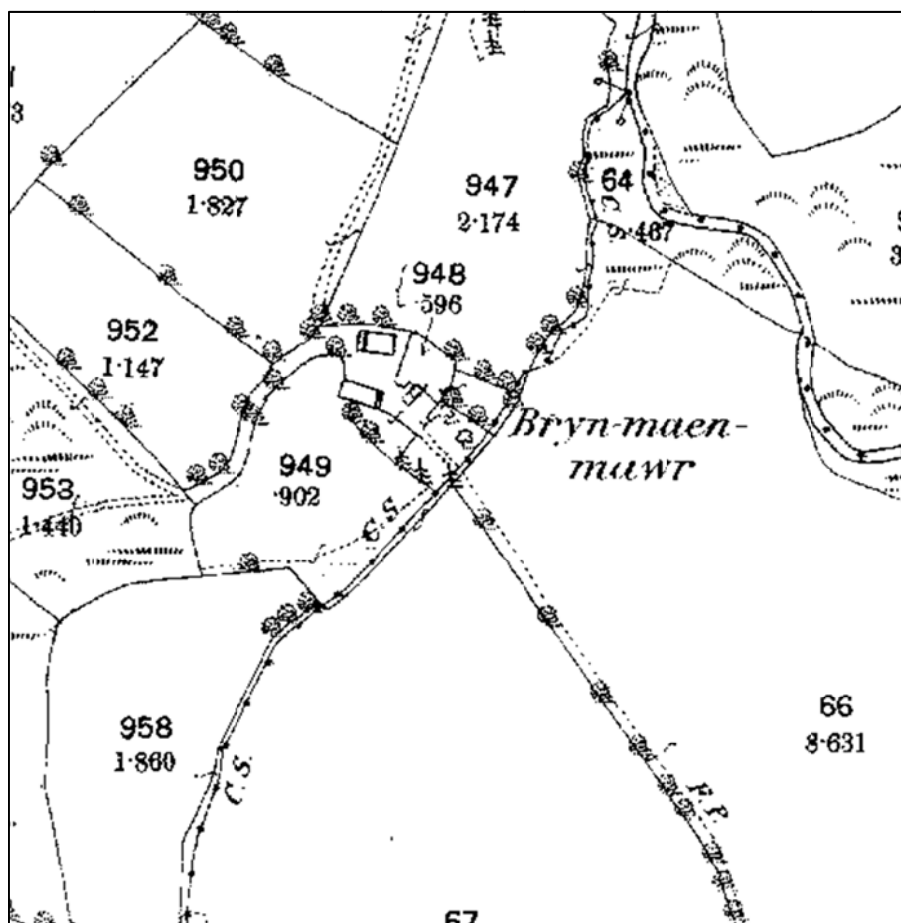
Detail from the Ordnance Survey 1st edition map (1889) © and database right Crown copyright and
Landmark Information Group Ltd (All rights reserved 08/05/2012)

A minor farmstead named as Bryn Maen Mawr on the Ordnance Survey 1st edition map (1889). It includes two opposing ranges of rectangular buildings one the farm house and the other a separate barn. There are two small fields around the buildings, which may have been gardens or paddocks.

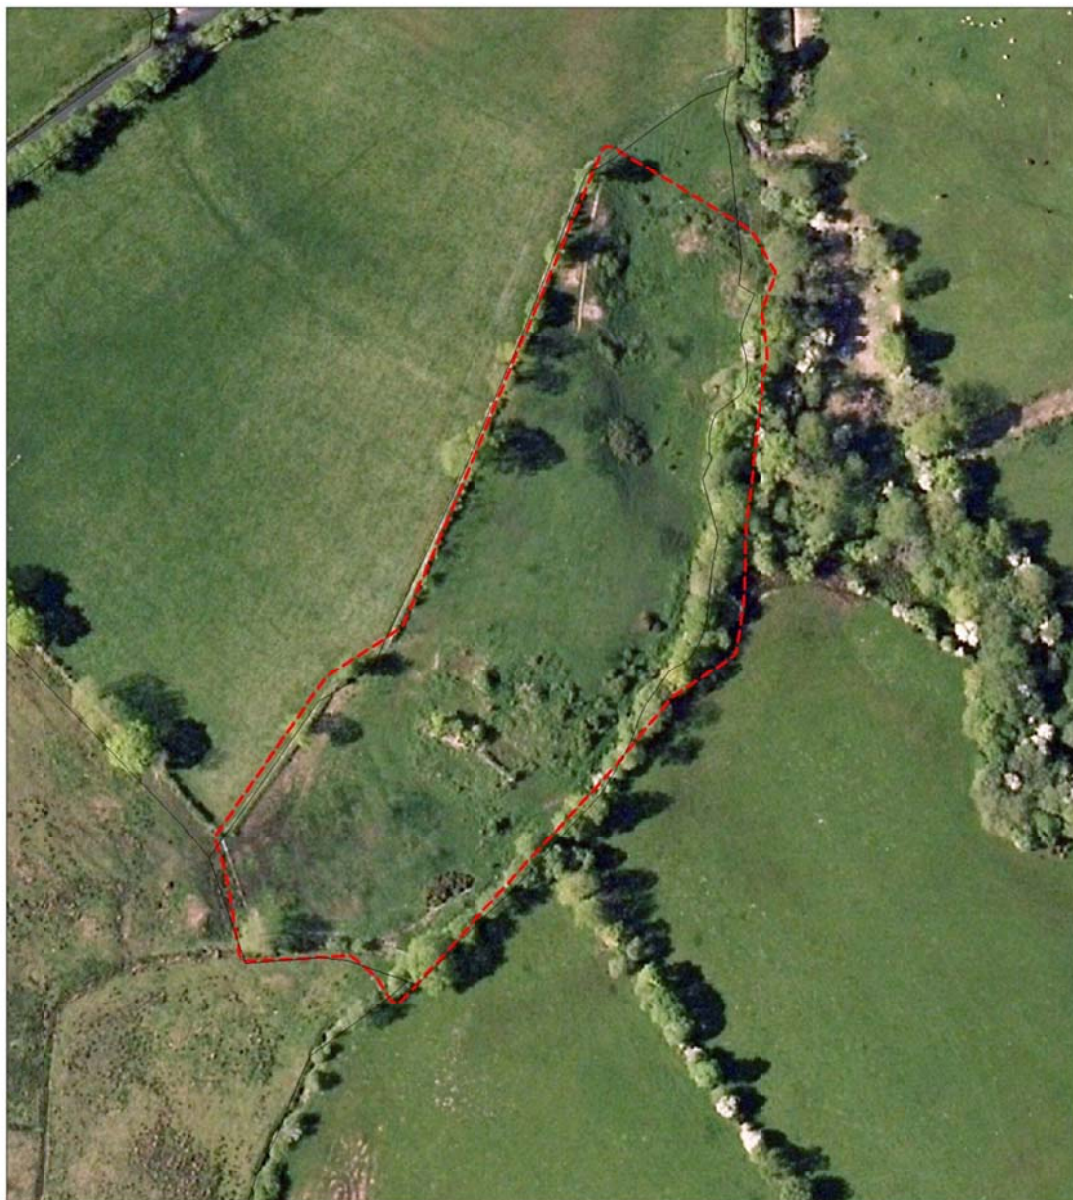
Aerial Photograph

The buildings are not shown on the most recent Ordnance Survey mapping (Mastermap 2011). However recent aerial photographs (Ordnance Survey Next Perspectives 2009) clearly show the remains of walls of the buildings and fields now ruined and partly overgrown with vegetation and rough grass.

- Cut back vegetation by hand in order to prevent further damage and to enhance the visibility of the structure.
- Do not pull-up by the roots as this is potentially destabilising to masonry bonds.
- Manage livestock levels on the ruins by fencing where appropriate.
